037-124-014 CE13-0012 211 THERESA STREET

CODE ENFORCEMENT OFFICER
CASSIDY ANDERSON
NOVEMBER 8, 2021

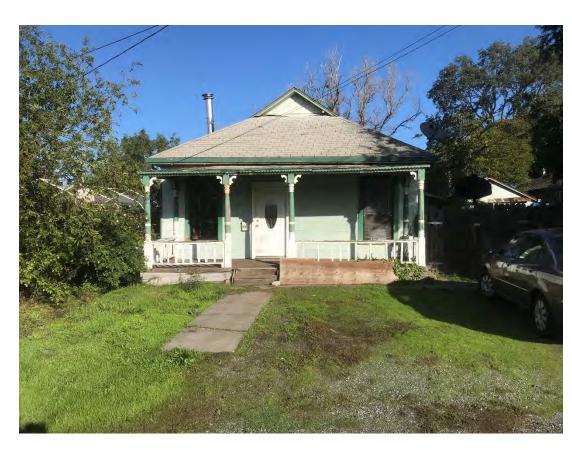
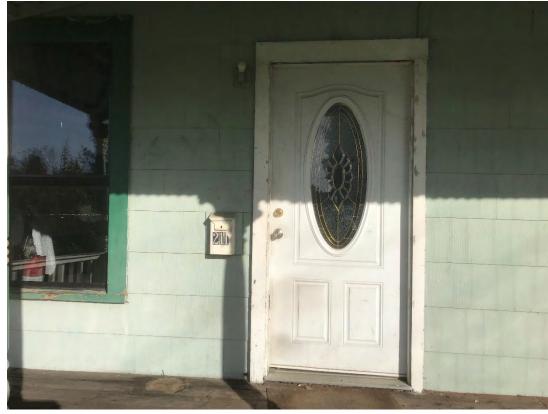
211 Theresa St Property frontage

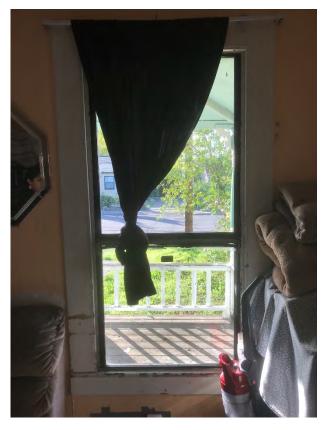
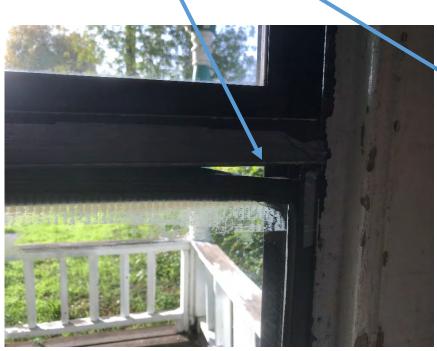
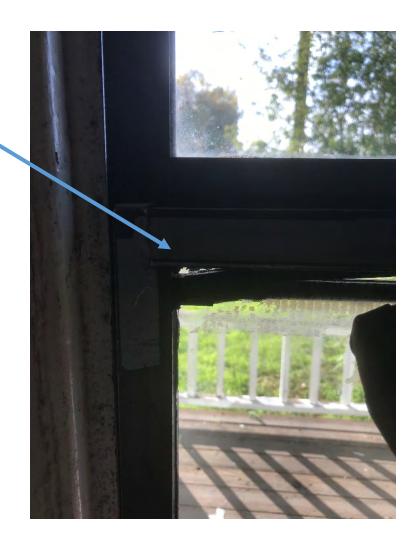
211 Theresa St Window seal is not weather tight Living room window

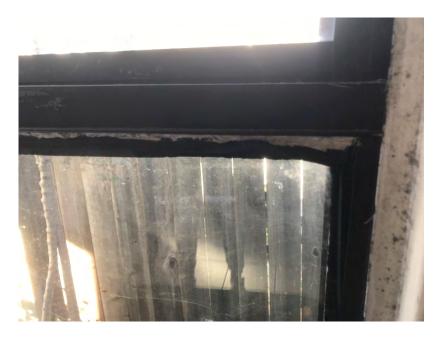
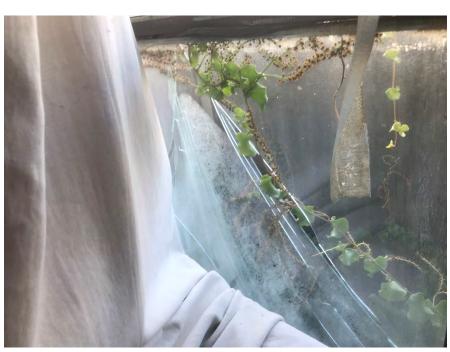
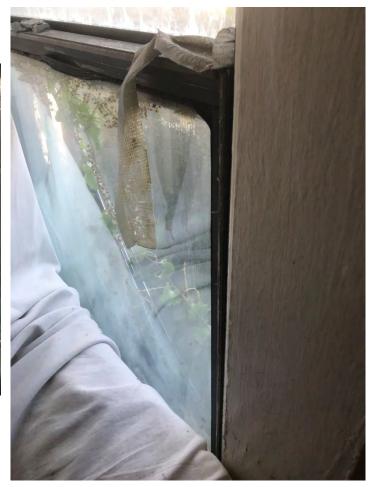
211 Theresa St Glazing broken

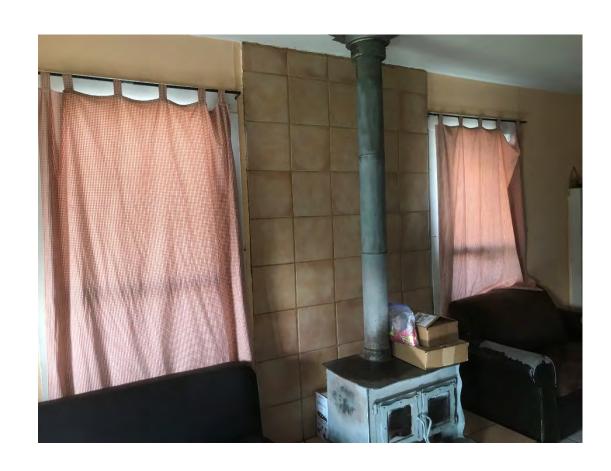
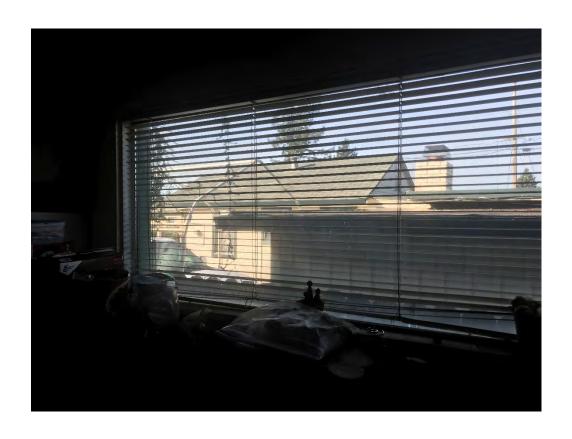
211 Theresa St Living room windows and kitchen windows

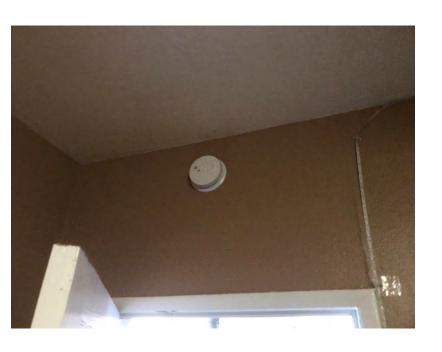
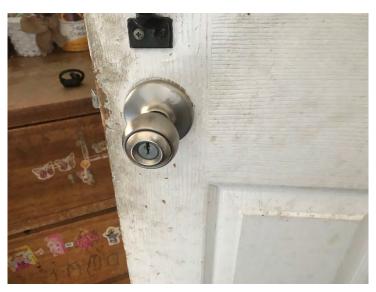
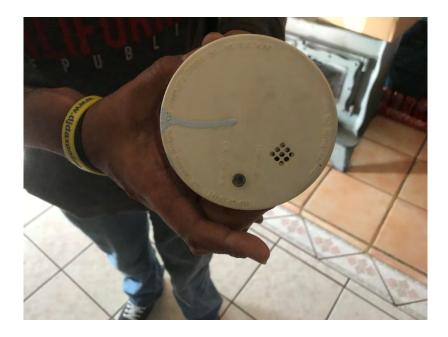
211 Theresa St.
Combo Smoke detector and carbon monoxide detector
Keyed locks on both bedrooms

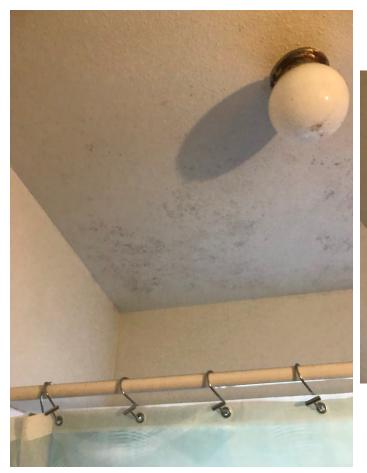
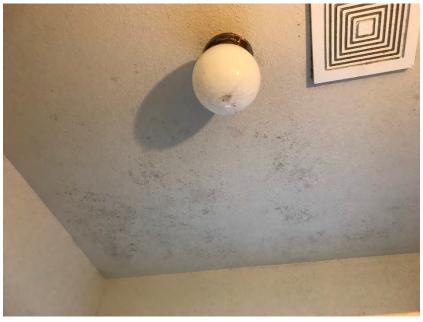
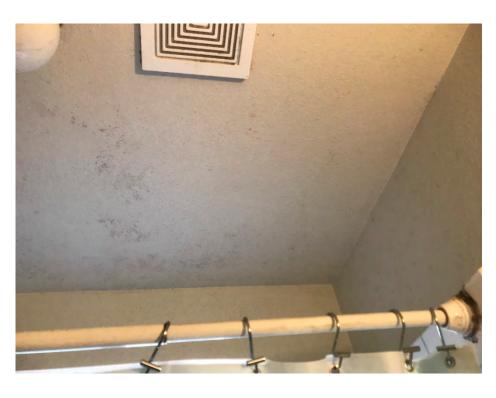
211 Theresa St Mildew on bathroom ceiling and wall

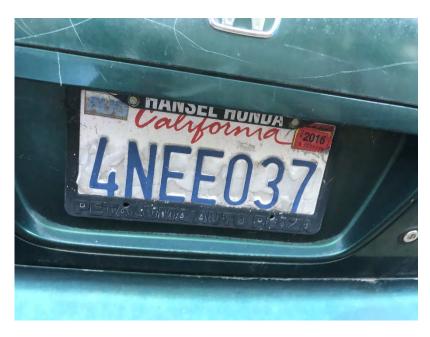
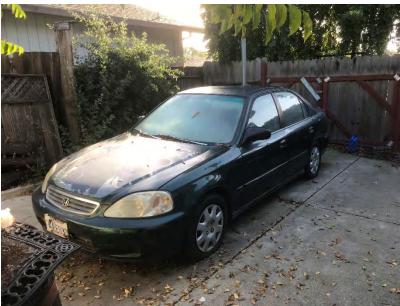
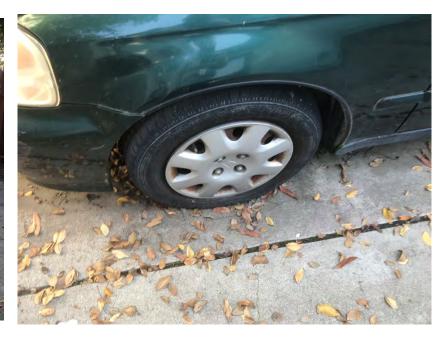
211 Theresa St Inoperable and unregistered vehicle

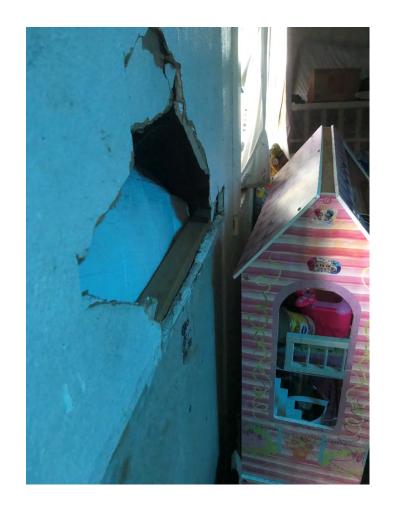
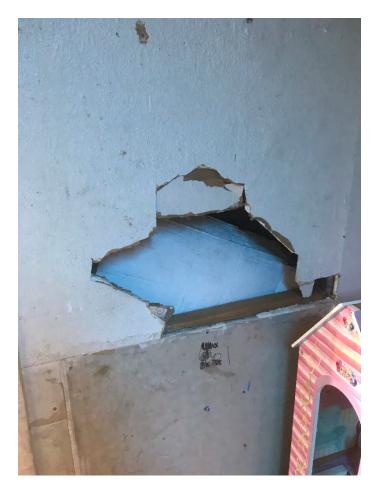
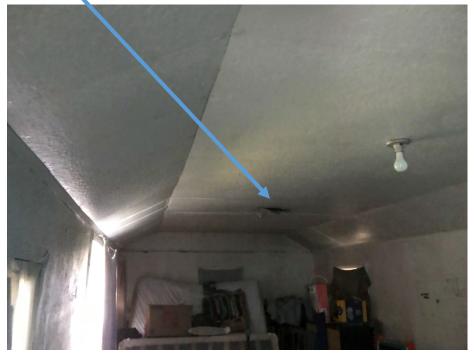
211 Theresa St Unapproved materials used to cover detached garage walls penetration in fire rating, required 5/8 or ½ inch gypsum board

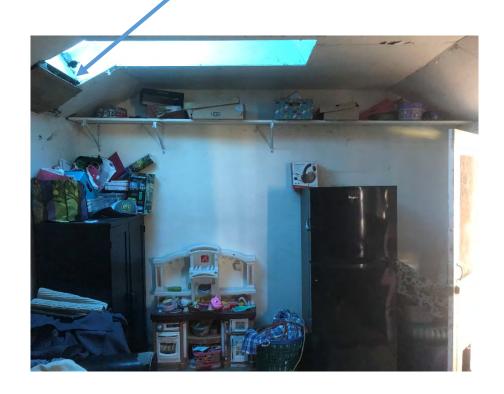
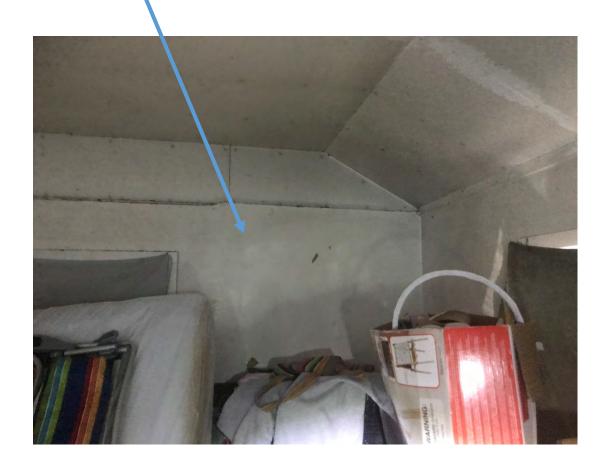
Detached garage door covered without benefit of permit

Extension cords have been removed

water intrusion at skylight

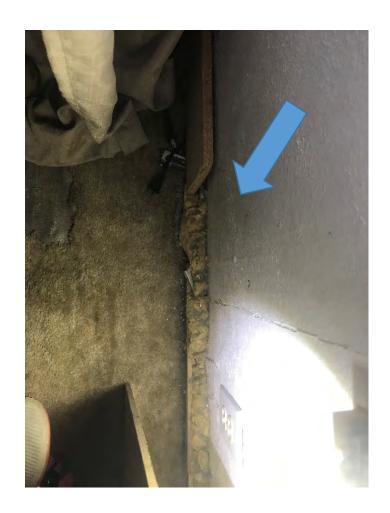
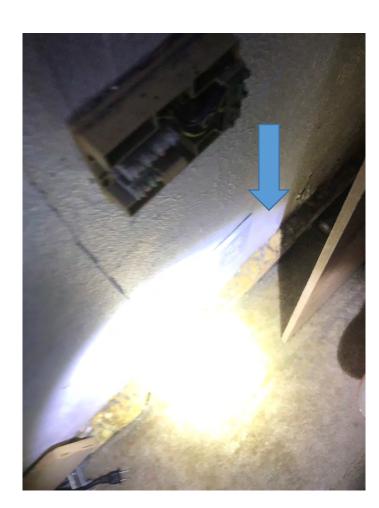
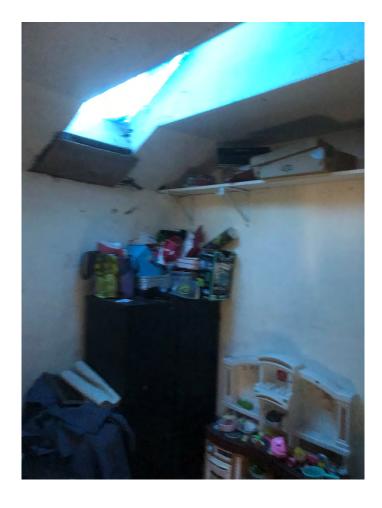
211 Theresa St Foam spray and particle board surrounding wall base in detached garage

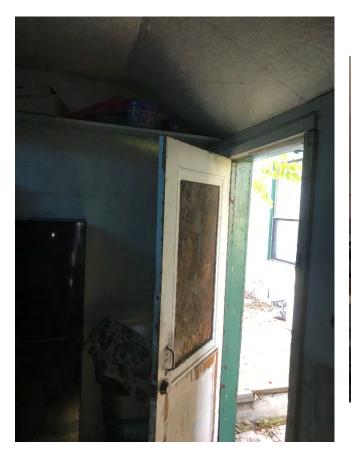
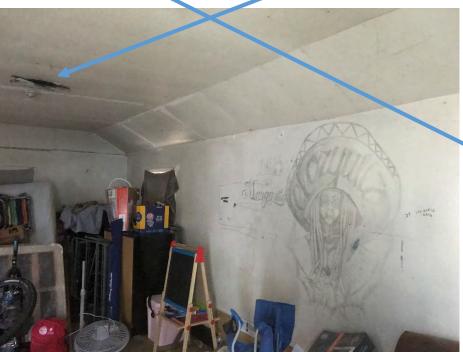
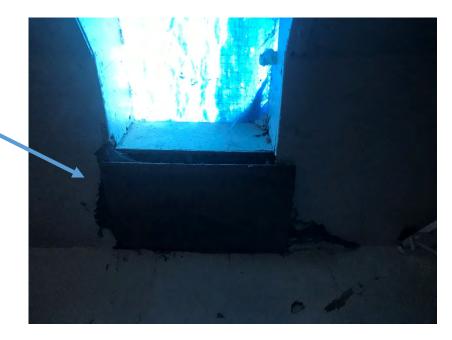
211 Theresa St Penetration in fire rating requires 5/8 or ½ inch gypsum board Water intrusion

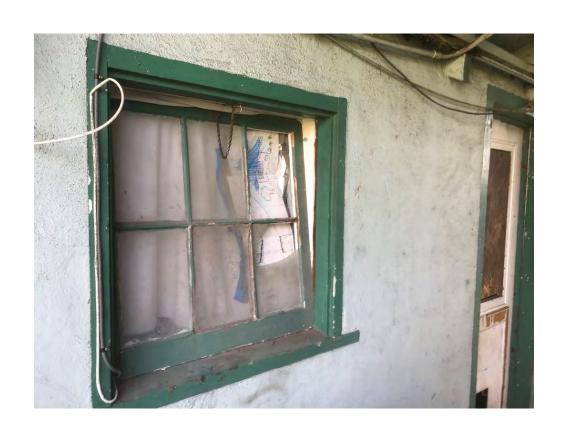
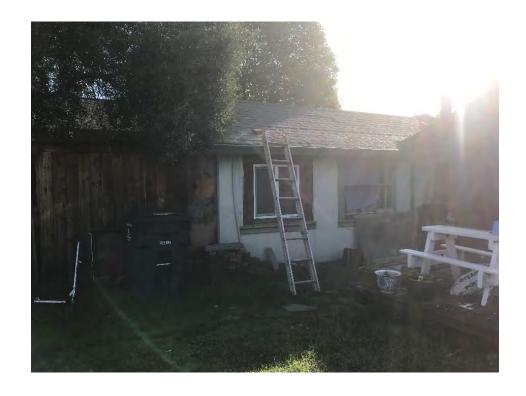
211 Theresa St glazing broken in window glazing

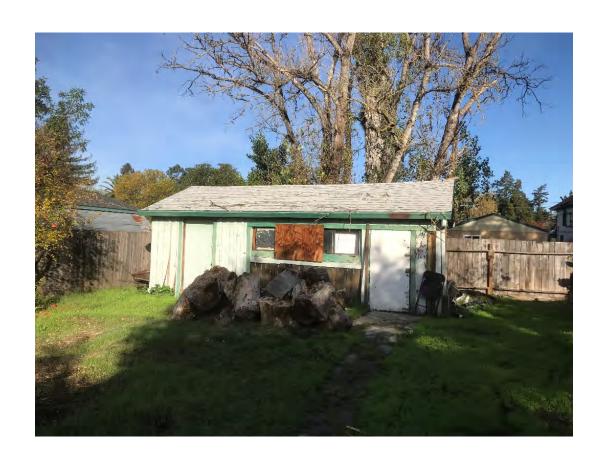
211 Theresa St Existing accessory structure with unpermitted electrical

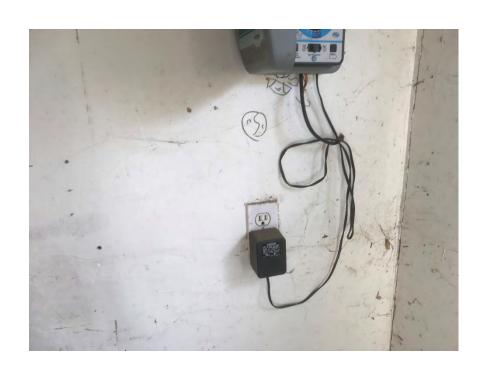
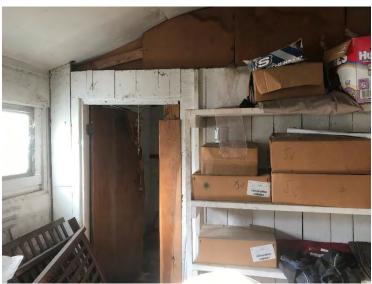
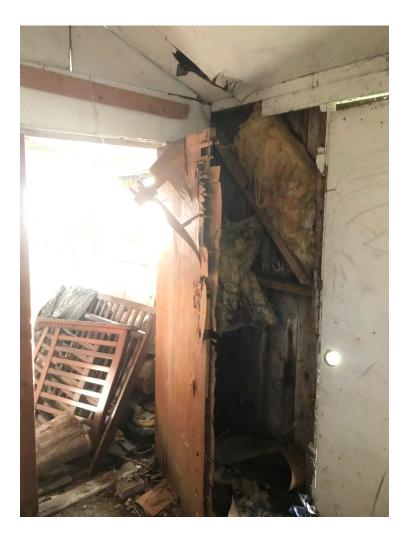
211 Theresa St Unpermitted electrical in existing accessory structure

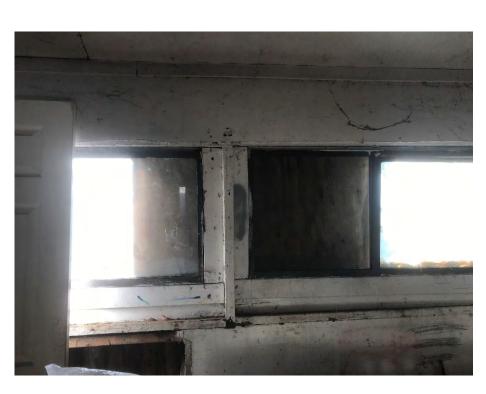
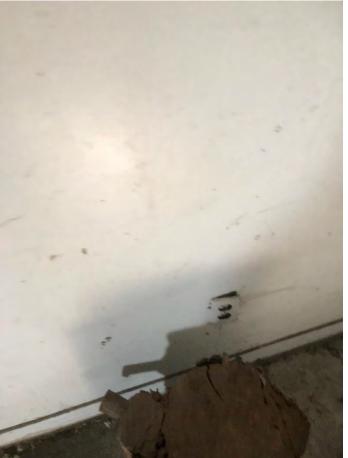
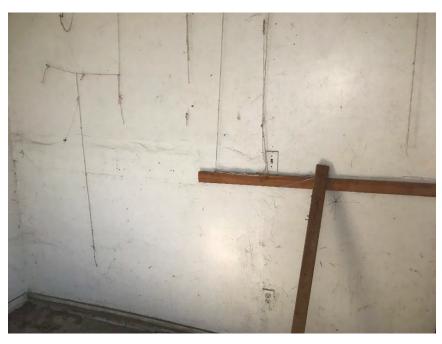
211 Theresa St Unpermitted electrical throughout detached structure
