## MEMORANDUM

**PROJECT:** Luther Burbank Home and Gardens Re-Roofing Project  
TreanorHL Project #: HP0883.2001.00

The purpose of this Memorandum is to outline the research undertaken to date on the roofs of the Main House and Carriage House and to provide recommendations for the re-roofing project.

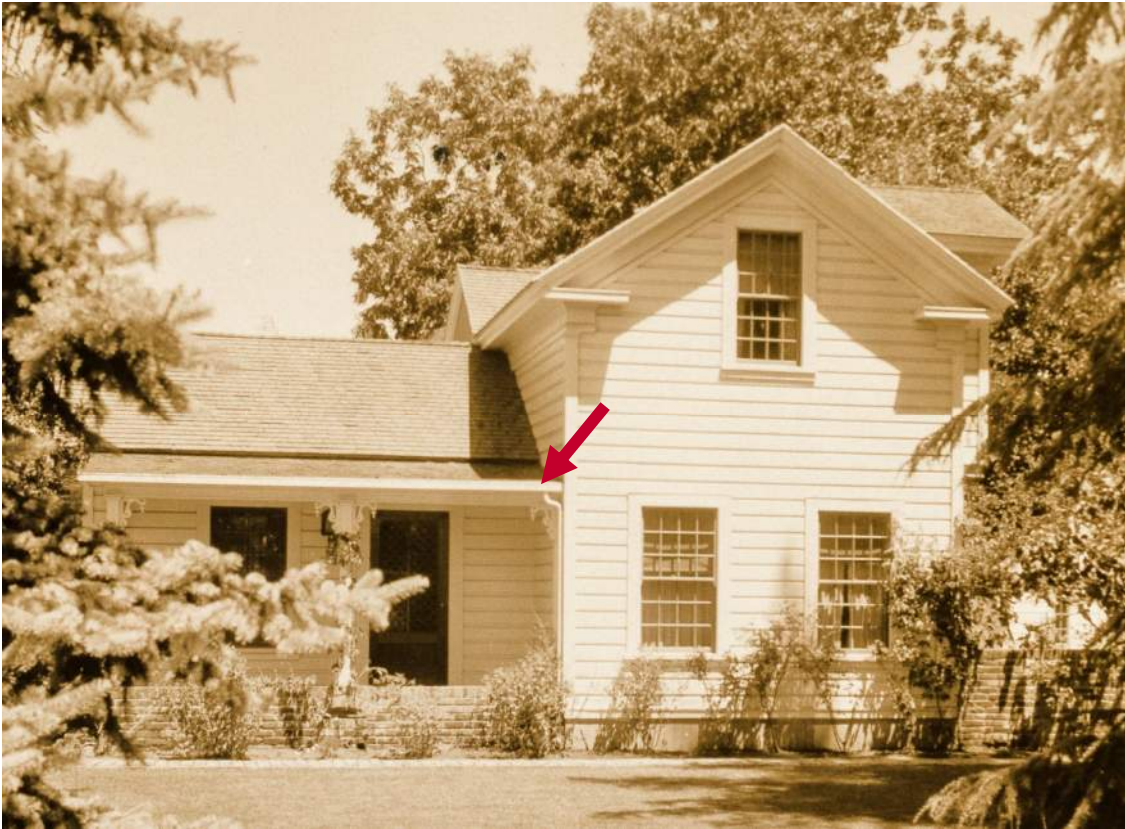
Image courtesy of the City of Santa Rosa and the Luther Burbank Home & Gardens Association c.1930. Only part of the original photograph is shown. Note wood shingle roof and new gutter and down spout at the porch (identified with the red arrow).

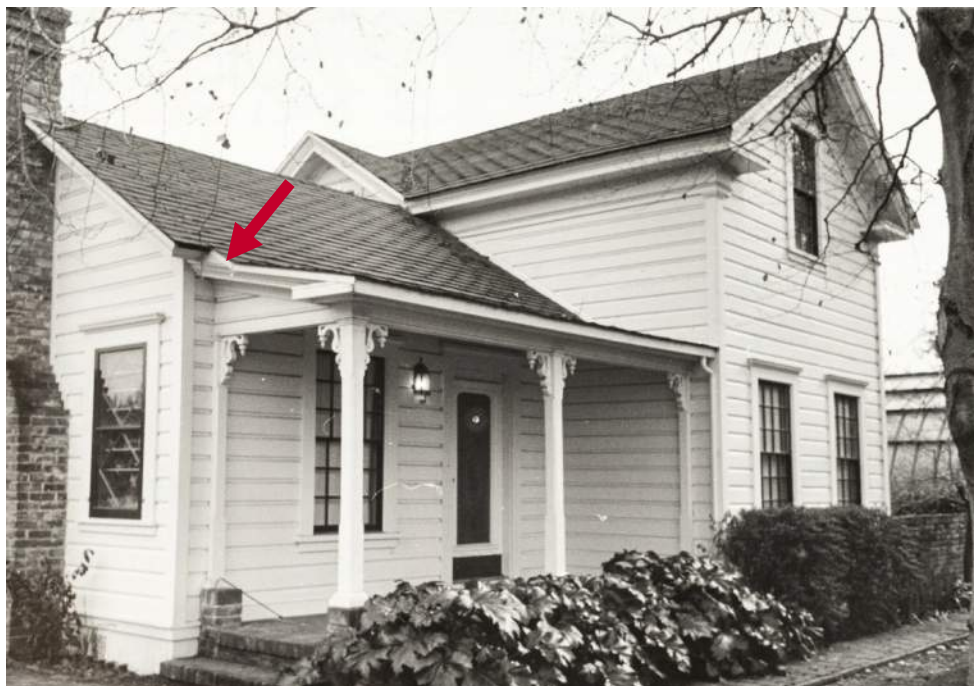
Image courtesy of the Western Sonoma County Historical Society Collection c.1940. Rolled asphalt roofing has been applied to the roof of the Main House. Note connection between the main roof and the porch roof (red arrow).

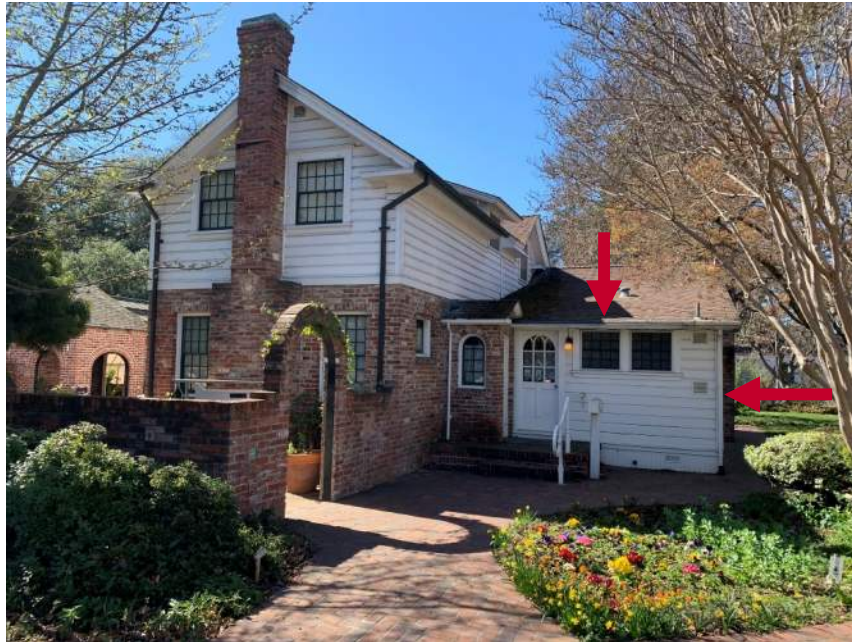
Current image of rear (east) elevation of Main House. Note the existing asphalt roofing is a red-brown color. One alteration to the gutters and downspouts is the installation of a new gutter and downspout on the east elevation (red arrows). This newer gutter and downspout replaced the existing wood box gutter integral to the cornice that was shingled over and abandoned at this location.

The original Main House had no gutters or downspouts. There are currently two types of drainage systems on the Main House, installed c.1930 and c.1940. These include the wood box gutter integral to the cornice with metal downspouts at three locations and copper gutters and downspouts. It is recommended that the existing wood box gutter integral to the cornice be reactivated as part of the project. The wood gutters will be inspected for reuse when the shingles are removed from the roof and the downspouts from c.1930 shall be reviewed for reuse as these appear to be in good condition. The gutters and downspouts from c.1940 are of copper, in good condition, and should remain. Also, it is recommended to install a new gutter and downspout at one location on the north elevation. This new gutter and downspout will be of painted aluminum or galvanized steel, and designed to blend into the edge of the roof and to the building to the greatest extent possible.

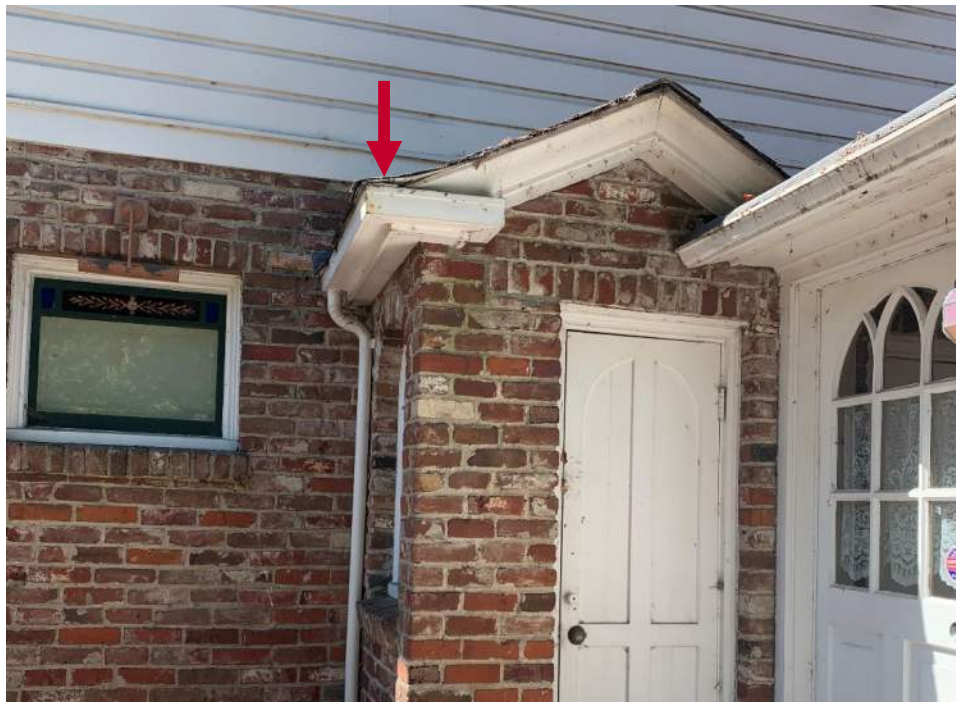
Current image of rear (north) elevation of Main House. An alteration to the drainage system is that the existing wood box gutter integral to the cornice has been shingled over at this location.

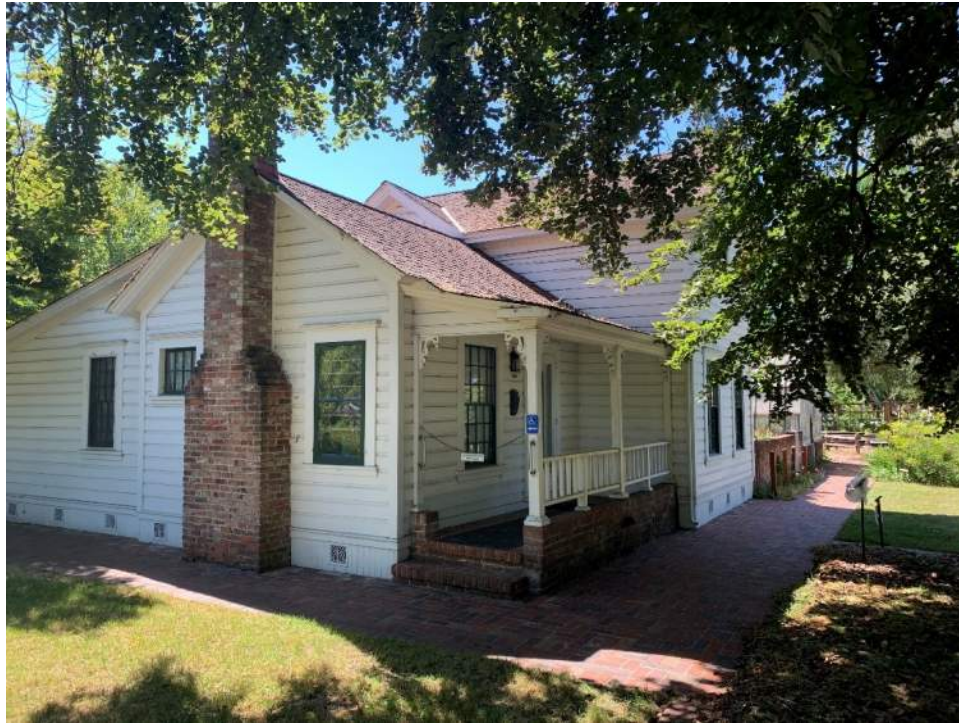
Current image of west elevation of Main House. Another alteration to the drainage system is that the existing wood box gutter integral to the cornice has been shingled over at this location.

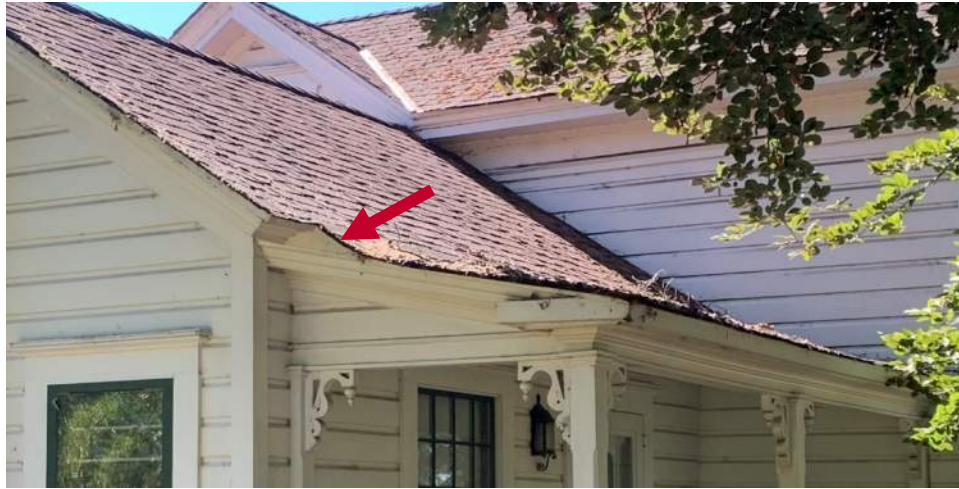
Current image of porch roof on west elevation of Main House.

The project proposes to remove the connection between the main roof and porch roof. This will help restore the original look of the porch area which historically featured two separate roof surfaces.

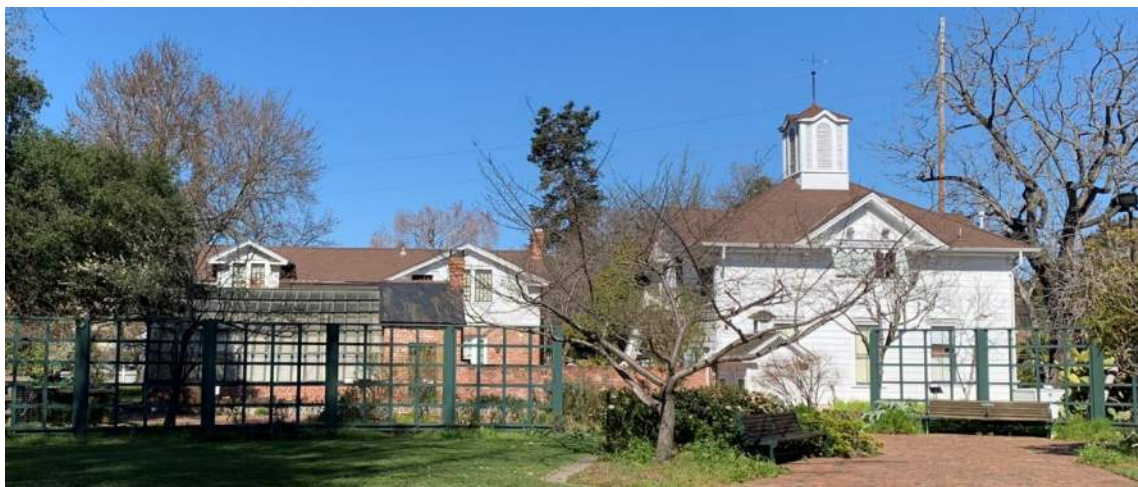
The Carriage House currently exhibits the same red-brown asphalt roofing material as the Main House suggesting that the work was done at the same time, c.1980. The cupola was also reconstructed c.1980.

Current image of south elevation of Carriage House. Note existing red-brown color of the asphalt roofing.

The Carriage House retains a strong association with Luther Burbank due to his involvement in the construction and relatively few alterations over time. A new wood shingle roof would be the most compatible choice for the building, but fire codes prohibit the use of wood roofing. Therefore, it is recommended that new asphalt roofing material simulate the original roofing to the greatest extent possible in size, shape, and color. The color of the Carriage House roof should match that of the Main House. The gutters and downspouts date to 2014 and are recommended to remain in place with any deficiencies repaired as part of the project.
