MEMORANDUM

PROJECT: Luther Burbank Home and Gardens Re-Roofing Project
TreanorHL Project #: HP0883.2001.00

The purpose of this Memorandum is to outline the research undertaken to date on the roofs of the Main House and Carriage House and to provide recommendations for the re-roofing project.

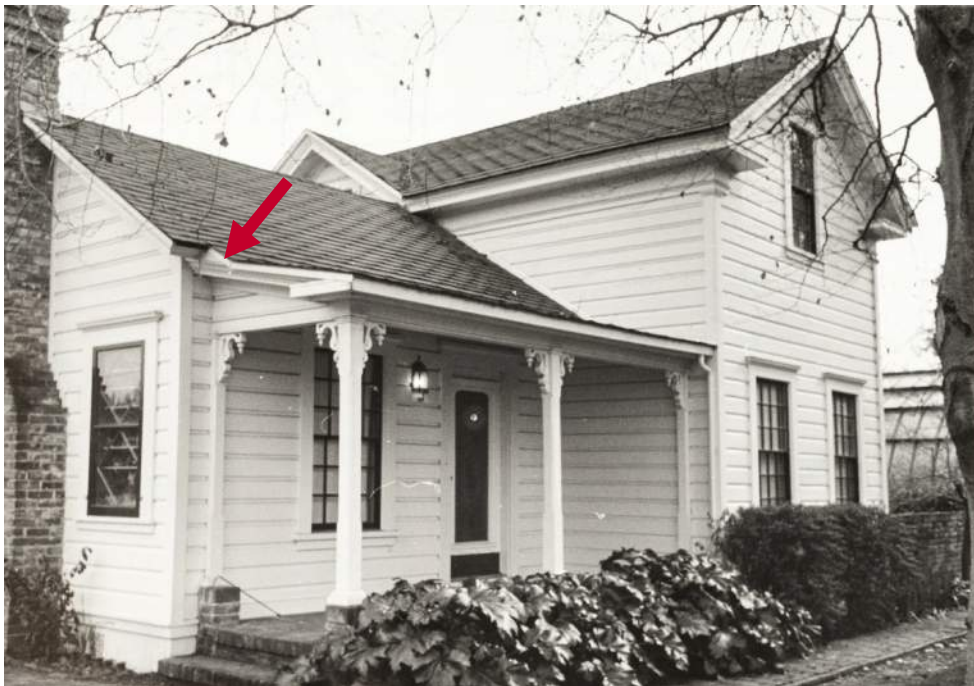
Image courtesy of the Western Sonoma County Historical Society Collection c.1940. Rolled asphalt roofing has been applied to the roof of the Main House. Note connection between the main roof and the porch roof (red arrow).

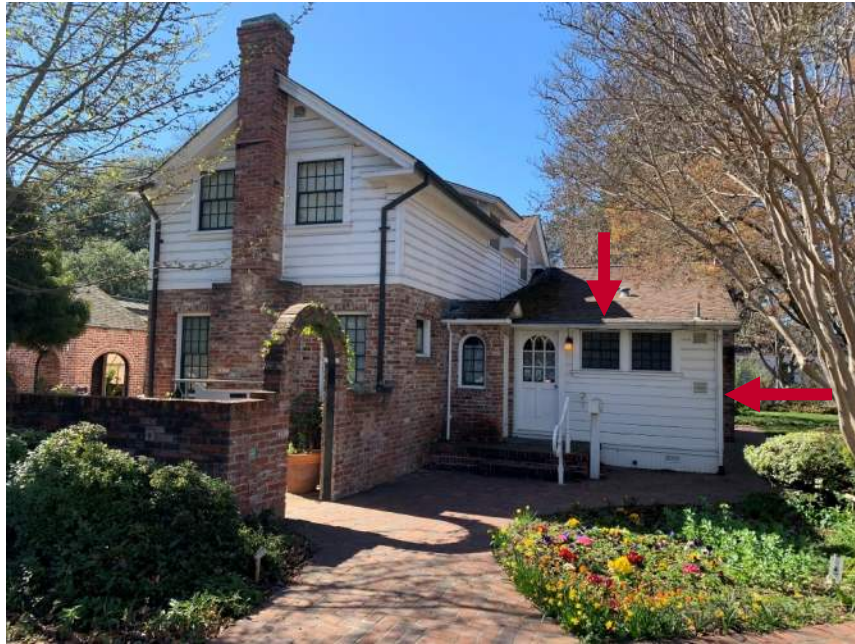
Current image of rear (east) elevation of Main House. Note the existing asphalt roofing is a red-brown color. One alteration to the gutters and downspouts is the installation of a new gutter and downspout on the east elevation (red arrows). This newer gutter and downspout replaced the existing wood box gutter integral to the cornice that was shingled over and abandoned at this location.

The original Main House had no gutters or downspouts. There are currently two types of drainage systems on the Main House, installed c.1930 and c.1940. These include the wood box gutter integral to the cornice with metal downspouts at three locations and copper gutters and downspouts. It is recommended that the existing wood box gutter integral to the cornice be reactivated as part of the project. The wood gutters will be inspected for reuse when the shingles are removed from the roof and the downspouts from c.1930 shall be reviewed for reuse as these appear to be in good condition. The gutters and downspouts from c.1940 are of copper, in good condition, and should remain. Also, it is recommended to install a new gutter and downspout at one location on the north elevation. This new gutter and downspout will be of painted aluminum or galvanized steel, and designed to blend into the edge of the roof and to the building to the greatest extent possible.

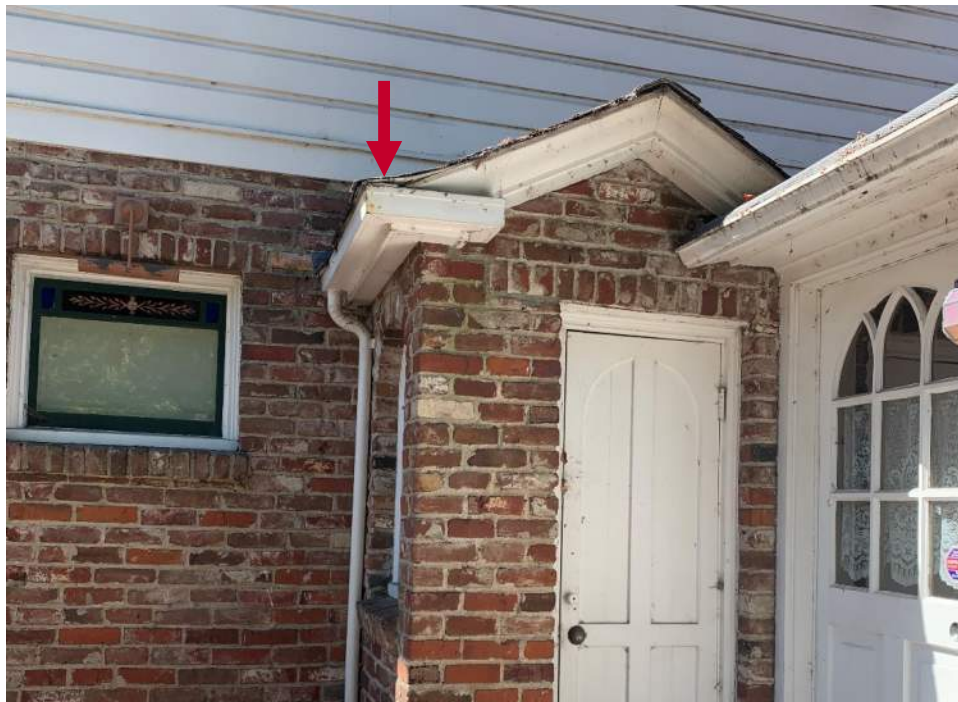
Current image of rear (north) elevation of Main House. An alteration to the drainage system is that the existing wood box gutter integral to the cornice has been shingled over at this location.

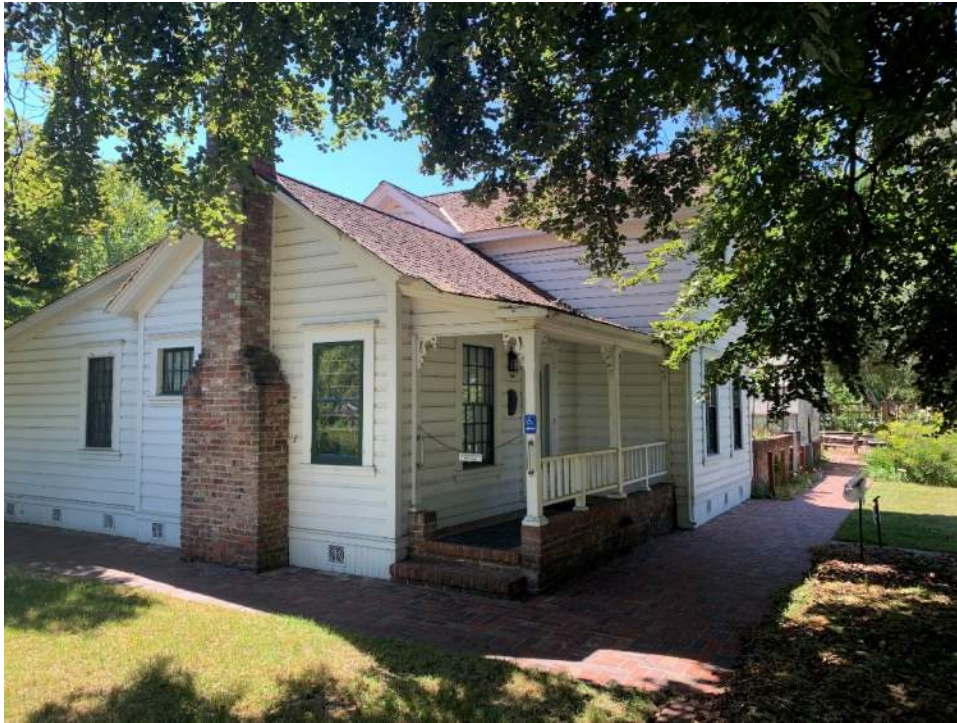
Current image of west elevation of Main House. Another alteration to the drainage system is that the existing wood box gutter integral to the cornice has been shingled over at this location.

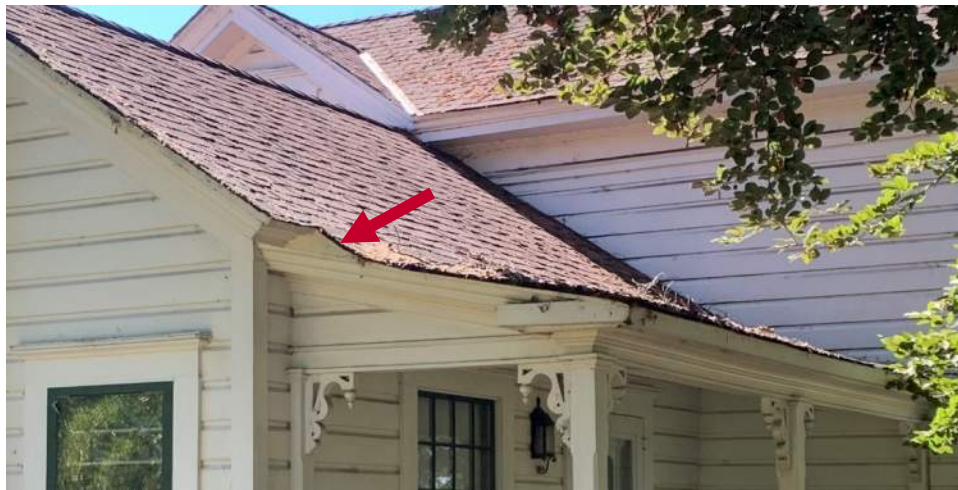
Current image of porch roof on west elevation of Main House.

The project proposes to remove the connection between the main roof and porch roof. This will help restore the original look of the porch area which historically featured two separate roof surfaces.

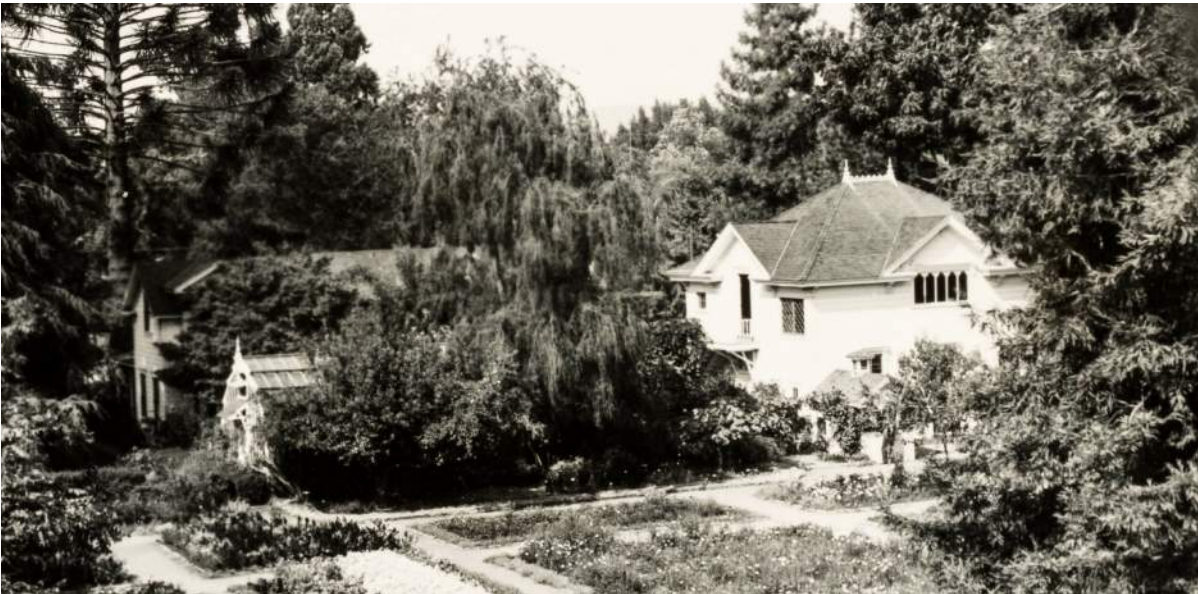
Image courtesy of the Luther Burbank Home & Gardens Association. c.1953. Only part of the original photograph is shown.
Note missing cupola and cresting on roof of Carriage House.
