PENSTEMON PLACE

SANTA ROSA, CA.

ARBORIST'S REPORT Tree Inventory & Evaluation

May 21, 2018

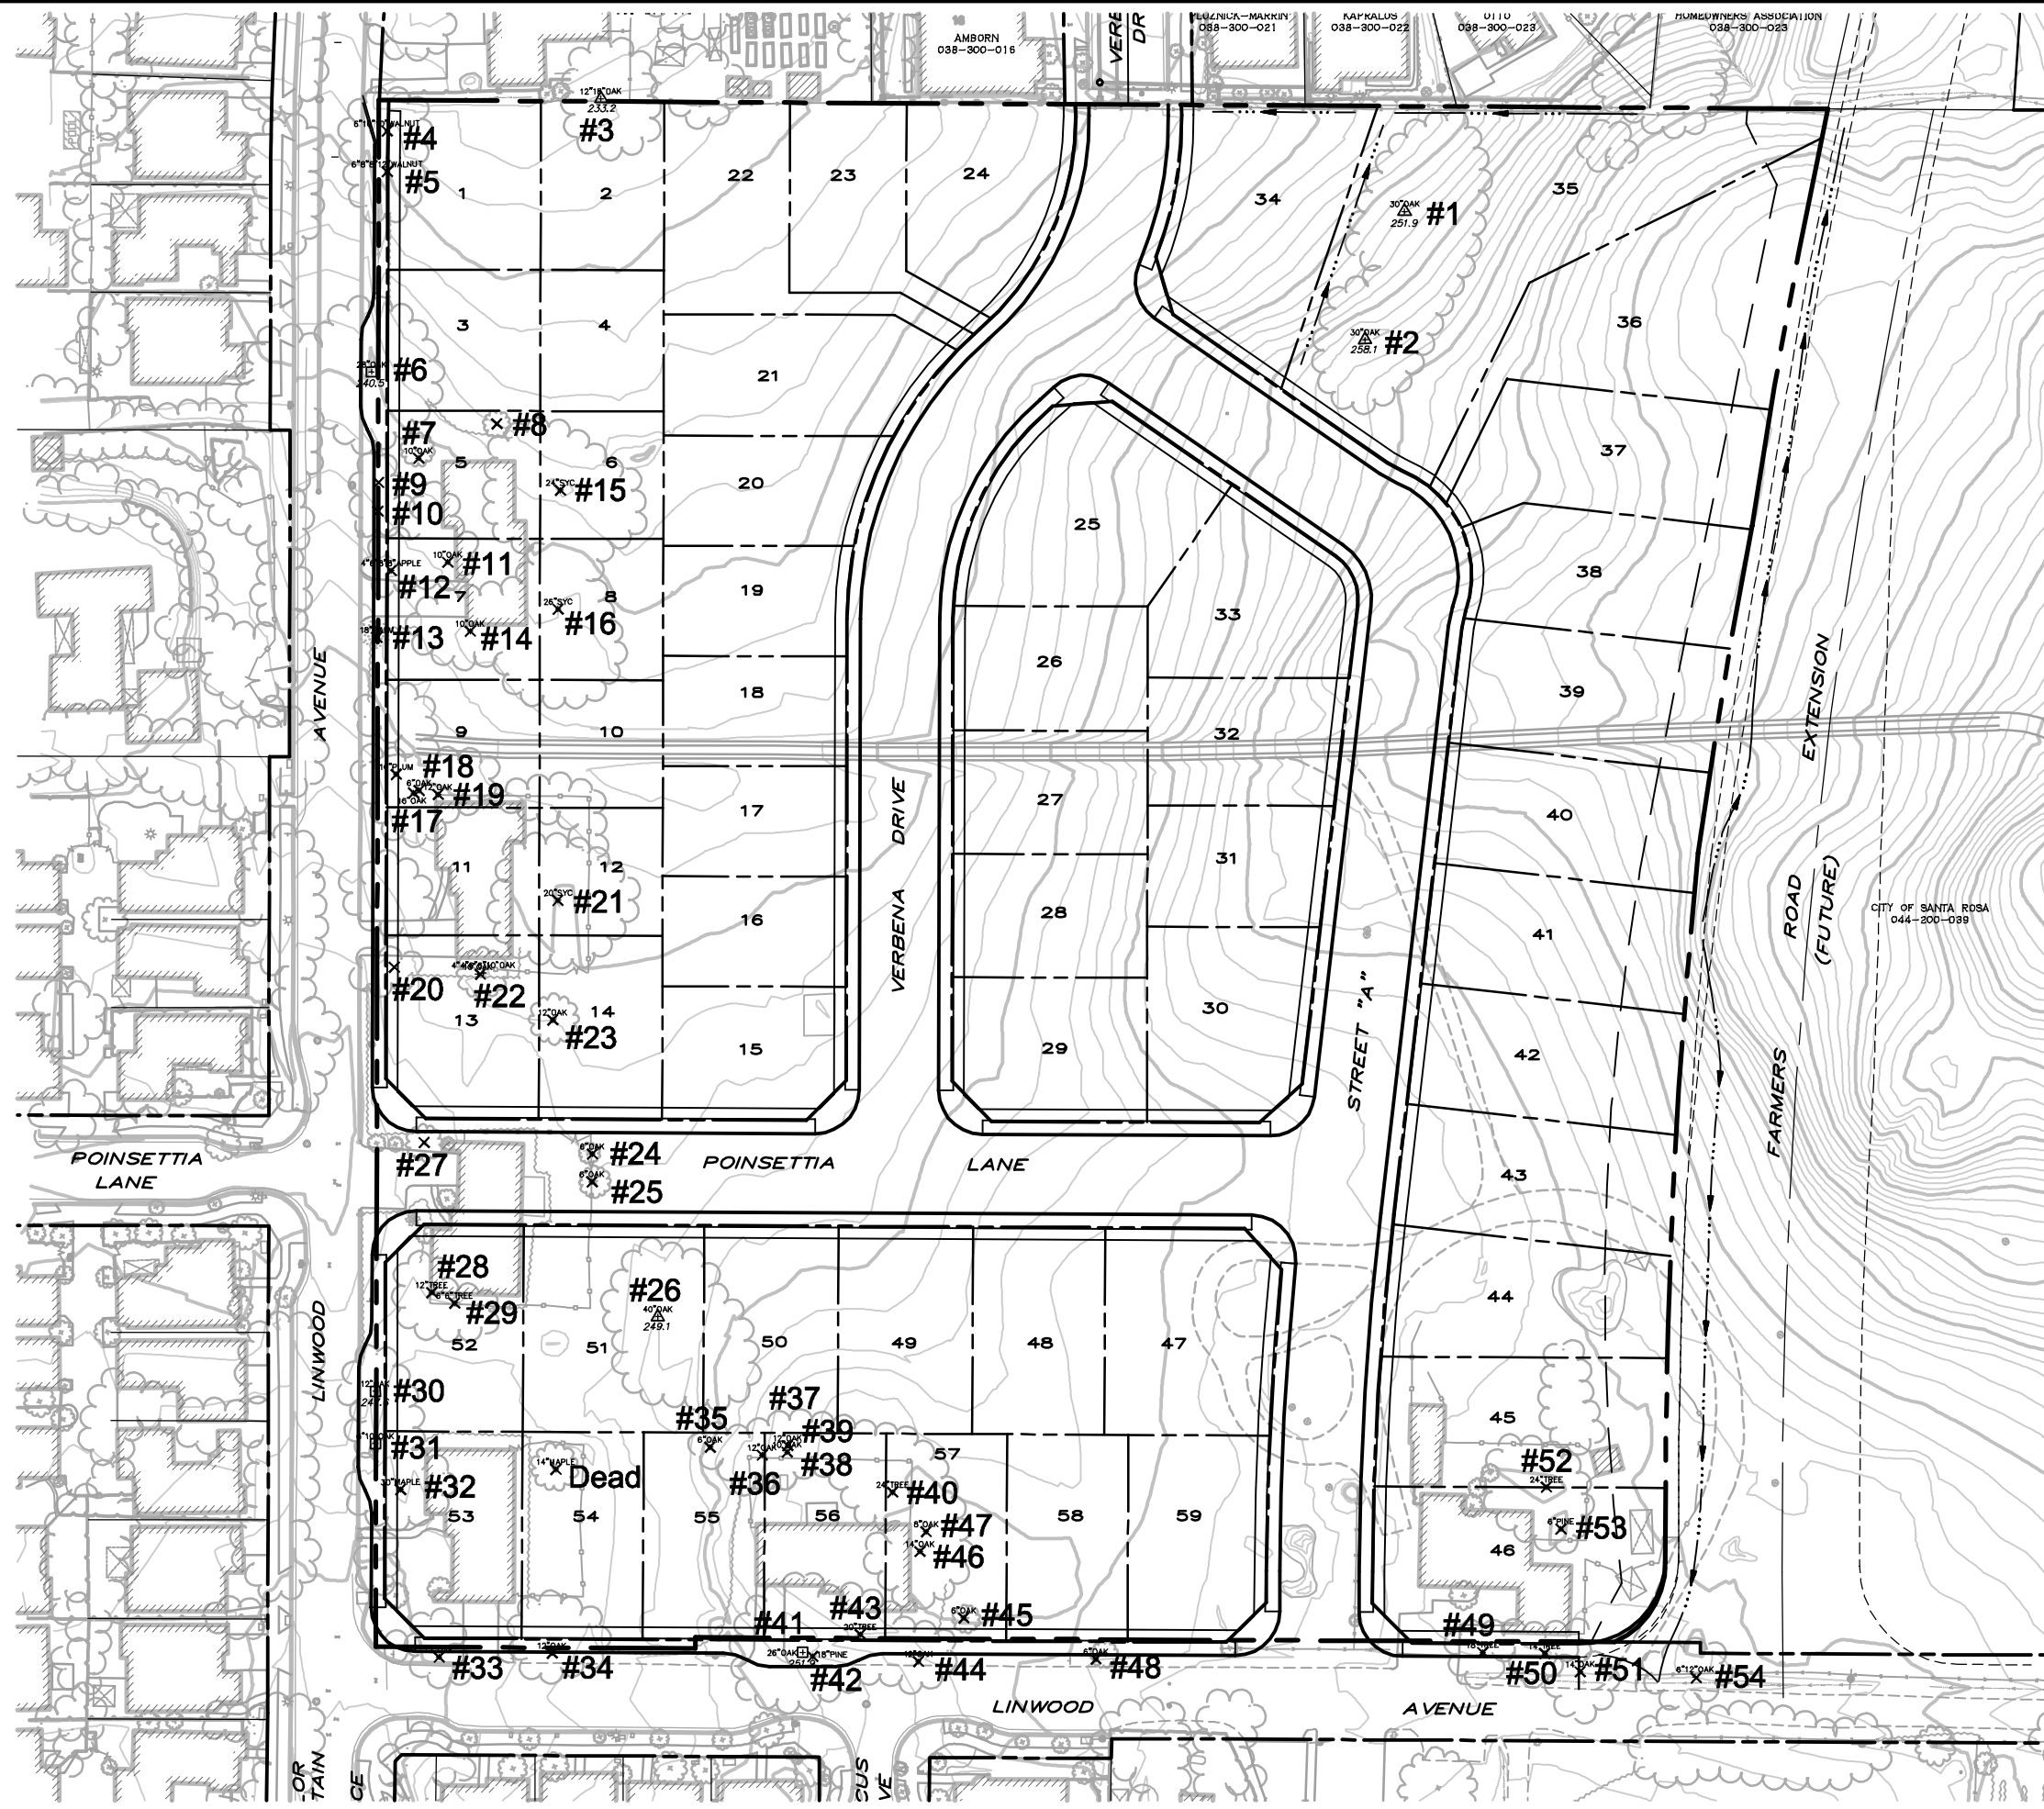
TREE LOCATION MAP PENSTEMON PLACE

TREE #	SPECIES	TRUNK DIAMETER (In.)	GENERAL HEALTH/CONDITIO	STRUCTURAL INTEGRITY	CONSTRUCTION IMPACT/RECOMMENDATIONS
1	Valley Oak/ <i>Quercus lobata</i>	34"	Good	Good	To be preserved; site plan has been developed to protect; heritage tree
2	Valley Oak/ <i>Quercus lobata</i>	30"	Good/Excellent	Good	To be preserved; site plan has been developed to protect; heritage tree
3	Coast Live Oak/ <i>Quercus agrifolia</i>	12,18"	Good/Excellent	Good	details of retaining wall and adjacent construction have been refined to protect tree
4	Black Walnut/ <i>Juglans nigra</i>	5,10,11"	Good	Good	To be removed for construction
5	Black Walnut/ <i>Juglans nigra</i>	6,7,7,8"	Fair	Fair	To be removed for construction
6	Valley Oak/ <i>Quercus lobata</i>	28"	Good/Excellent	Good/Excellent	Will attempt to preserve; may have to be removed; minimize depth of road section/paving; heritage tree
7	Coast Live Oak/ <i>Quercus agrifolia</i>	6,7" @ 3'	Good/Excellent	Good	To be removed for construction

8	Valley Oak/ <i>Quercus lobata</i>	5"	Good/Excellent	Good/Excellent	To be removed for construction
9	Black Acacia/ <i>Acacia melanoxylon</i>	6+ multi	Fair	Fair	To be removed for construction; exempt tree
10	Cherry/ <i>Prunus</i> sp.	4"+ multi	Fair	Fair	To be removed for construction; exempt tree
11	Valley Oak/ <i>Quercus lobata</i>	9"	Excellent	Good	To be removed for construction; heritage tree
12	Apple/ <i>Malus</i> sp.	3,4,6,7"	Good	Fair/Good	To be removed for construction; exempt tree
13	Mexican Fan Palm/ <i>Washingtonia robusta</i>	17"	Good	Fair/Good	To be removed for construction
14	Valley Oak/ <i>Quercus lobata</i>	12"	Good	Good	To be removed for construction; heritage tree
15	London Plane/ <i>Platanus x acerifolia</i>	25"	Excellent	Excellent	To be removed for construction
16	London Plane/ <i>Platanus x acerifolia</i>	30"	Excellent	Excellent	To be removed for construction
17	Coast Live Oak/ <i>Quercus agrifolia</i>	17"	Excellent	Good/Excellent	To be removed for construction

18	Coast Live Oak/ <i>Quercus agrifolia</i>	7"	Good	Good	To be removed for construction
19	Coast Live Oak/ <i>Quercus agrifolia</i>	13"	Good	Poor; fallen, growing horizontally	To be removed for construction
20	Coast Live Oak/ <i>Quercus agrifolia</i>	5"	Good/Excellent	Fair; poor form	To be removed for construction
21	London Plane/ <i>Platanus x acerifolia</i>	24"	Good/Excellent	Good/Excellent	To be removed for construction
22	Valley Oak/ <i>Quercus lobata</i>	4,4,5,6,6,7"	Good	Fair; multi-trunk	To be removed for construction; heritage tree
23	Coast Live Oak/ <i>Quercus agrifolia</i>	15" @ 2'	Excellent	Good	To be removed for construction
24	Valley Oak/ <i>Quercus lobata</i>	7"	Excellent	Good/Excellent	To be removed for construction; heritage tree
25	Valley Oak/ <i>Quercus lobata</i>	6"	Excellent	Excellent	To be removed for construction; heritage tree

TREE #	SPECIES	TRUNK DIAMETER (In.)	GENERAL HEALTH/CONDITIO	STRUCTURAL INTEGRITY	CONSTRUCTION IMPACT/RECOMMENDATIONS
26	Valley Oak/ <i>Quercus lobata</i>	39"	Good/Excellent	Good	To be preserved; low-branched on south & east; may need clearance pruning; heritage tree
27	Hackberry/ <i>Celtis</i> sp.	5"	Good/Excellent	Good	To be removed for construction
28	Black Acacia/ <i>Acacia melanoxylon</i>	14"	Good	Fair	To be removed for construction; exempt tree
29	Black Acacia/ <i>Acacia melanoxylon</i>	7,8"	Good	Fair	To be removed for construction; exempt tree
30	Valley Oak/ <i>Quercus lobata</i>	13"	Good	Good/Excellent	May be removed; minimize depth of road section/paving; monitor grading; heritage tree
31	Coast Live Oak/ <i>Quercus agrifolia</i>	7,11"	Good/Excellent	Good	May be removed; minimize depth of road section/paving; will need clearance pruning; heritage tree
32	Silver Maple/ <i>Acer saccharinum</i>	35"	Poor	Poor; fallen, decayed	Fallen, decayed; not viable, exempt tree; to be removed

33	Coast Live Oak/ <i>Quercus agrifolia</i>	10,14"	Excellent	Good	To be removed for construction; heritage tree
34	Coast Live Oak/ <i>Quercus agrifolia</i>	12"	Excellent	Fair	To be removed for construction
35	Valley Oak/ <i>Quercus lobata</i>	7"	Good/Excellent	Good	To be removed for construction; heritage tree
36	Coast Live Oak/ <i>Quercus agrifolia</i>	6"	Good/Excellent	Good	To be removed for construction
37	Valley Oak/ <i>Quercus lobata</i>	12"	Good	Good	To be removed for construction; heritage tree
38	Valley Oak/ <i>Quercus lobata</i>	9"	Good/Excellent	Good/Excellent	To be removed for construction; heritage tree
39	Valley Oak/ <i>Quercus lobata</i>	13"	Good/Excellent	Good/Excellent	To be removed for construction; heritage tree
40	Fruitless Mulberry/ <i>Morus alba</i>	20" @ 3'	Good/Excellent	Fair	To be removed for construction; exempt tree
41	Coast Live Oak/ <i>Quercus agrifolia</i>	28" @ 3'	Good/Excellent	Good	May have to be removed; minimize depth of road section/paving; monitor grading; will need clearance pruning; heritage tree

42	Monterey Pine/ <i>Pinus radiata</i>	20"	Good	Good	To be removed for construction; exempt tree
43	Fruitless Mulberry/ <i>Morus alba</i>	23"	Good	Fair	To be removed for construction; exempt tree
44	Coast Live Oak/ <i>Quercus agrifolia</i>	8,11"	Excellent	Good	To be removed for construction; heritage tree
45	Coast Live Oak/ <i>Quercus agrifolia</i>	7"	Excellent	Good	To be removed for construction
46	Coast Live Oak/ <i>Quercus agrifolia</i>	21"	Excellent	Good/Excellent	To be removed for construction; heritage tree
47	Coast Live Oak/ <i>Quercus agrifolia</i>	10"	Excellent	Good	To be removed for construction
48	Valley Oak/ <i>Quercus lobata</i>	4"	Good/Excellent	Good	To be removed for construction
49	Fruitless Mulberry/ <i>Morus alba</i>	18"	Good	Good	To be removed for construction; exempt tree

TREE #	SPECIES	TRUNK DIAMETER (In.)	GENERAL HEALTH/CONDITIO	STRUCTURAL INTEGRITY	CONSTRUCTION IMPACT/RECOMMENDATIONS
50	Fruitless Mulberry/ <i>Morus alba</i>	15"	Good	Fair	To be removed for construction; exempt tree
51	Coast Live Oak/ <i>Quercus agrifolia</i>	15"	Fair	Fair	To be removed for construction
52	Fruitless Mulberry/ <i>Morus alba</i>	27"	Good	Fair	To be removed for construction; exempt tree
53	Monterey Pine/ <i>Pinus radiata</i> Coast Live Oak/ <i>Quercus</i>	7"	Good	Good	To be removed for construction; exempt tree
54	<i>agrifolia</i>	5,7,11"	Good/Excellent	Good	To be removed for construction; heritage tree
