Painter Preservation
HISTORIC PRESERVATION & URBAN DESIGN

May 16, 2022

Re Historic Resource Evaluation (HRE) for Minor Landmark Alteration, 349 College Avenue

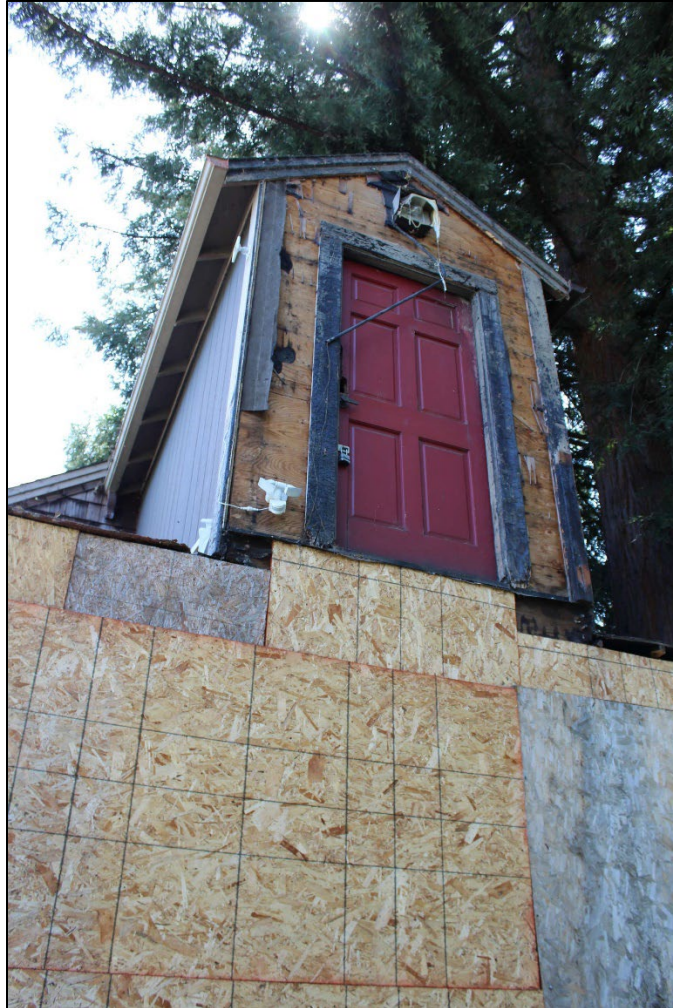
This report finds that the enclosed hallway on the second floor of the building (on the rear façade) and the modern concrete planter, which were added at about mid-20th-century, have not gained

significance in themselves. They were inconsistent with the building when added and remain so today. Other features that may have also been added about that time, such as the wood shingles on the wood horizontal board siding and the alteration of the front porch (it had already been altered at least twice) and are not substantial enough to undermine the historic character of the building.

Photo 7: Enclosed hallway and entry door, north façade, second floor

All changes to the house are over 50 years old, to our knowledge. As the present owners, you are under no obligation to remove these subsequent changes to the building. It is recommended here, however, that the enclosed hallway on the second floor of the building and the concrete planter be removed to improve the historic appearance and function of the building and site. Both are non-contributing elements to the ca 1893 building. The enclosed hallway on the rear of the building is not visible from the public right-of-way. Its removal will not change the status of the current permitting process for a Minor Landmark Alteration.

Exterior alterations that are being proposed as part of this project are primarily the repair of fire-damaged areas. The proposed removal of the second story enclosed hallway and the concrete planter will not destroy historic materials, as they have been determined as part of this report to not be historically significant. No new materials or features are being proposed.

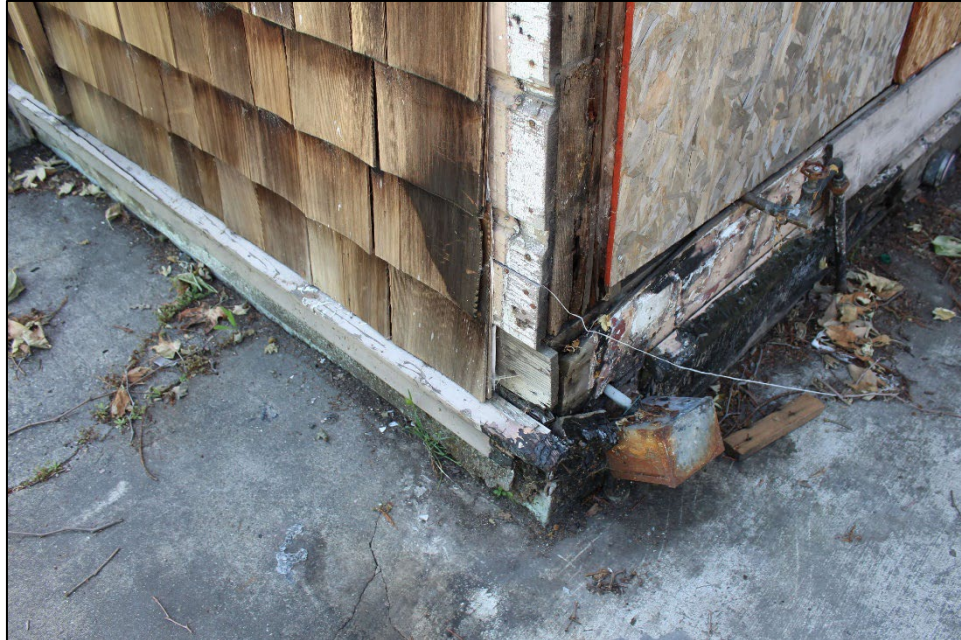
The fire that damaged the building burned the exterior stairs on the north side (not original to the building) and the materials on the north façade of the building.

Photo 10: Fire damage, northeast corner

Deteriorated historic features, including the burned areas on the back of the building, will be repaired as part of the proposed changes for the building. No missing features will be added.

Repair of the rear of this building will utilize best practices when removing or treating the damaged areas of the building.

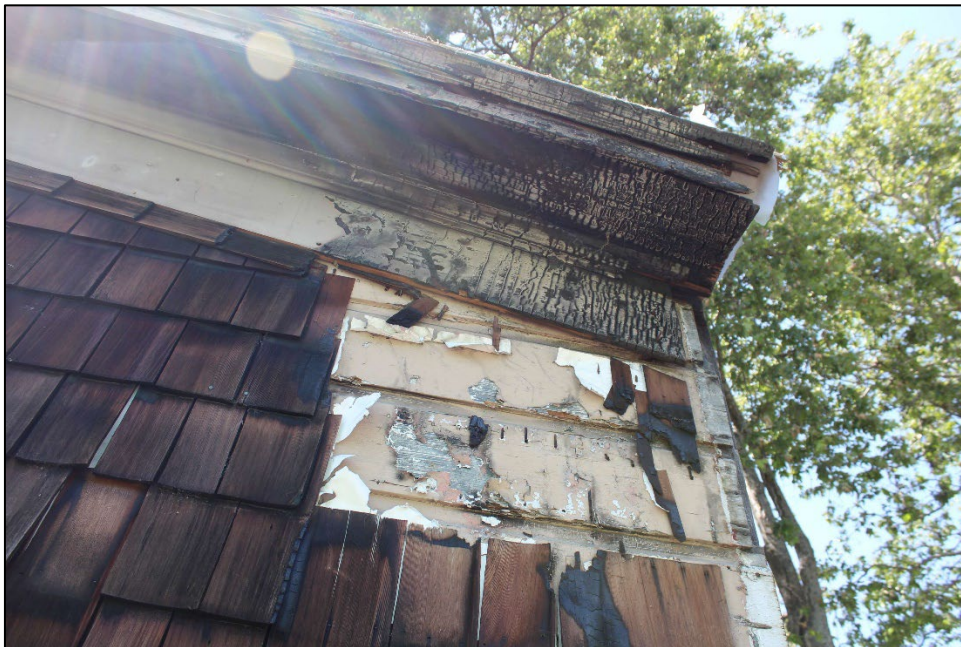
Photo 11: Fire damage, northeast corner
