# **SEISMIC HAZARD EVALUATION REPORT**

## **SANTA ROSA CITY HALL**

### **SANTA ROSA, CA**

**DECEMBER 16, 2018**

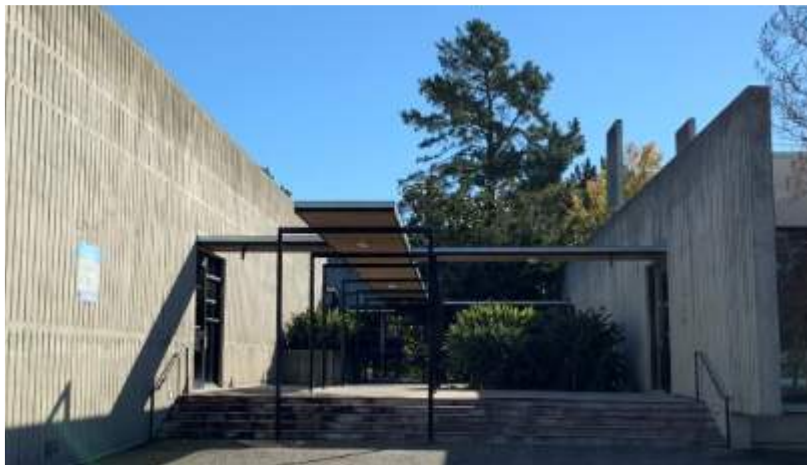
- The canopy structure has been evaluated for stability and strength. At the seismic joint locations between Buildings 5 and 6, there is insufficient stiffness to prevent loss of gravity support. The canopy is also tied into the tower entry structure effectively connecting this structure with Building 5.

Figure 12: Entry Canopy Between Building 5 and 6

It is recommended that these portions of the canopy be retrofitted or removed.

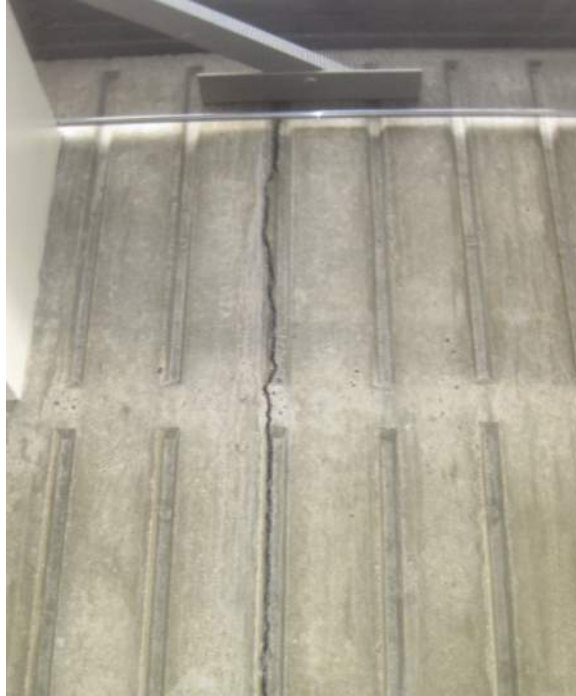
- Reinforcing Steel – Wall meets volumetric requirements; however, large vertical cracks were observed in both walls over their entire height. Based on the size of the cracks it is likely that the wall horizontal reinforcing is no longer continuous through the cracks. See Figure 30.
- Uplift at Pile Caps – There is no top reinforcement at the pile caps.
- Transfer to Shear Walls – The diaphragm is not directly connected to the concrete shear walls.
- Diaphragm Continuity – The diaphragm has a large gap around the perimeter to allow for light.
- Openings at Shear Walls – The diaphragm has a large gap around the perimeter to allow for light.

- Reinforcing Steel – There is sufficient length of wall when the cracks are considered. There is also diaphragm bracing in this area. This item is considered compliant.

Figure 30: Large Crack Found in Building 5/6/7
