SEISMIC HAZARD EVALUATION REPORT
SANTA ROSA CITY HALL
SANTA ROSA, CA

FORELL/ELSESSER ENGINEERS, INC.
160 PINE STREET, 6TH FLOOR
SAN FRANCISCO, CA 94111

F/E PROJECT NO. 18-080

DECEMBER 16, 2018

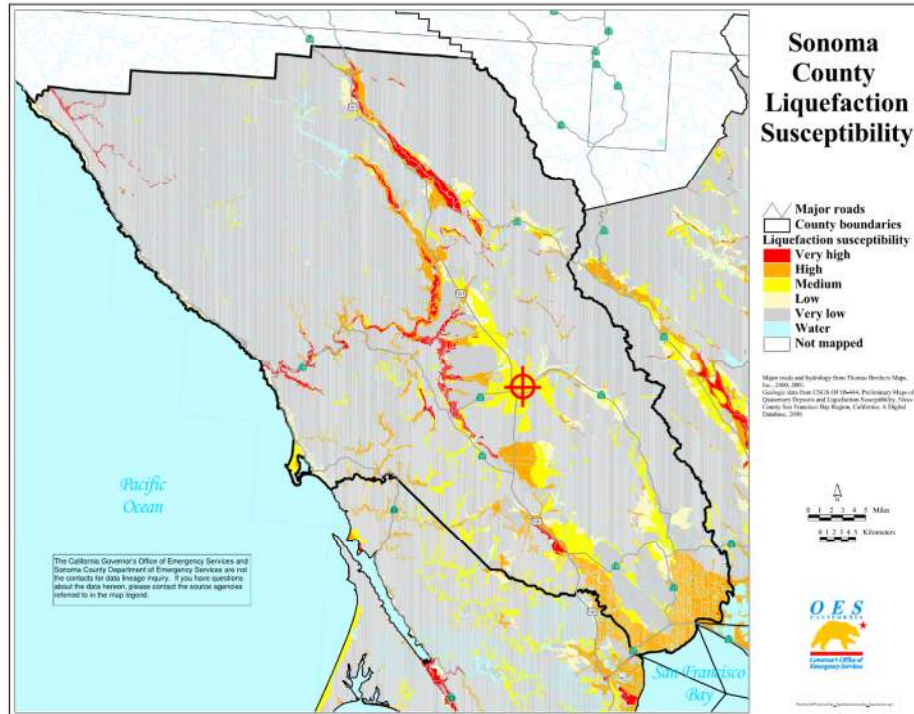
Figure 5: Site Liquefaction Susceptibility

- Liquefaction: The site is located on soil that has a medium potential for liquefaction. Liquefaction can result in large total and differential settlements of on-grade foundations and slabs. A geotechnical engineer should be consulted to determine the likelihood and magnitudes of potential settlements.

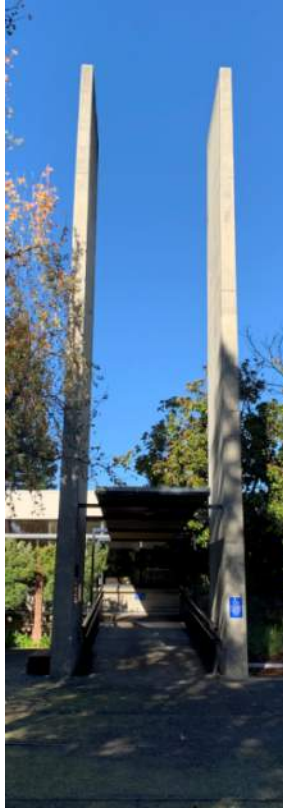
Figure 11: Courtyard Tower Structure Elevation

- The tower structure has been evaluated for stability and strength. The walls are just sufficient to resist the anticipated lateral forces for the BSE-1E hazard but are inadequate for the BSE-2E hazard and may result in collapse.

It is recommended that the tower walls be retrofitted or removed.

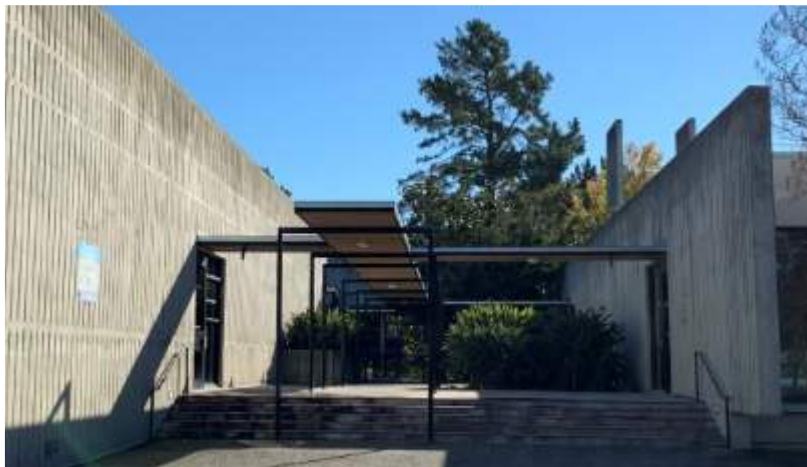
Figure 12: Entry Canopy Between Building 5 and 6

- The canopy structure has been evaluated for stability and strength. At the seismic joint locations between Buildings 5 and 6, there is insufficient stiffness to prevent loss of gravity support. The canopy is also tied into the tower entry structure effectively connecting this structure with Building 5.

It is recommended that these portions of the canopy be retrofitted or removed.

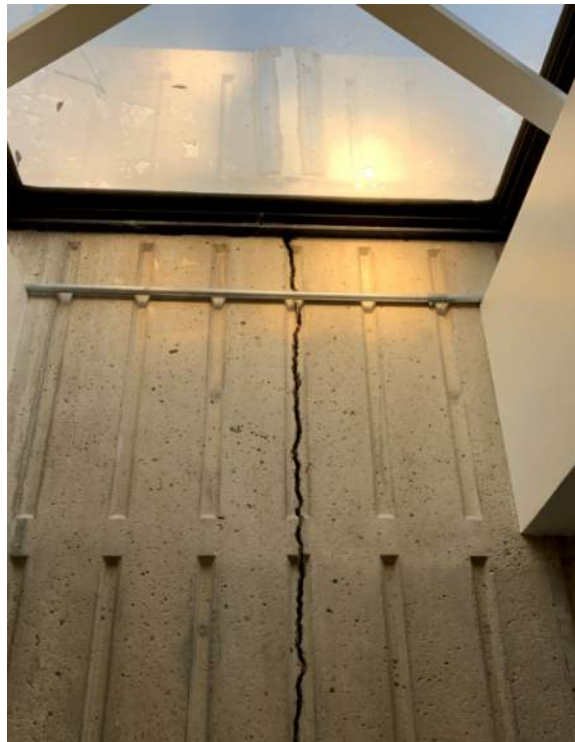
Figure 29: Large Crack Found in Building 3/4

- Shear Stress Check – The plywood shear demands are higher than the Tier 1 threshold.
- Reinforcing Steel – Wall meets volumetric requirements; however, large vertical cracks were observed in both walls over their entire height. Based on the size of the cracks it is likely that the wall horizontal reinforcing is no longer continuous through the cracks. See Figure 29.

- Reinforcing Steel – There is sufficient length of wall when the cracks are considered. There is also diaphragm bracing in this area. This item is considered compliant.

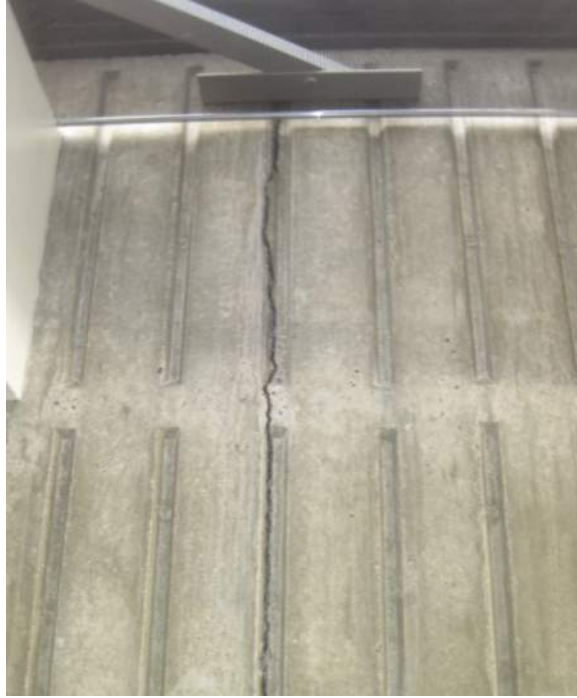
Figure 30: Large Crack Found in Building 5/6/7

- Reinforcing Steel – Wall meets volumetric requirements; however, large vertical cracks were observed in both walls over their entire height. Based on the size of the cracks it is likely that the wall horizontal reinforcing is no longer continuous through the cracks. See Figure 30.
- Uplift at Pile Caps – There is no top reinforcement at the pile caps.
- Transfer to Shear Walls – The diaphragm is not directly connected to the concrete shear walls.
- Diaphragm Continuity – The diaphragm has a large gap around the perimeter to allow for light.
- Openings at Shear Walls – The diaphragm has a large gap around the perimeter to allow for light.

- Reinforcing Steel – There is sufficient length of wall when the cracks are considered. There is also diaphragm bracing in this area. This item is considered compliant.
