Subject: Arborist Inventory Report  
Stonehouse Santa Rosa, 3555 Sonoma Hwy, Santa Rosa CA 95405

**TREE INVENTORY LIST: STONEHOUSE SANTA ROSA, DECEMBER 5<sup>TH</sup>, 2024**

STONEHOUSE RENOVATION AND HOTEL - TREE INVENTORY MAP

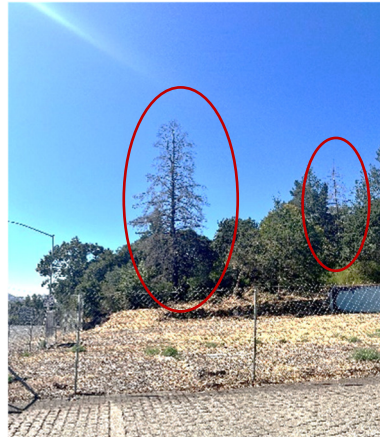
Area 2: Tree #114 Dead Fir, also additional dead fir (T#136) further up hill and to the right. Both trees are of poor health &amp; structure

| KEY | SPECIES | | DBH | HERITAGE? | GENERAL<br>CONDITION | STRUCTURAL<br>INTEGRITY | DEVELOPMENT<br>IMPACTS | ACTION | NOTABLE COMMENTS & RECOMMENDATIONS |
|---|---|---|---|---|---|---|---|---|---|
| T 114 | Douglas Fir | <i>Pseudotsuga menziesii</i> | 32" | Y | POOR | POOR | SIGNIFICANT | REMOVE | Standing dead tree; to be removed. |

| KEY | SPECIES | | DBH | HERITAGE? | GENERAL<br>CONDITION | STRUCTURAL<br>INTEGRITY | DEVELOPMENT<br>IMPACTS | ACTION | NOTABLE COMMENTS & RECOMMENDATIONS |
|---|---|---|---|---|---|---|---|---|---|
| T 136 | Douglas Fir | <i>Pseudotsuga menziesii</i> | 42" | Y | MARGINAL | MARGINAL | MODERATE | REMOVE | Remove due to poor condition + construction impacts |

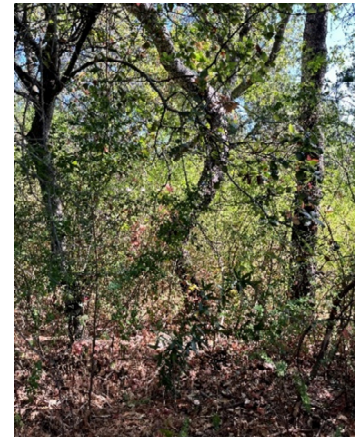
Area 2: general conditions in densely overgrown area consisting of small brushy black oaks of marginal structure

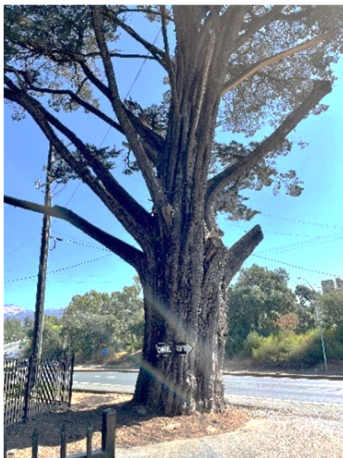
Offsite Tree: "B" a large heritage-sized Monterey Cypress, visible from Sonoma Hwy, is to be undisturbed, preserved and protected.

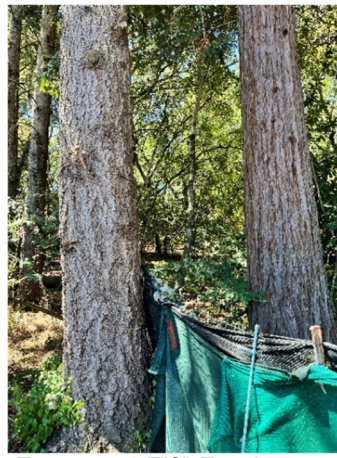
Trees #125 &amp; T'C': T125 is an on-site Fir, and T "C" Redwood is on the adjacent property. Both trees are to be preserved and protected.

| KEY | SPECIES | | DBH | HERITAGE? | GENERAL<br>CONDITION | STRUCTURAL<br>INTEGRITY | DEVELOPMENT<br>IMPACTS | ACTION | NOTABLE COMMENTS & RECOMMENDATIONS |
|---|---|---|---|---|---|---|---|---|---|
| T 125 | Douglas Fir | <i>Pseudotsuga menziesii</i> | 33" | Y | GOOD | GOOD | MODERATE | PRESERVE | General condition and structure good/ fair, average health, color, and vigor. Has potential for longevity on site if construction impacts are minimized: spread a 4" layer of bark mulch and temporary protective fencing at edge of dripline prior to construction, maintain fencing in place for duration of construction; do not disturb root zone, also with nearby offsite Redwood (as shown in photo) |

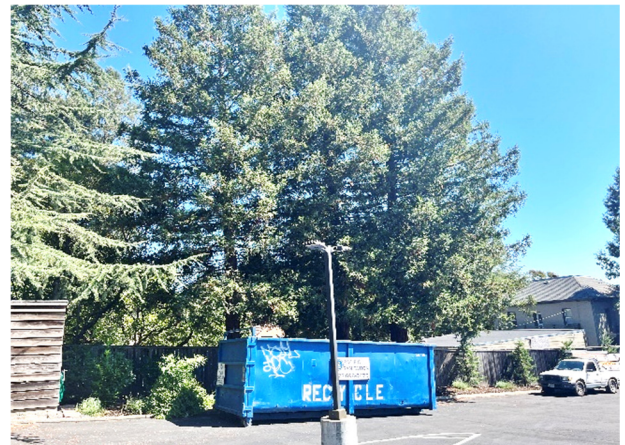
Area 1: Coast Redwood Trees # 102, 103, 104 located along north property boundary are all in good condition and are to be preserved and protected.

| KEY | SPECIES | | DBH | HERITAGE? | GENERAL<br>CONDITION | STRUCTURAL<br>INTEGRITY | DEVELOPMENT<br>IMPACTS | ACTION | NOTABLE COMMENTS & RECOMMENDATIONS |
|---|---|---|---|---|---|---|---|---|---|
| T 102 | Coast Redwood | <i>Sequoia sempervirens</i> | 23" | N | EXCELLENT | GOOD | MINOR | PRESERVE | General condition and structure good, average health, color, and vigor. Has potential for longevity on site; spread a 4" layer of bark mulch and tree protection fencing at edge of dripline prior to construction, maintain fencing in place and provide irrigation for duration of construction |
| T 103 | Coast Redwood | <i>Sequoia sempervirens</i> | 26" | Y | EXCELLENT | GOOD | MINOR | PRESERVE | General condition and structure good, average health, color, and vigor. Has potential for longevity on site; spread a 4" layer of bark mulch and tree protection fencing at edge of dripline prior to construction, maintain fencing in place and provide irrigation for duration of construction |
| T 104 | Coast Redwood | <i>Sequoia sempervirens</i> | 32" | Y | EXCELLENT | GOOD | MINOR | PRESERVE | General condition and structure good, average health, color, and vigor. Has potential for longevity on site; spread a 4" layer of bark mulch and tree protection fencing at edge of dripline prior to construction, maintain fencing in place and provide irrigation for duration of construction |
