SEISMIC HAZARD EVALUATION REPORT

SANTA ROSA CITY HALL

SANTA ROSA, CA

DECEMBER 16, 2018

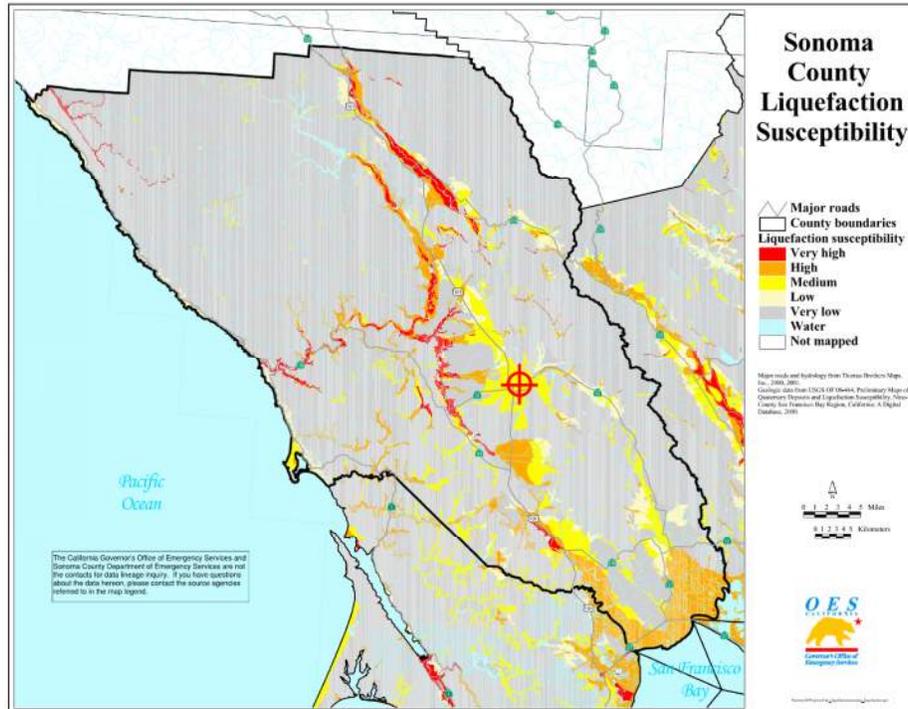
- Liquefaction: The site is located on soil that has a medium potential for liquefaction. Liquefaction can result in large total and differential settlements of on-grade foundations and slabs. A geotechnical engineer should be consulted to determine the likelihood and magnitudes of potential settlements.

Figure 5: Site Liquefaction Susceptibility

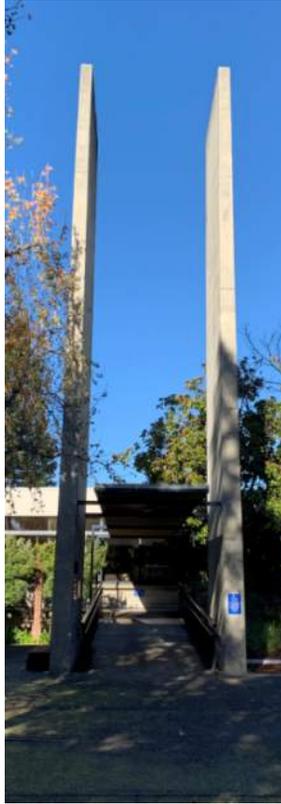
- The tower structure has been evaluated for stability and strength. The walls are just sufficient to resist the anticipated lateral forces for the BSE-1E hazard but are inadequate for the BSE-2E hazard and may result in collapse.

Figure 11: Courtyard Tower Structure Elevation

It is recommended that the tower walls be retrofitted or removed.

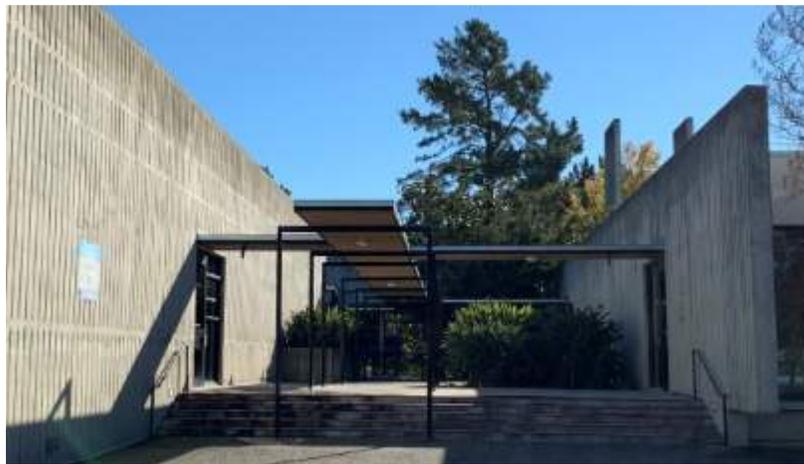
- The canopy structure has been evaluated for stability and strength. At the seismic joint locations between Buildings 5 and 6, there is insufficient stiffness to prevent loss of gravity support. The canopy is also tied into the tower entry structure effectively connecting this structure with Building 5.

Figure 12: Entry Canopy Between Building 5 and 6

It is recommended that these portions of the canopy be retrofitted or removed.

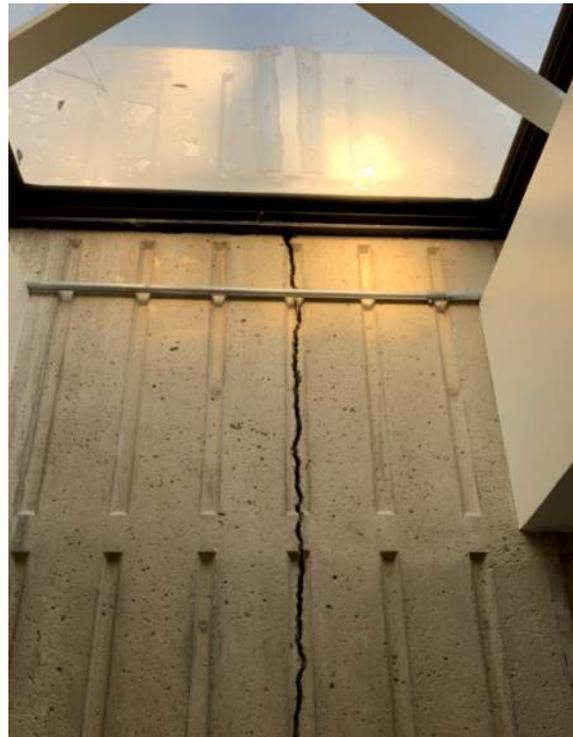
- Shear Stress Check – The plywood shear demands are higher than the Tier 1 threshold.
- Reinforcing Steel – Wall meets volumetric requirements; however, large vertical cracks were observed in both walls over their entire height. Based on the size of the cracks it is likely that the wall horizontal reinforcing is no longer continuous through the cracks. See Figure 29.

- Reinforcing Steel – There is sufficient length of wall when the cracks are considered. There is also diaphragm bracing in this area. This item is considered compliant.

Figure 29: Large Crack Found in Building 3/4

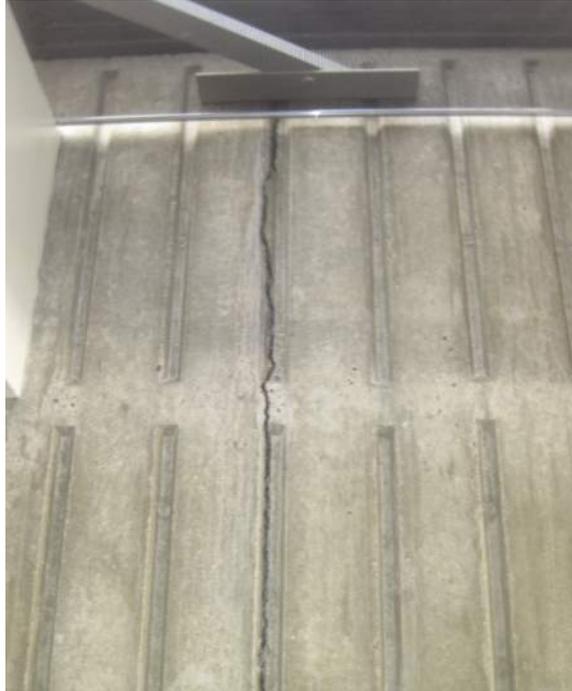
- Reinforcing Steel – Wall meets volumetric requirements; however, large vertical cracks were observed in both walls over their entire height. Based on the size of the cracks it is likely that the wall horizontal reinforcing is no longer continuous through the cracks. See Figure 30.
- Uplift at Pile Caps – There is no top reinforcement at the pile caps.
- Transfer to Shear Walls – The diaphragm is not directly connected to the concrete shear walls.
- Diaphragm Continuity – The diaphragm has a large gap around the perimeter to allow for light.
- Openings at Shear Walls – The diaphragm has a large gap around the perimeter to allow for light.

- Reinforcing Steel – There is sufficient length of wall when the cracks are considered. There is also diaphragm bracing in this area. This item is considered compliant.

Figure 30: Large Crack Found in Building 5/6/7
