RE: REQUEST TO REMOVE A BUNYA BUNYA TREE AT 1080 2ND STREET, SANTA ROSA
APN: 009-082-003
ZONING: Planned Development (PD 0067)
GENERAL PLAN: Office
FILE NO: TR22-062

Arborist Report

Inspect Bunya Pine located at 1080 2nd St., Santa Rosa, Ca 95404 to rate the risk of the multiple stem portion(s) in upper canopy of the tree, provide mitigation option(s) to aid in minimizing the likelihood(s) for failure and determine residual risk of the same area(s). The evaluation to be achieved by a ground level, visual perspective as well as by climbing the tree to more closely observe the stem attachment(s) and arrangement. The current risk and residual risk rating to be determined by utilizing the Tree Risk Assessment Qualification (TRAQ) matrices.

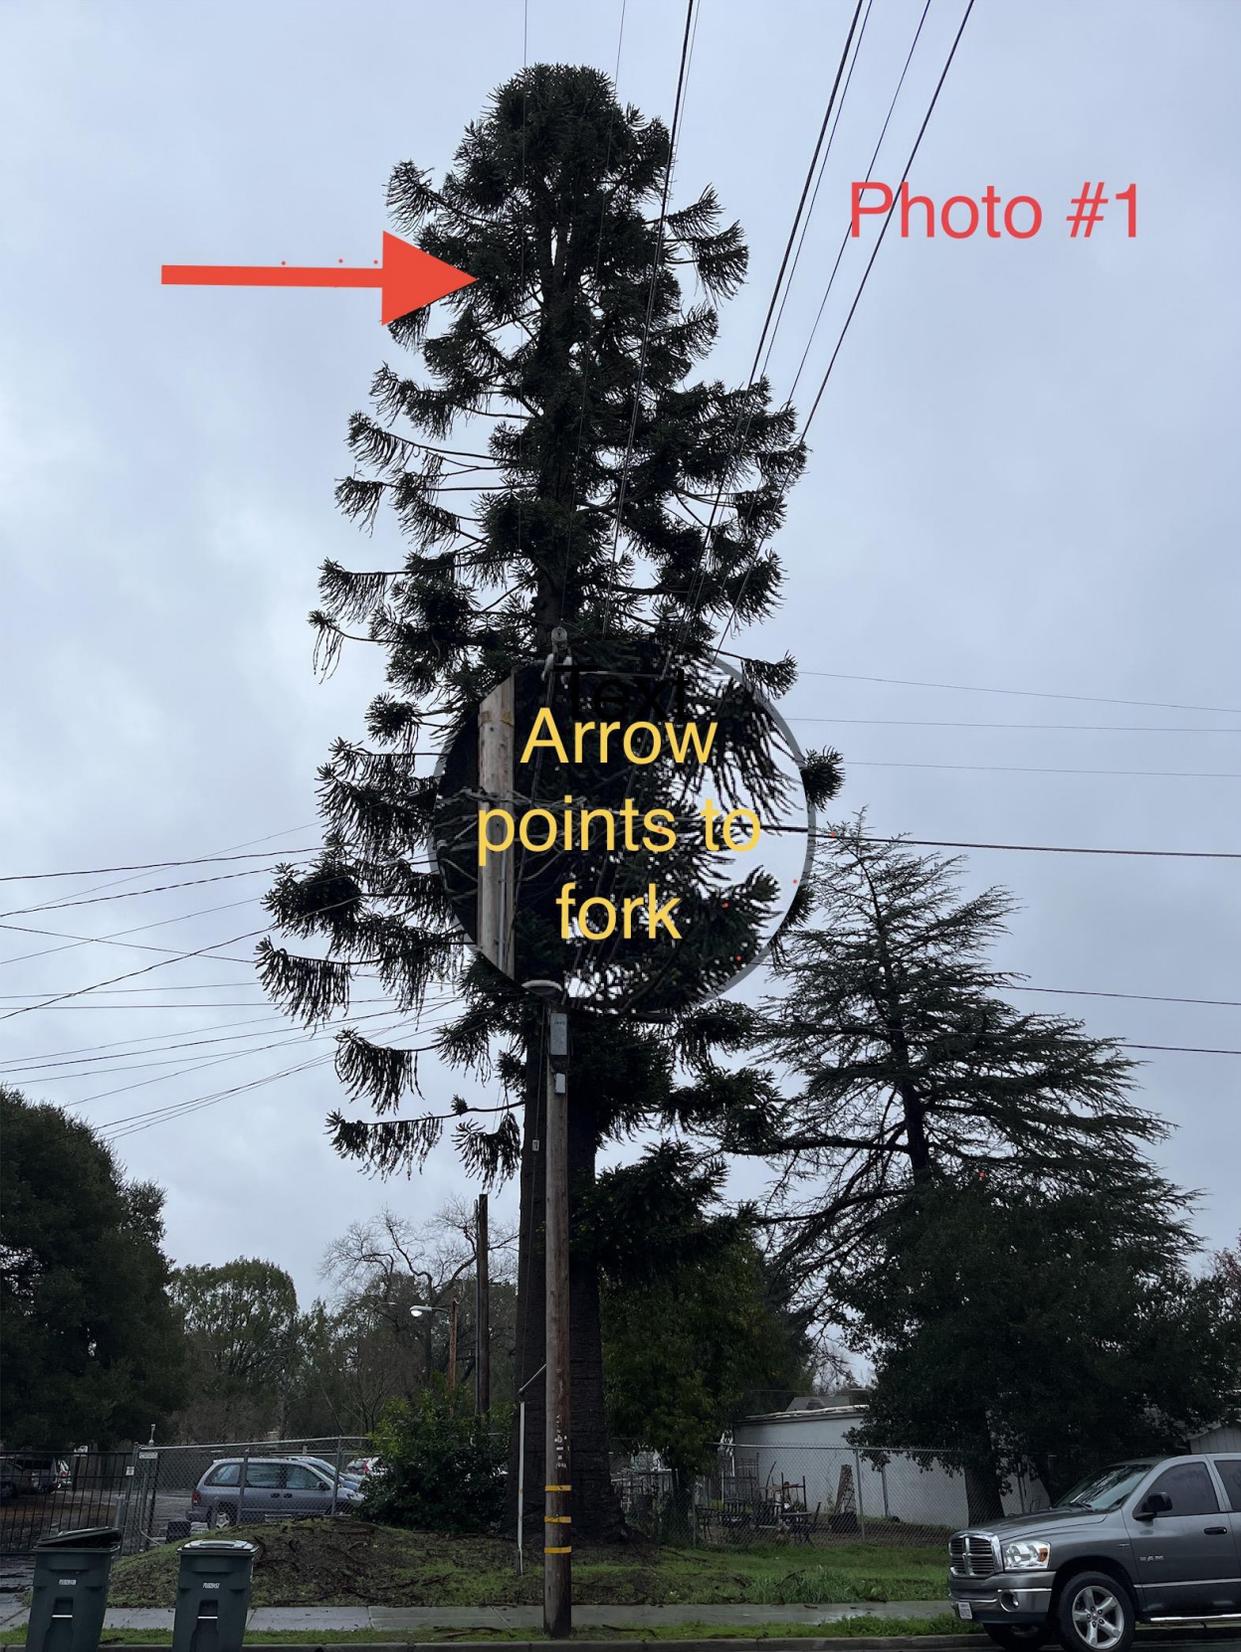
Photo #1

ground level, with subordinated lateral limbs extending up through the canopy to approximately 100' above ground level. At the approximate 100' height range, the tree forks into three stems (see photo #1).

Arrow
points to
fork

To reduce the stems' failure risk, I recommend installation of a cable support system in addition to, or apart from crown thinning and mass reduction in the upper 25' of the tree.

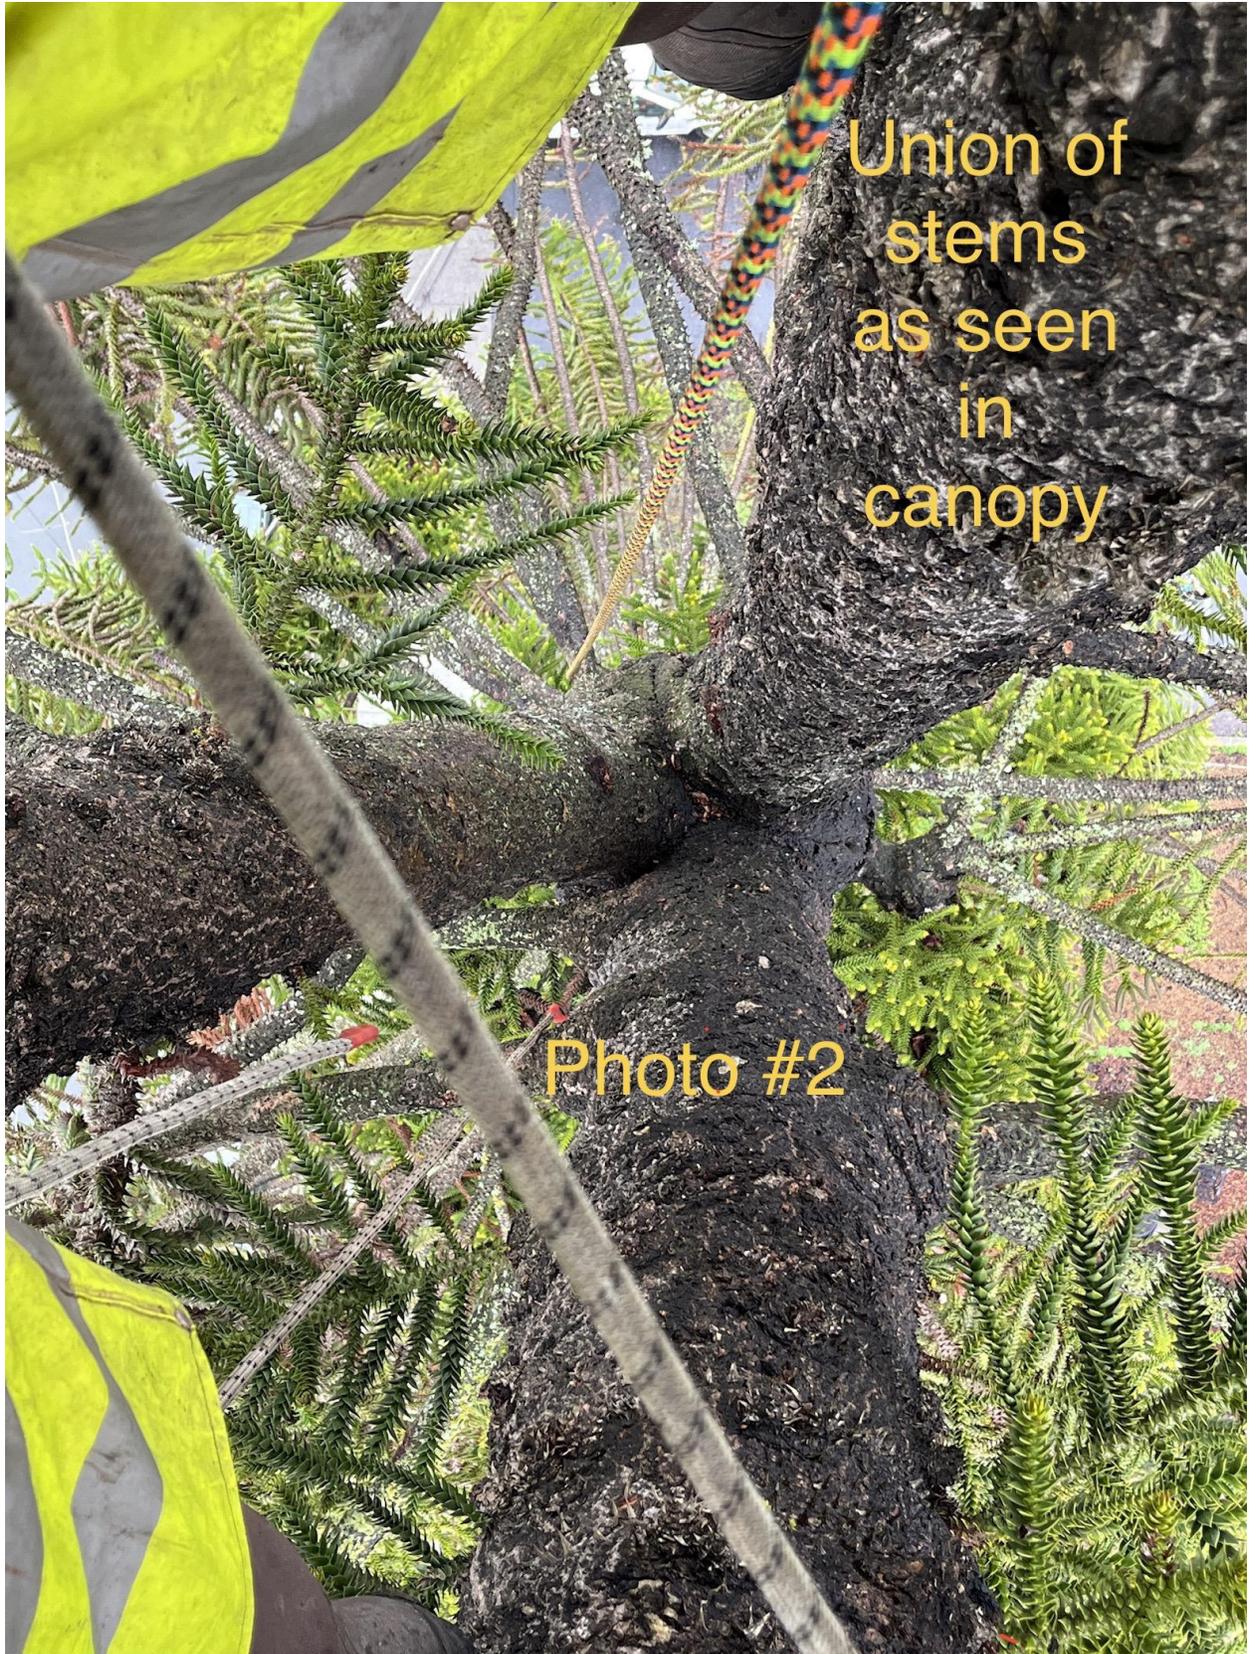
Photo #2

While in the tree I also observed the point of attachment of the three competitive stems. Each stem possesses an average stem diameter of 12-14". The three stems originate at the same position on the tree (see photo #2).

The presence of a dominant stem, with subordinated limbs is a well designed system for weight distribution and improved limb attachments at trunk. Multiple stems, especially those similar in diameter, which originate in one location, possess an increased likelihood for failure at the attachment point. These stems do not appear to possess a high weight load. These co-dominant stems are closely oriented to one another. In my experience, this closeness minimizes exposure to load increasing elements, such as wind, rain, etc. and improves stem retention likelihood. While the load on these stems appears low, there persists a likelihood of failure at the point of attachment. In my experience, a very effective method of managing the load on stems like these and minimizing their current risk for failure is a support cable system in the form of a triangle. An additional risk management tool to cabling is thinning and reduction of the crown in the portion(s) above the stems' point of attachment.

Union of
stems
as seen
in
canopy
