## Tree Inspection Report

DATE: 9/1/2017

PROPERTY: MONTGOMERY CREEK SUBDIVISION

INSPECTOR: Blaine D. Mugleston

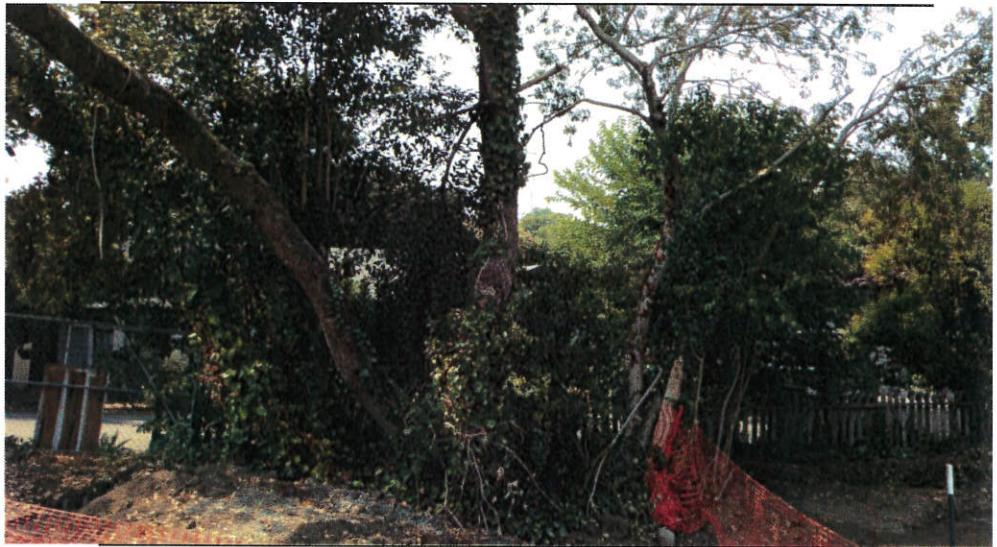
## Trees 11 &amp; 16

Umbellaria have two main trunks and other new growth at the base.

In the middle of this growth is the stump of Tree 10, the missing Live Oak which shows evidence of being cut and removed approximately two years ago (see picture below)

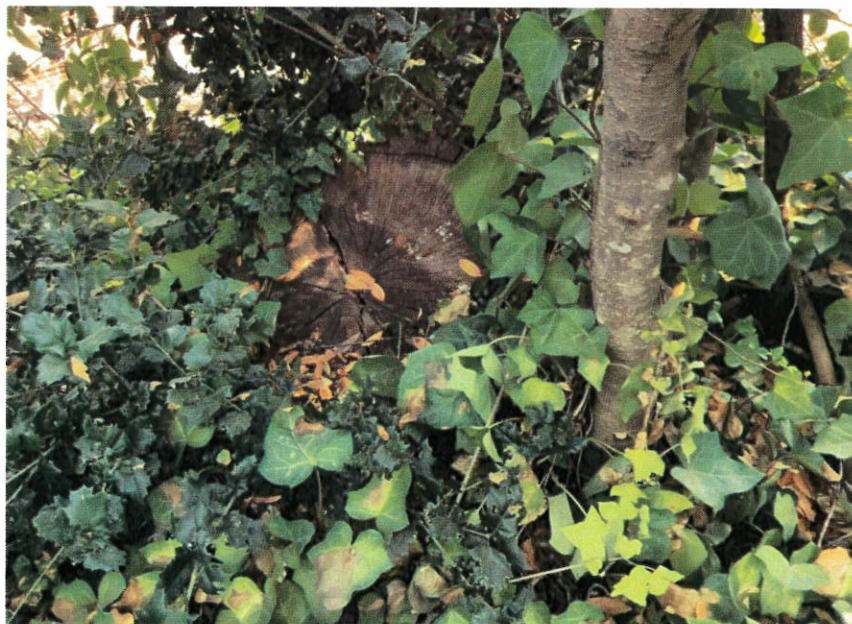
## Tree stump 10

This stump is the remainder of tree 10. The cut is approximately two plus seasons old. The neighbors claimed that they had to pay \$2,000 to have it removed after it fell on their property. The new developers paid the neighbors the \$2K to make sure that things go smoothly with adjacent property.

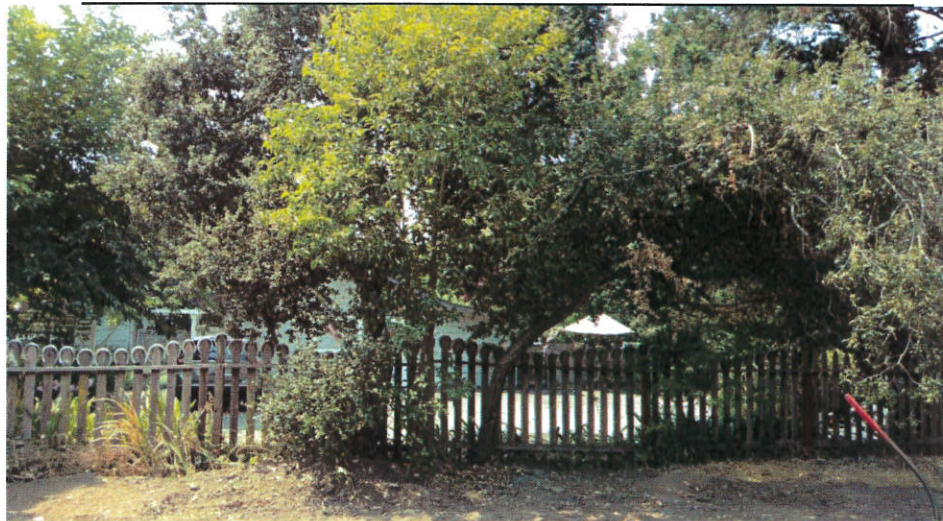
Tree 12  
Live Oak with two  
individual trunks

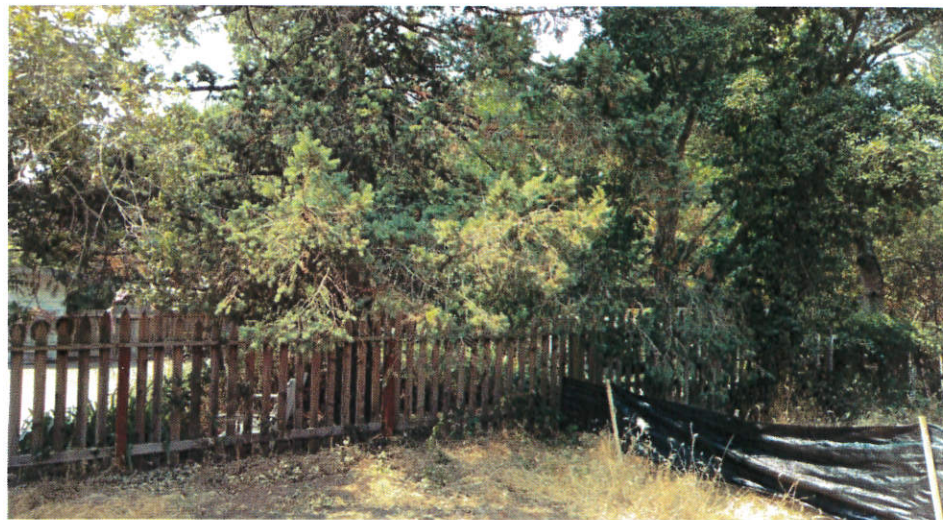
Tree 13  
Doug Fir is located on  
the neighbor side of the  
picket fence per plans.  
To the right in the  
picture also on the  
neighbors side of the  
fence is Tree 27,  
Fremontii in good health

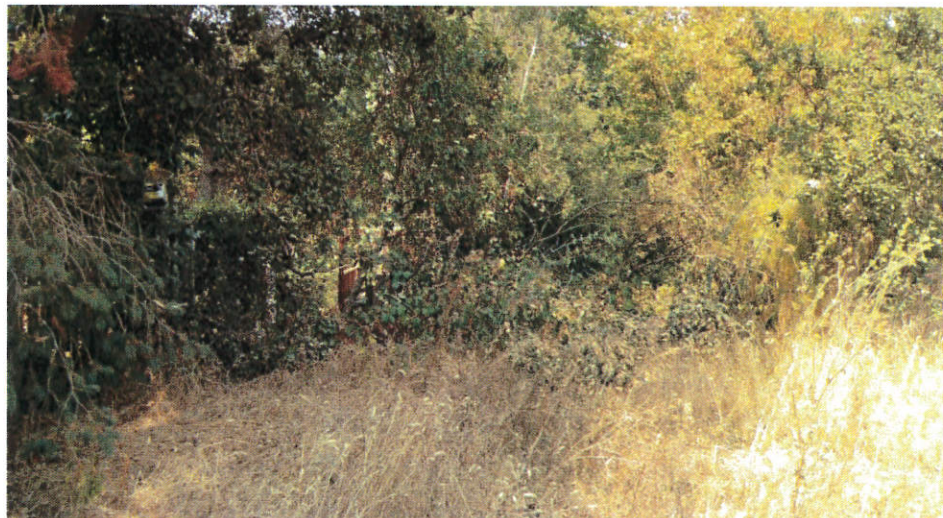
Tree 14 & 15 Live Oaks  
located along the fence  
next to the Doug fir  
tree. This is the location  
where a large 24"  
caliper M. Pine is  
suppose to be. No  
evidence that this tree  
existed for some time. It  
must have been  
removed in the past as  
well.

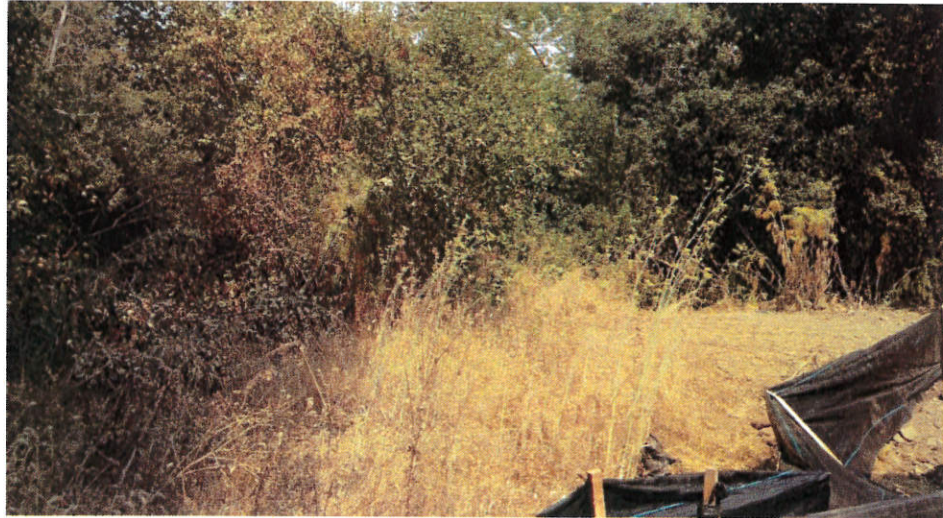
Tree 21

M. Pine is not existing.  
No stump or root  
evidence of this tree  
shown on the plans. It  
was removed before  
new developer  
purchased the property

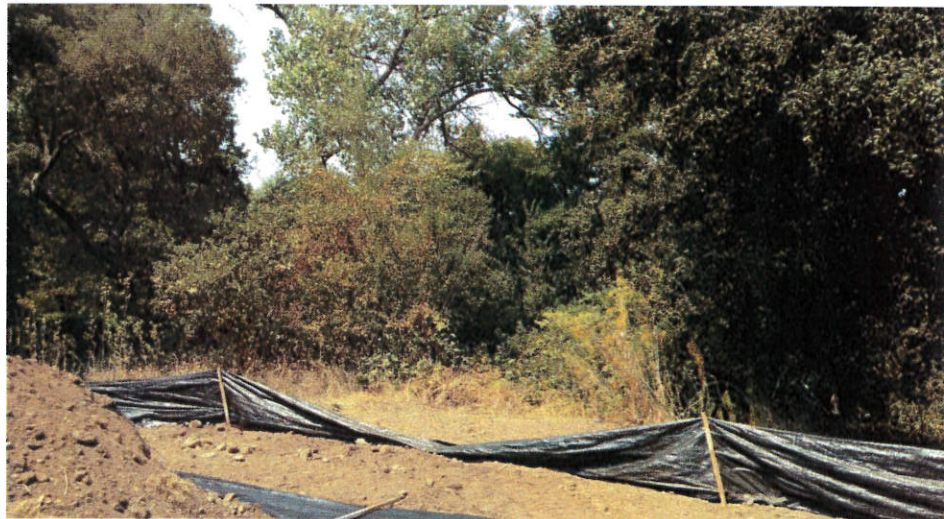
Tree 22 and 23

Red Alder and Live Oak  
trees in place and silt  
fence is being placed at  
canopies edge

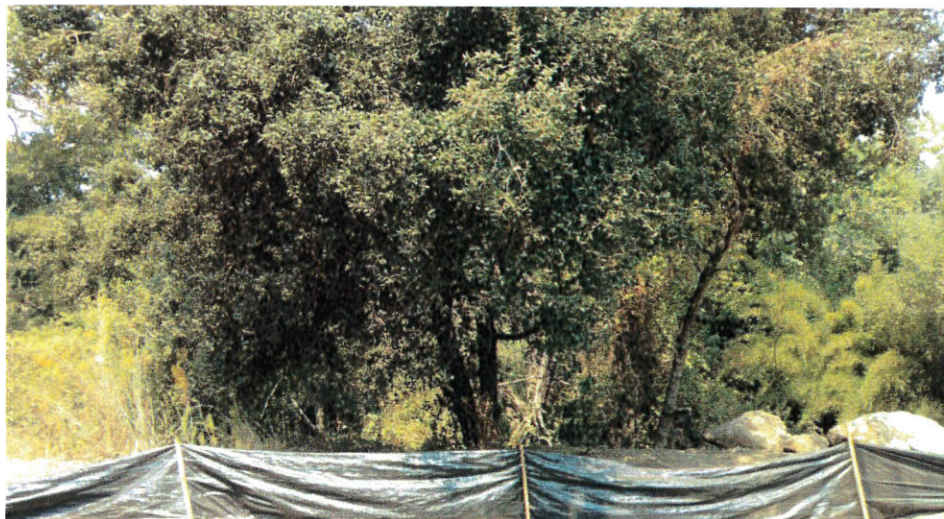
Tree 23

Live Oak is existing and  
silt fence is placed at  
canopies edge

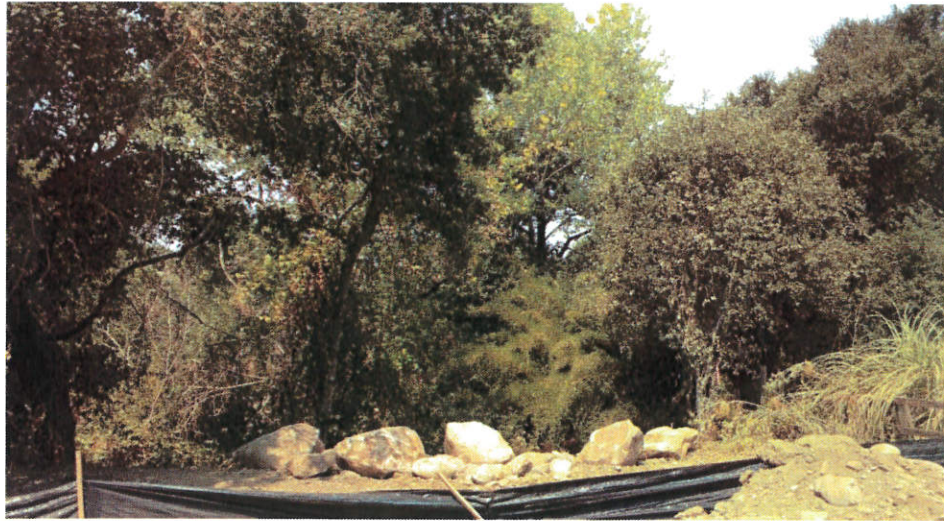
Trees 24, 25, 26  
Cottonwood, and two  
Red Alders are existing  
and have several other  
trees around them  
untouched. An  
additional Live oak tree  
is at the corner of the  
property, not marked on  
the plans but is existing  
and in good health

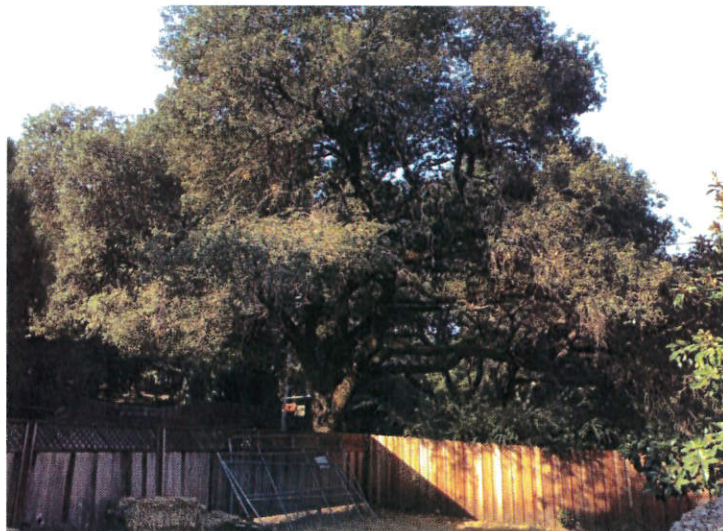
Tree 18 Live Oak in the  
front yard outside of the  
wood fencing is in good  
health. Plans call out  
Tree 19 as a Cypress to  
be removed however  
the tree existing in the  
front we list as tree 17  
and is a Magnolia in  
good health. Plans are  
to save this tree. (see  
right edge of picture)
