Post-fire Water Quality Investigation

March 27, 2018

Joint City Council and Board of Public Utilities Meeting

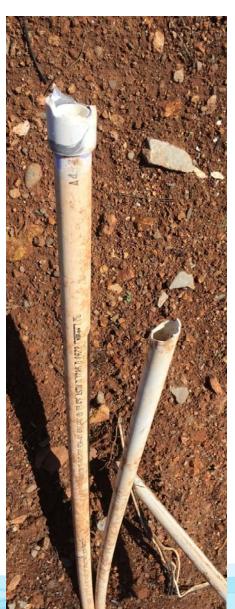
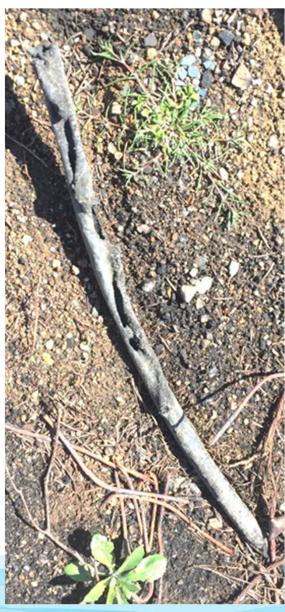
What is the Source?

- Leaching from Plastics
- Backflow of
 - Burned/Melted Plastics
 - Soot/Ash/ Fire Debris

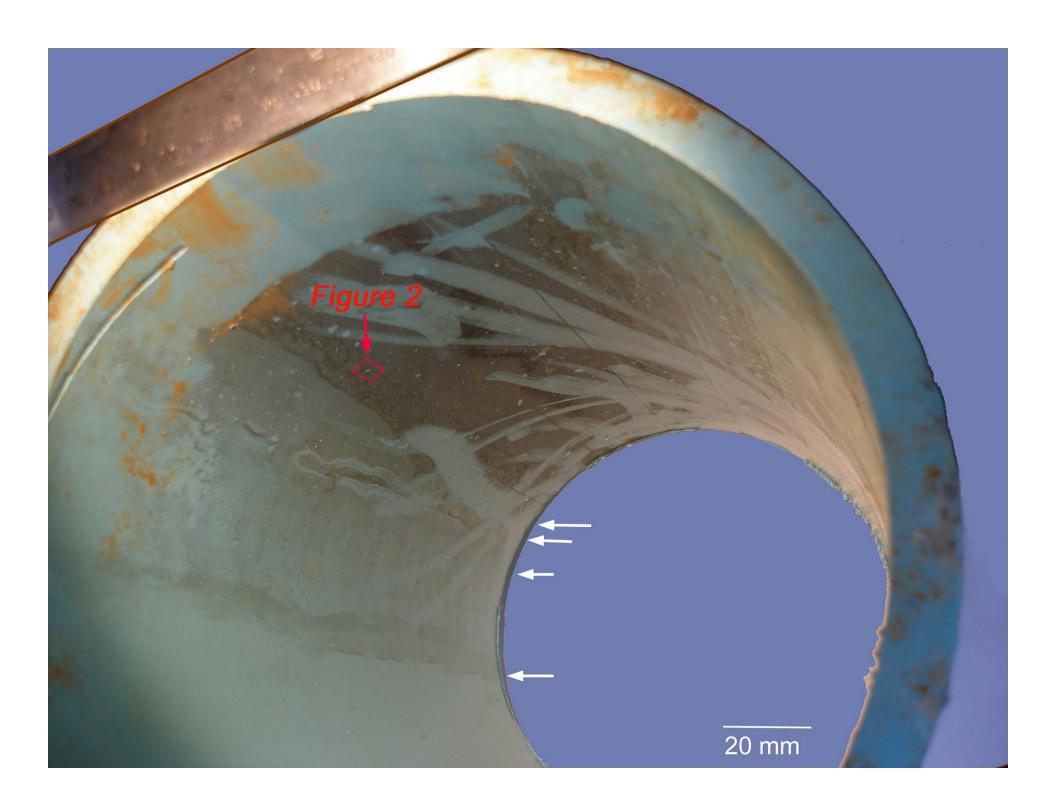
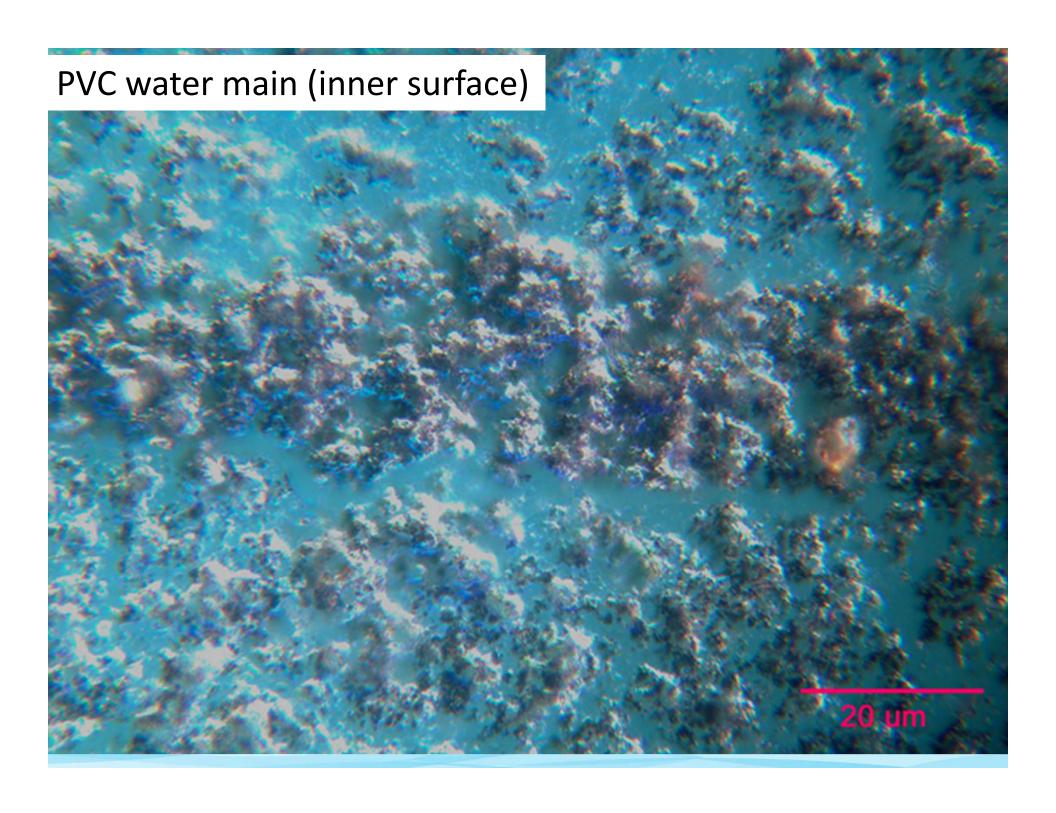
Physical Testing

- Microscopic evaluation of 18 samples: PVC, HDPE, meters, valves, wedges, gaskets-ongoing
- Evaluation of damage due to exposure to high heat
- Testing has identified a variety of particles including char from smoke in some sections of the piping
