**FAULT TRENCH INVESTIGATION  
SANTA ROSA MEMORIAL HOSPICE HOUSE  
520 DOYLE PARK DRIVE  
SANTA ROSA, CALIFORNIA**

February 24, 2020

Project 2964.001

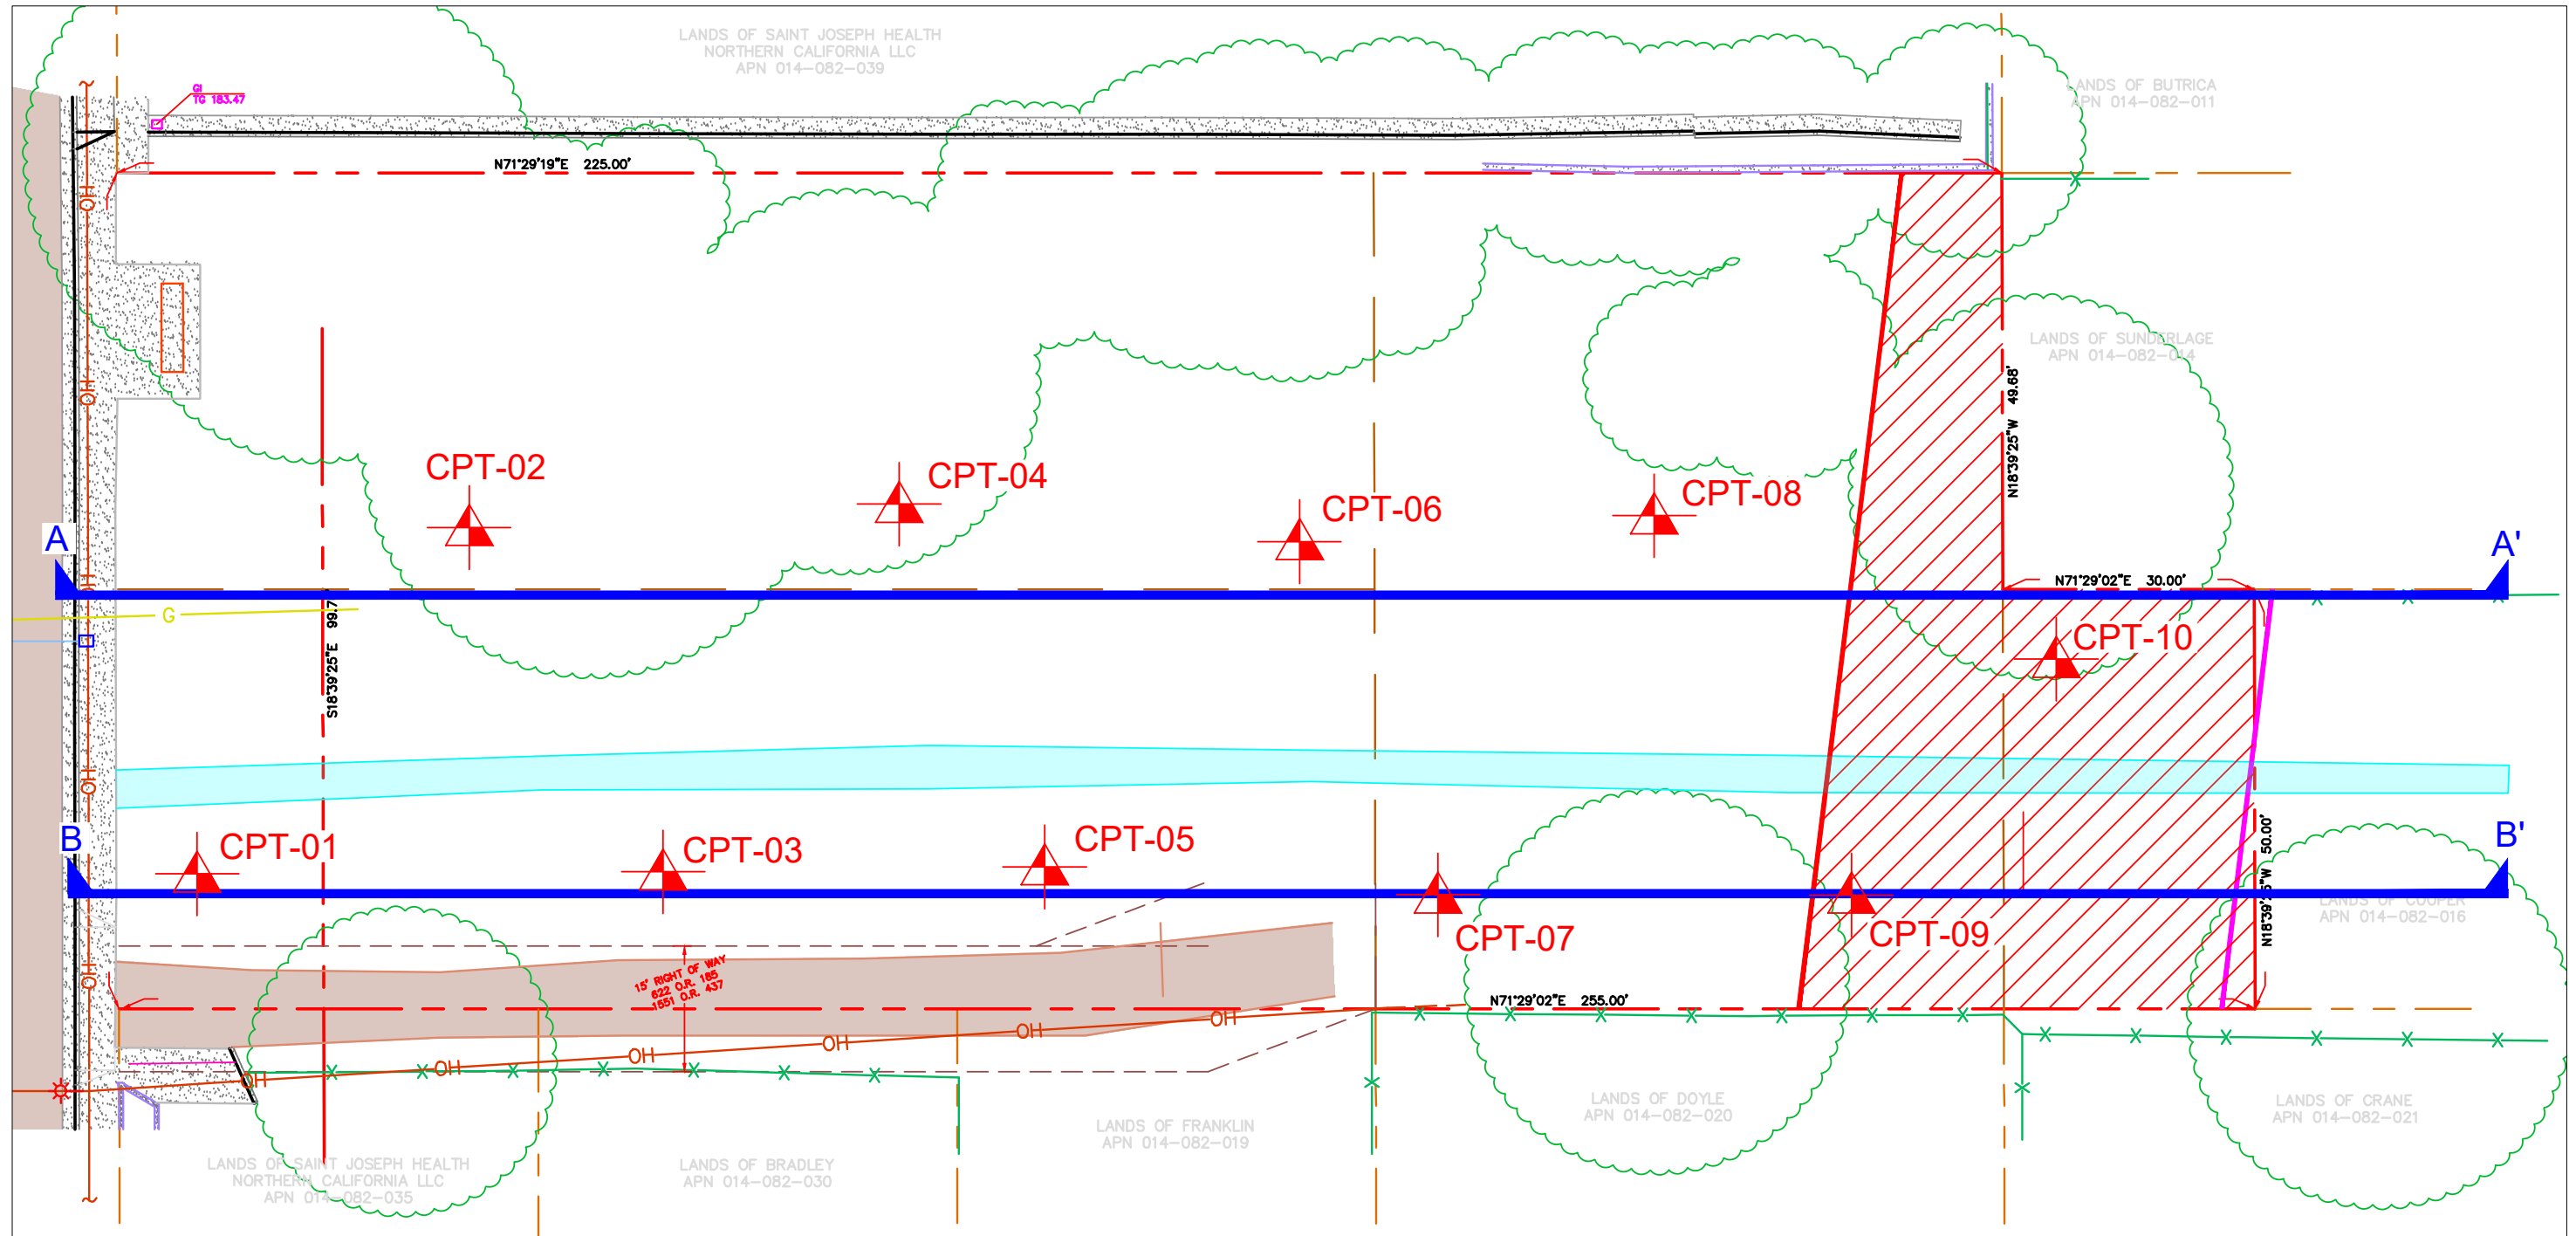
**2**  
 FIGURE

Although we were unable to directly observe the entirety of the Holocene record in areas west of the mapped fault trace shown on Figure 2, we note that previous research by Hecker et al (2005) suggests an average recurrence interval for large earthquakes on the Rodgers Creek Fault of about 300-years. Therefore, since 1) we observed continuous and largely conformable contacts west of Station 230 in our trench exposures and CPT soundings; 2) we exposed several recurrence intervals’ worth of geologic record; and 3) no evidence of active faulting or ground deformation is shown on regional maps or was observed at the ground surface, we judge no active faults are present at the site west of Station 230.

Based on our observations, we recommend minimum building setbacks of 50-feet from the active fault traces, as shown on Figure 2. Although it is possible additional faults or related ground deformation exists between Stations 230 and 250, we judge additional setbacks to the west are not required given that this zone is already encompassed by the recommended 50-foot setback.

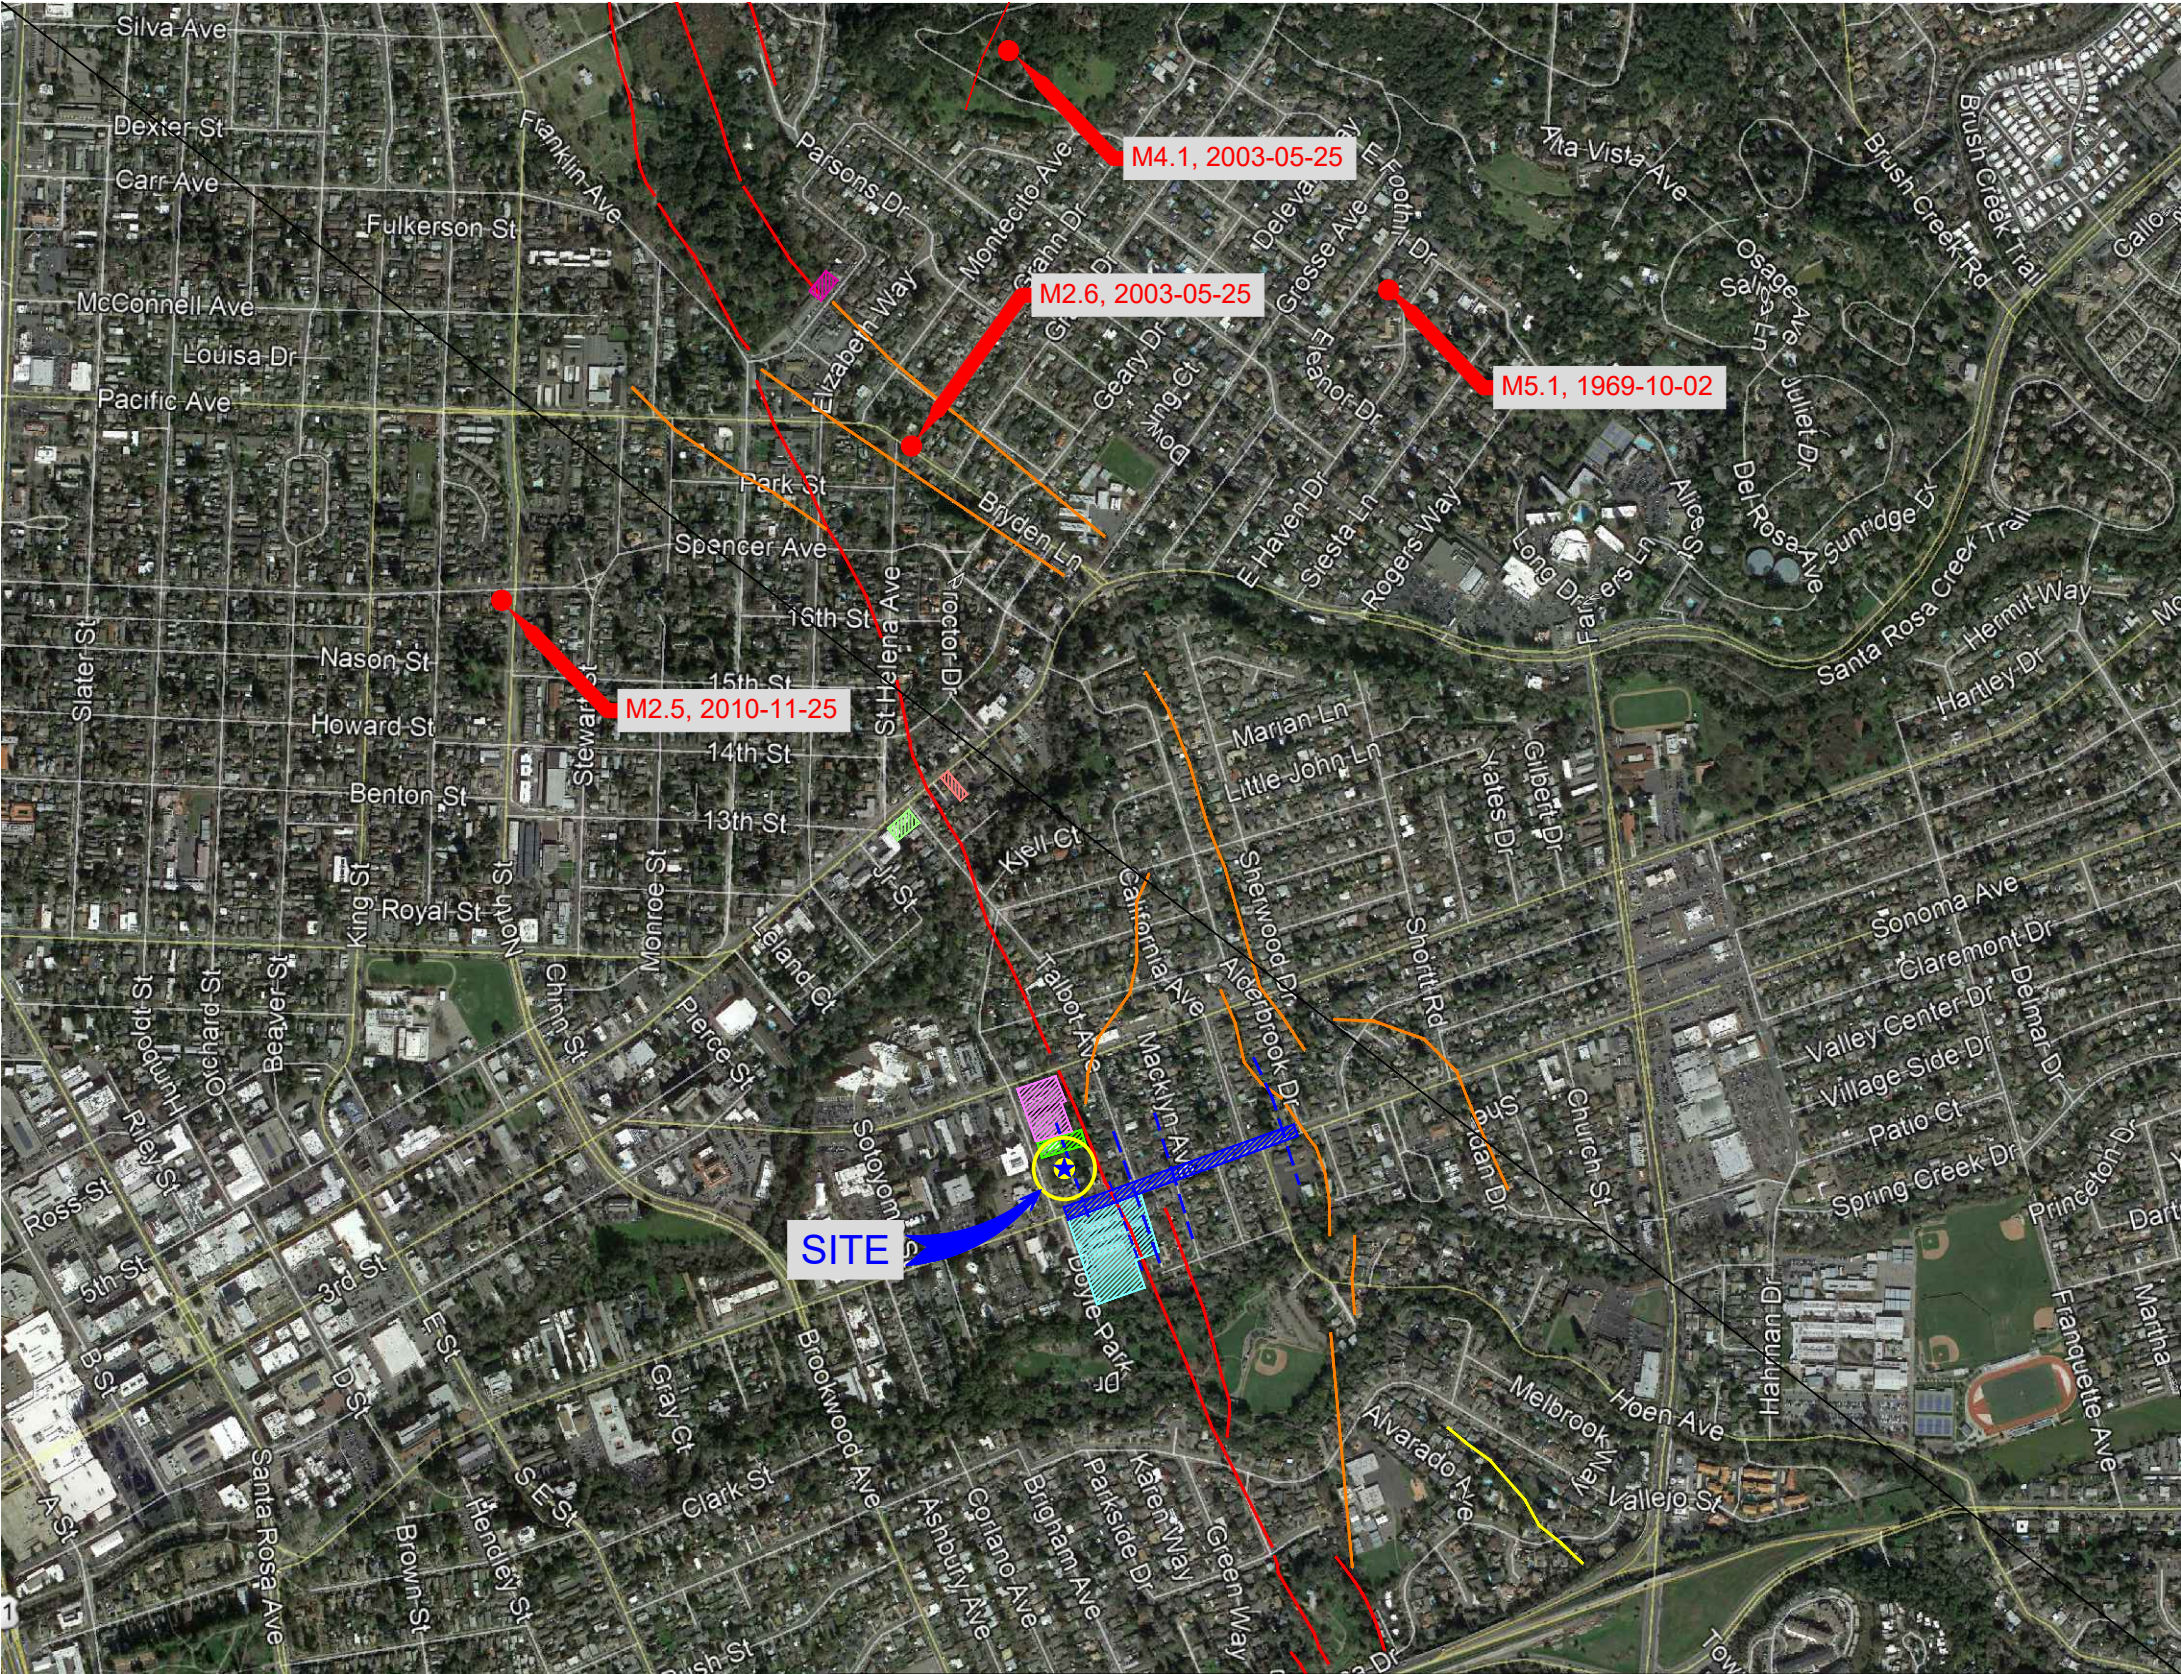
5  
FIGURE

Several smaller earthquakes have occurred near the site in historic times, the nearest of which are shown for reference on Figure 5 (USGS, 2020). The most significant of these was a 2003, Mw=4.1 earthquake centered near Montecito Avenue about a mile north of the site, while an Mw=2.6 event centered beneath Bryden Lane about ¾-mile north-northwest of the site occurred that same day. Neither event apparently caused significant damage.

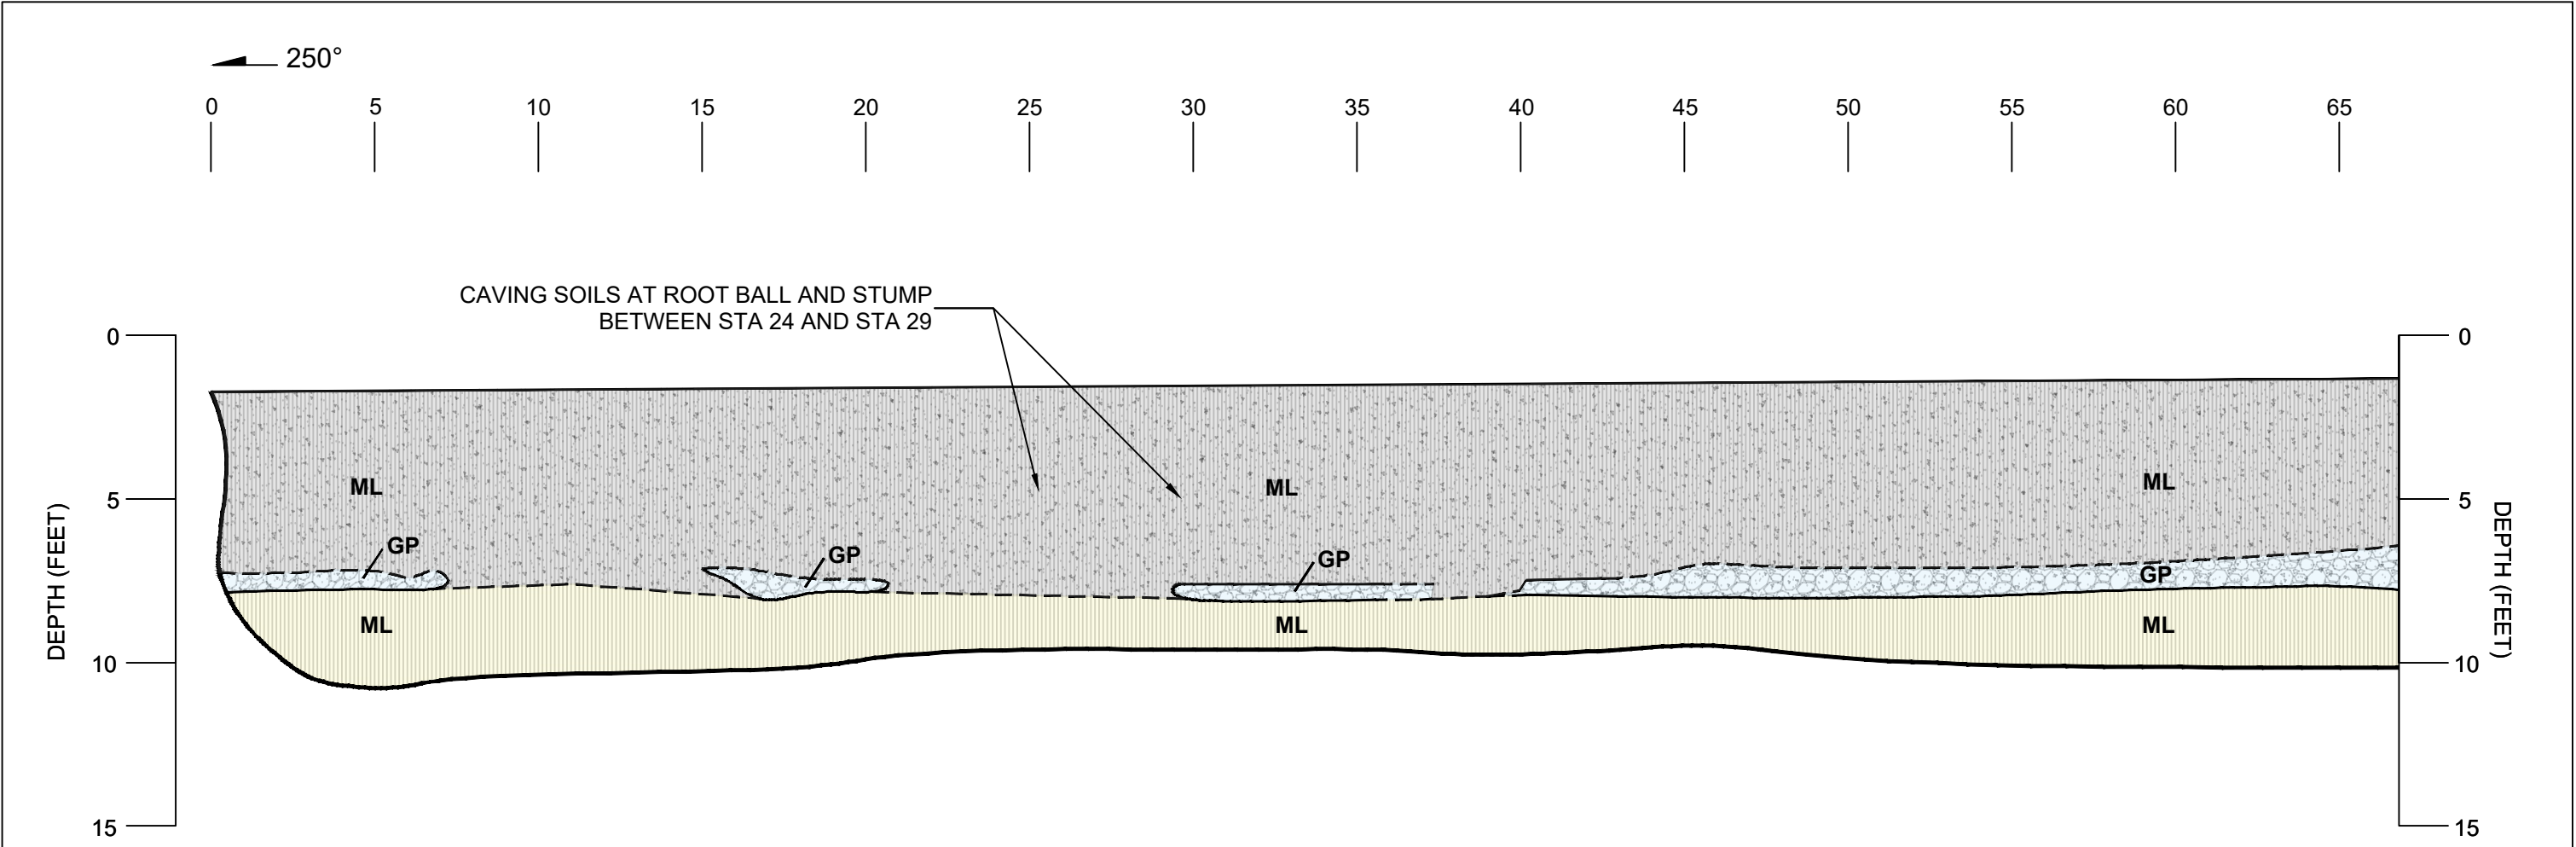
Trench T-1 was excavated to a total length of 285-feet, extending from the back-of-sidewalk along Doyle Park Drive to a point 30-feet east of the eastern property boundary. The trench exposed essentially flat-lying, apparently conformable alluvial soils of interpreted Middle to Late Holocene age. One thrust fault plane was identified in the north wall of the trench at Station 253, as shown on Figure B-5. The fault dips steeply to the east and has an apparent “up to the east” sense of motion. The fault projects across the trench along a strike of approximately N12°W, offsetting at least 5 relatively sharp stratigraphic contacts between 5- and 10-feet below the ground surface, with apparent vertical offsets measured at about 9-inches. A second thrust fault also having an “up to the east” sense of motion was identified at Station 255 in the south wall of the trench at Station 254, offsetting two contacts about 7- to 10-feet below the ground surface, and exhibiting apparent vertical offsets of about 4-inches.

Coarse gravelly soils encountered in the east end of the trench, extending from Stations 255 to 285, were found to contain considerable groundwater and resulted in significant caving and instability of the trench walls. This area was not logged for safety reasons. Additionally, unstable trench conditions were encountered in the zone of an apparent cross-cutting channel or shallow basin deposit of soft sandy silt between Stations 230 and about 250. This area was logged, although conditions generally precluded definitive observation of an absence of faults or other structures.
