TREE PRESERVATION AND MITIGATION REPORT

800 Yolanda Avenue
Santa Rosa, CA

December 1, 2017

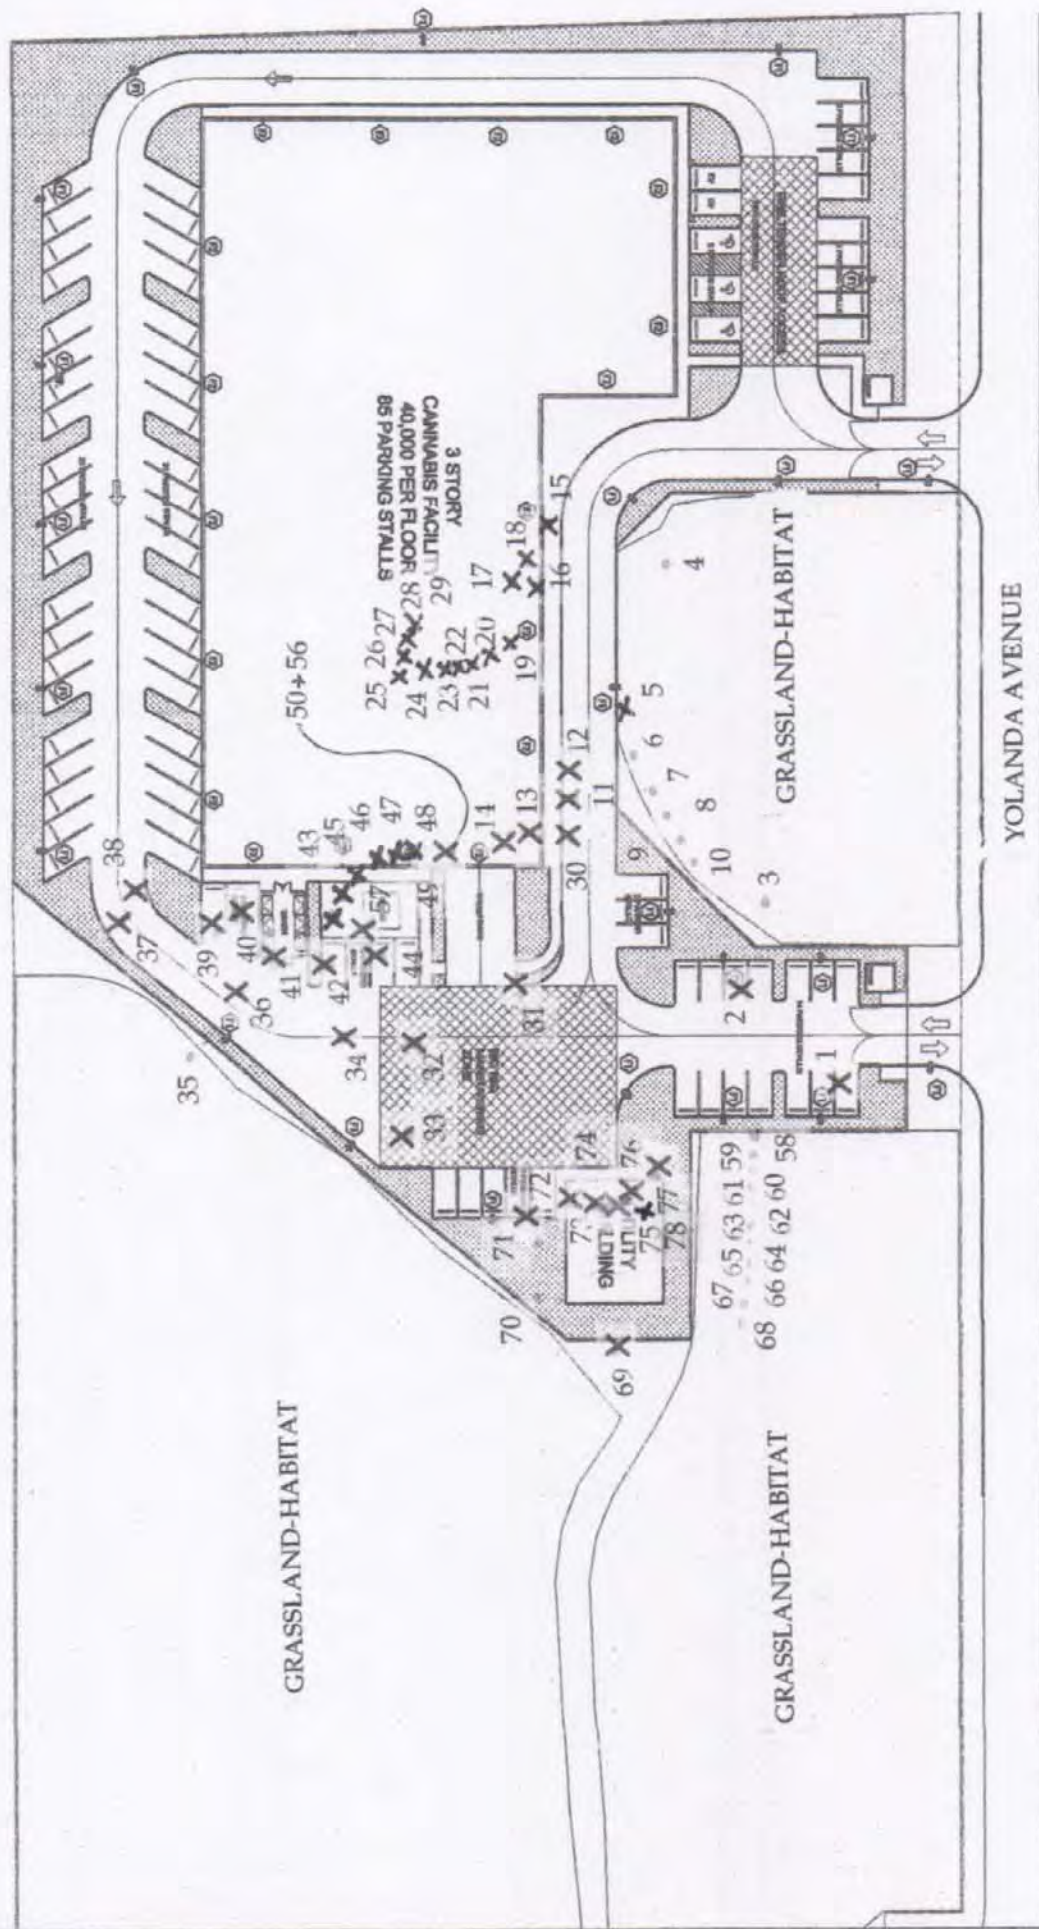
TREE LOCATION AND NUMBERING PLAN
 800 Yolanda Avenue
 Santa Rosa, CA

Each tree has been identified in the field with an aluminum tag and reference number. Tags are attached to the trunk at approximately eye level and the *Tree Location Plan* illustrates the location of each numbered tree that is outside the creek setback area. Trees in the creek setback area have been tagged and numbered, but only their approximate locations have been illustrated.
