**RE: REQUEST TO REMOVE A BUNYA BUNYA TREE AT 1080 2<sup>ND</sup> STREET, SANTA ROSA**  
APN: 009-082-003  
ZONING: Planned Development (PD 0067)  
GENERAL PLAN: Office  
FILE NO: TR22-062

## Arborist Report

February 5, 2023

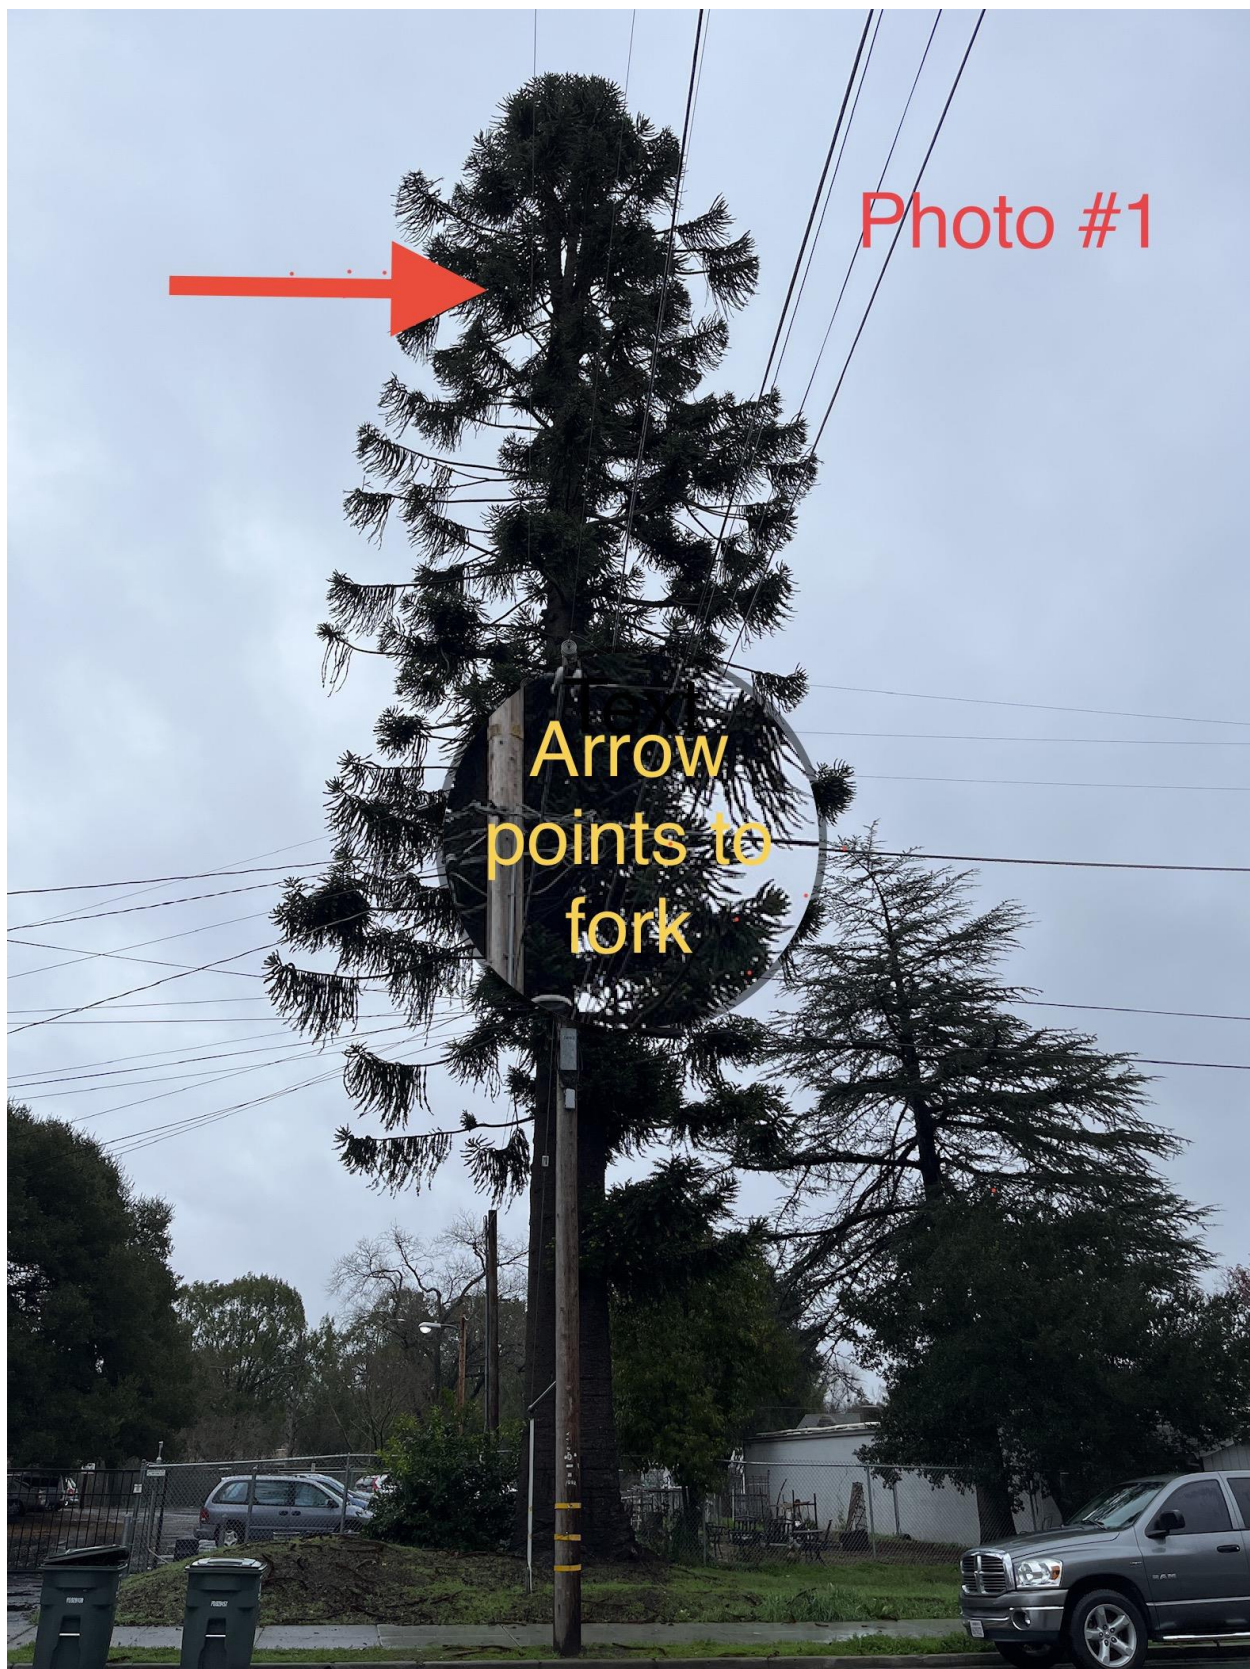
Photo #1

ground level, with subordinated lateral limbs extending up through the canopy to approximately 100' above ground level. At the approximate 100' height range, the tree forks into three stems (see photo #1).

Arrow  
points to  
fork

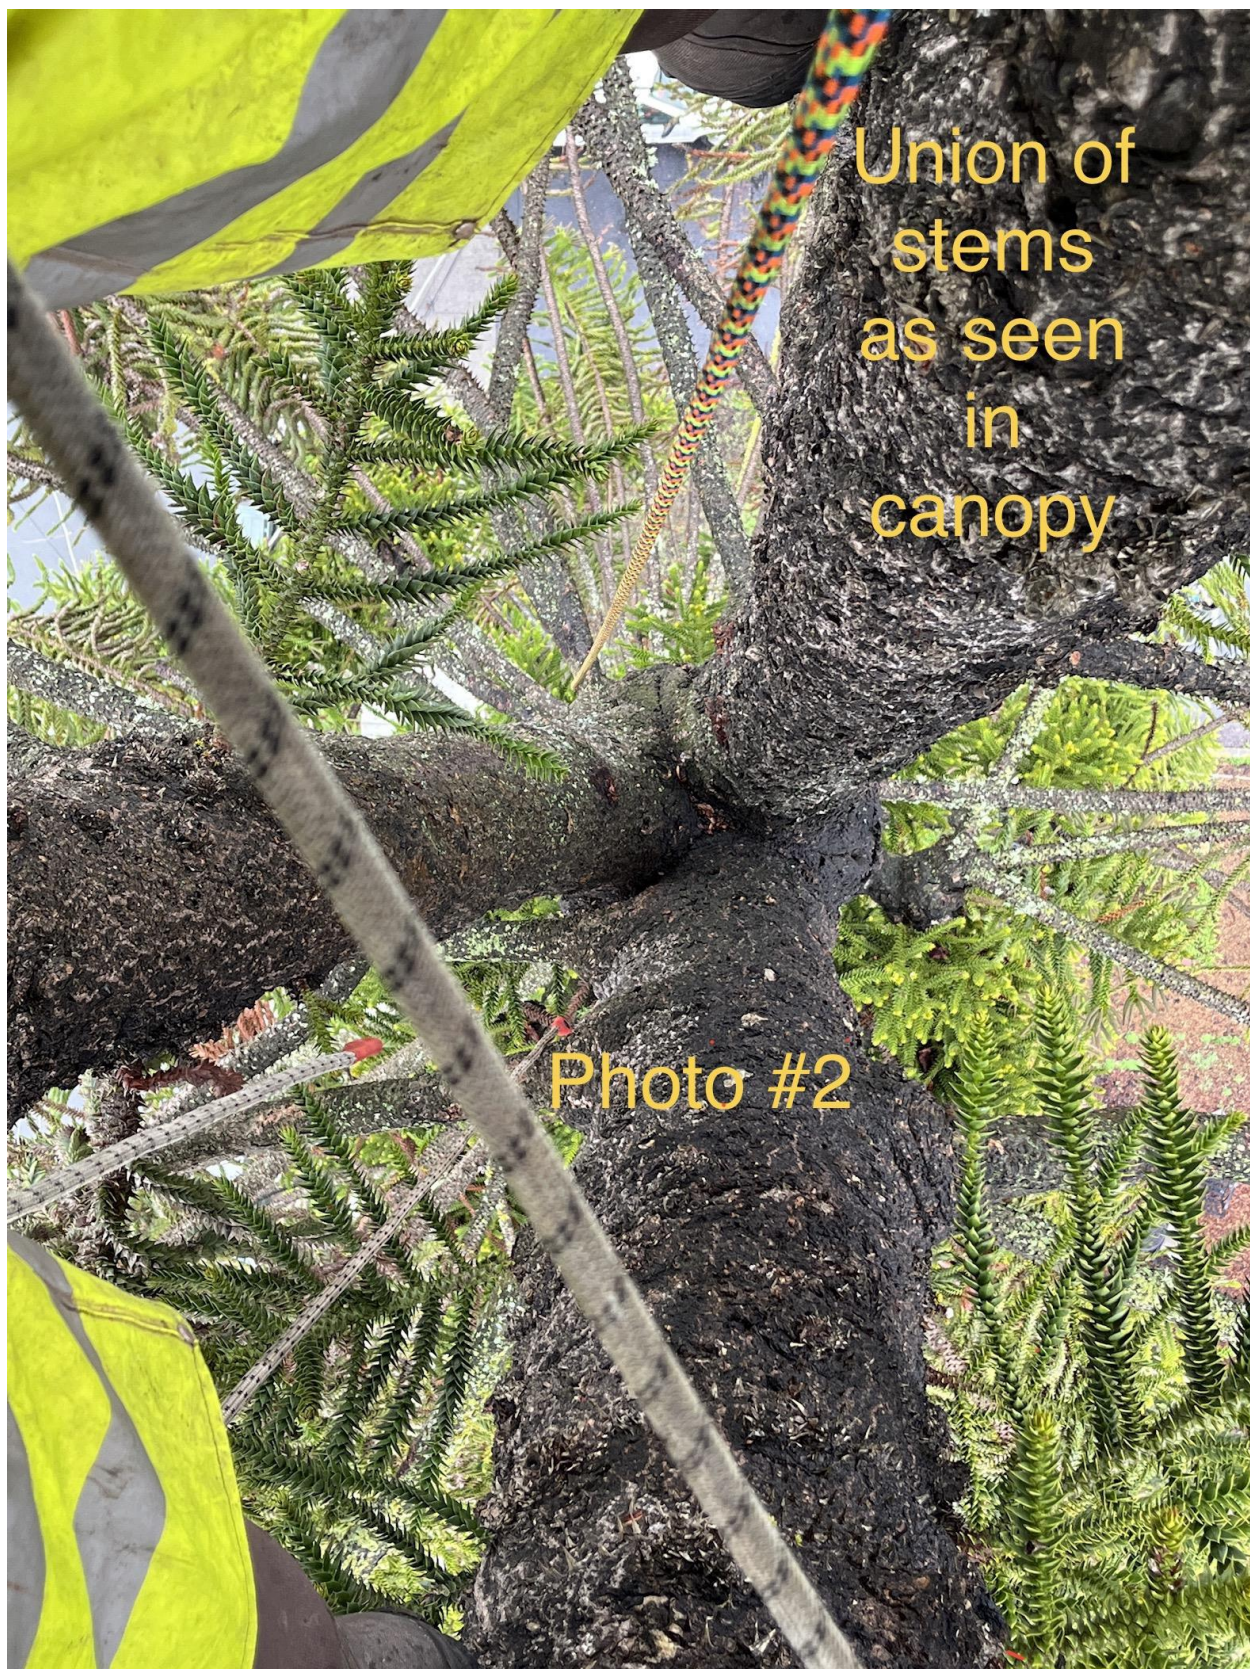
Photo #2

While in the tree I also observed the point of attachment of the three competitive stems. Each stem possesses an average stem diameter of 12-14". The three stems originate at the same position on the tree (see photo #2).

The presence of a dominant stem, with subordinated limbs is a well designed system for weight distribution and improved limb attachments at trunk. Multiple stems, especially those similar in diameter, which originate in one location, possess an increased likelihood for failure at the attachment point. These stems do not appear to possess a high weight load. These co-dominant stems are closely oriented to one another. In my experience, this closeness minimizes exposure to load increasing elements, such as wind, rain, etc. and improves stem retention likelihood. While the load on these stems appears low, there persists a likelihood of failure at the point of attachment. In my experience, a very effective method of managing the load on stems like these and minimizing their current risk for failure is a support cable system in the form of a triangle. An additional risk management tool to cabling is thinning and reduction of the crown in the portion(s) above the stems' point of attachment.

Union of  
stems  
as seen  
in  
canopy

To reduce the stems' failure risk, I recommend installation of a cable support system in addition to, or apart from crown thinning and mass reduction in the upper 25' of the tree.

Due to the sensitive nature of pruning and/or cabling of a tree, it should be performed and/or overseen by an ISA Certified Arborist to ensure the highest likelihood of proper execution of the care. The tree should then be monitored by an ISA Certified Arborist (recommended is every twelve months, or until a different interval is deemed appropriate).
