Arborist Report

February 5, 2023

Inspect Bunya Pine located at 1080 2nd St., Santa Rosa, Ca 95404 to rate the risk of the multiple stem portion(s) in upper canopy of the tree, provide mitigation option(s) to aid in minimizing the likelihood(s) for failure and determine residual risk of the same area(s). The evaluation to be achieved by a ground level, visual perspective as well as by climbing the tree to more closely observe the stem attachment(s) and arrangement. The current risk and residual risk rating to be determined by utilizing the Tree Risk Assessment Qualification (TRAQ) matrices.

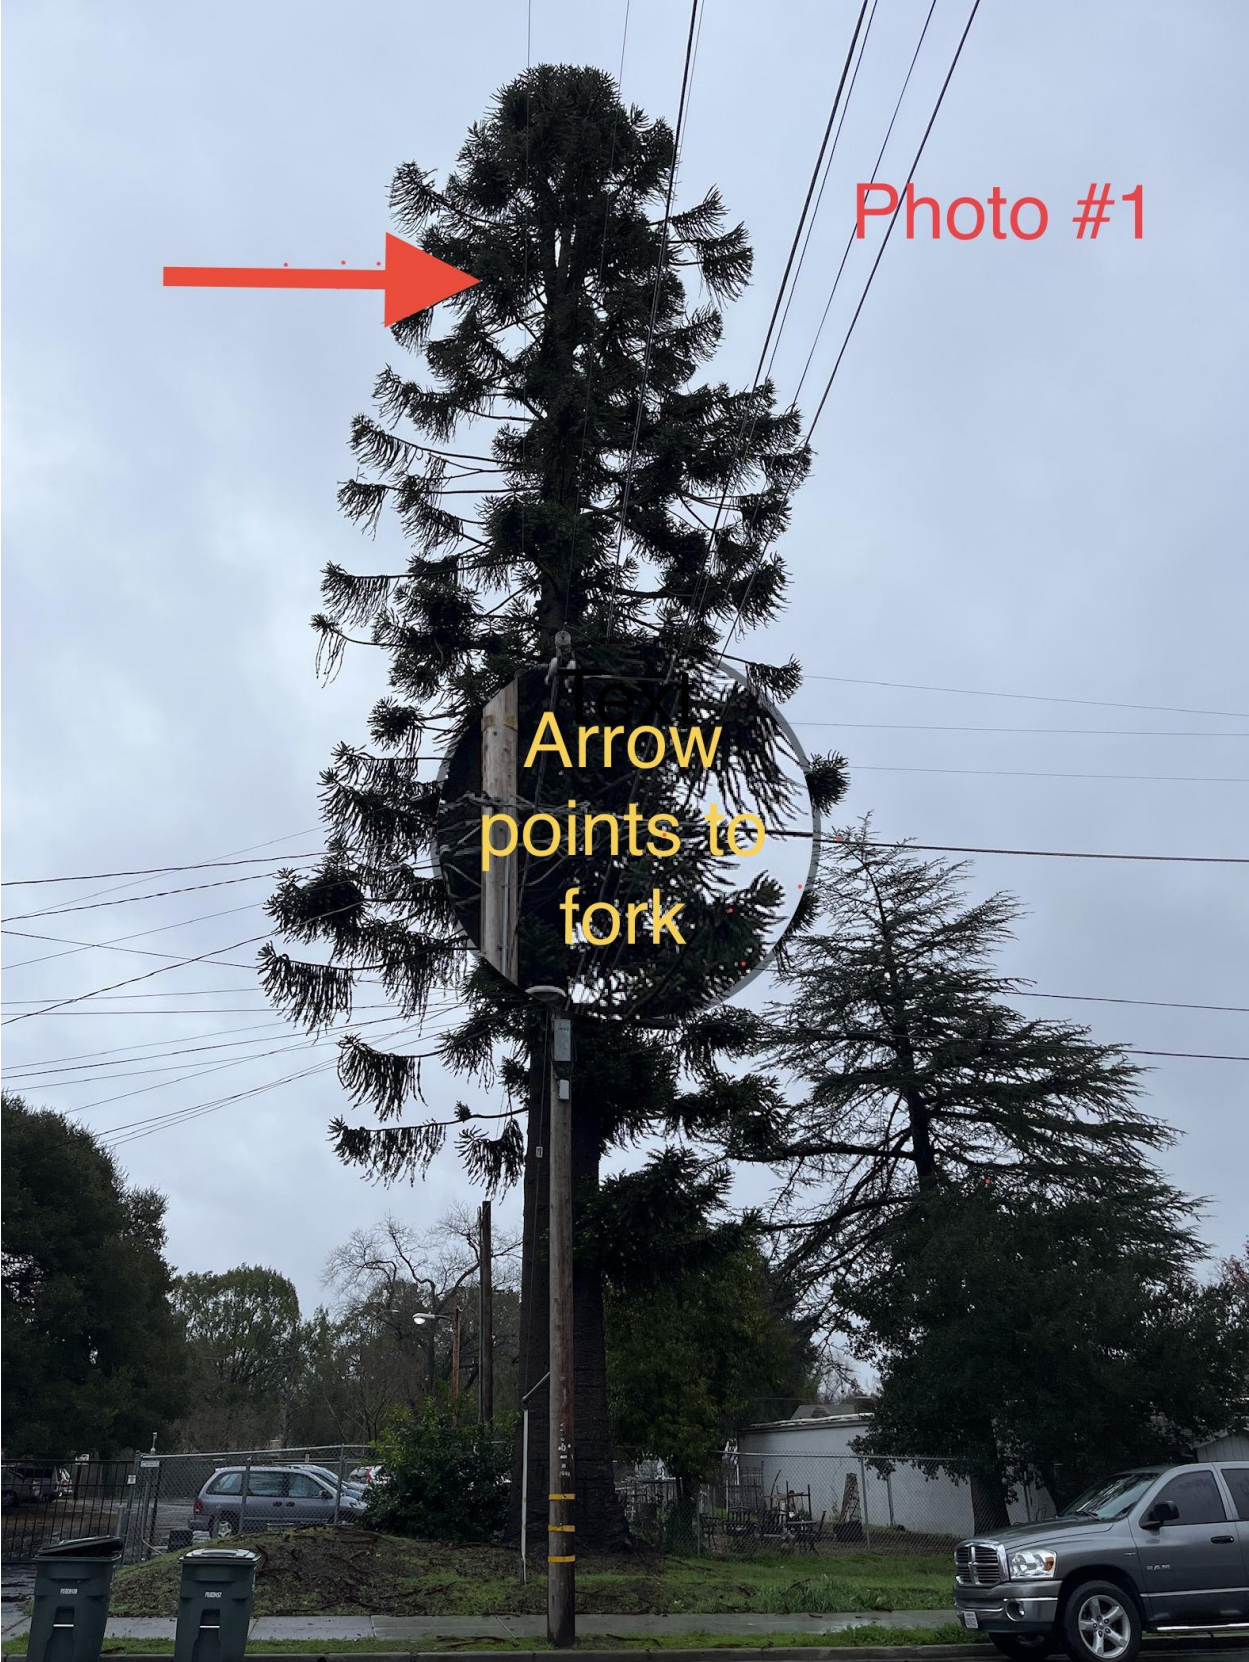
Photo #1

ground level, with subordinated lateral limbs extending up through the canopy to approximately 100' above ground level. At the approximate 100' height range, the tree forks into three stems (see photo #1).

Arrow
points to
fork
