December 5th, 2024

Subject: Arborist Inventory Report
 Stonehouse Santa Rosa, 3555 Sonoma Hwy, Santa Rosa CA 95405

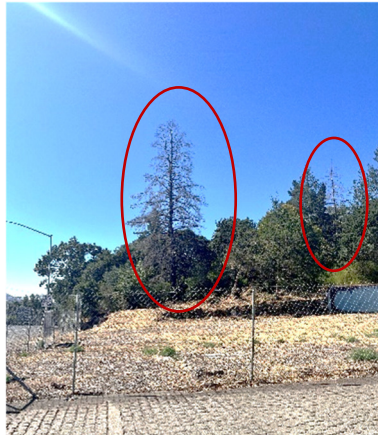
Area 2: Tree #114 Dead Fir, also additional dead fir (T#136) further up hill and to the right. Both trees are of poor health & structure

T 112	Coast Live Oak	<i>Quercus agrifolia</i>	17"	N	POOR	POOR	SIGNIFICANT	REMOVE	Remove due to poor structure + construction impacts
T113	Coast Live Oak	<i>Quercus agrifolia</i>	16"	N	POOR	POOR	SIGNIFICANT	REMOVE	Remove due to poor structure + construction impacts
T 114	Douglas Fir	<i>Pseudotsuga menziesii</i>	32"	Y	POOR	POOR	SIGNIFICANT	REMOVE	Standing dead tree; to be removed.
T 115	Coast Live Oak	<i>Quercus agrifolia</i>	7"	N	MARGINAL	POOR	SIGNIFICANT	REMOVE	Remove due to poor structure + construction impacts
T 117	Black Oak	<i>Quercus kelloggii</i>	32"	Y	FAIR	POOR	SIGNIFICANT	REMOVE	Located in rock outcropping with other recent tree failures; remove due to poor structure + construction impacts
T 118	Coast Live Oak	<i>Quercus agrifolia</i>	18"	Y	MARGINAL	POOR	MODERATE	REMOVE	Near rock outcropping, remove due to poor structure + construction impacts
T 119	Coast Live Oak	<i>Quercus agrifolia</i>	14"	N	MARGINAL	POOR	SIGNIFICANT	REMOVE	Near rock outcropping, remove due to poor structure + construction impacts

T 134	Coast Live Oak	<i>Quercus agrifolia</i>	6"	N	POOR	MARGINAL	SIGNIFICANT	REMOVE	Remove due to poor structure + construction impacts
T 135	Coast Live Oak	<i>Quercus agrifolia</i>	6"	N	MARGINAL	MARGINAL	MODERATE	REMOVE	Remove due to poor structure + construction impacts
T 136	Douglas Fir	<i>Pseudotsuga menziesii</i>	42"	Y	MARGINAL	MARGINAL	MODERATE	REMOVE	Remove due to poor condition + construction impacts
T 137	Coast Live Oak	<i>Quercus agrifolia</i>	8"-12"	N	FAIR	MODERATE	MINOR	PRESERVE	Tree #137 indicates several trees in this area (within dripline shown and which are located outside of the development impacts), are in fair overall general health, and are potentials to be protected and preserved within tree protection fencing. Current concept plan shows no development in this zone.
T 138	Coast Live Oak	<i>Quercus agrifolia</i>	9",6"	N	MARGINAL	POOR	MODERATE	REMOVE	Remove due to structure + construction impacts

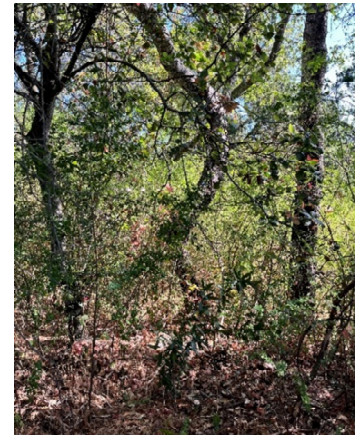
Area 2: general conditions in densely overgrown area consisting of small brushy black oaks of marginal structure

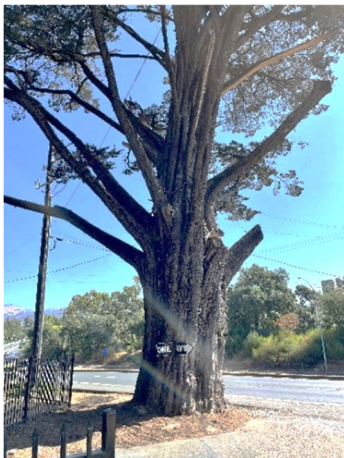
Offsite Tree: "B" a large heritage-sized Monterey Cypress, visible from Sonoma Hwy, is to be undisturbed, preserved and protected.

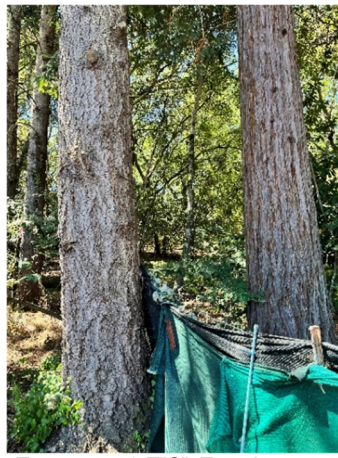
Trees #125 & T'C': T125 is an on-site Fir, and T "C" Redwood is on the adjacent property. Both trees are to be preserved and protected.

OFFSITE TREE "C"	Coast Redwood	<i>Sequoia sempervirens</i>	32"	Y	GOOD	MODERATE	MODERATE	PRESERVE	HERITAGE TREE - OFFSITE TREE TO BE PRESERVED (no tree tag label), treat as any on-site tree to be preserved—ensure minimal impact to root zone, do not disturb roots, install mulch layer + tree protection fencing at dripline, canopy may overhang project site

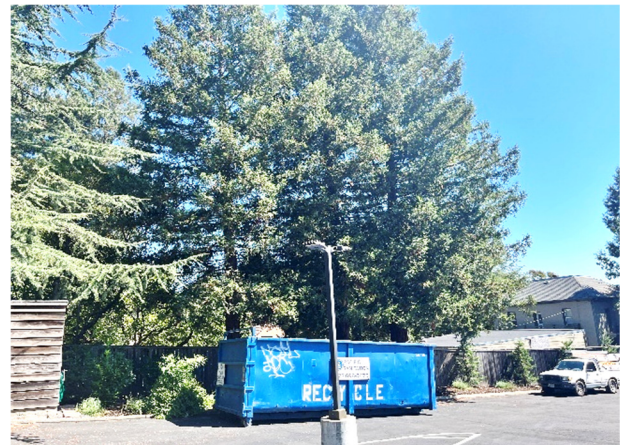
Area 1: Coast Redwood Trees # 102, 103, 104 located along north property boundary are all in good condition and are to be preserved and protected.

T 103	Coast Redwood	<i>Sequoia sempervirens</i>	26"	Y	EXCELLENT	GOOD	MINOR	PRESERVE	General condition and structure good, average health, color, and vigor. Has potential for longevity on site; spread a 4" layer of bark mulch and tree protection fencing at edge of dripline prior to construction, maintain fencing in place and provide irrigation for duration of construction
T 104	Coast Redwood	<i>Sequoia sempervirens</i>	32"	Y	EXCELLENT	GOOD	MINOR	PRESERVE	General condition and structure good, average health, color, and vigor. Has potential for longevity on site; spread a 4" layer of bark mulch and tree protection fencing at edge of dripline prior to construction, maintain fencing in place and provide irrigation for duration of construction
T 105	Coast Live Oak	<i>Quercus agrifolia</i>	17"	N	GOOD	MODERATE	MINOR	PRESERVE	Not tagged—located within existing developed courtyard with limited access; general condition good, structurally moderate with co-dominant main scaffold branches; average health, color and vigor; potential for minimal impacts in this courtyard, preserve with fencing for the duration of construction

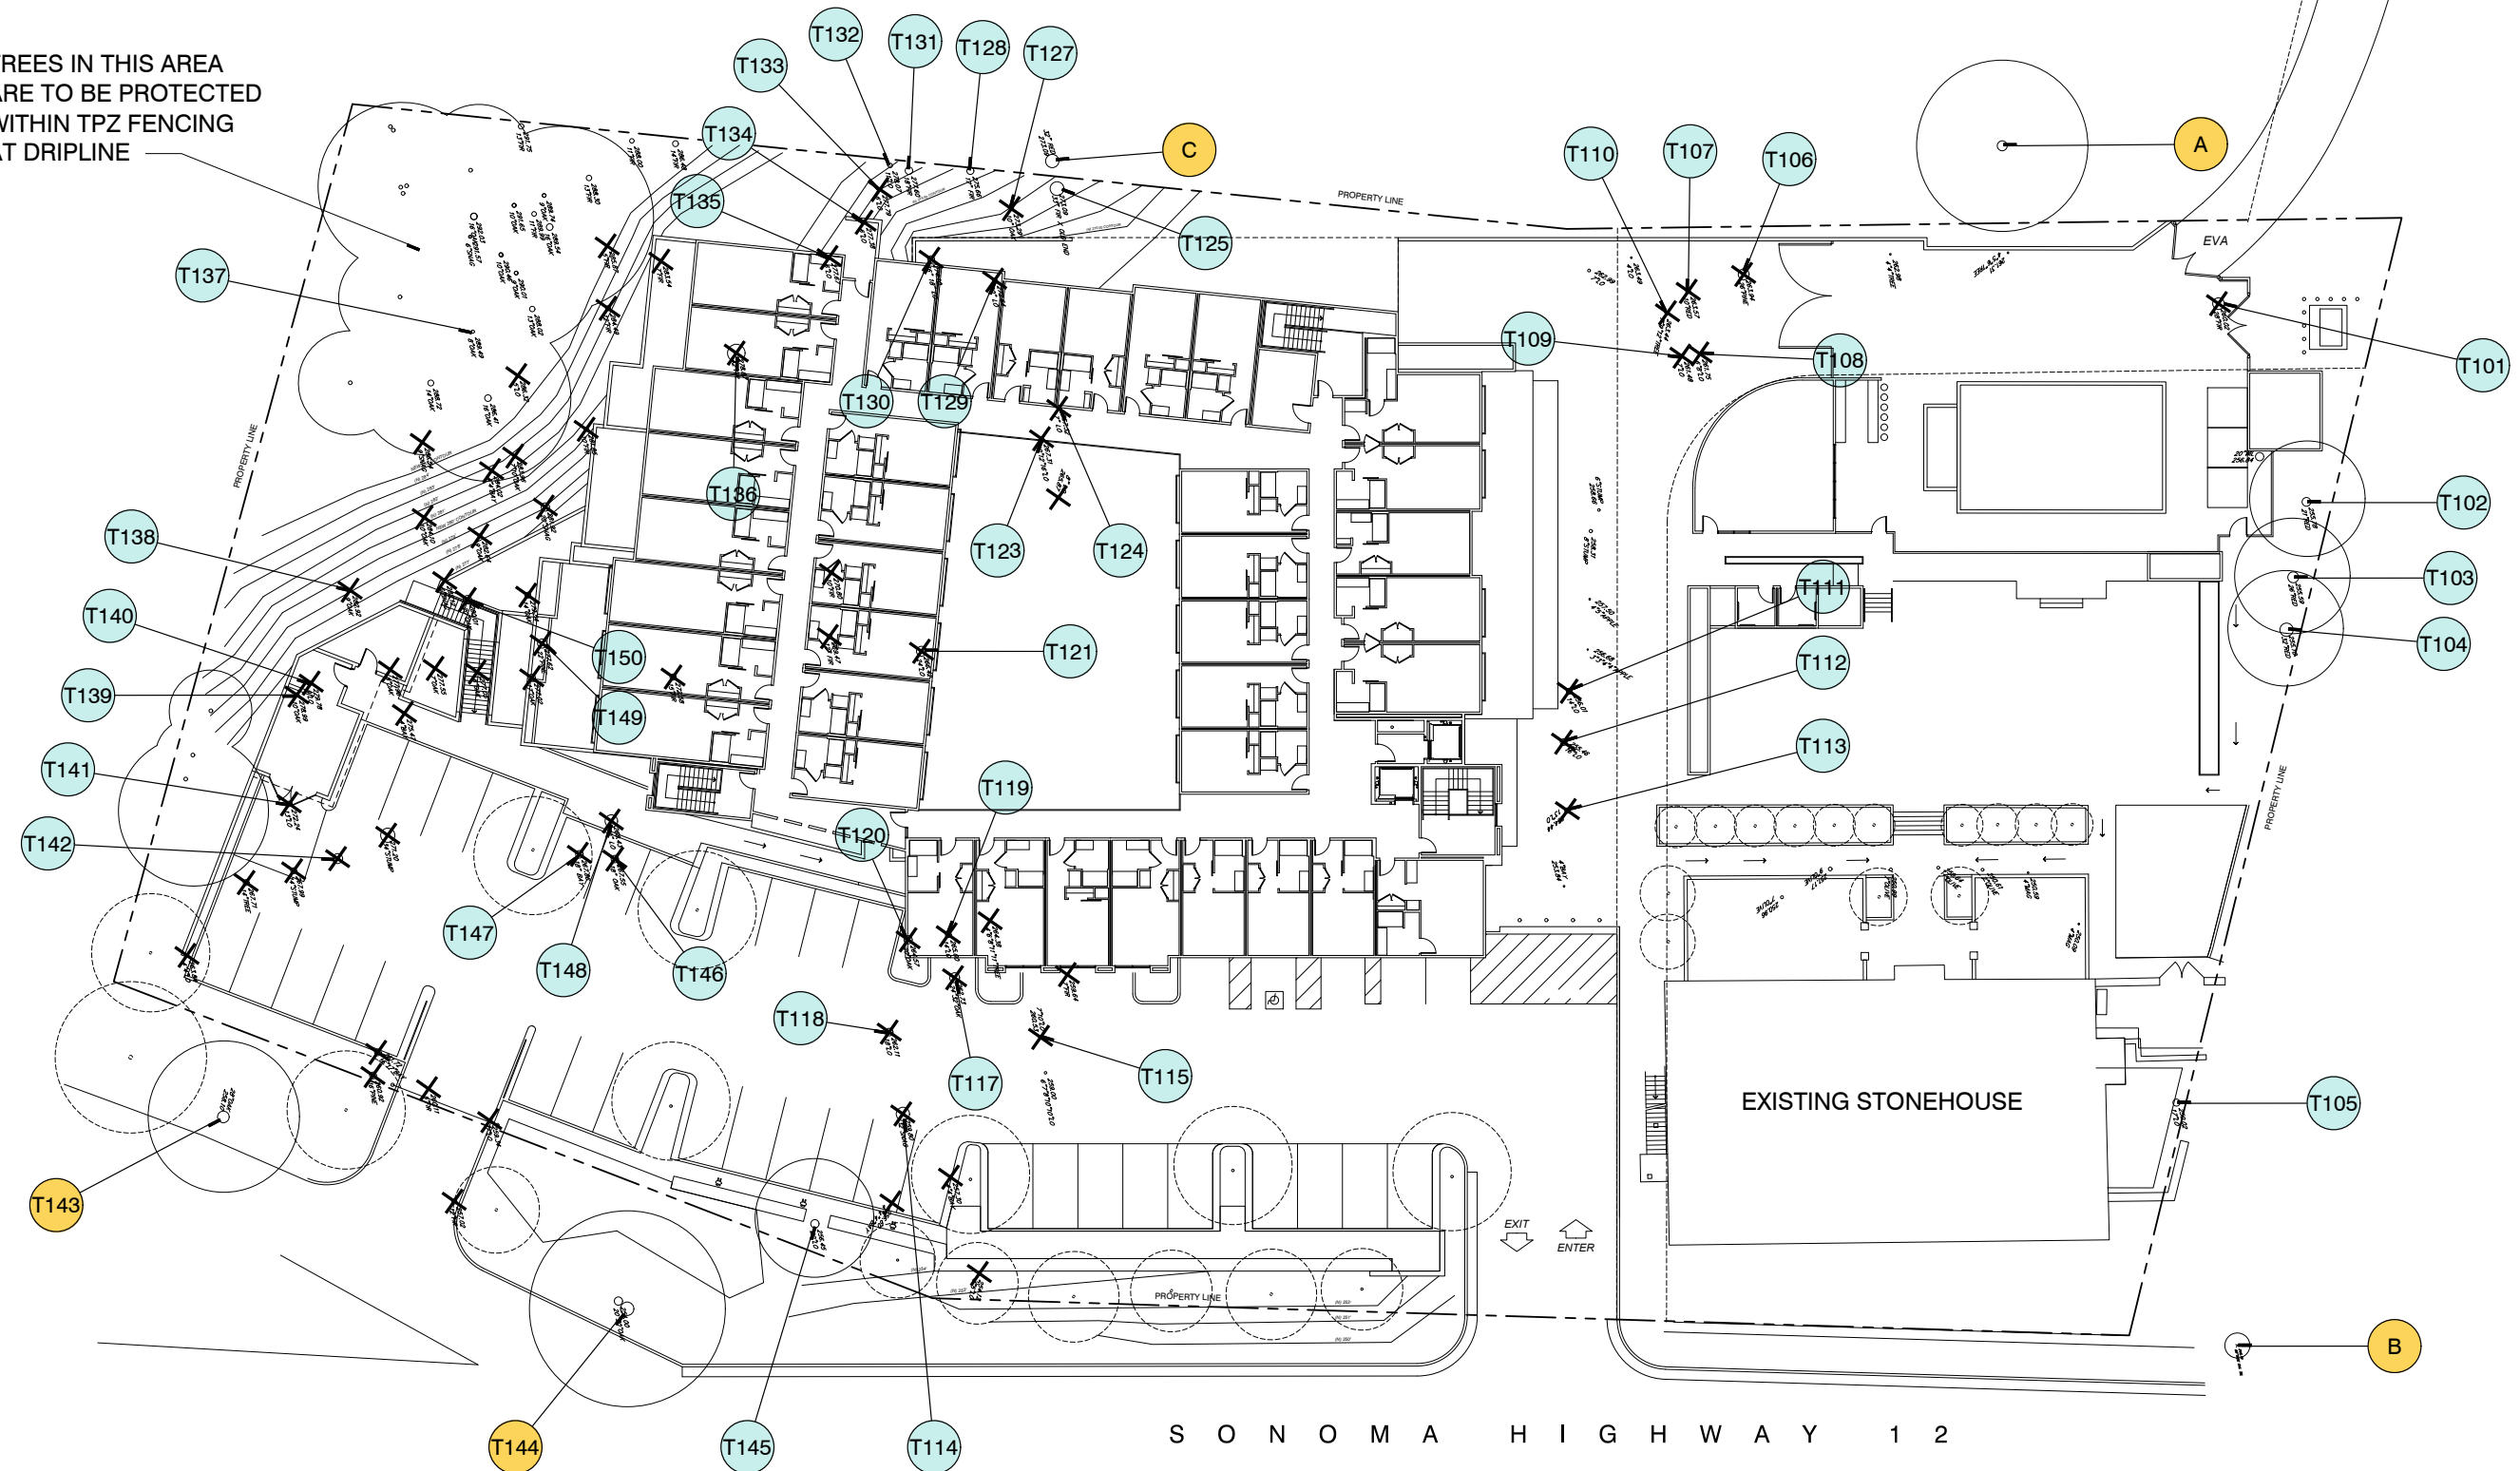
STONEHOUSE RENOVATION AND HOTEL - TREE INVENTORY MAP

TREES IN THIS AREA
ARE TO BE PROTECTED
WITHIN TPZ FENCING
AT DRIPLINE
