## Arborist Report

February 5, 2023

Inspect Bunya Pine located at 1080 2nd St., Santa Rosa, Ca 95404 to rate the risk of the multiple stem portion(s) in upper canopy of the tree, provide mitigation option(s) to aid in minimizing the likelihood(s) for failure and determine residual risk of the same area(s). The evaluation to be achieved by a ground level, visual perspective as well as by climbing the tree to more closely observe the stem attachment(s) and arrangement. The current risk and residual risk rating to be determined by utilizing the Tree Risk Assessment Qualification (TRAQ) matrices.

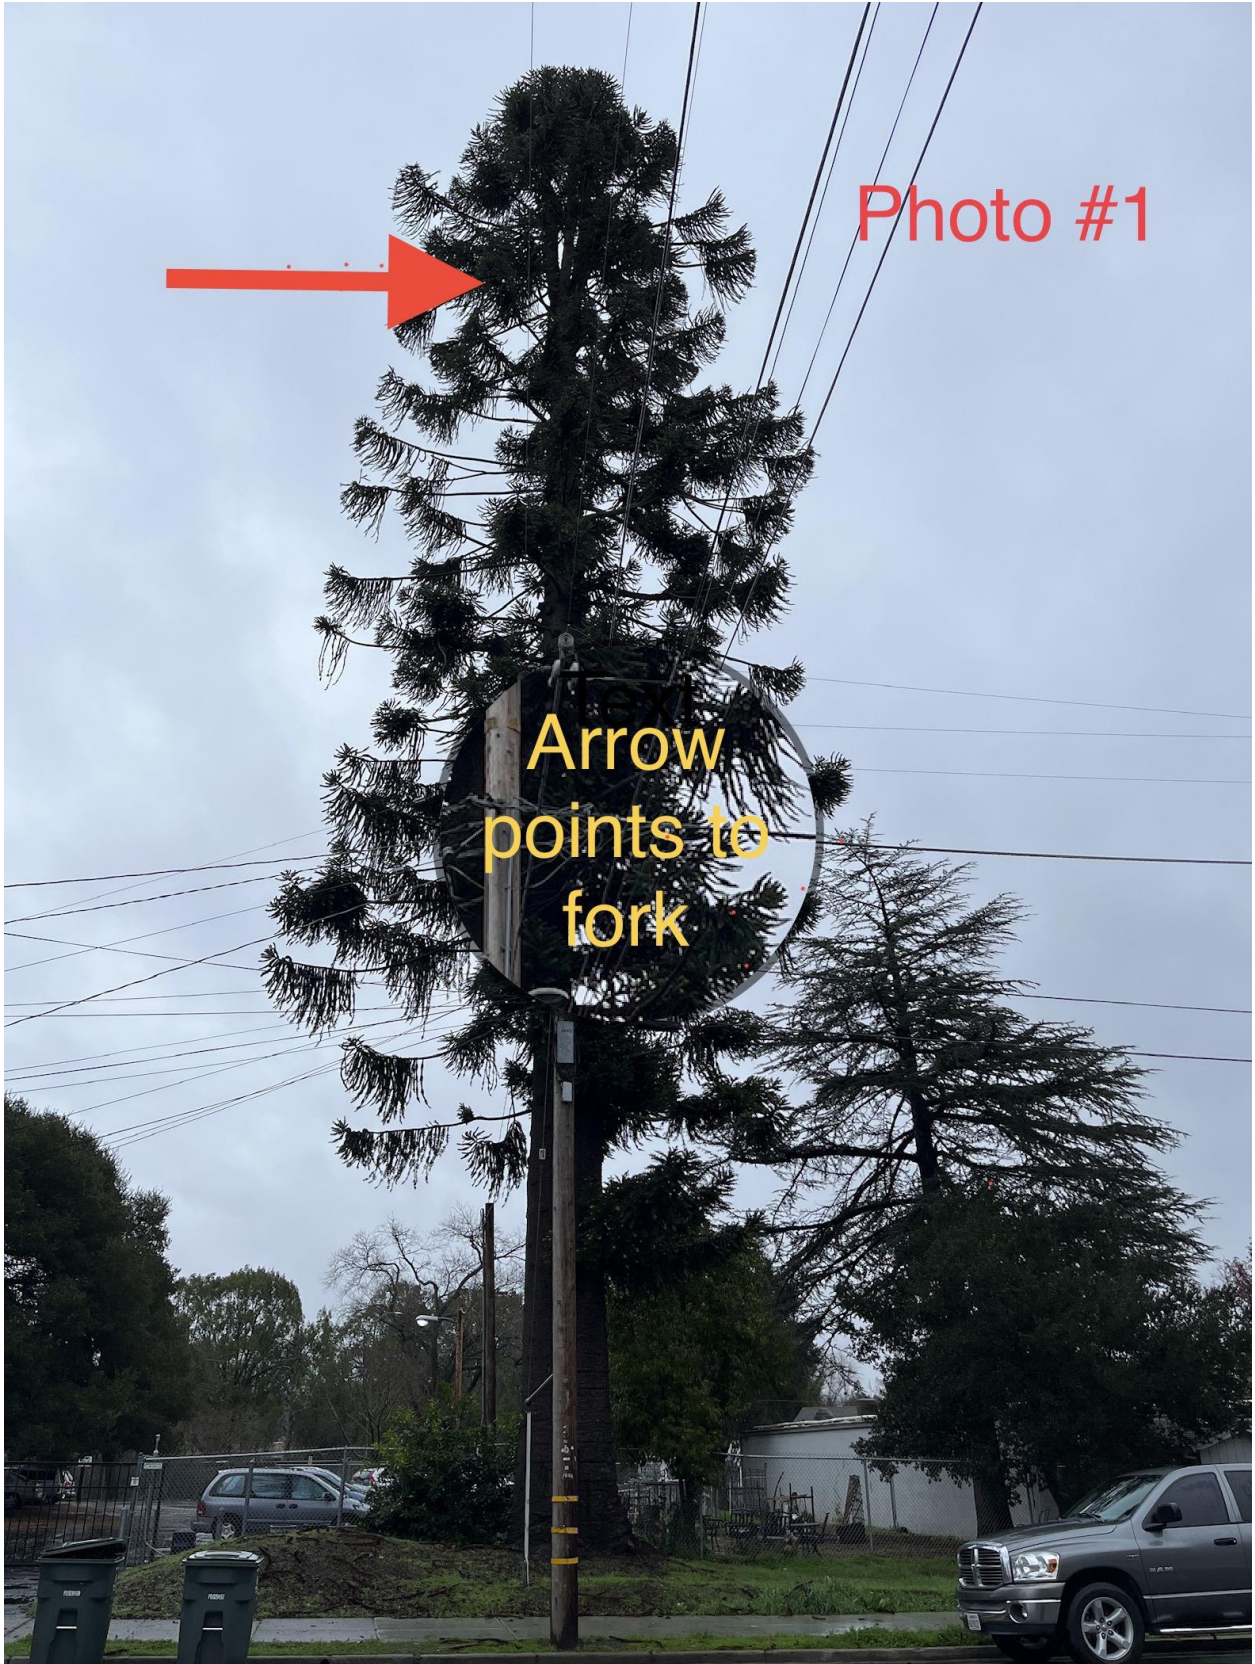
Photo #1

ground level, with subordinated lateral limbs extending up through the canopy to approximately 100' above ground level. At the approximate 100' height range, the tree forks into three stems (see photo #1).

Arrow  
points to  
fork

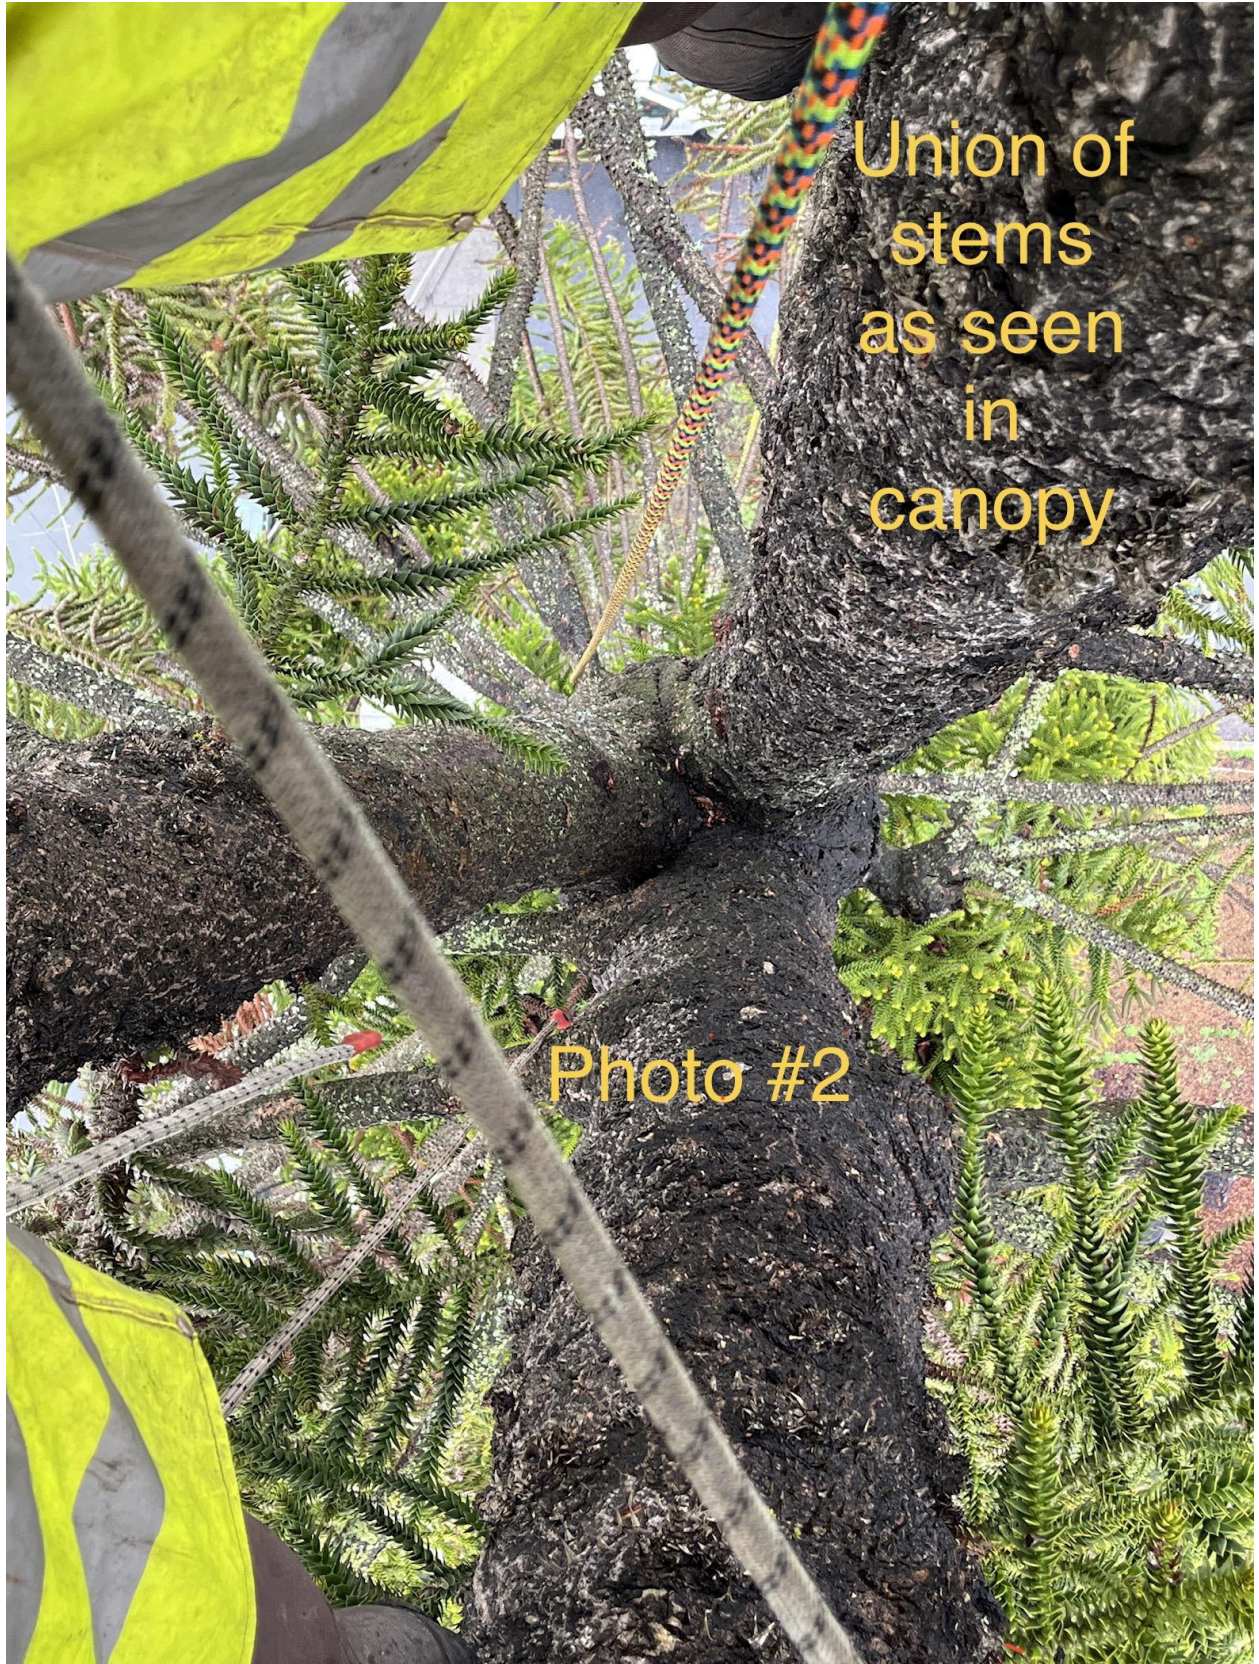
Photo #2

While in the tree I also observed the point of attachment of the three competitive stems. Each stem possesses an average stem diameter of 12-14". The three stems originate at the same position on the tree (see photo #2).

The presence of a dominant stem, with subordinated limbs is a well designed system for weight distribution and improved limb attachments at trunk. Multiple stems, especially those similar in diameter, which originate in one location, possess an increased likelihood for failure at the attachment point. These stems do not appear to possess a high weight load. These co-dominant stems are closely oriented to one another. In my experience, this closeness minimizes exposure to load increasing elements, such as wind, rain, etc. and improves stem retention likelihood. While the load on these stems appears low, there persists a likelihood of failure at the point of attachment. In my experience, a very effective method of managing the load on stems like these and minimizing their current risk for failure is a support cable system in the form of a triangle. An additional risk management tool to cabling is thinning and reduction of the crown in the portion(s) above the stems' point of attachment.

Based on the current condition of the tree and processing it through the TRAQ matrices, its overall risk rating is low, as it relates to likelihood for failure in addition to the likelihood for impact and consequences of failure to its target(s). While a rating of "low" is the lowest achievable through this industry accepted risk evaluation system, there are still options available to manage the current risk associated with the multiple stems.

Union of  
stems  
as seen  
in  
canopy

To reduce the stems' failure risk, I recommend installation of a cable support system in addition to, or apart from crown thinning and mass reduction in the upper 25' of the tree.
