RE: REQUEST TO REMOVE A BUNYA BUNYA TREE AT 1080 2ND STREET, SANTA ROSA

FILE NO: TR22-062

Arborist Report

February 5, 2023

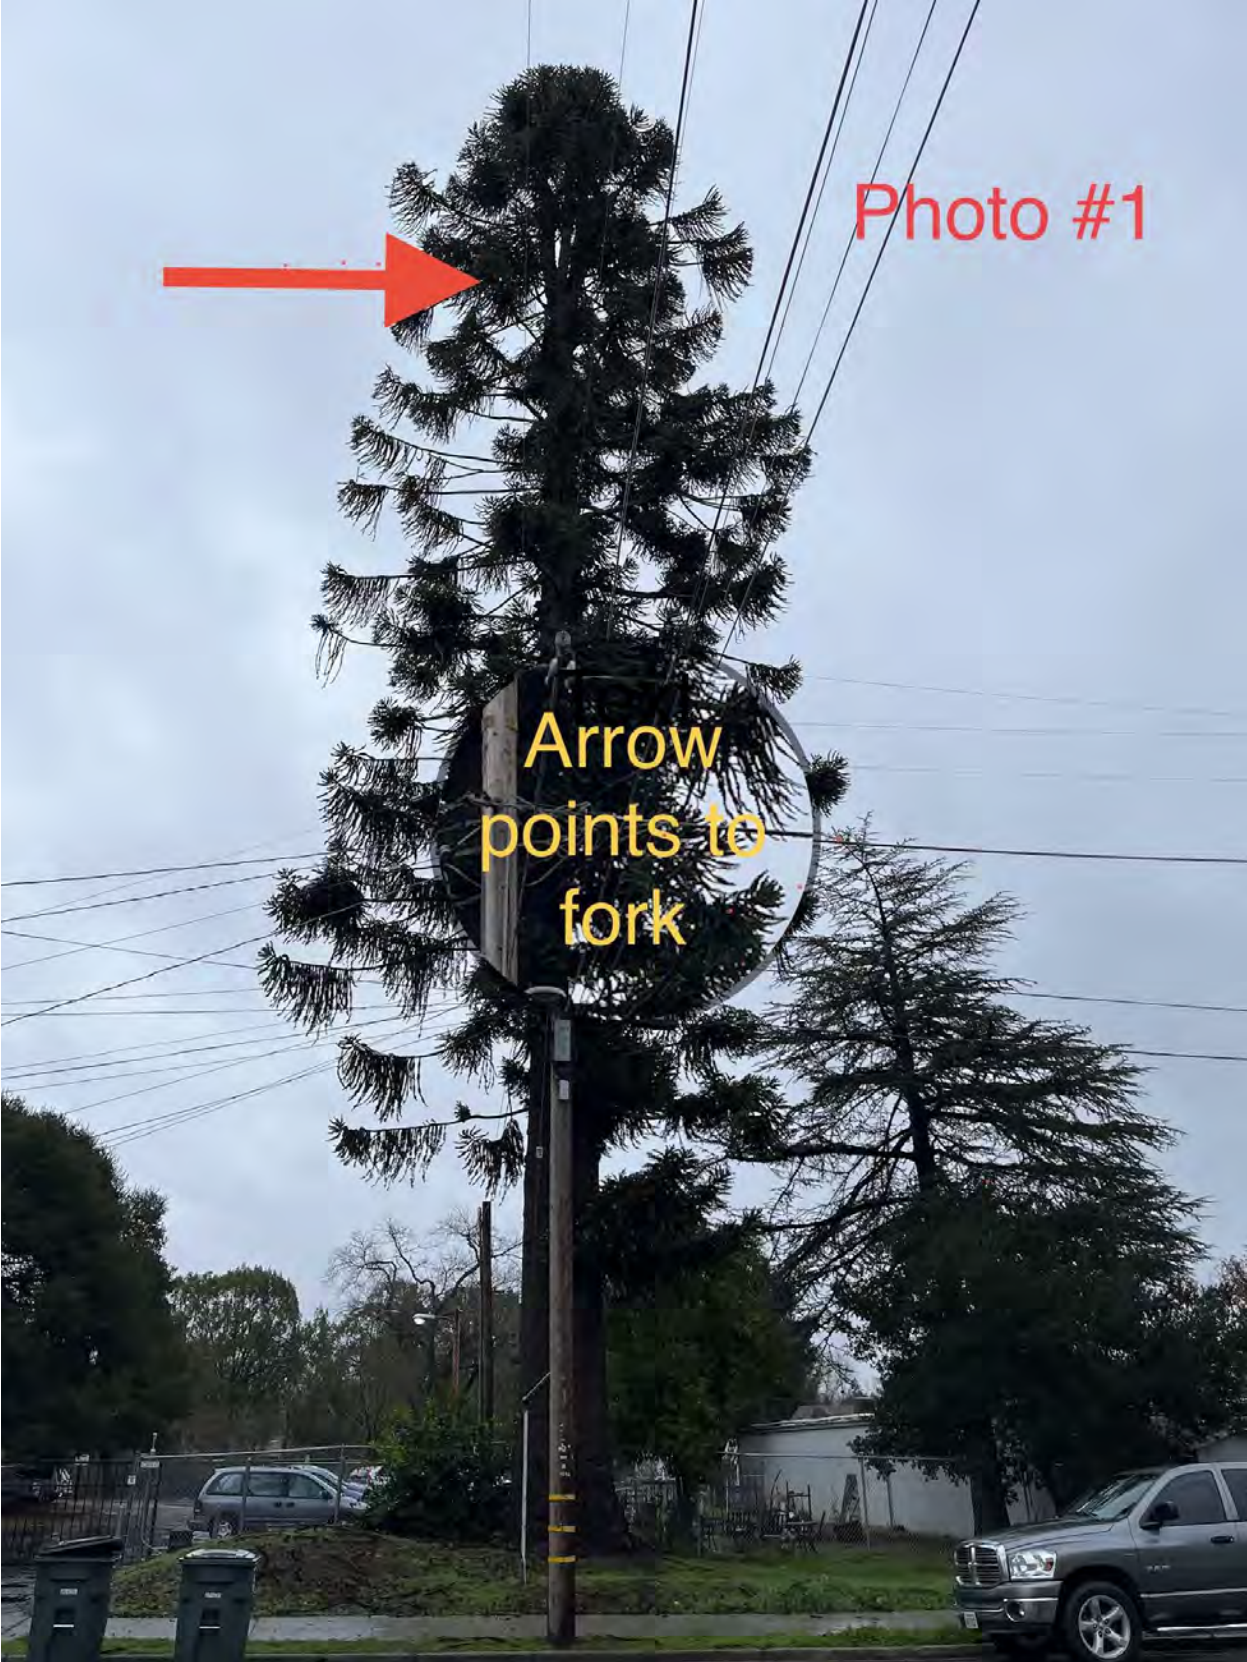
Photo #1

ground level, with subordinated lateral limbs extending up through the canopy to approximately 100' above ground level. At the approximate 100' height range, the tree forks into three stems (see photo #1).

The presence of a dominant stem, with subordinated limbs is a well designed system for weight distribution and improved limb attachments at trunk. Multiple stems, especially those similar in diameter, which originate in one location, possess an increased likelihood for failure at the attachment point. These stems do not appear to possess a high weight load. These co-dominant stems are closely oriented to one another. In my experience, this closeness minimizes exposure to load increasing elements, such as wind, rain, etc. and improves stem retention likelihood. While the load on these stems appears low, there persists a likelihood of failure at the point of attachment. In my experience, a very effective method of managing the load on stems like these and minimizing their current risk for failure is a support cable system in the form of a triangle. An additional risk management tool to cabling is thinning and reduction of the crown in the portion(s) above the stems' point of attachment.

Based on the current condition of the tree and processing it through the TRAQ matrices, its overall risk rating is low, as it relates to likelihood for failure in addition to the likelihood for impact and consequences of failure to its target(s). While a rating of "low" is the lowest achievable through this industry accepted risk evaluation system, there are still options available to manage the current risk associated with the multiple stems.

Arrow
points to
fork

To reduce the stems' failure risk, I recommend installation of a cable support system in addition to, or apart from crown thinning and mass reduction in the upper 25' of the tree.

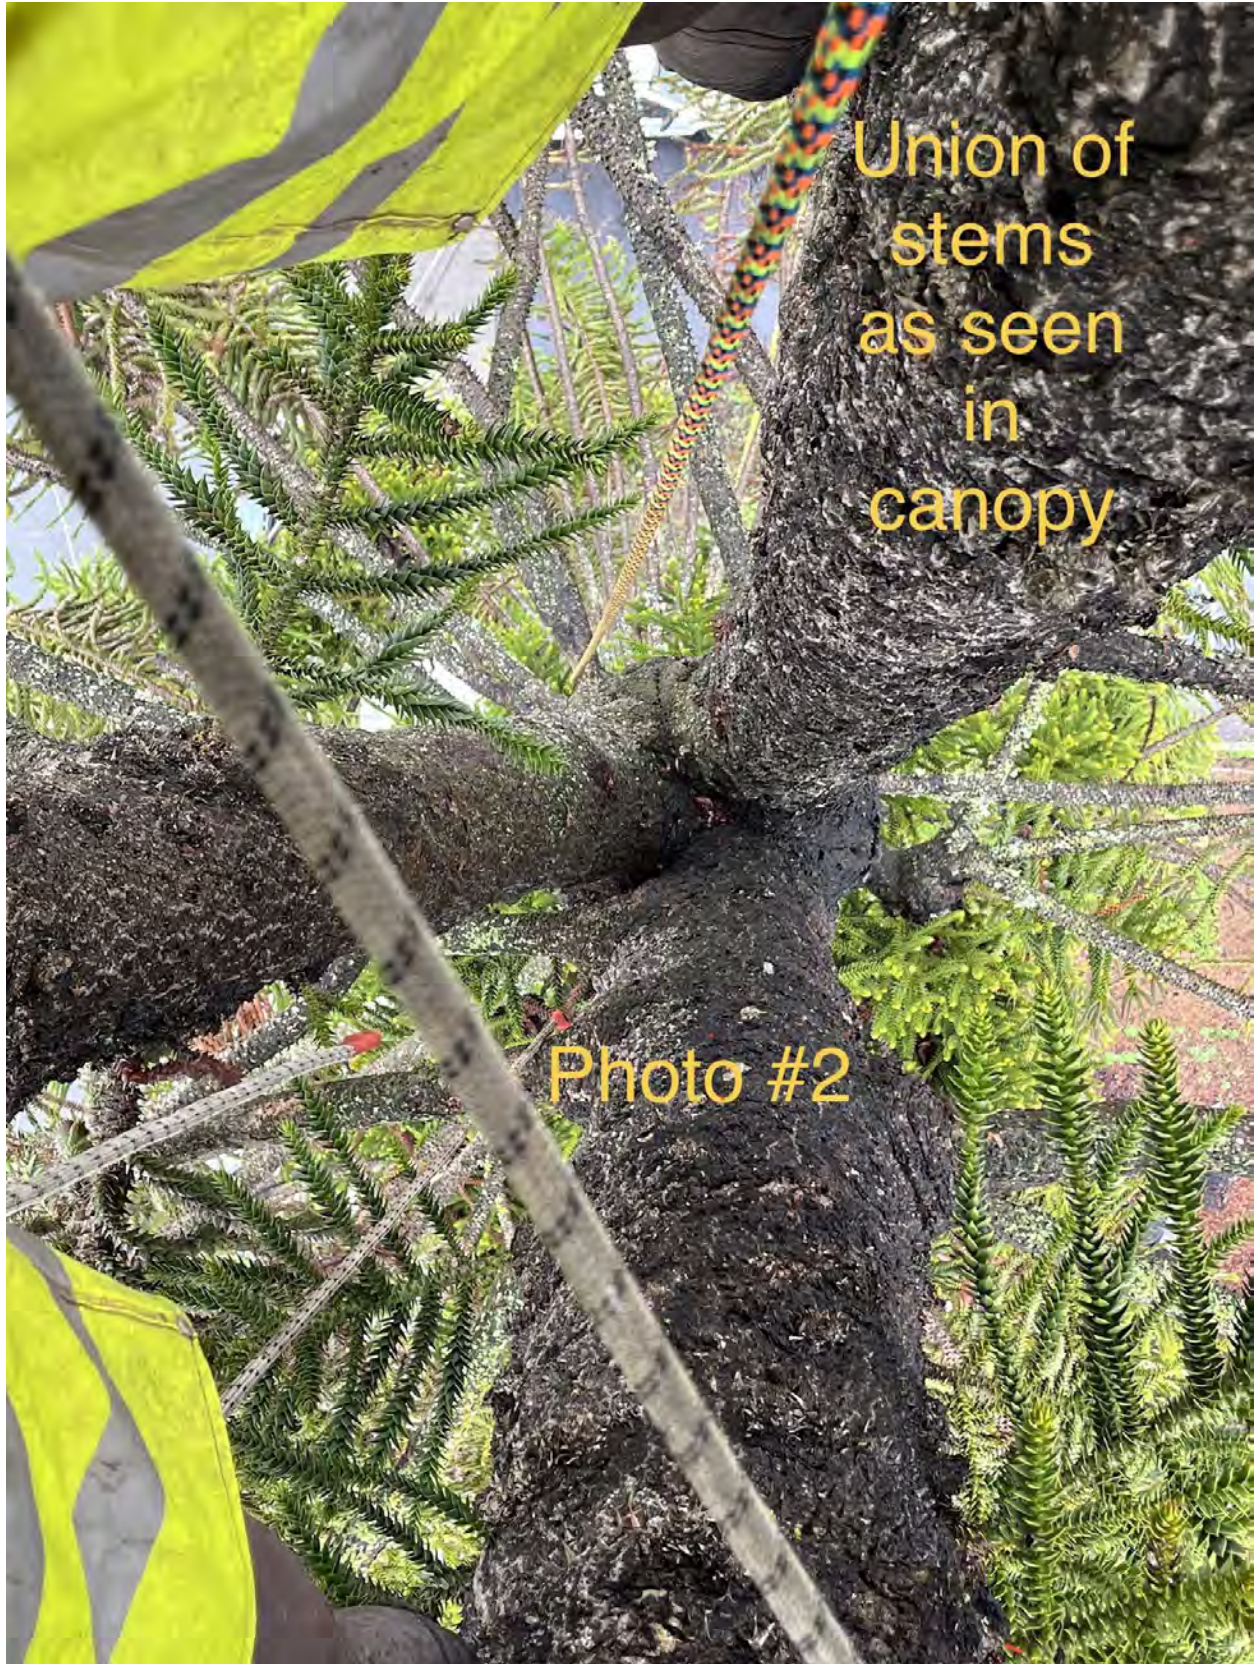
Photo #2

While in the tree I also observed the point of attachment of the three competitive stems. Each stem possesses an average stem diameter of 12-14". The three stems originate at the same position on the tree (see photo #2).

Union of
stems
as seen
in
canopy
