**RE: REQUEST TO REMOVE A BUNYA BUNYA TREE AT 1080 2<sup>ND</sup> STREET, SANTA ROSA**  
APN: 009-082-003  
ZONING: Planned Development (PD 0067)  
GENERAL PLAN: Office  
FILE NO: TR22-062

## Arborist Report

Inspect Bunya Pine located at 1080 2nd St., Santa Rosa, Ca 95404 to rate the risk of the multiple stem portion(s) in upper canopy of the tree, provide mitigation option(s) to aid in minimizing the likelihood(s) for failure and determine residual risk of the same area(s). The evaluation to be achieved by a ground level, visual perspective as well as by climbing the tree to more closely observe the stem attachment(s) and arrangement. The current risk and residual risk rating to be determined by utilizing the Tree Risk Assessment Qualification (TRAQ) matrices.

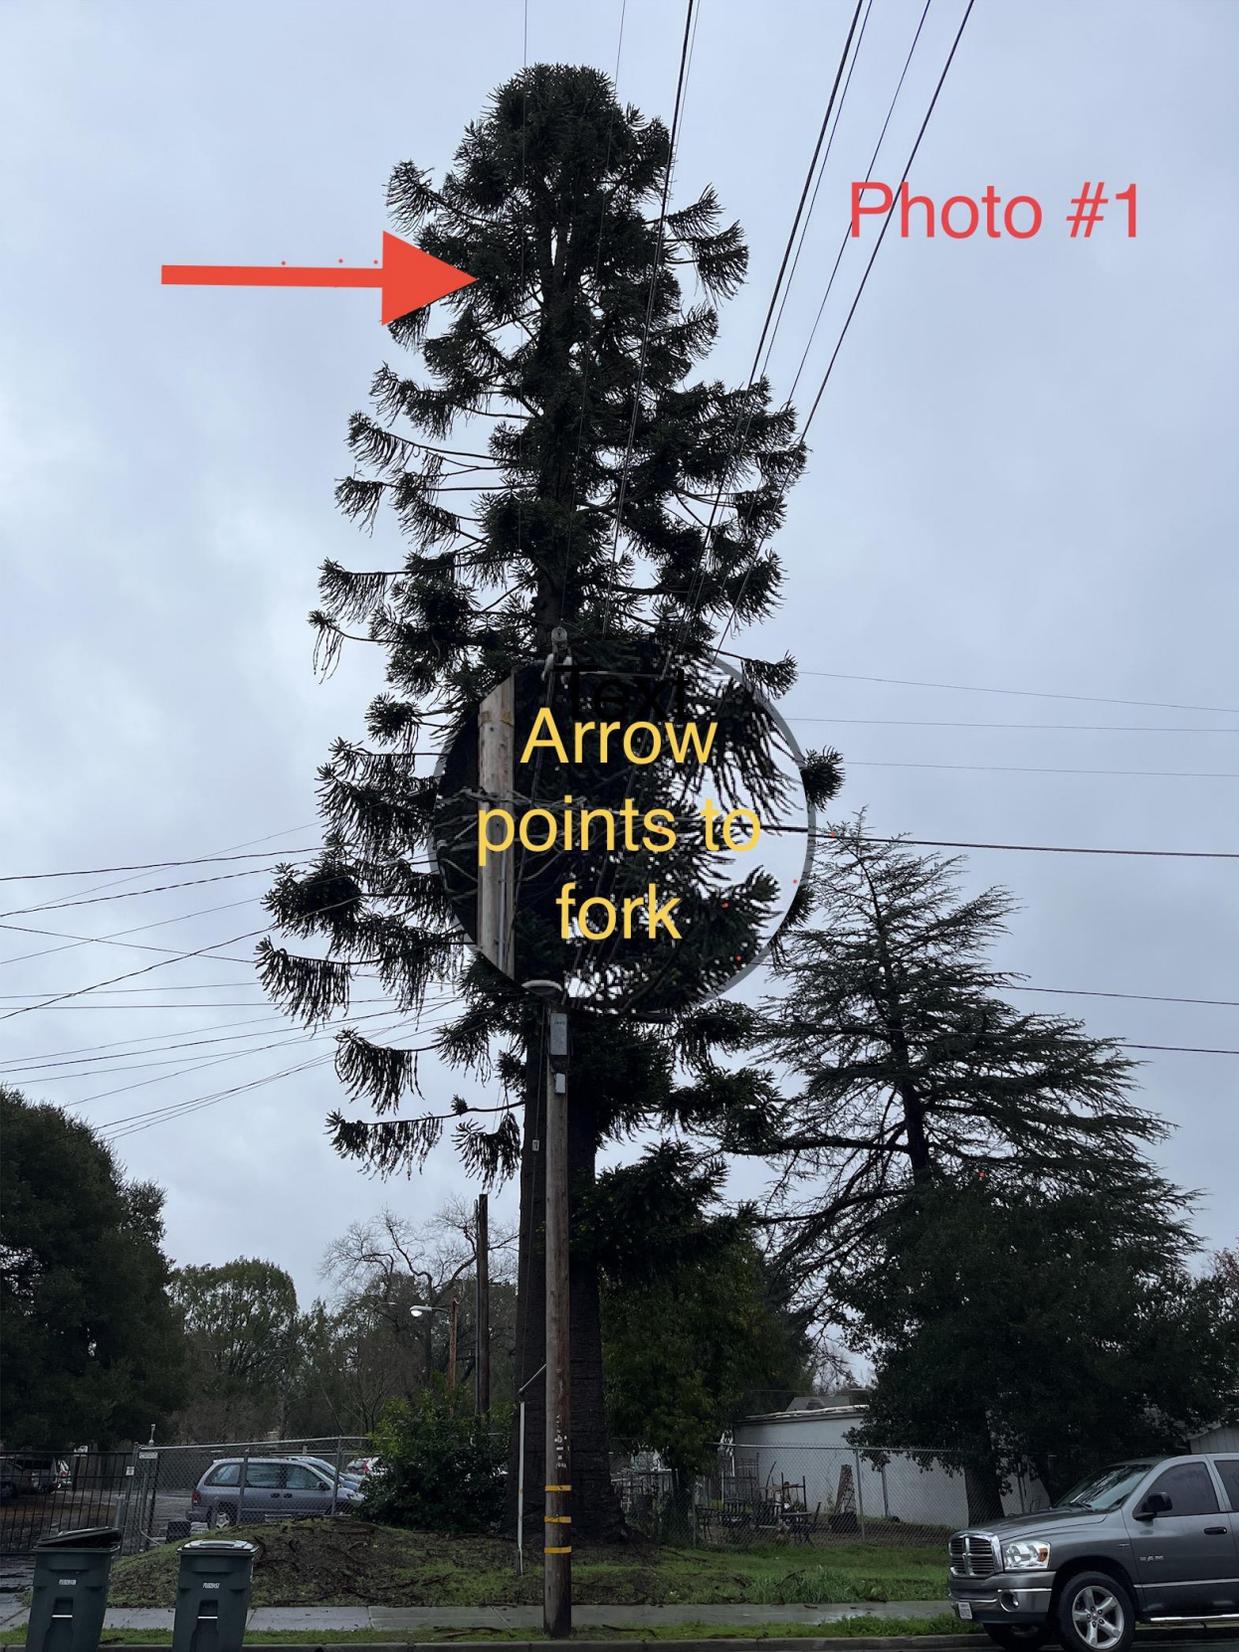
Photo #1

ground level, with subordinated lateral limbs extending up through the canopy to approximately 100' above ground level. At the approximate 100' height range, the tree forks into three stems (see photo #1).

Arrow  
points to  
fork

To reduce the stems' failure risk, I recommend installation of a cable support system in addition to, or apart from crown thinning and mass reduction in the upper 25' of the tree.
