MEMO

RV009362.0003

Certified Arborist Report: 4224 Highway 12, Santa Rosa, Ca

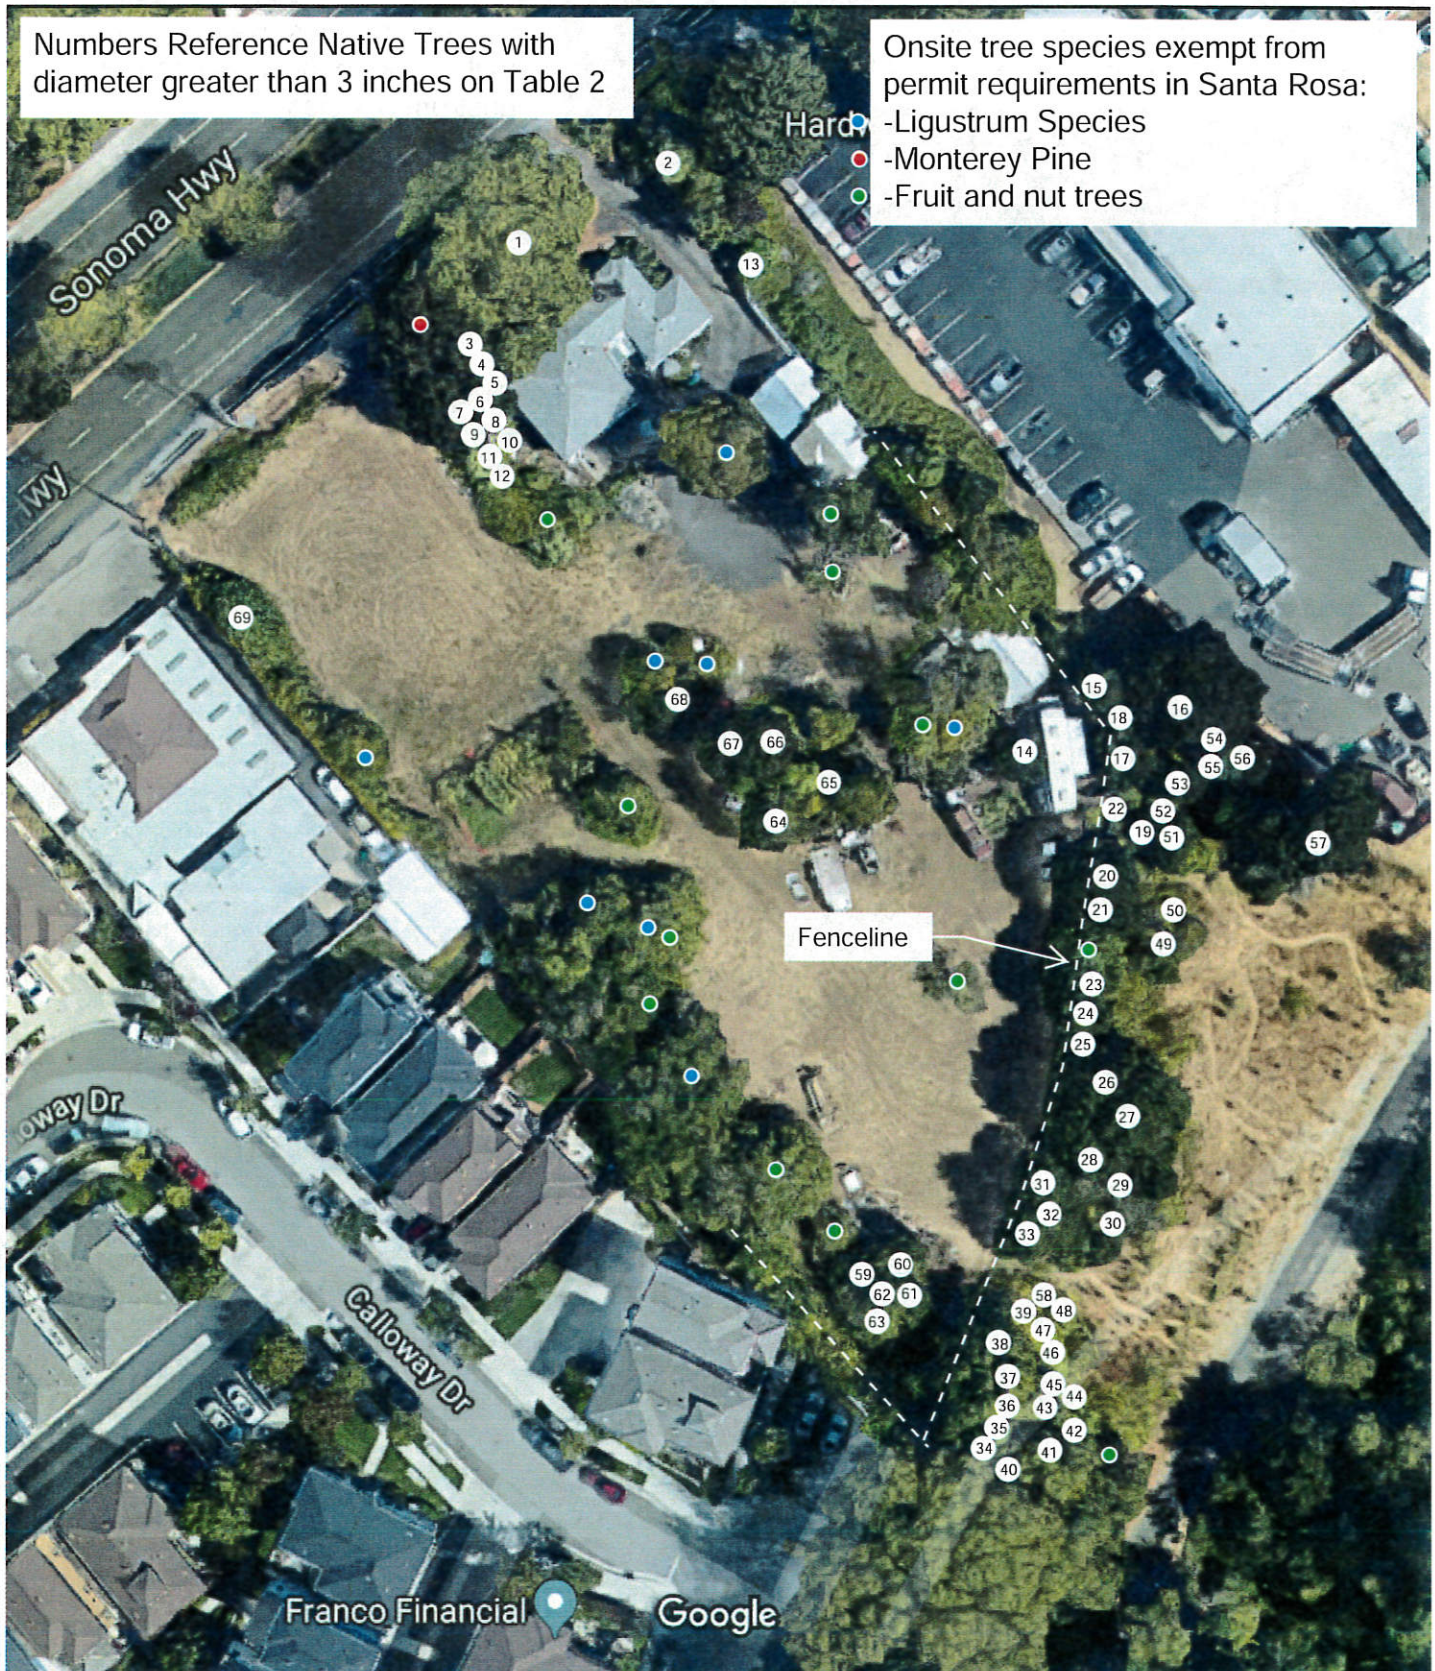
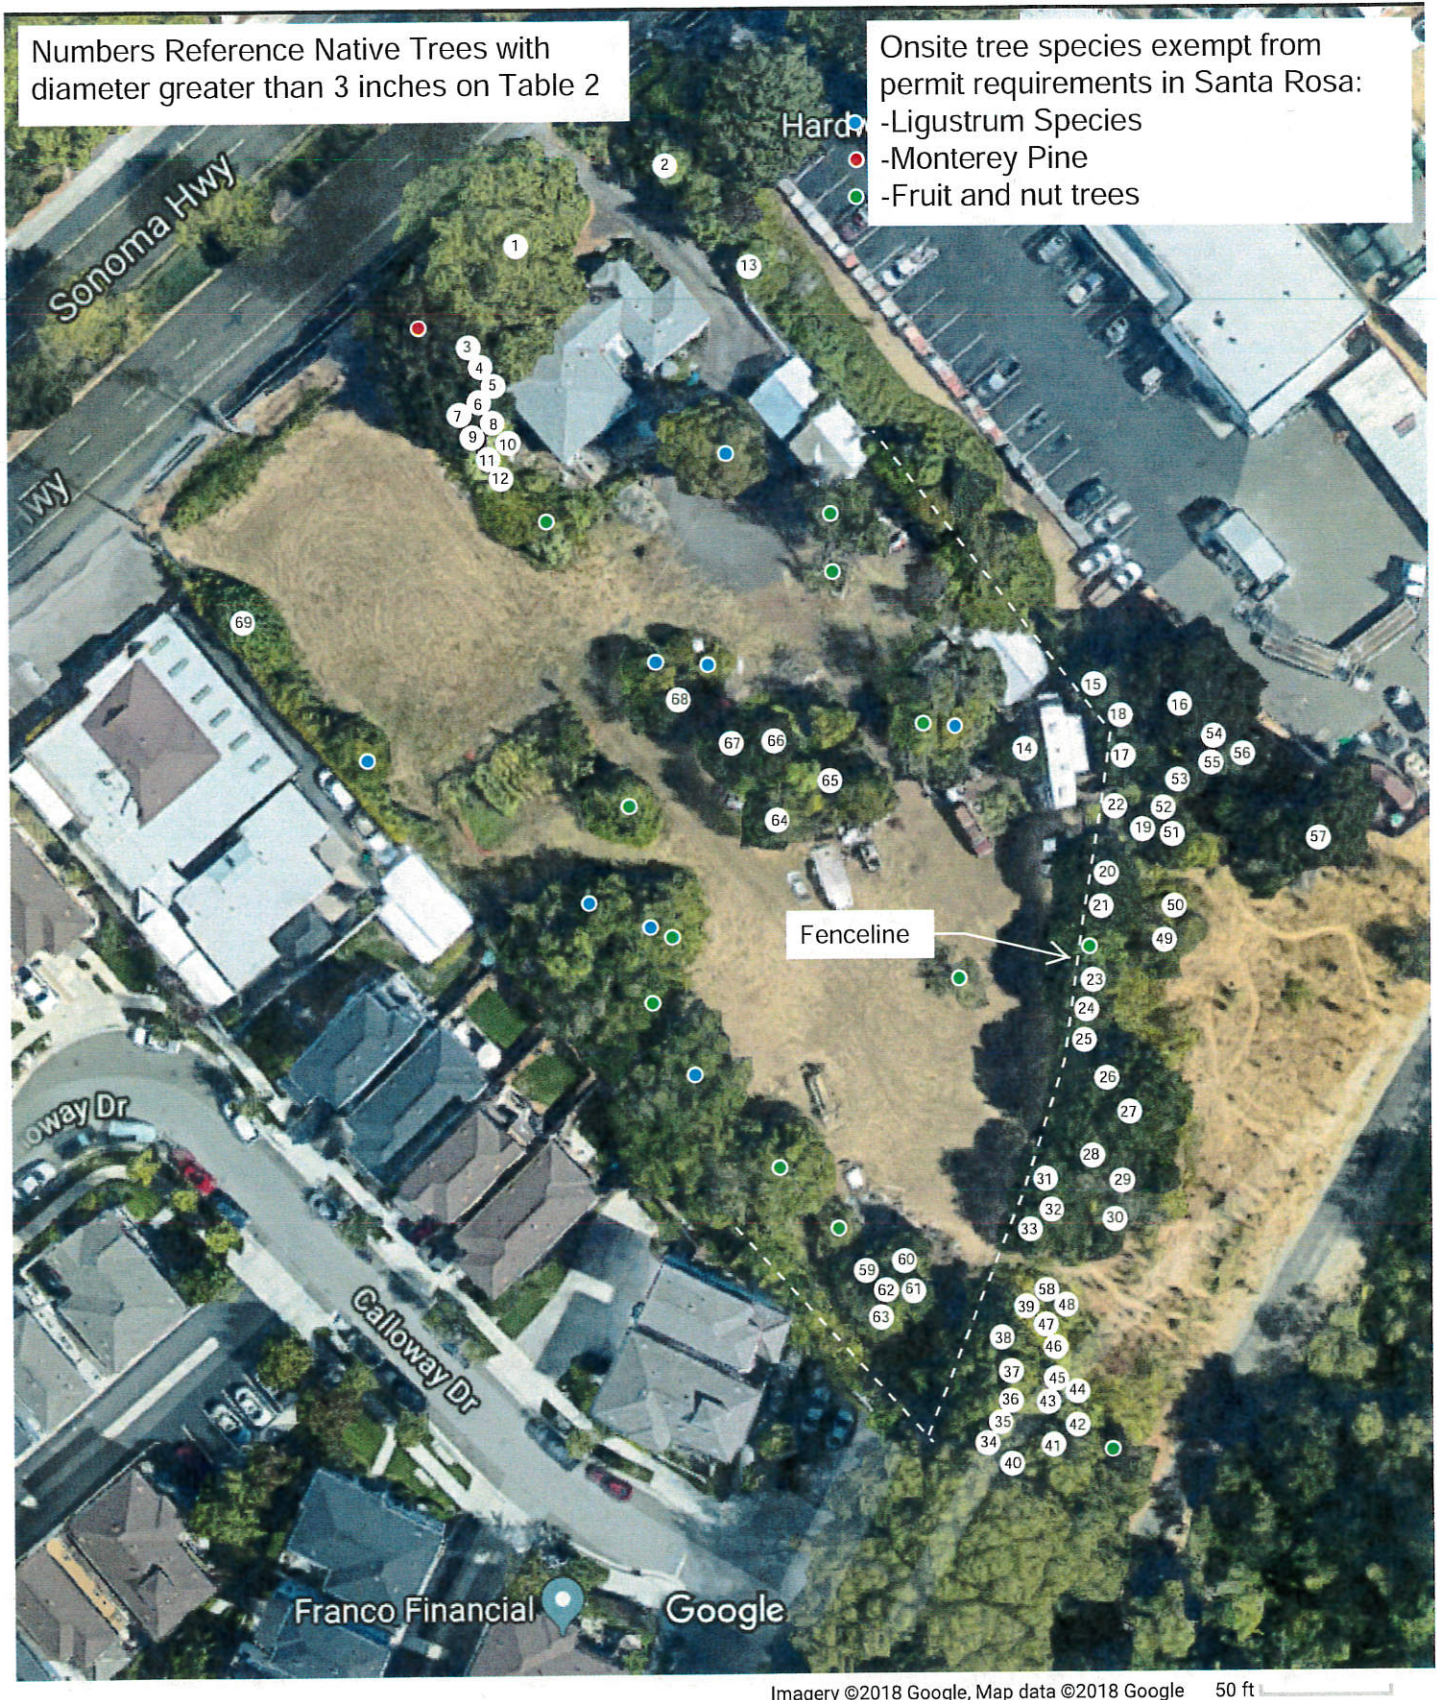
Attachment 1: Tree Location Map

Tree species that are exempt from permit requirements under Santa Rosa's tree removal and preservation ordinance were not assessed but locations were documented on Attachment 1. The exempt species observed were Ligustrums, Monterey pine (*Pinus radiata*), and fruit and nut trees (excluding northern California black walnut).
