ARCHITECTURAL History Services

February 8, 2021

RE: 659 Pine Street: District Compatibility Study

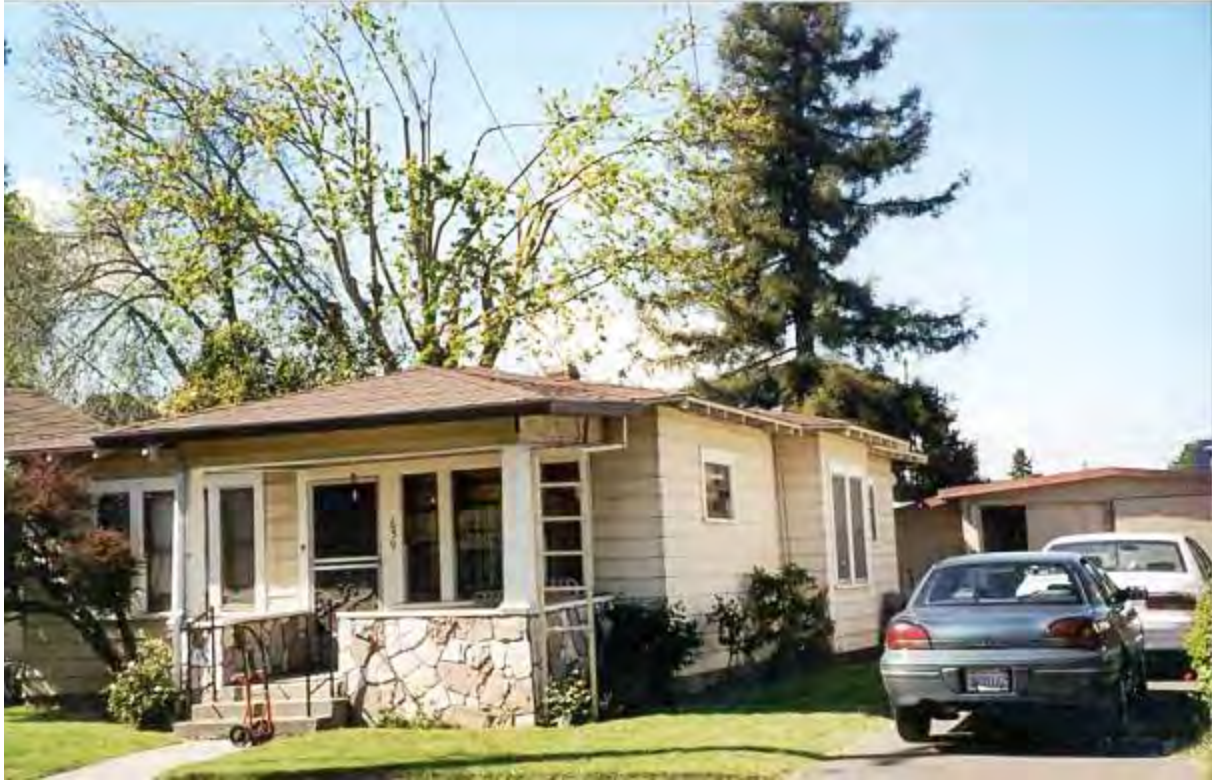
Constructed in c.1923, the Harry and Mary Mitchell House is a one-story, bungalow-type dwelling, designated a Contributing resource to the Burbank Gardens Preservation District. A DPR 523 A form completed in 2005 documented the house with its original façade fenestration. At that time, the windows consisted of two groupings of 1/1 wood sash (Figure 3). They have since been replaced with vinyl windows with grid inserts. The form did not address the shed at the rear of the property.

Figure 3: 659 Pine Street, 2005 photograph. Note grouped double-hung windows at façade. Courtesy City of Santa Rosa.

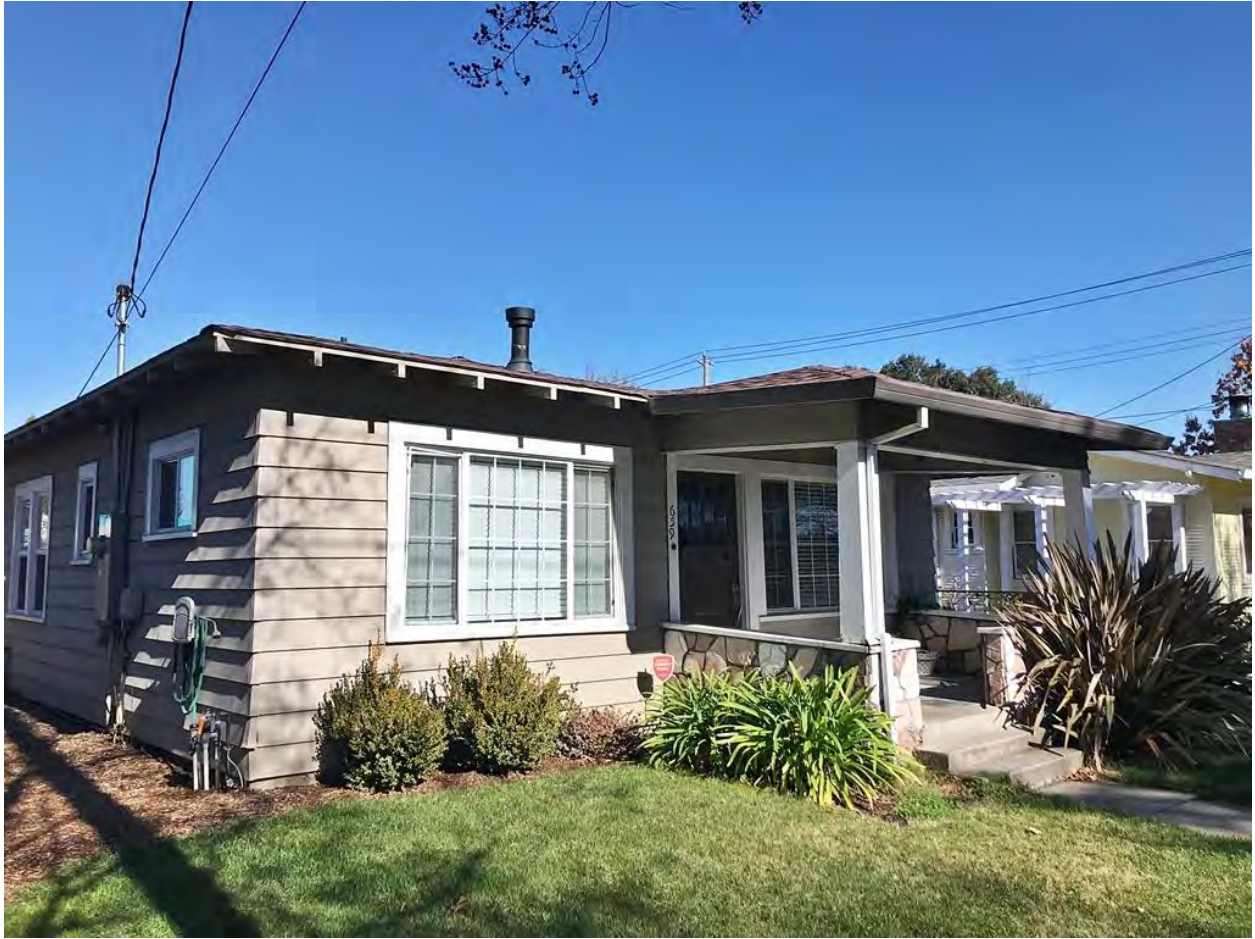
The subject house is an approximately 1,120-square-foot, one-story, single-family residence of wood-frame construction (Figures 6 & 7). The hipped roof dwelling includes a front-façade porch of unknown vintage. On inspection, the porch revealed a combination of older (tongue-and-groove ceiling and battered columns) and new elements (metal fascia and cultured stone veneer). The house is clad in textured metal siding. Its façade windows have been replaced with non-compatible vinyl units (Figure 8).

**Figure 6: 659 Pine Street, west and south elevations.
Camera facing northeast. February 5, 2021.**

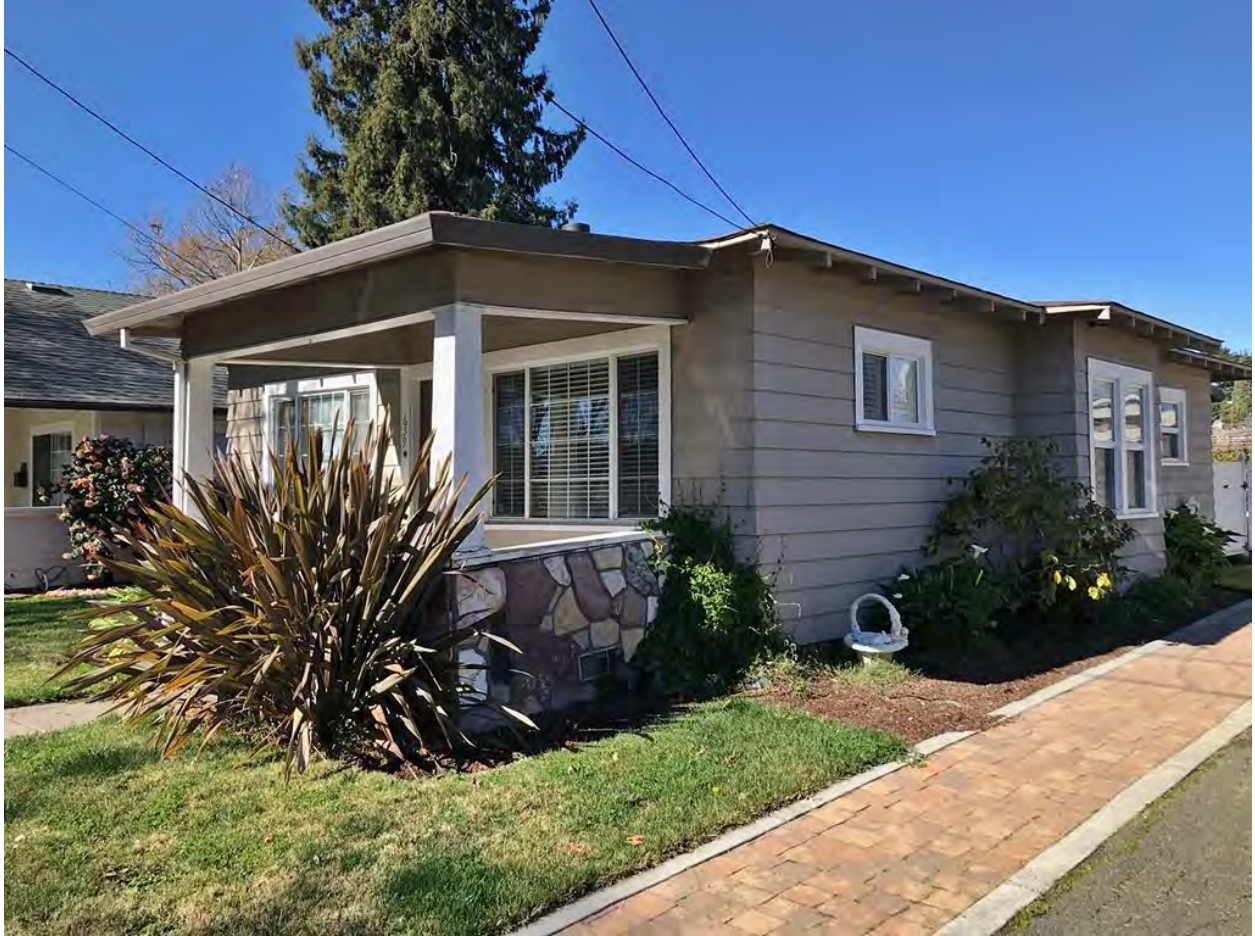
**Figure 7: 659 Pine Street, south and east elevations.
Camera facing northwest. February 5, 2021.**

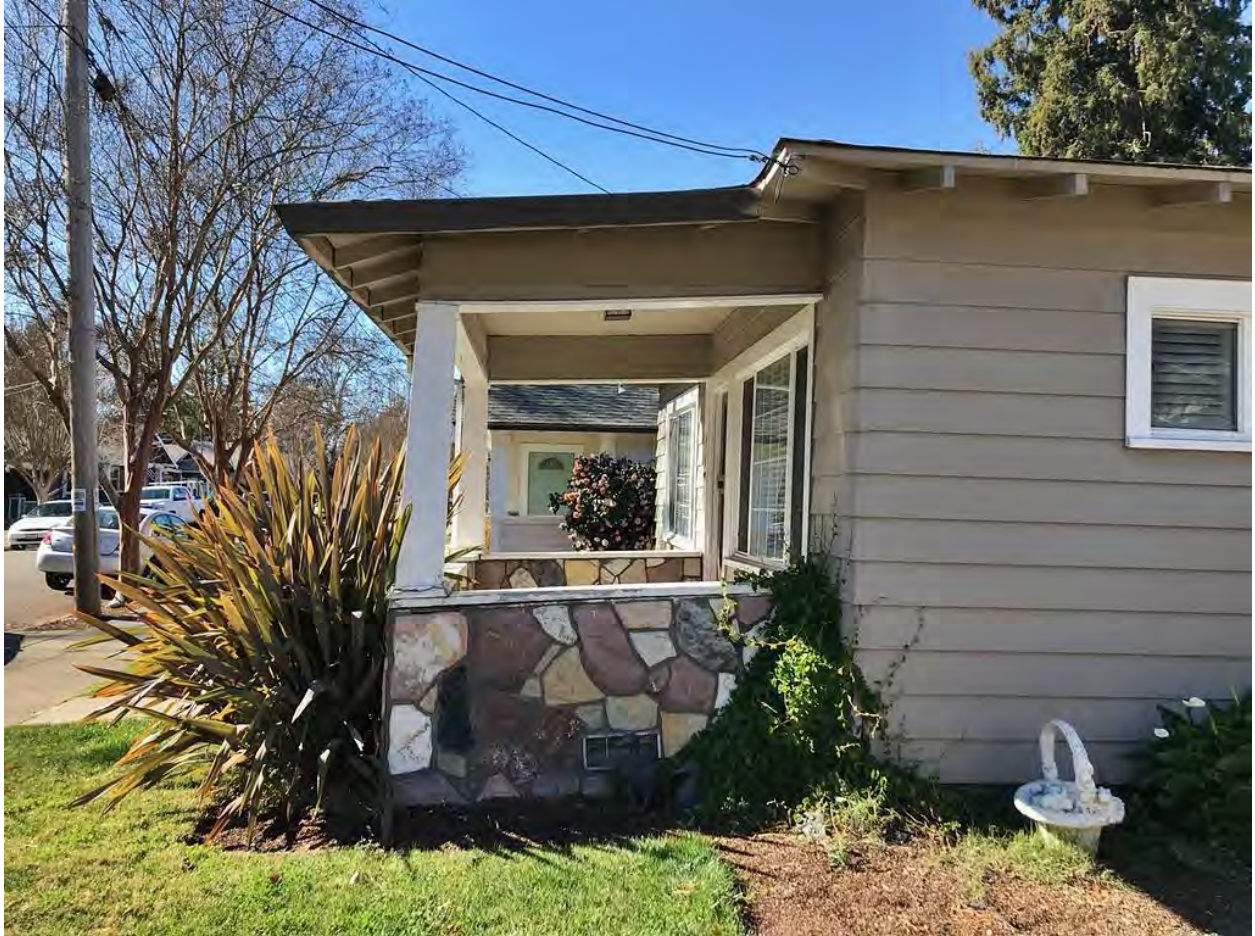
**Figure 8: 659 Pine Street, porch, east elevation.
Camera facing west. February 5, 2021.**

The street-facing porch will be removed and reconstructed. It will feature a Craftsman-type front gable over the porch. The gable end will be faced with re-sawn plywood with a vertical pattern. Existing wood porch columns will be repaired and incorporated, if feasible, or replaced in-kind with similar supports. The walls will be faced with a manufactured veneer stone.

In order to satisfy the above standard, it is advised that the porch renovation use materials and design elements that will differentiate it from similar historic features in the streetscape and district, to prevent a false sense of historical development. It appears that the proposed materials and design elements will achieve this.

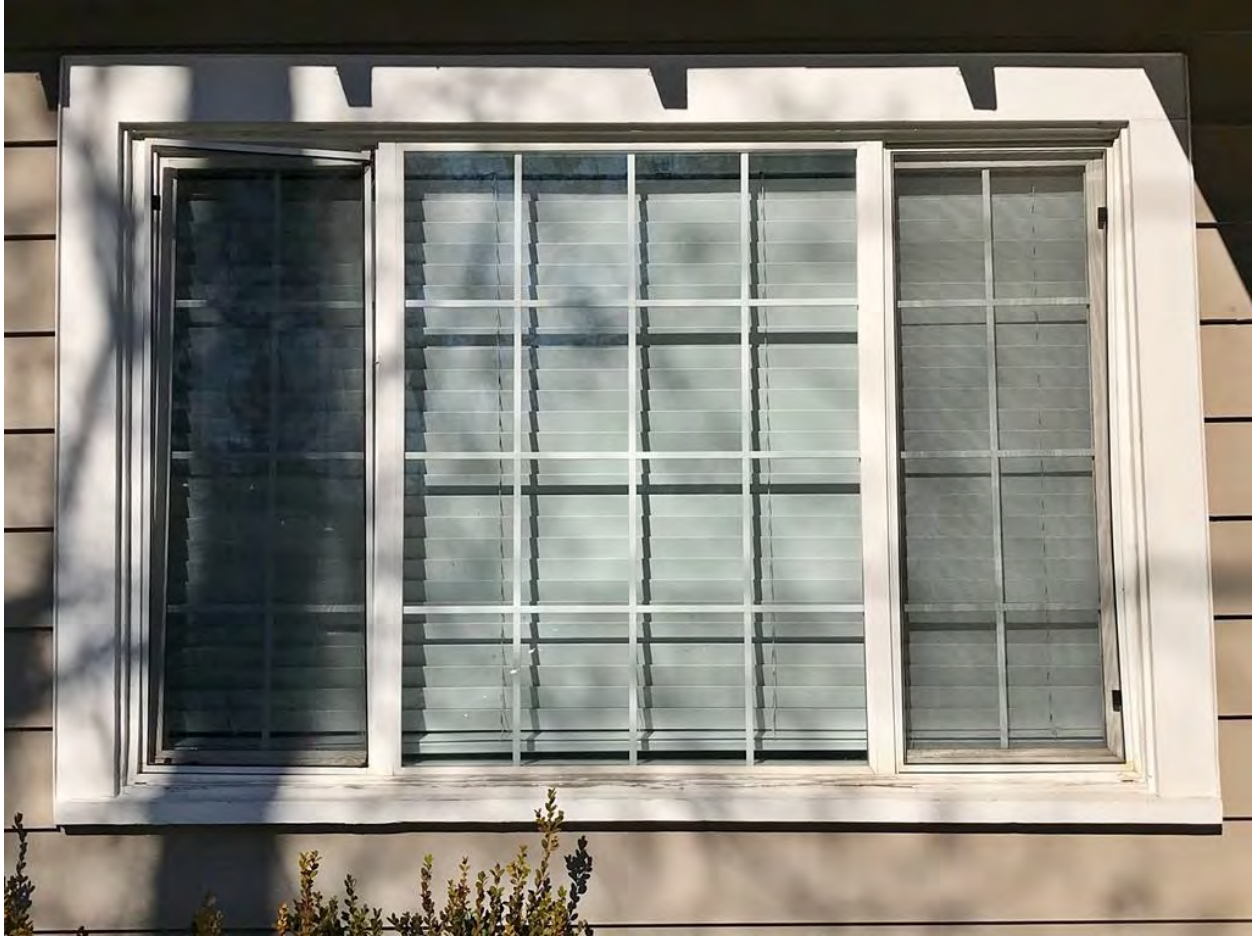
**Figure 9: 659 Pine Street, south elevation, replaced windows.
Camera facing north. February 5, 2021.**

Work includes removing two sets of non-historic vinyl windows on the front façade and replacing them with fiberglass, single-hung units. These will consist of two units west of the front entry and a combination window — made of sash flanking fixed glass — on the east side of the door. The proposed sash are a 1/1 light pattern.

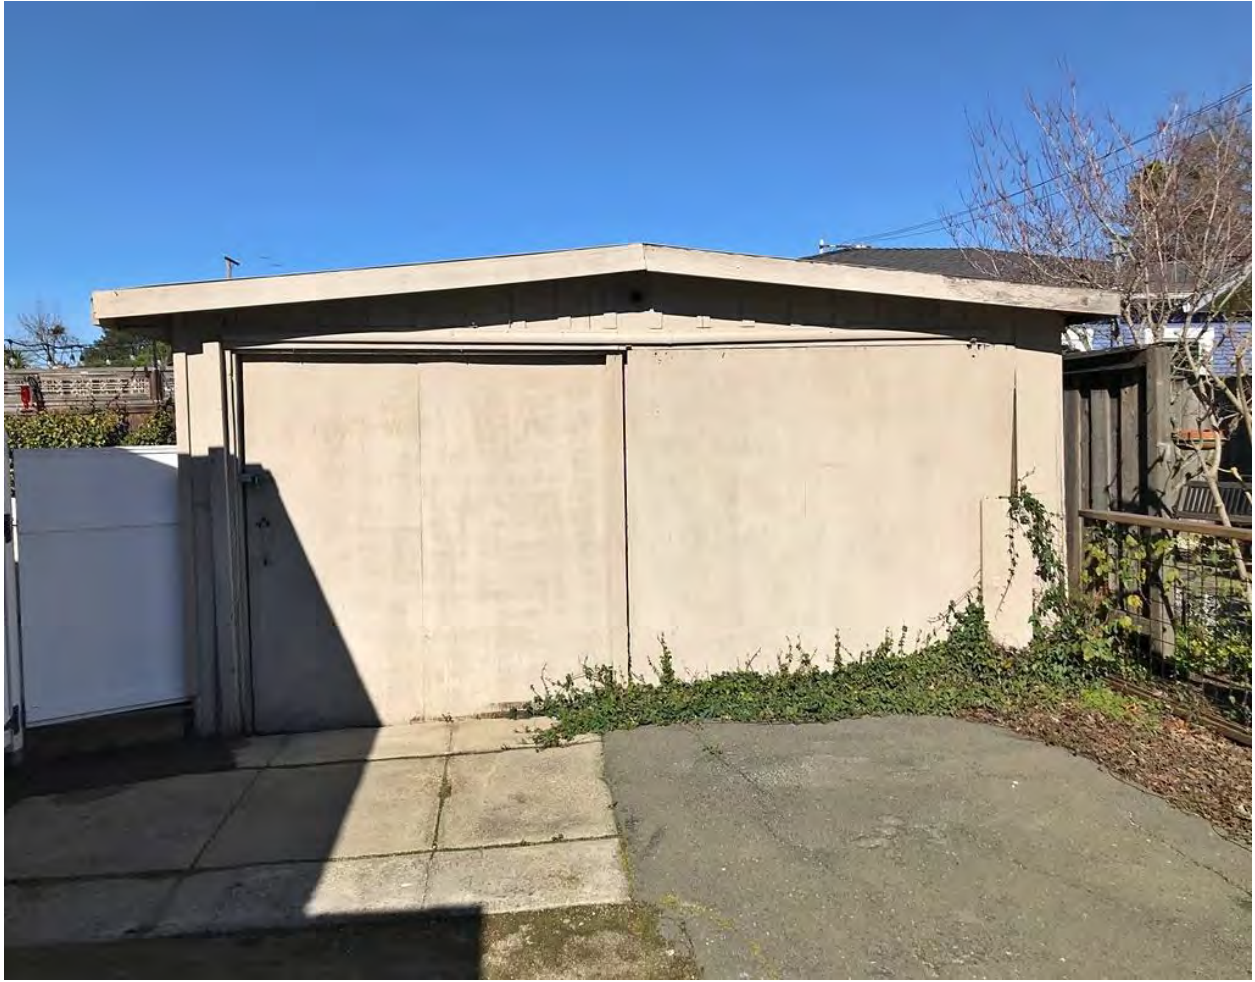
At the northeast corner of the property is an approximately 320-square-foot shed structure which may have originated as a garage (Figure 10). It is made of single-wall construction and is capped with a low pitch roof. The east elevation appears to be made of recycled boards; the west wall and soffit are faced with T 1-11 siding. Plywood-faced sliding doors fenestrate its south elevation.

The Accessory Dwelling Unit will replace a shed of unknown origin, and of no historical value. Its placement and design will be compatible with the residence.

**Figure 10: 659 Pine Street, shed, south elevation.
Camera facing north. February 5, 2021.**

A 315-square-foot Accessory Dwelling Unit is proposed to replace the shed. The front-gabled structure will give the appearance of a c.1920s garage, presenting to the street a set of outswing carriage doors. It will be clad with the same three-lap drop siding as the residence. Its setback is similar to the shed and surviving garages on the street.
