BOARD OF COMMUNITY SERVICES REGULAR MEETING AGENDA AND SUMMARY REPORT - CANCELLED SEPTEMBER 28, 2022

8.2 PARKS CONDITION ASSESSMENT AND PRIORITIZATION REPORT UPDATE

- CITY OF SANTA ROSA -PARKS CONDITION ASSESSMENT & PRIORITIZATION REPORT

- FUNDED BY MEASURE M - PARKS FOR ALL -

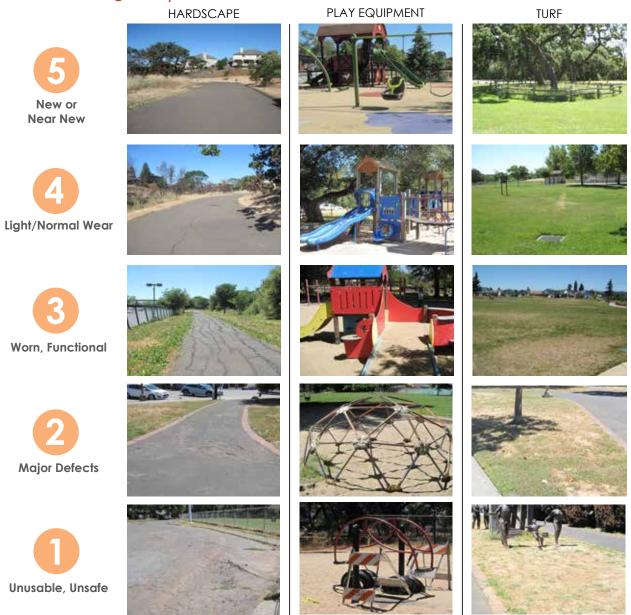
Figure 10: Condition Rating Examples

Condition Rating Examples
