#### Water and Recycled Water Update

Board of Public Utilities Meeting January 19, 2023

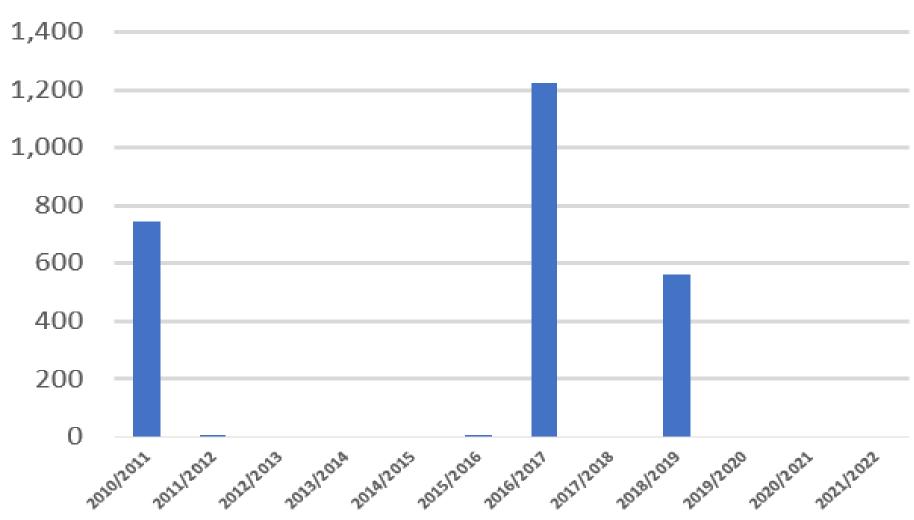
#### **Recent Historical Discharge Trend**

Discharge Volume (million gallons)
