# Delineation of Waters of the U.S.

## SCHELLINGER BURBANK AVENUE DEVELOPMENT PROJECT SANTA ROSA, SONOMA COUNTY, CALIFORNIA

WRA, Inc.  
2169-G E. Francisco Blvd.  
San Rafael, CA 94901

June 2018

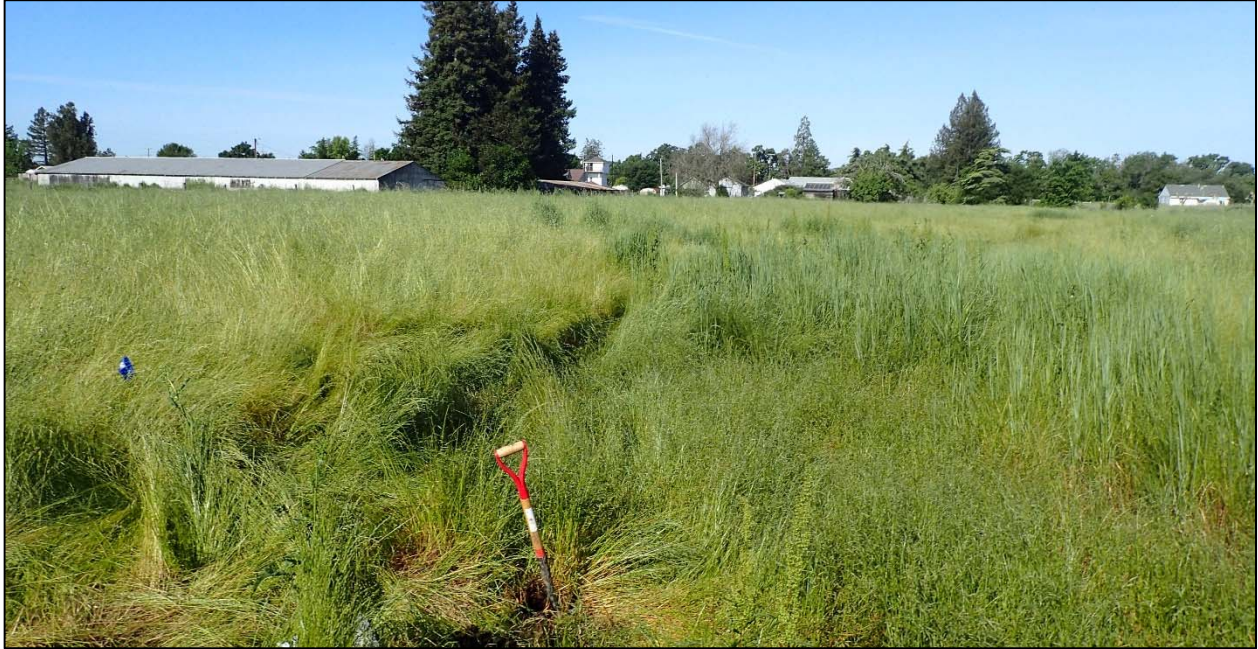
Photograph 1. Photograph depicting seasonal wetland SW-1, dominated by annual semaphore grass (*Pleuropogon californicus* var. *californicus*, OBL).

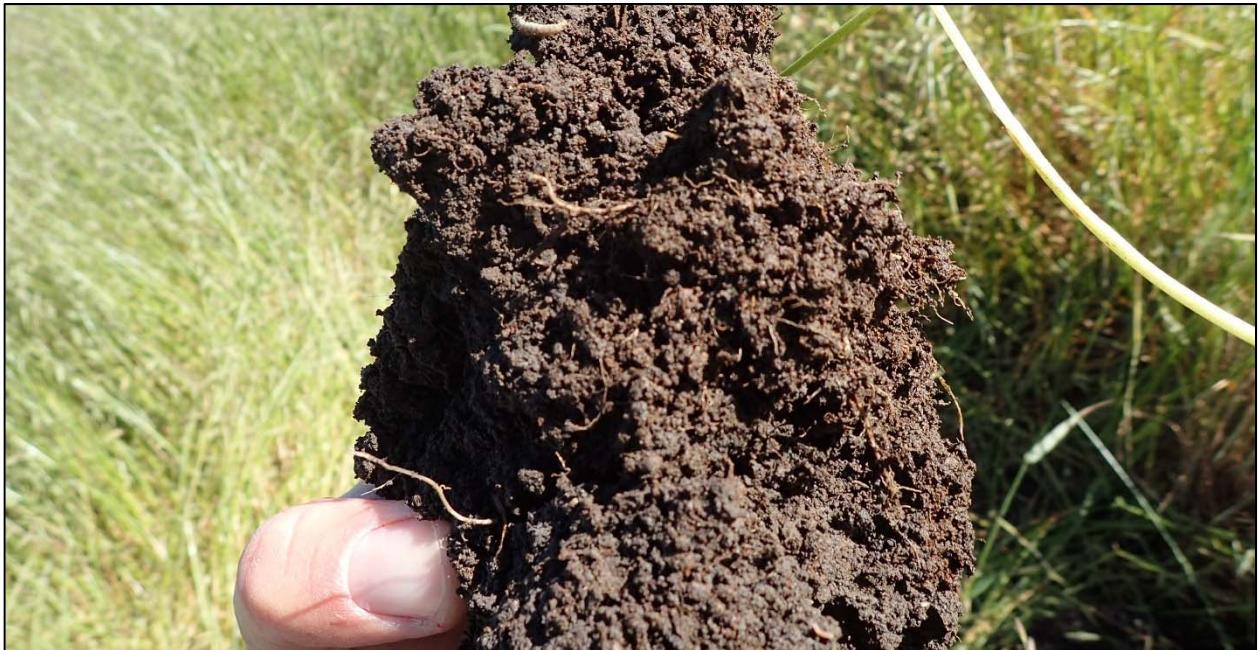
Profile description: (Describe to the depth needed to document the indicator or confirm the absence of indicators.)								
Depth (inches)	Matrix		Redox Features				Texture	Remarks
	Color (moist)	%	Color (moist)	%	Type <sup>1</sup>	Loc <sup>1</sup>		
0-16	10YR 2/2	90	5YR 3/4	10	C	M, PL	Clay loam	Prominent redox concentrations.

Photograph 2. Photograph depicting wetland soil sample at SP01 (SW-1), which meets Redox Dark Surface (F6) hydric soil indicator.

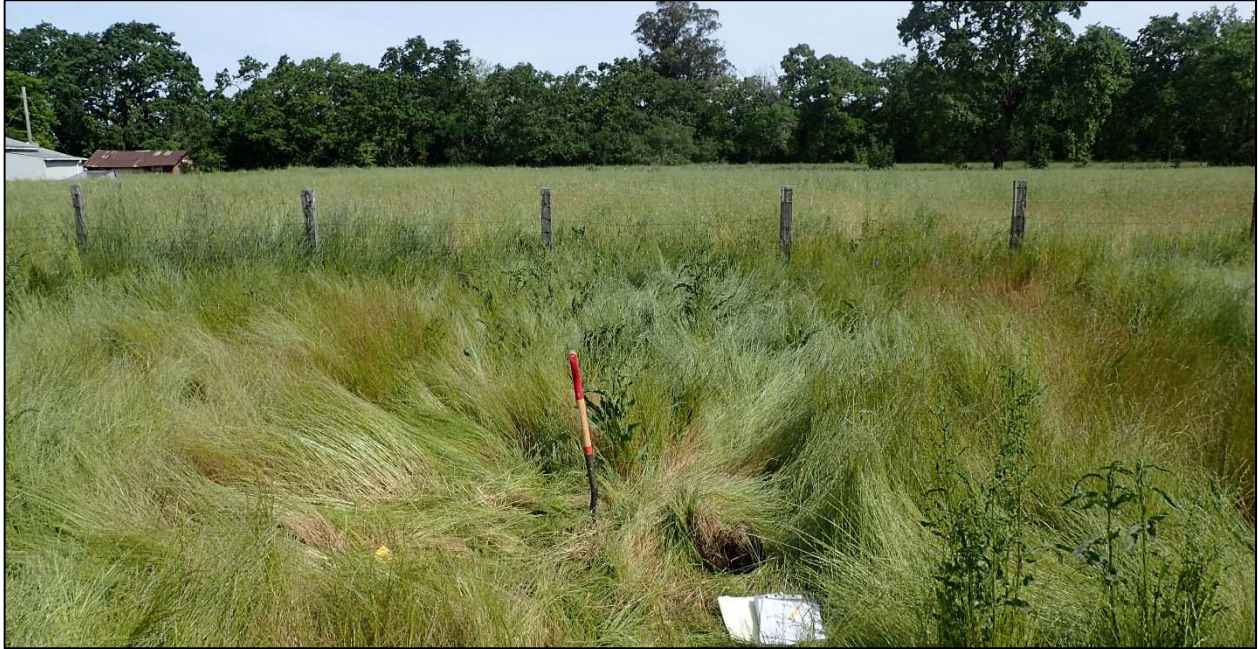
Photograph 3. Photograph depicting wetland sample point SP03, located in seasonal wetland SW-2. The seasonal wetland is dominated by Italian ryegrass (*Festuca perennis*, FAC).

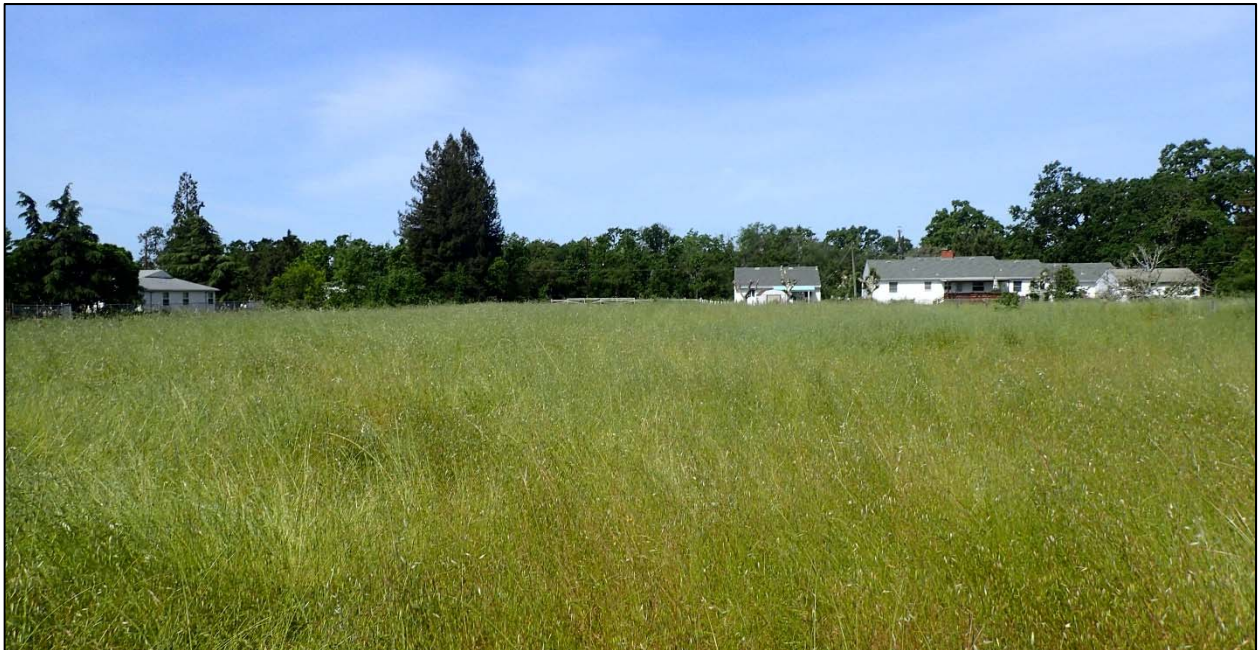
Photograph 4. Photograph depicting typical uplands within the Study Area dominated by non-native annual grasses including wild oats (*Avena fatua*, NL), and slim oat (*A. barbata*, NL).

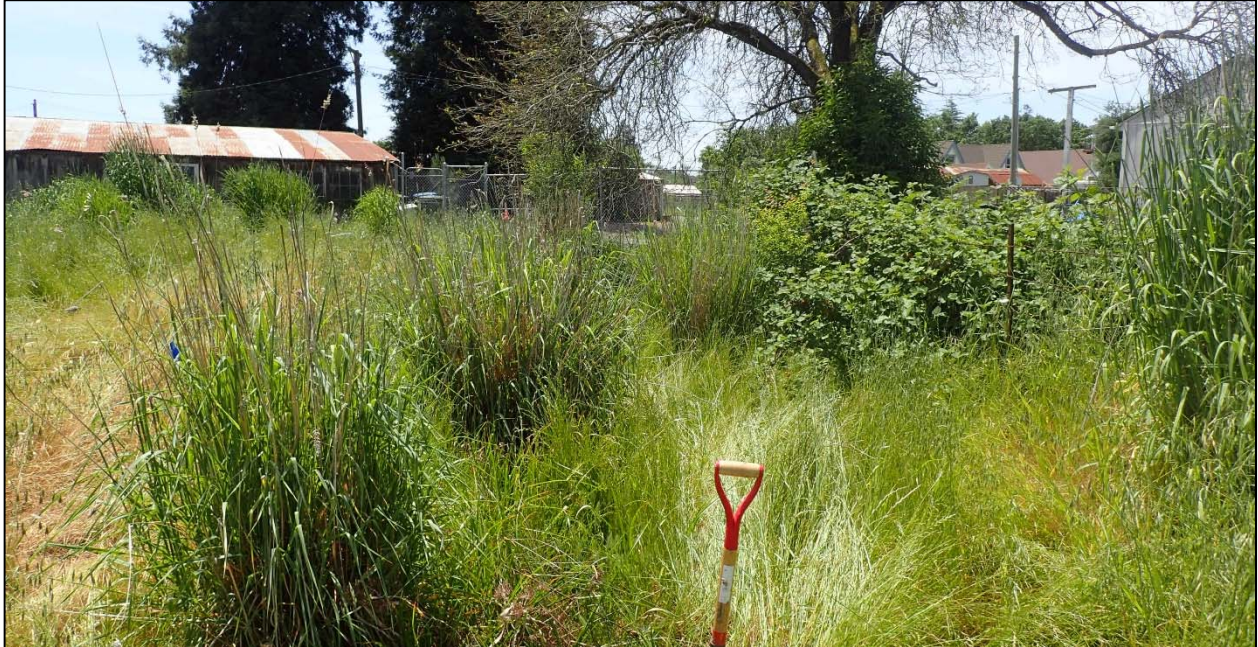
Photograph 4. Photograph depicting wetland point SP06 located in seasonal wetland ditch SWD-1.

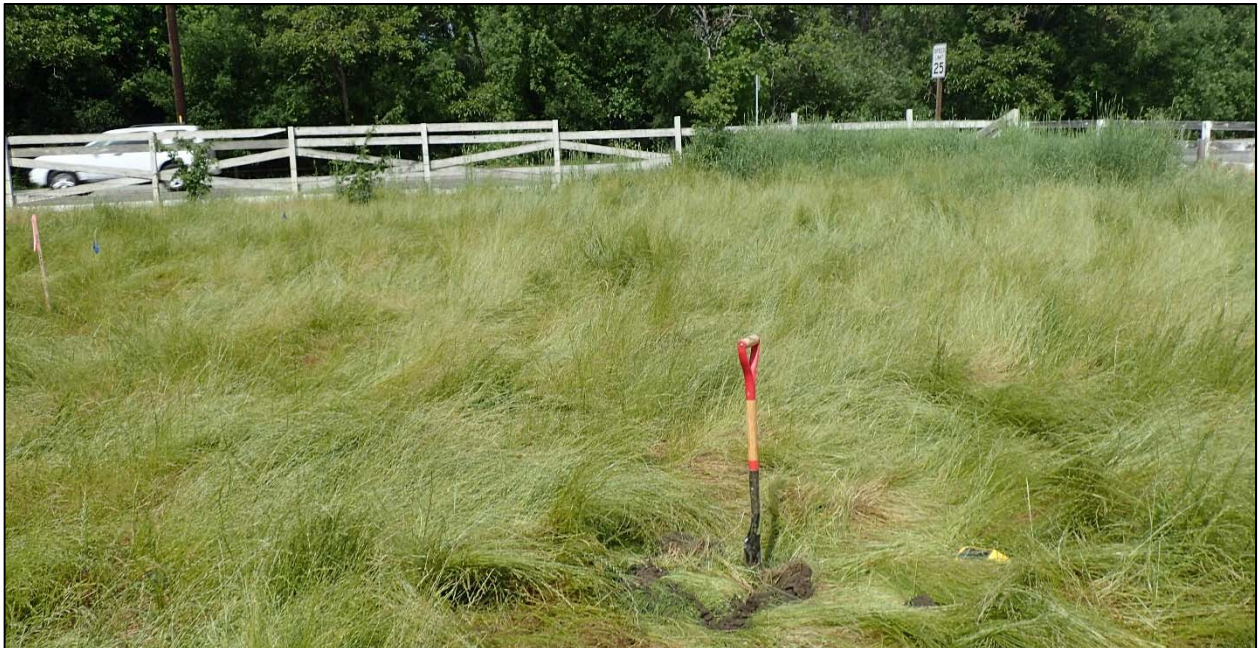
Photograph 5. Photograph depicting upland sample point SP05. Sample point was taken in a slightly mesic grassland area with a slightly darker aerial signature than surrounding areas. The sample point was dominated by Italian ryegrass (*Festuca perennis*, FAC), but did not contain wetland hydrology or hydric soil indicators.
