Delineation of Waters of the U.S.

SCHELLINGER BURBANK AVENUE DEVELOPMENT PROJECT SANTA ROSA, SONOMA COUNTY, CALIFORNIA

WRA, Inc.
2169-G E. Francisco Blvd.
San Rafael, CA 94901

June 2018

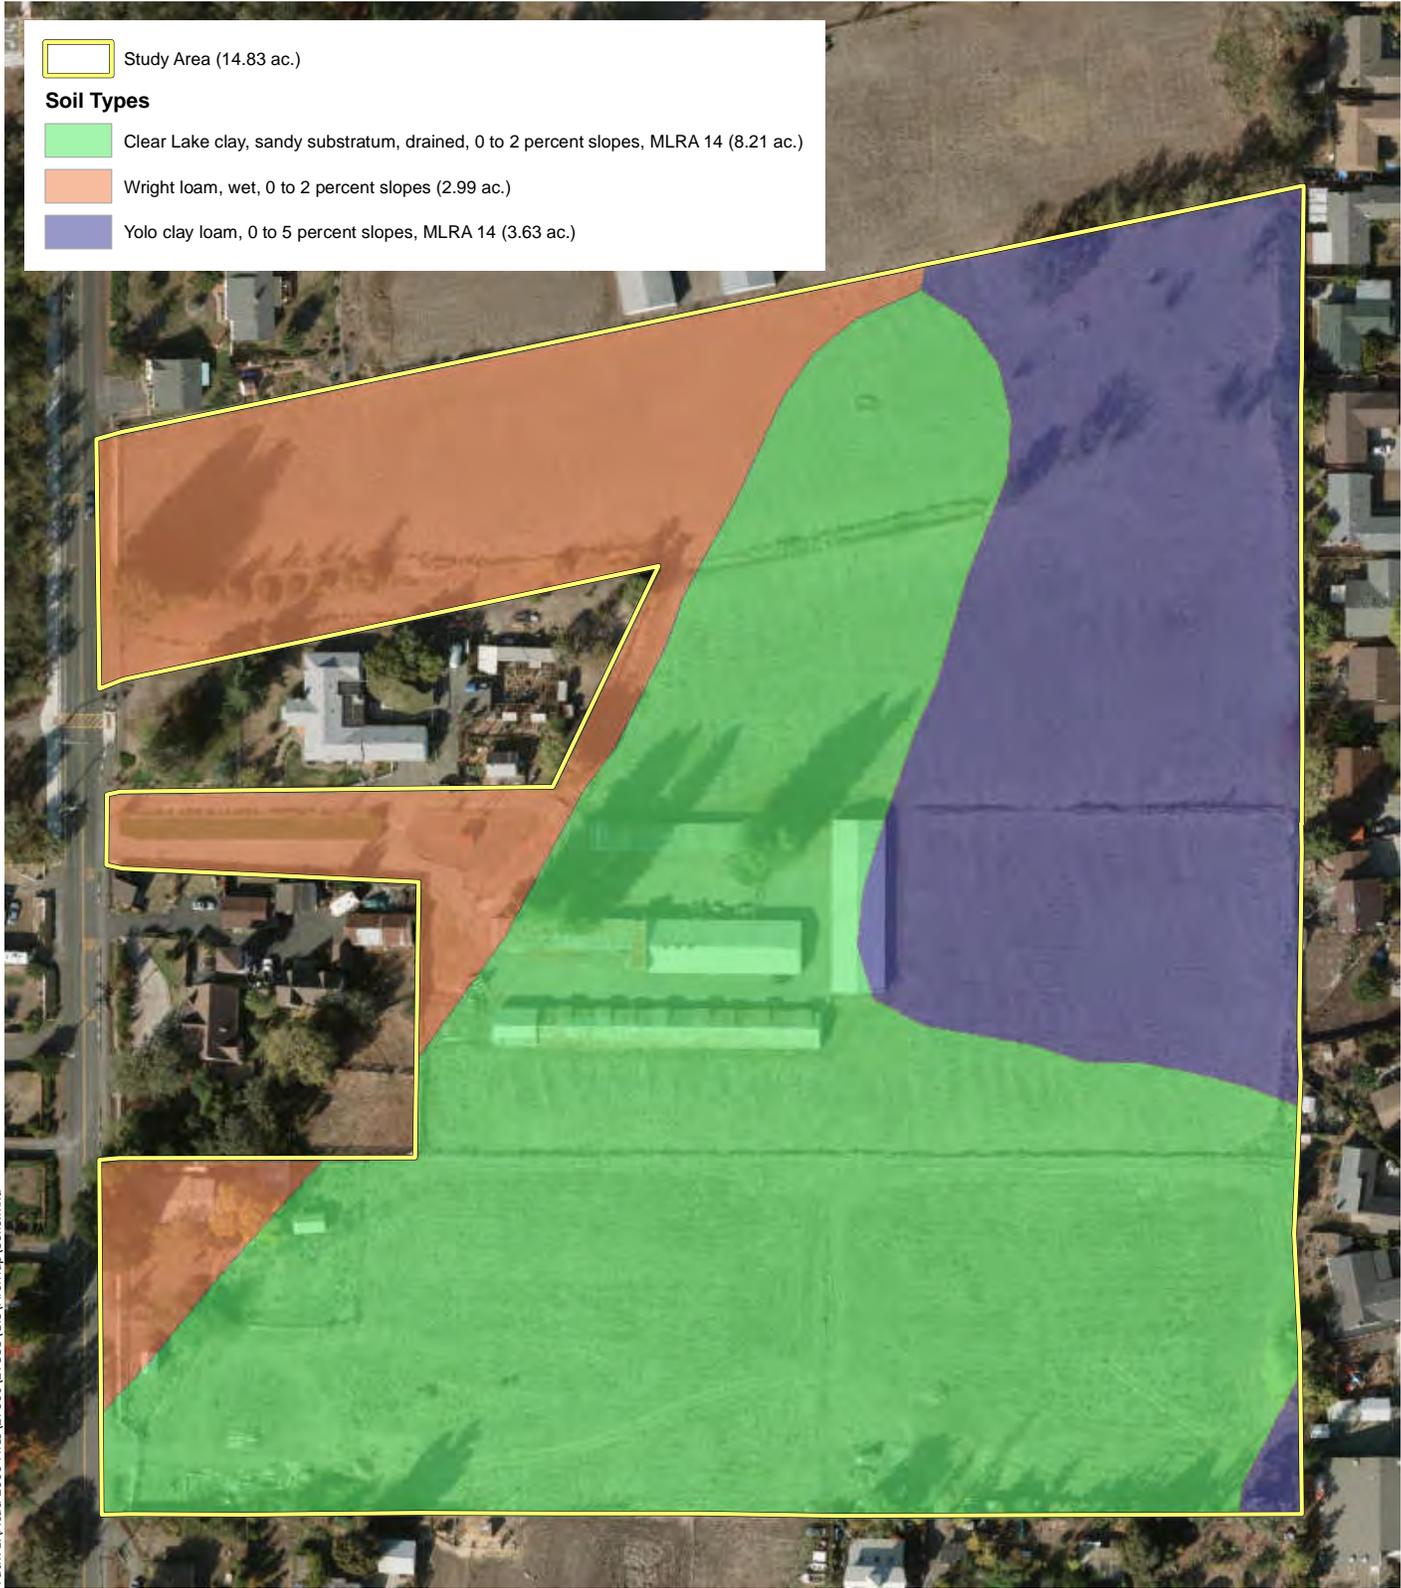
Figure 2. Soils in the Study Area

Wright Series: The Wright series consists of somewhat poorly drained and moderately well drained loams that have a clay subsoil. These soils are underlain by old valley plain alluvium of mixed origin such as volcanic and marine sediment. Within Sonoma County these soils are mostly undulating, and are on low terraces, mainly on the central Santa Rosa Plain, and south of the town of Sonoma. In a typical profile, the surface layer is very dark grayish brown (10YR 3/2) loam with common medium prominent strong brown mottles (7.5YR 5/6), about 15 inches thick. This is underlain by a strongly acidic dark grayish brown (10YR 4/2) sandy clay loam. This is underlain by various clay loam to clay layers to a depth of 98 inches. Wright loam, wet, 0 to 2 percent

Clear Lake Series: The Clear Lake series consists of clays that formed under poorly drained conditions. These soils are underlain by alluvium from basic and sedimentary rock. They are on plains and flat basin areas. In a typical profile, the surface layer is black (N 4/0) or very dark gray (10YR 3/1) clay, about 39 inches thick. This is underlain by a dark-gray moderately alkaline clay that has light gray mottles, black (10YR 2/1) when moist. At a depth of about 46 inches, it is gray and light brownish-gray, moderately alkaline clay. At a depth of about 60 inches, it is light gray to white, mildly alkaline sandy clay loam. Clear Lake clay, sandy substratum, drained, 0 to 2 percent slopes is not listed as a hydric soil.

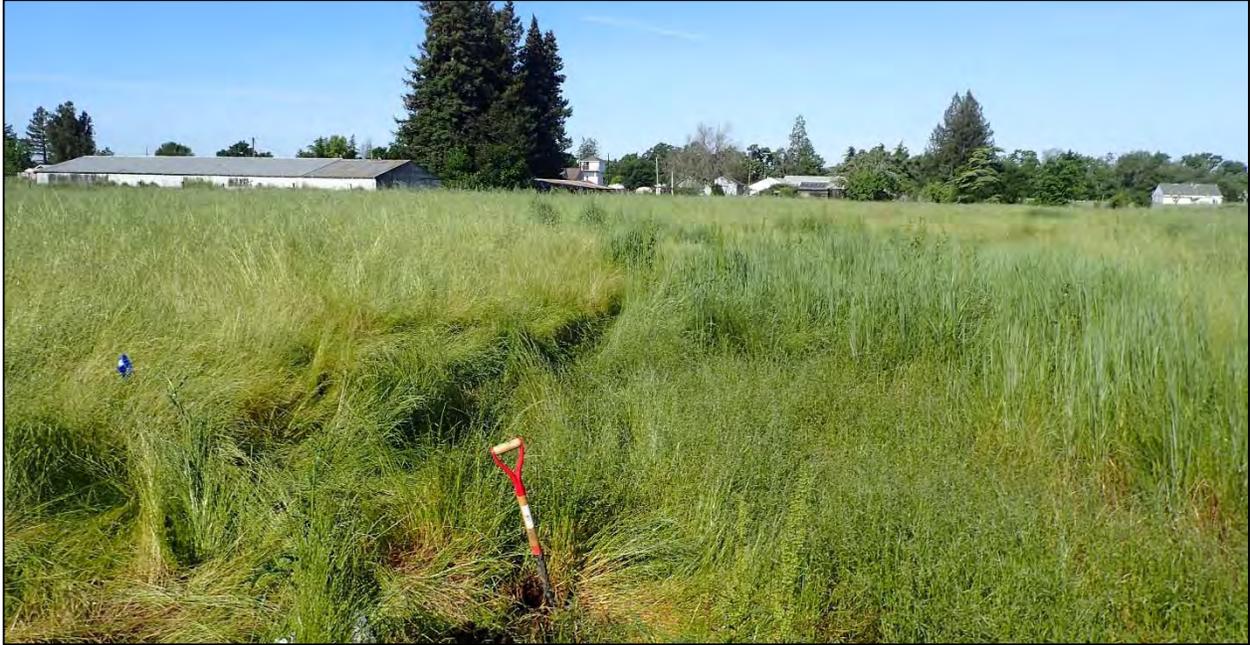
Photograph 1. Photograph depicting seasonal wetland SW-1, dominated by annual semaphore grass (*Pleuropogon californicus* var. *californicus*, OBL).

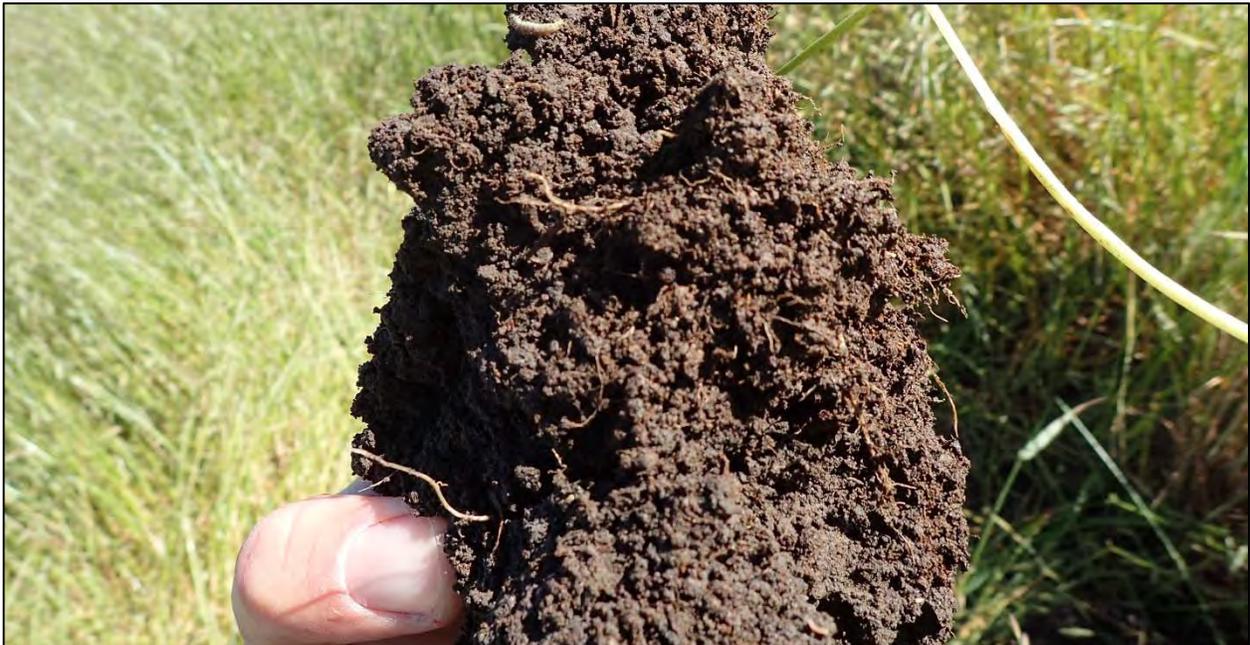
Profile description: (Describe to the depth needed to document the indicator or confirm the absence of indicators.)								
Depth (inches)	Matrix		Redox Features				Texture	Remarks
	Color (moist)	%	Color (moist)	%	Type ¹	Loc ¹		
0-16	10YR 2/2	90	5YR 3/4	10	C	M, PL	Clay loam	Prominent redox concentrations.

Photograph 2. Photograph depicting wetland soil sample at SP01 (SW-1), which meets Redox Dark Surface (F6) hydric soil indicator.

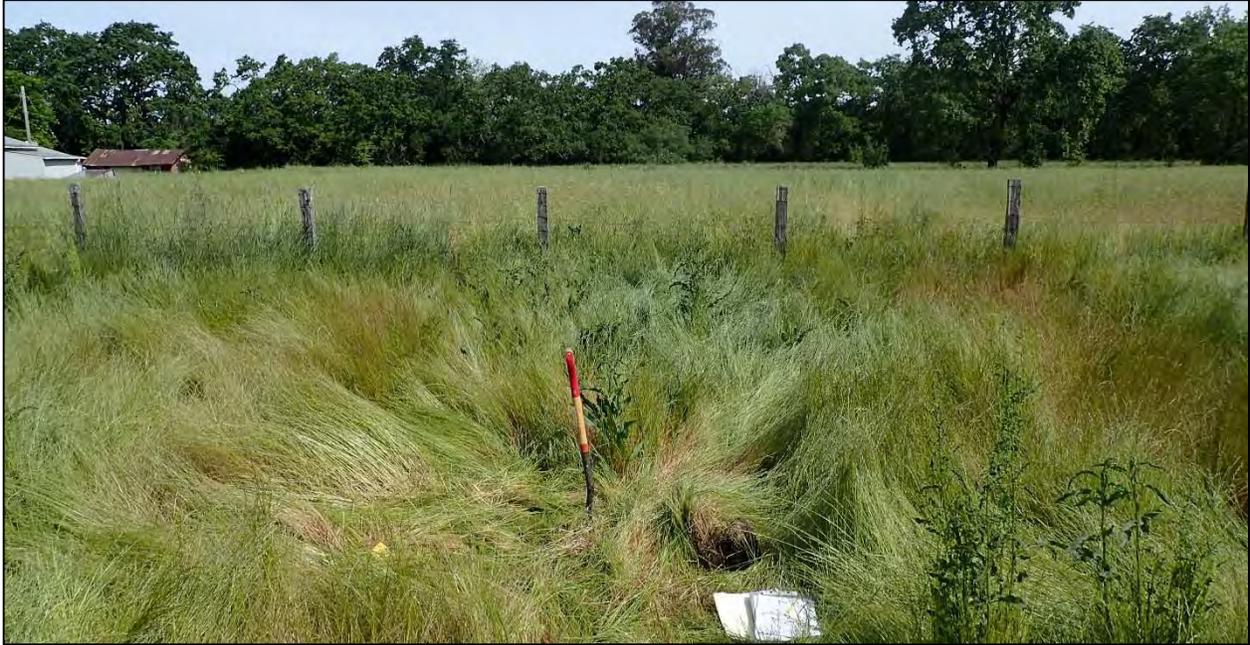
Photograph 3. Photograph depicting wetland sample point SP03, located in seasonal wetland SW-2. The seasonal wetland is dominated by Italian ryegrass (*Festuca perennis*, FAC).

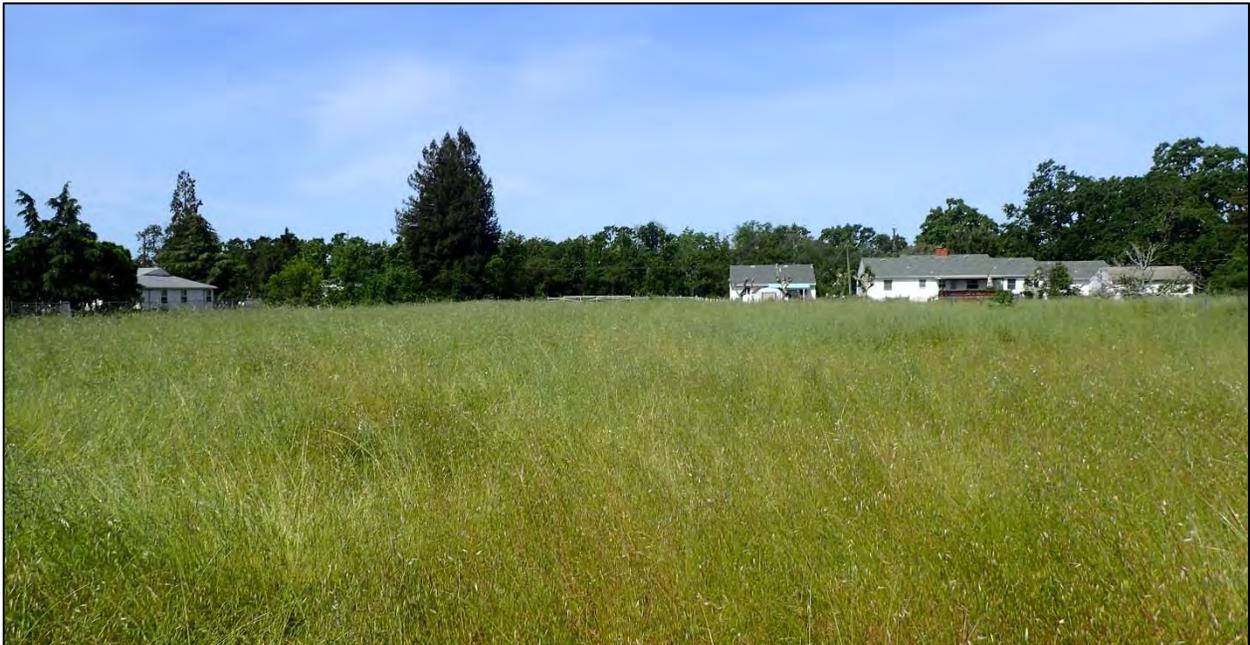
Photograph 4. Photograph depicting typical uplands within the Study Area dominated by non-native annual grasses including wild oats (*Avena fatua*, NL), and slim oat (*A. barbata*, NL).

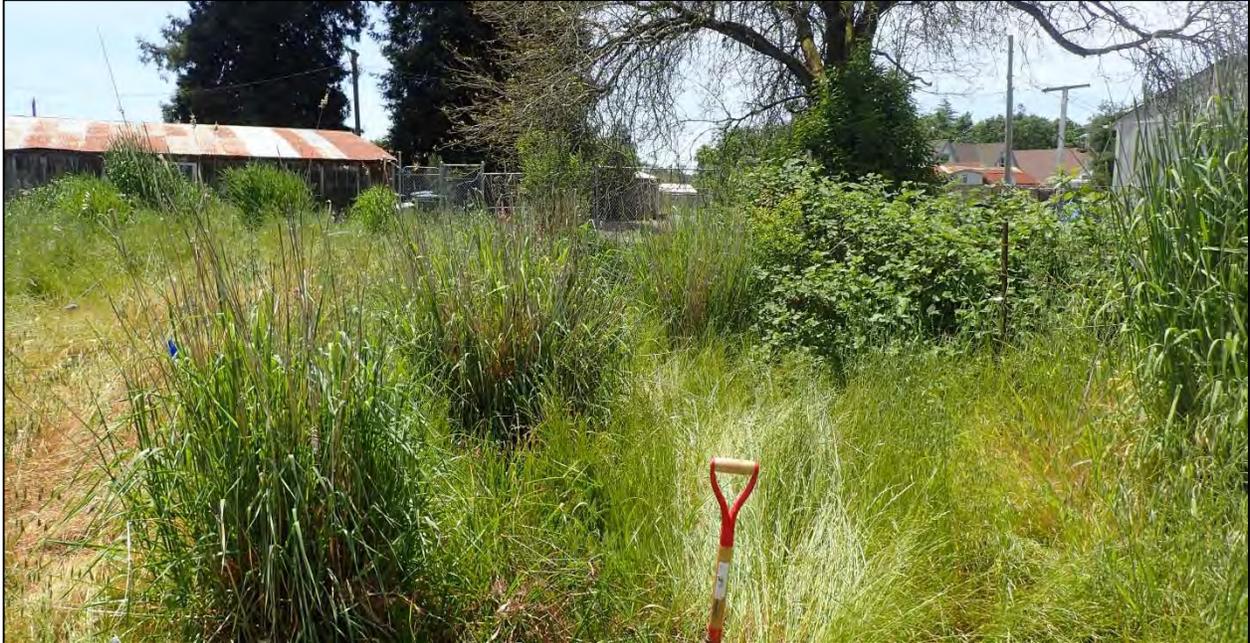
Photograph 4. Photograph depicting wetland point SP06 located in seasonal wetland ditch SWD-1.

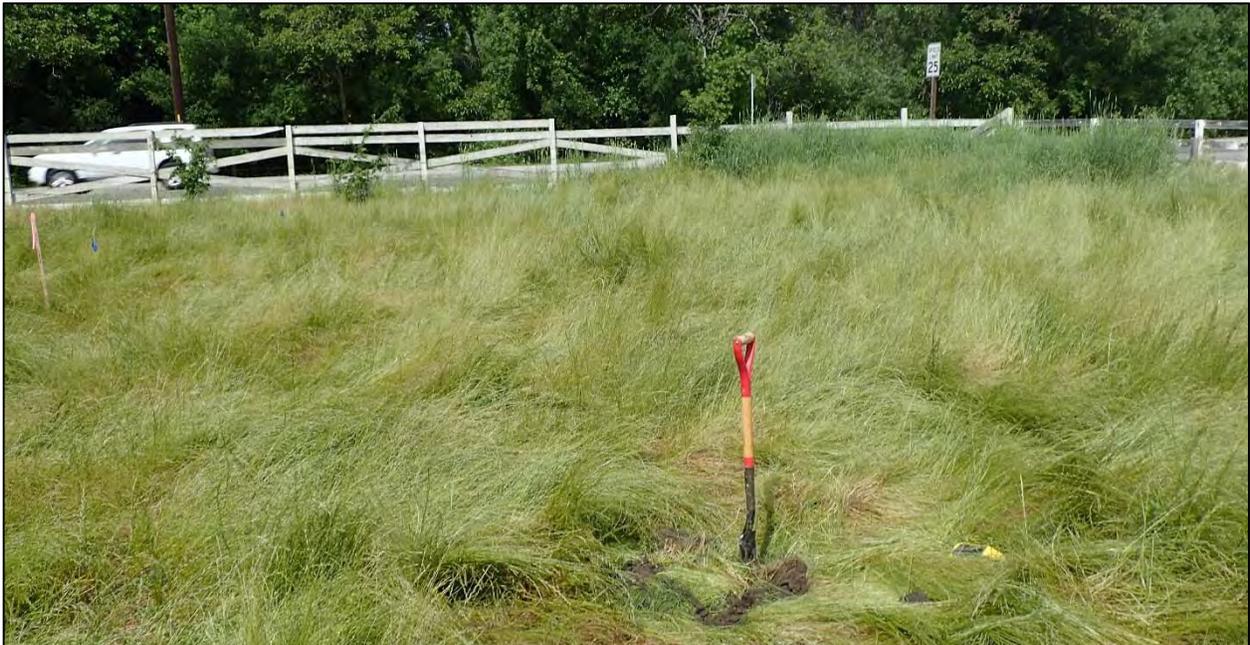
Photograph 5. Photograph depicting upland sample point SP05. Sample point was taken in a slightly mesic grassland area with a slightly darker aerial signature than surrounding areas. The sample point was dominated by Italian ryegrass (*Festuca perennis*, FAC), but did not contain wetland hydrology or hydric soil indicators.
