**Fremont Park
Santa Rosa, California
Historic Resources Study**

October 2023

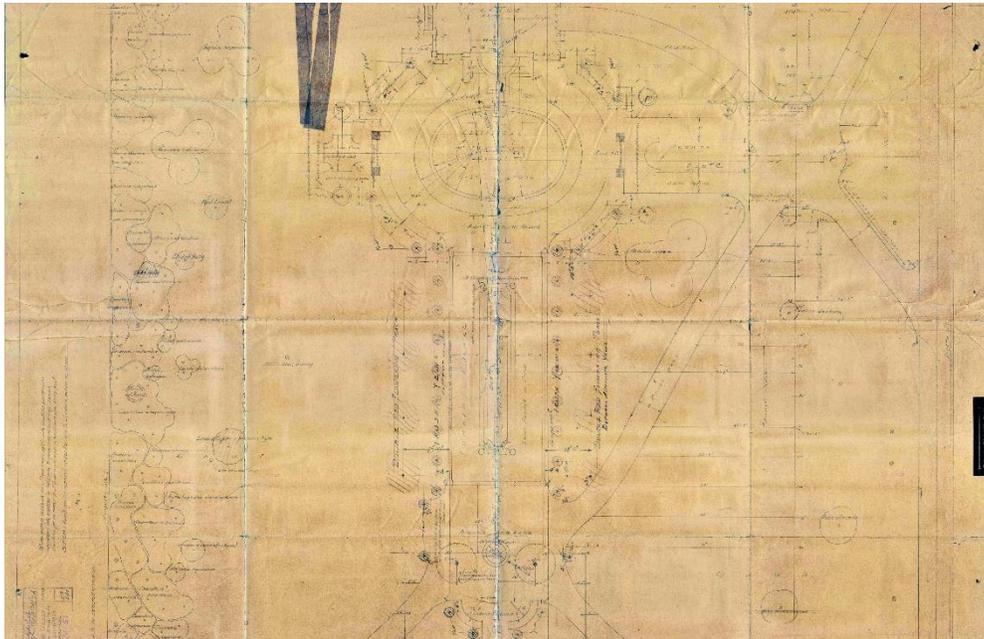
A square terrace was located along Fifth Street behind the fountain, with a stone bench on its west edge. All the plazas and circulation elements in the original concept were to be paved in brick. Gilkey’s plot plan noted that the brick pavers should be selected from whatever was common to the area.

FIGURE 4. A SCAN OF HOWARD GILKEY'S "PLOT PLAN" FOR FREMONT PARK IN THE CITY OF SANTA ROSA. THE TITLE BLOCK IS DATED JUNE 10, 1929. NORTH IS UP. FOR A LARGER REPLICATION OF THE IMAGE SEE APPENDIX A. SOURCE: COURTESY OF THE SANTA ROSA DEPARTMENT OF PARKS AND RECREATION.

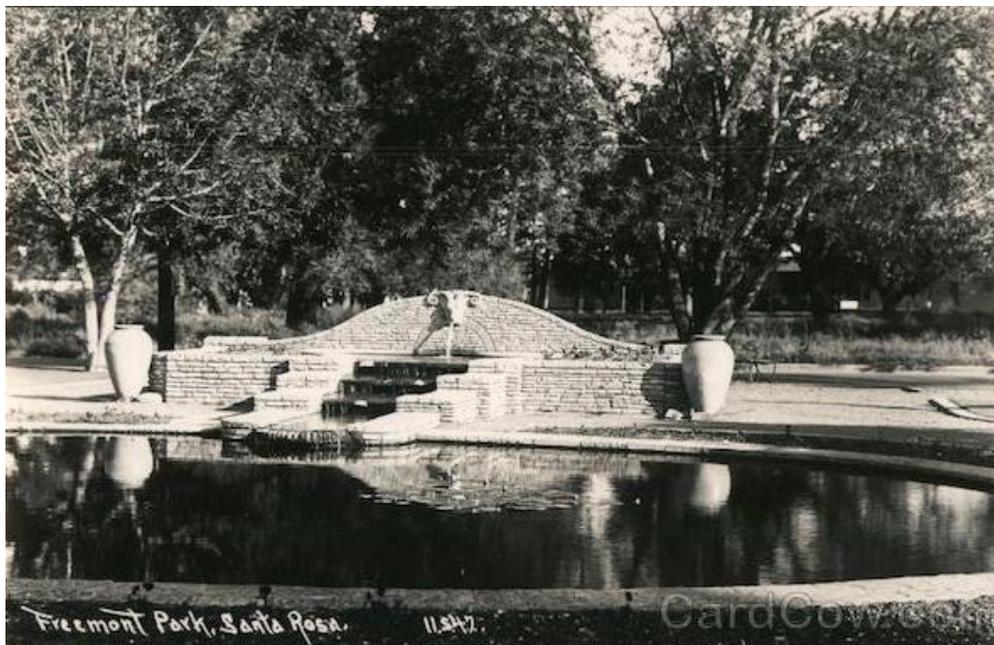
FIGURE 5. HISTORIC PHOTO OF THE FINISHED FOUNTAIN AND ELLIPTICAL POOL. LILIES ARE VISIBLE ON THE SURFACE OF THE POOL. DATE UNKNOWN. SOURCE: COURTESY OF THE SANTA ROSA DEPARTMENT OF PARKS AND RECREATION.

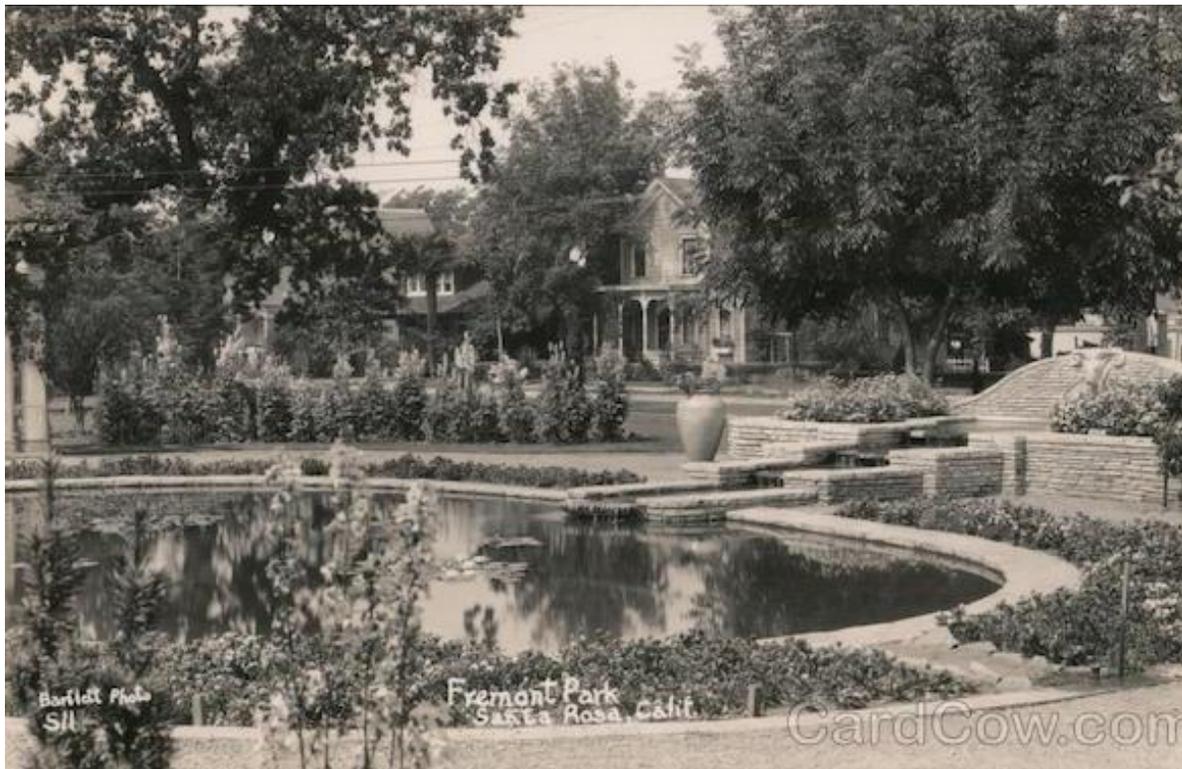
The promenade terminated with a step up to an oval-plan plaza featuring an elliptical lily pool at its center. A planter with soil was located at the center of the lily pool. Like the elongated pool, the lily pool was lined with stone coping, and it was encircled by a planted bed and an 8 ft wide path. The east and west edges of the plaza contained “*portales de las rosas*”, or arbors, that formed the secondary axis. The west portal opened onto a 6 ft by 6 ft flower bed with brick edges, while the east portal led to a 25 ft wide brick path that connected to another system of pedestrian paths in the east half of the park. An elongated flower bed with curved ends was located at the center of the wide pathway, thereby extending the secondary axis formed by the portals. The perimeter of the fountain plaza was lined with four curved flower beds with brick edges that were marked with Irish yews at each end (**Figure 6**).

**FIGURE 6. FLOWERING VEGETATION LOCATED AROUND THE ELLIPTICAL POOL. DATE UNKNOWN.
SOURCE: COURTESY OF THE SANTA ROSA DEPARTMENT OF PARKS AND RECREATION.**

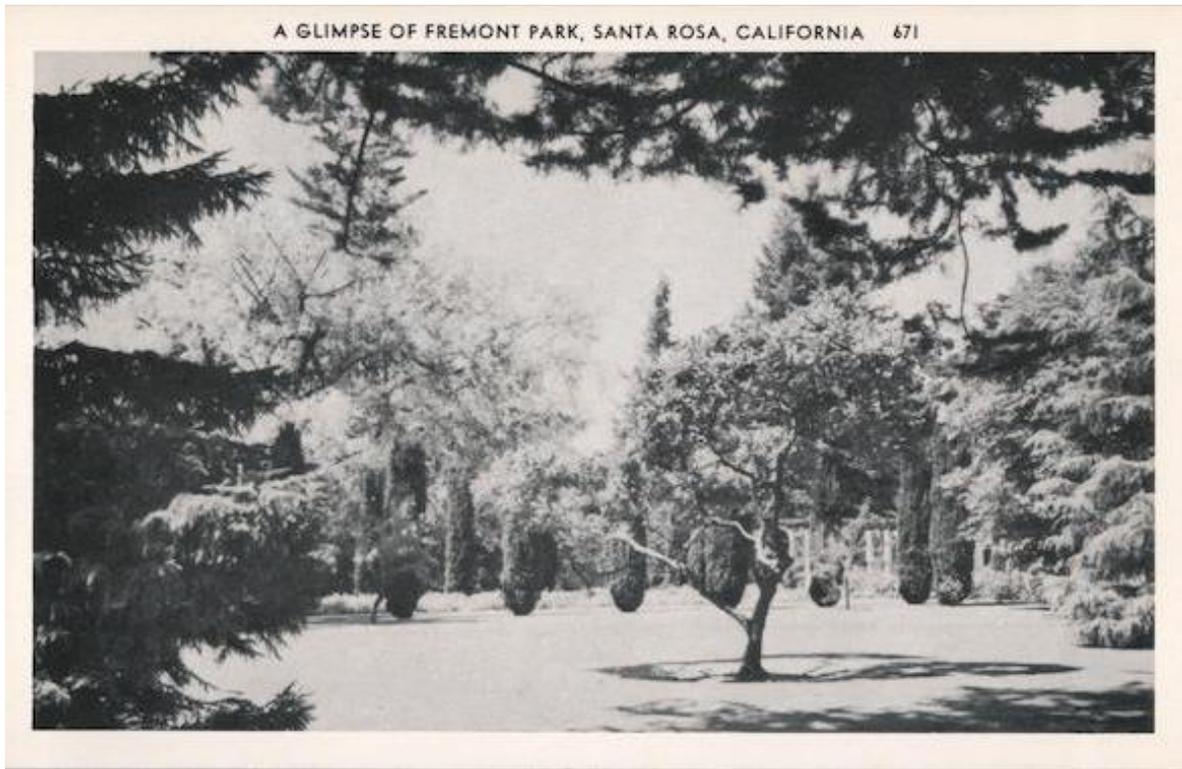
Gilkey's vegetation and circulation plans for the east and west halves of the park diverted from the formal symmetry he employed along the central axis. The east half included two diagonal brick pathways that crossed one another in the north half of the park and connected to the central *parti* via the secondary axis. Gilkey indicated potential locations for two benches where the paths crossed but noted that they were not included in the contract. The remainder of the east half was comprised of open lawn areas with a sparse scattering of specimen trees and one cluster of three red horse chestnut trees (*Aesculus carnea*). The individual specimen trees included one deodar cedar (*Cedrus deodara*), one Caucasian spruce (*Picea orientalis*), and one Caucasian fir (*Abies normanniana*) (**Figure 7**).

FIGURE 7. THE EAST LAWN AREA, LOOKING NORTHWEST TOWARDS THE CENTRAL AXIS. THE ALLÉE OF YEWS IS VISIBLE, AS IS A DEODAR CEDAR ON THE RIGHT. DATE UNKNOWN BUT ESTIMATED TO HAVE BEEN TAKEN CA 1940S BEFORE THE YEW TREES FILLED OUT THE ALLÉE ROWS. SOURCE: COURTESY OF THE SANTA ROSA DEPARTMENT OF PARKS AND RECREATION.

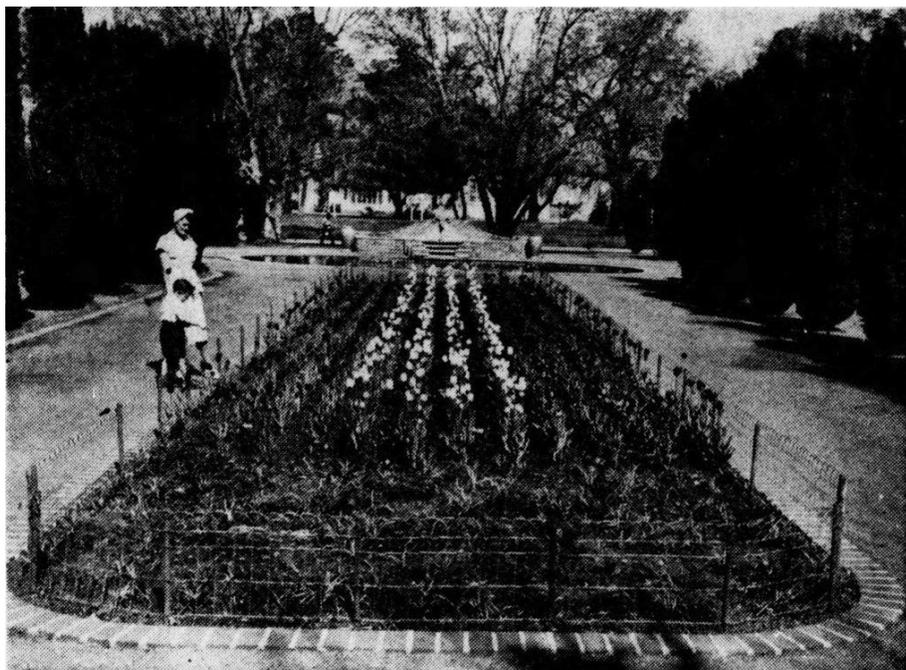
Although not specified by Gilkey in the original concept, the City stocked the lily pool with goldfish. They were later removed after the stock was fished by local residents and then became a popular feeding spot for cranes.²² Another notable design deviation appears at the focal point of the park, where the representation of a lion in the 1929 concept was replaced with that of a ram on the parapet wall of the cascading fountain. The ram’s head was carved from local sandstone by William R. Brown, who also installed the stonework in Doyle Park.²³ Finally, while Gilkey’s plans called for brick paving throughout the system of pedestrian paths and plazas at Fremont Park, it appears only red brick edging was ever installed along the paths and the flower beds (**Figure 9**).

FIGURE 9. LOOKING NORTH ALONG THE CENTRAL PROMENADE AND TULIP BED IN 1952. SOURCE: PRESS DEMOCRAT ARCHIVES, VIA THE CALIFORNIA DIGITAL NEWSPAPER COLLECTION.

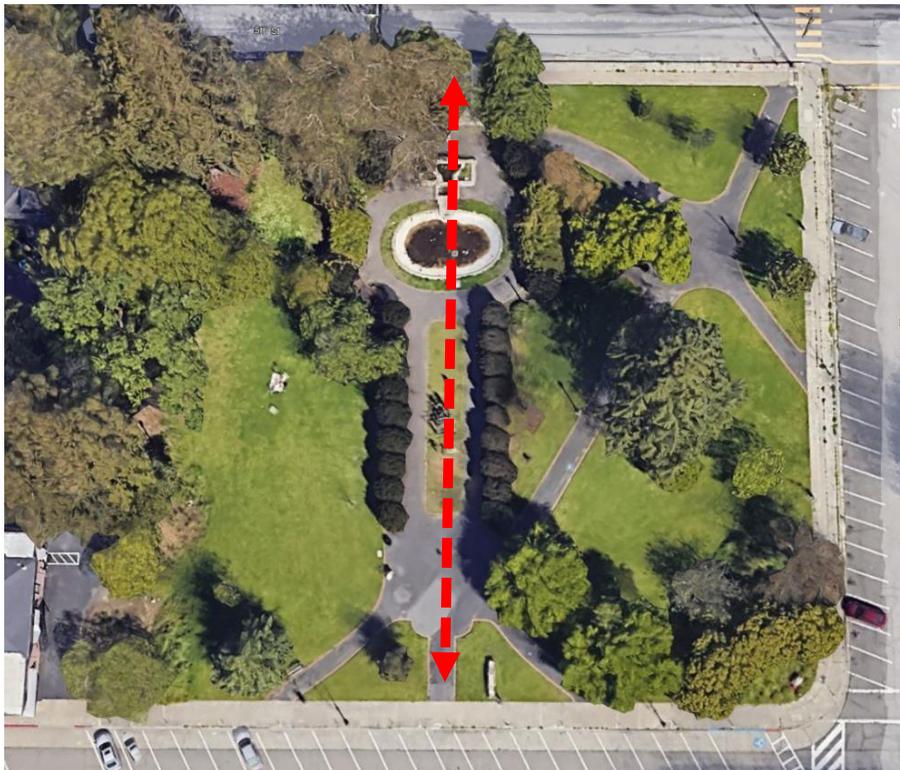
Fremont Park is square in plan, with a central axis in a north-south alignment that divides the 1.7-acre park into two equal halves (**Figure 14**). The *parti* aligns with the central axis, leading pedestrians from the park's primary entry point on Fourth Street through a progression of spaces until they arrive at the elliptical pool and stone fountain. Per the original design, Fremont Park's spatial organization emphasizes symmetry along the central axis, but departs from this treatment in the planting plan, circulation patterns, and edge treatments within the two halves of the park. The existing condition of the park is described and illustrated below, organized under applicable landscape characteristics.⁵⁰ Dates of known alterations or additions to the park are noted where known.

FIGURE 14. AERIAL VIEW OF FREMONT PARK, WITH PRIMARY AXIS ILLUSTRATED IN RED. SOURCE: GOOGLE EARTH, EDITED BY MIG.

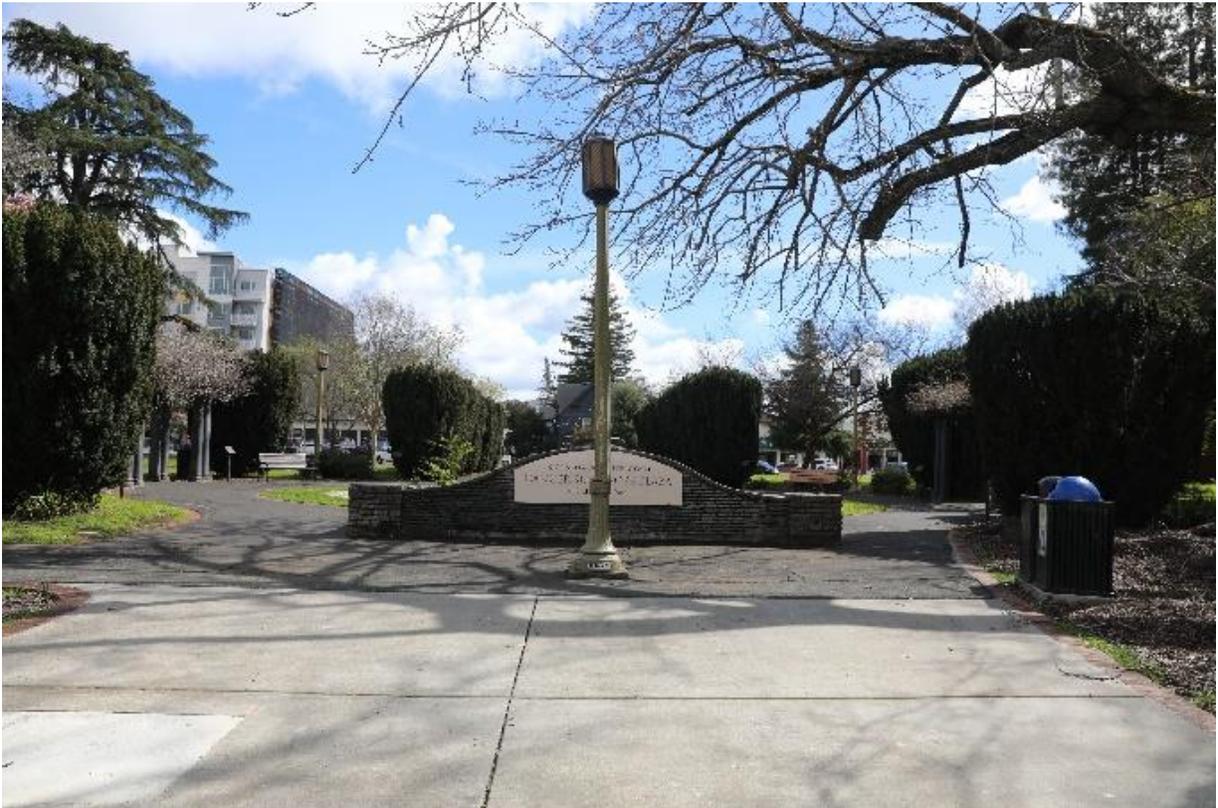
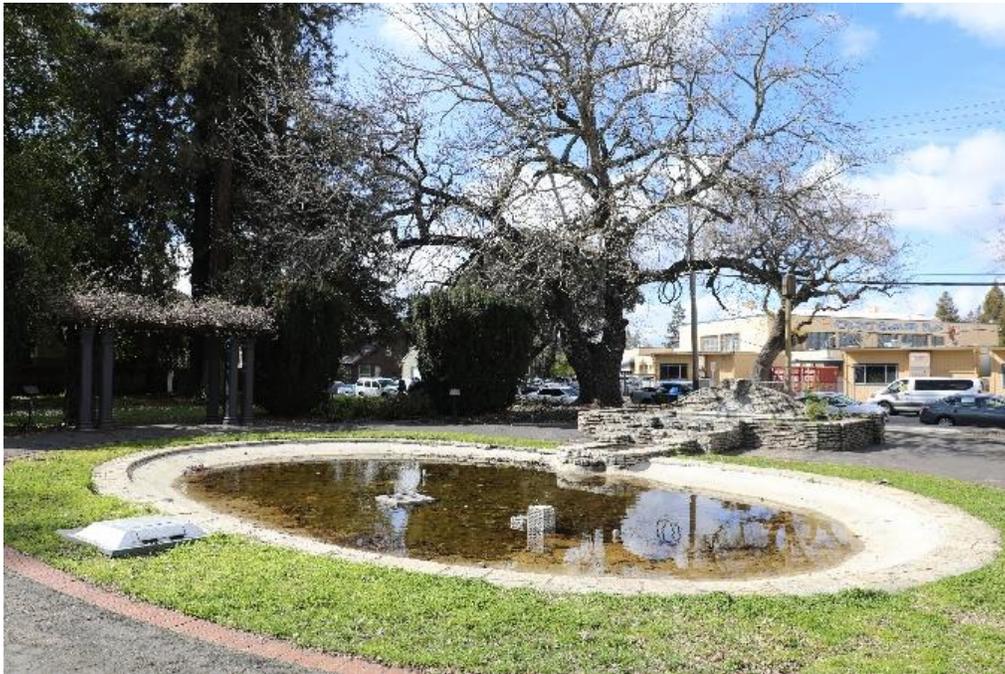
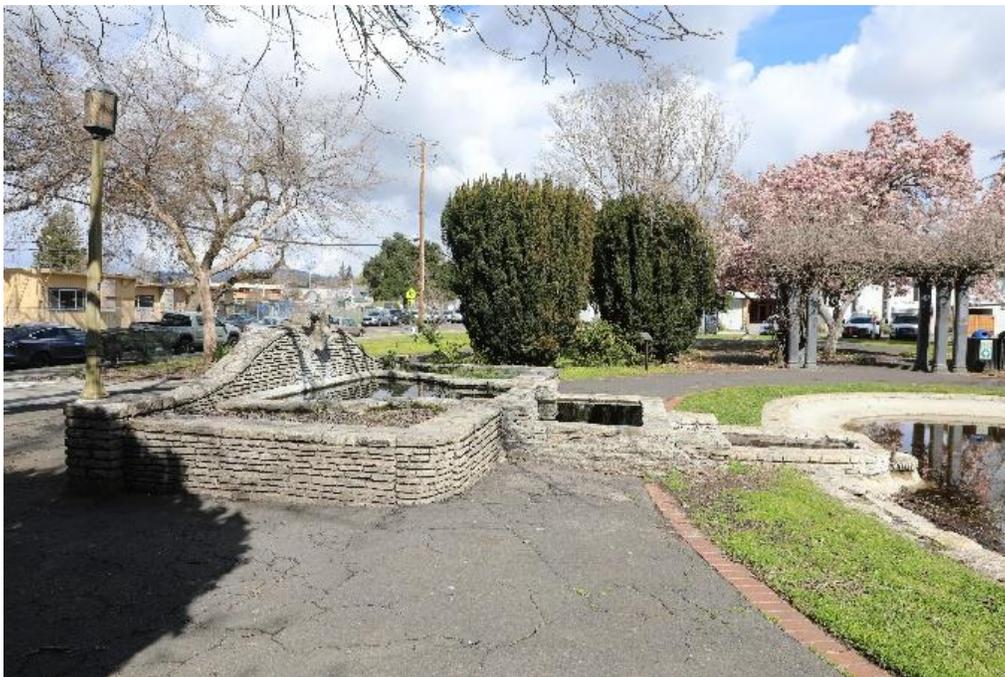
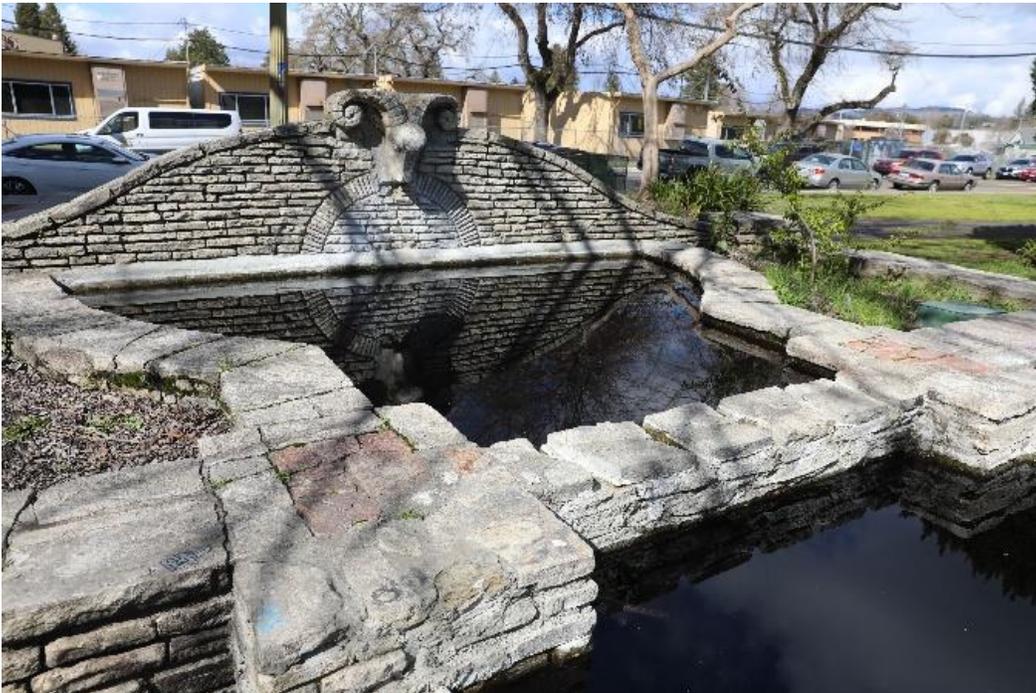
An elliptical pool basin is located towards the north end of the central axis within a oval plaza. The shallow basin is lined in concrete with rough stone copping, and ringed in concentric circles of lawn, a pedestrian walkway, and planted beds featuring lilies, flowering shrubs, and English yew trees. The lawn replaced flower beds at an unknown date.

A rough stone fountain is located along the north edge of the pool basin. It is composed of three levels upon which water is intended to cascade into the pool. A stone head of a ram is mounted upon a parapet wall at the rear of the fountain, and it is flanked by raised planted beds which are not maintained. The fountain is not currently operating although rainwater collects in the otherwise empty pool basin. A water pump is located in a utility box immediately adjacent to the pool on its south edge. The utility box is embedded within the narrow strip of lawn that encircles the basin (**Figure 20**). The stone facing of the fountain and the stone coping around the pool basin is showing signs of deterioration, with chipped edges and cracks.

FIGURE 15. LOOKING SOUTH ALONG THE CENTRAL AXIS FROM FIFTH STREET; VIEW OF THE REAR OF THE FOUNTAIN. SOURCE: MIG, 2023.

FIGURE 16. LOOKING NORTHWEST FROM WITHIN THE FOUNTAIN PLAZA; VIEW OF LILY POND BASIN AND FOUNTAIN. SOURCE: MIG 2023.

FIGURE 17. LOOKING EAST AT CASCADE FOUNTAIN. PORTAL IN BACKGROUND. SOURCE: MIG, 2023.

FIGURE 18. DETAIL OF STONE FOUNTAIN PARAPET WALL AND RAM HEAD. SOURCE: MIG, 2023.

The concept for the fountain and system of pools designed by Gilkey was at least partially implemented and continues to possess high artistic value despite its poor condition.⁵⁴ The water that flowed through the system of constructed water features along the central axis, originating at the headwall of the fountain and continuously overflowing into the basin before emptying into the city sewer system, was an elaborate design. The source of the water within a mounted animal head and the rough stone facing and coping along the fountain and pools, with integrated flower beds, combines classical references with local materials in a thoughtful arrangement that articulates Gilkey's Beaux Arts training within a grounded regional vernacular. The artistic value inherent in the design was and is a defining characteristic of the park.

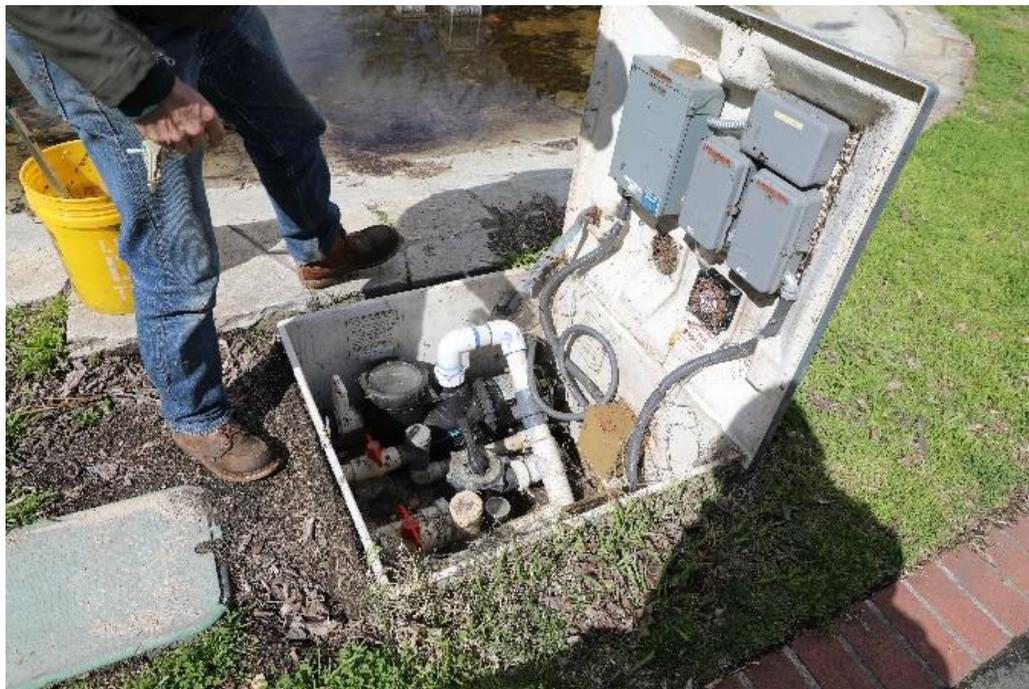
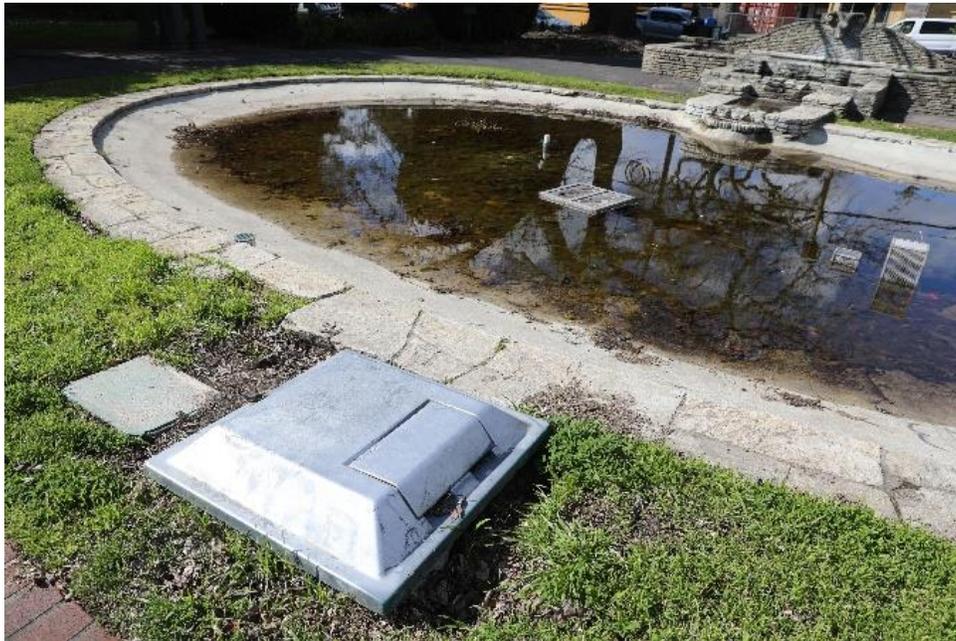
FIGURE 19. DETAIL OF FOUNTAIN PUMP. SOURCE: MIG, 2023.

FIGURE 20. FOUNTAIN PUMP WITH BASIN AND FOUNTAIN IN BACKGROUND. SOURCE: MIG, 2023.

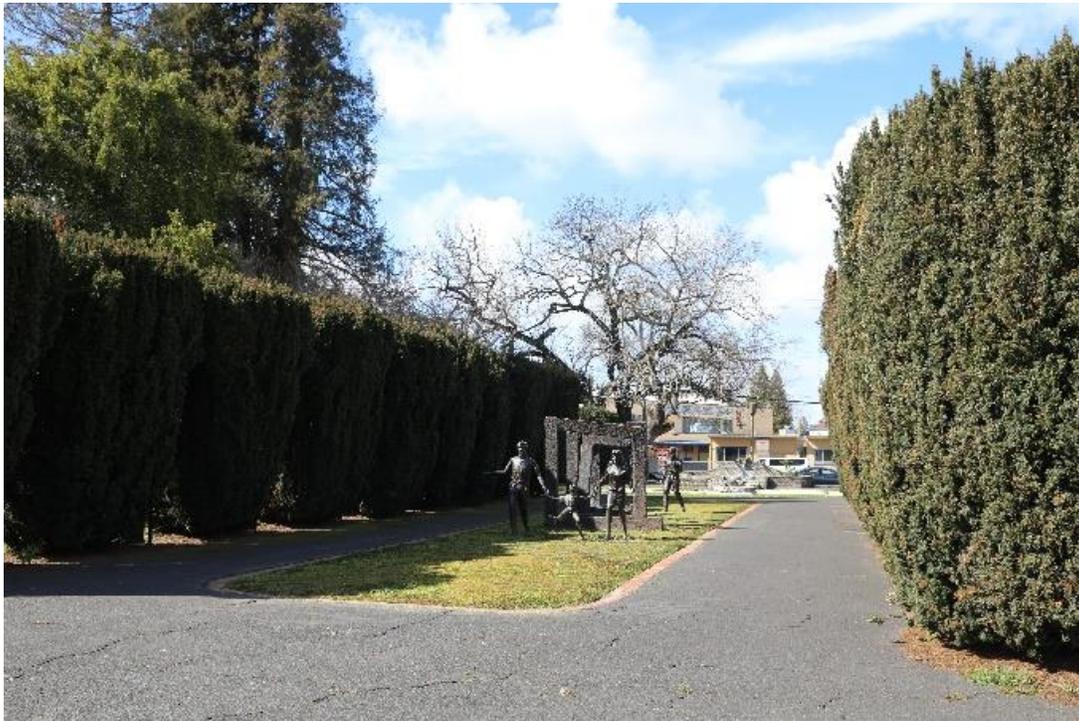
One of the most prominent features in the park is its circulation pattern, represented by two different types of pedestrian paths. The first is the central axis that draws visitors along a central promenade towards the focal point of the park, comprised of two parallel paths flanking a memorial installation. Wide paved terraces are located at the north and south ends of the central axis. The north terrace, behind the fountain, was recently patched with concrete when a sewer pipe was repaired.

While the location of the walkways within the park is retained from the historic period, they appear to have been repaved in asphalt. The original brick edges were retained or replaced in kind (**Figure 21, 22**). The asphalt is in poor condition throughout; it's uneven and exhibits long cracks with evidence of inconsistent repairs and patching.

FIGURE 21. LOOKING NORTH ALONG CENTRAL PROMENADE. SOURCE: MIG, 2023.

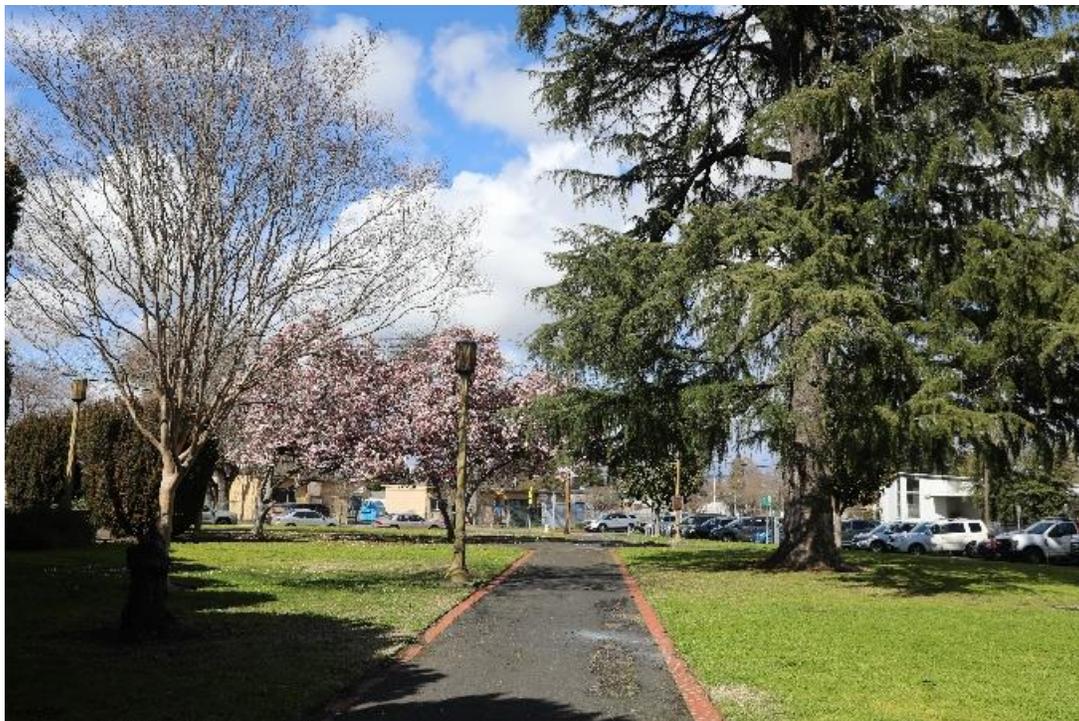
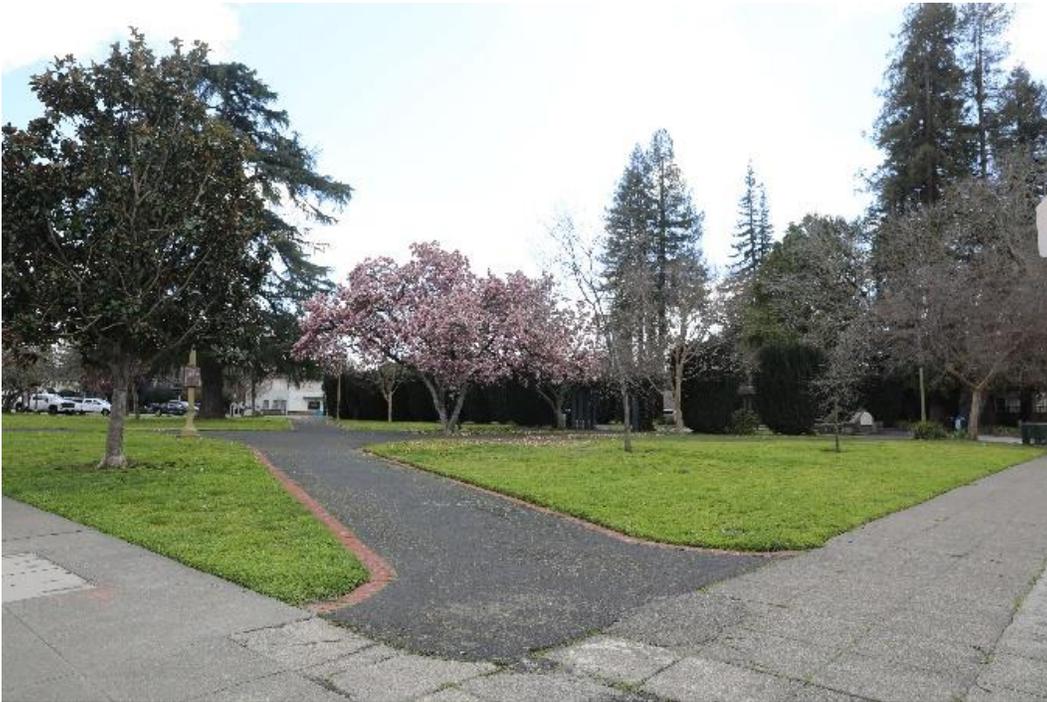
The second type of paths are the curved pedestrian walkways that are found in the east half of the park. These walkways crisscross the lawn area, allowing pedestrians to cut across the park between Fourth, Hope, and Fifth streets. They are approximately 8 ft in width (**Figures 22, 23**). No pedestrian circulation is located within the west half of the park.

FIGURE 22. LOOKING NORTHEAST TOWARDS HOPE STREET ALONG A DIAGONAL PEDESTRIAN PATH IN THE EAST HALF OF THE PARK. SOURCE: MIG 2023.

FIGURE 23. LOOKING SOUTHEAST TOWARDS FOURTH STREET; SHOWS THE INTERSECTION BETWEEN THE PERIMETER SIDEWALK AND THE PARK PATHWAYS. SOURCE: MIG, 2023.

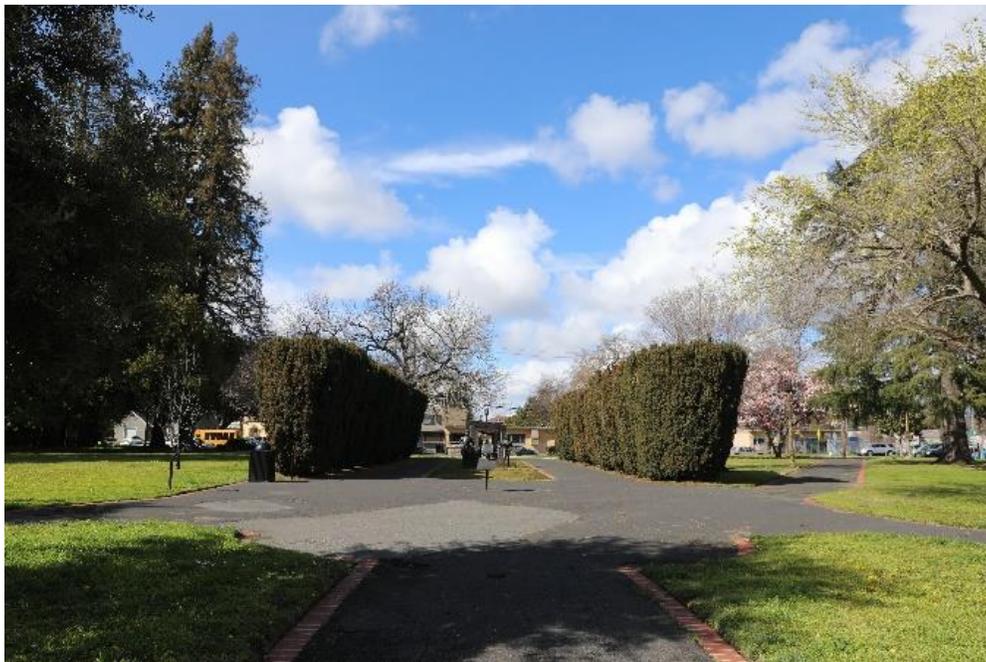
The yews are sited to emphasize the central *parti*, following Gilkey's original Beaux-Arts inspired design concept. They form a dense allée and continue along the outside of the path that encircles the fountain plaza (**Figures 25, 28, 29**); a second row of flowering trees that was included in the original design has been lost over time. It's possible that three crepe myrtles (*lagerstroemia x fauriei*) and a flowering cherry (*Prunus serrulata*) located within the general location of the exterior row date to the historic period and were part of the double allée and symmetrical plaza planting plan if the red flowering peaches were not available during construction.

FIGURE 25. LOOKING NORTH ALONG THE CENTRAL AXIS. SOURCE: MIG, 2023.

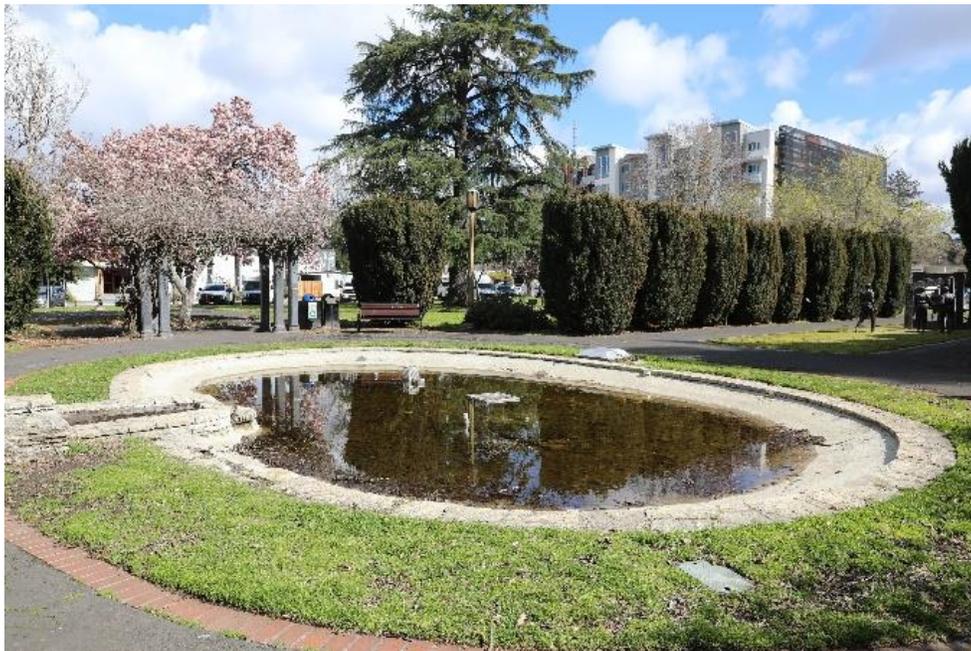
Two arbors align with the yew trees, flanking the plaza area on the east and west ends, and forming the secondary axis through the center of the elliptical pool. The portals support wisteria plants that have extended beyond the arbor structures and are growing into the adjacent yew trees. The wisteria plants replaced the historic rose plants at an unknown date (**Figure 30**). Planted beds are located along the primary and secondary axes; the beds around the current fountain plaza contain lilies and low shrubs. The elongated flower bed along the secondary axis in the east half of the park has been replanted with two saucer magnolia trees. Like the pedestrian walkways, red brick lines the edges of the planted beds.

**FIGURE 28. VIEW OF THE ELLIPTICAL POOL ENCIRCLED BY LAWN. THE EAST PORTAL IS TO THE
LEFT, WHILE THE YEW ALLÉE IS TO THE RIGHT. SOURCE: MIG, 2023.**

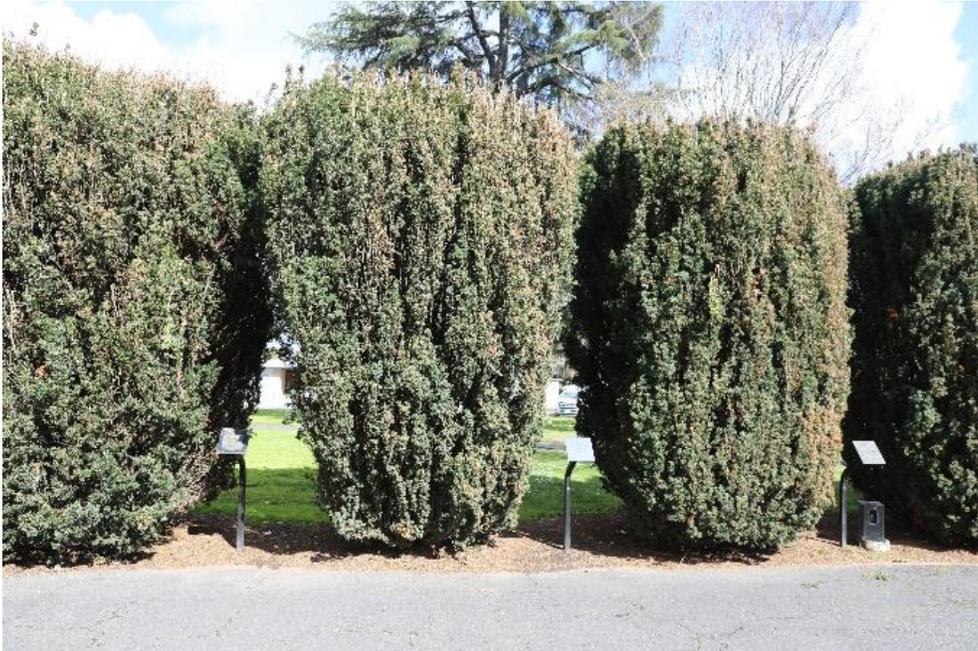
FIGURE 29. DETAIL OF YEWE TREES IN ALLÉE. SOURCE: MIG, 2023.

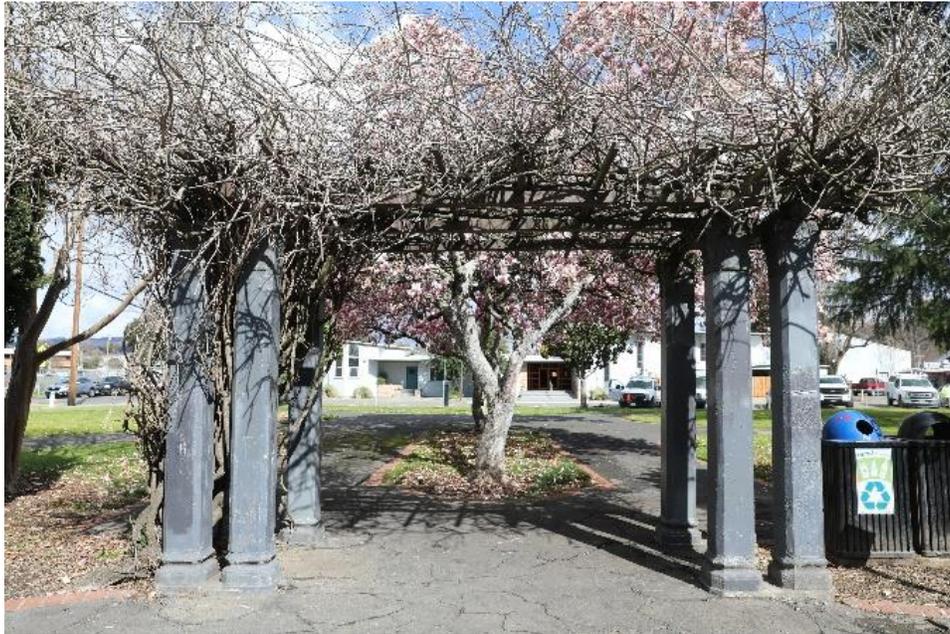
FIGURE 30. DETAIL OF EAST ROSE PORTAL, LOOKING EAST FROM THE FOUNTAIN PLAZA. SOURCE: MIG, 2023.

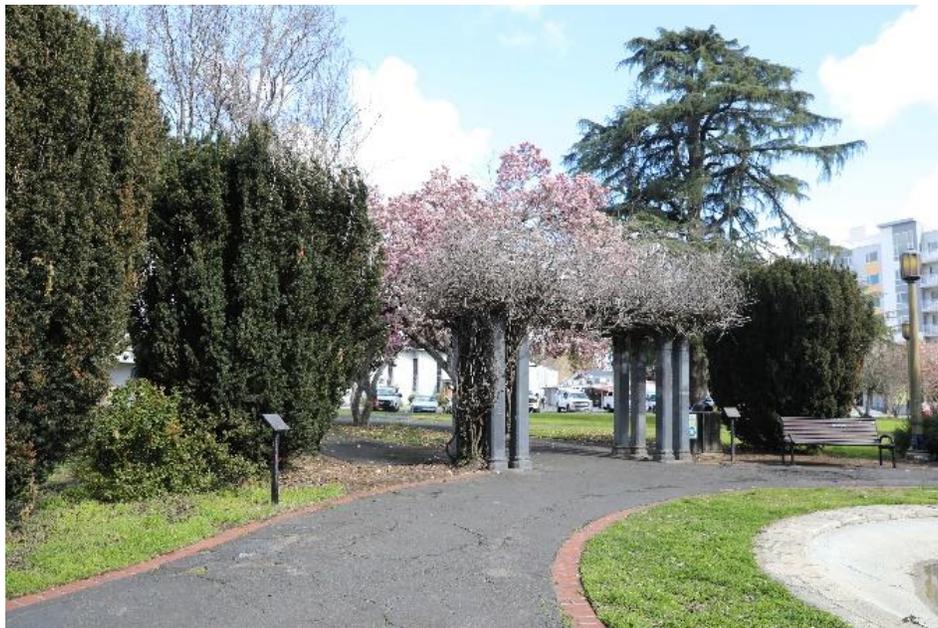
FIGURE 31. VIEW TOWARDS EAST PORTAL FROM WITHIN THE FOUNTAIN PLAZA, SHOWING THE CONCENTRIC ROWS OF YEWS, CIRCULATION, AND LAWN. SOURCE: MIG, 2023.

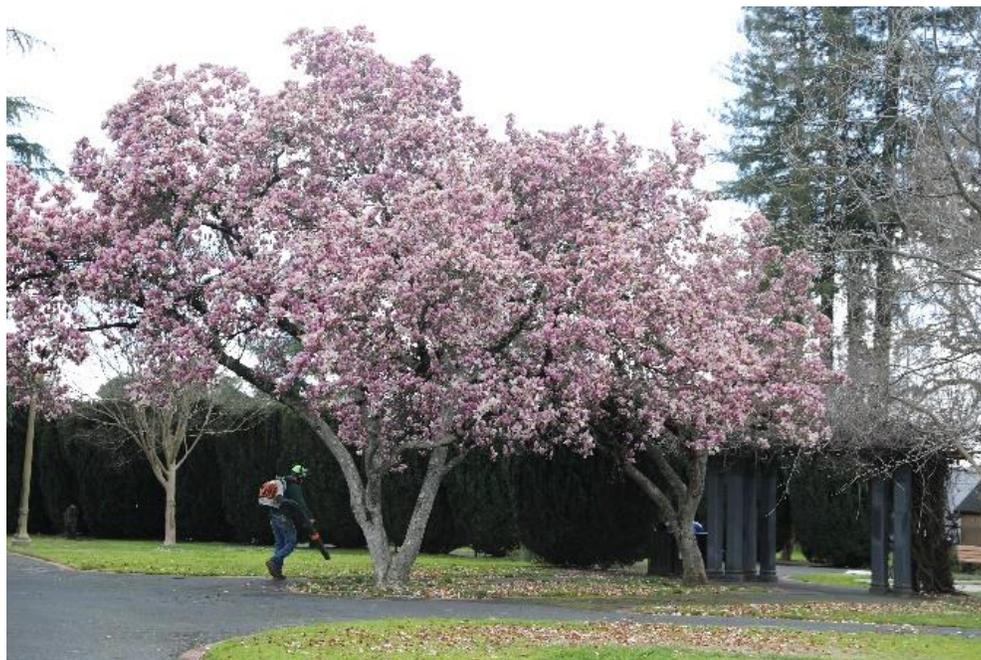
FIGURE 32. TWO FLOWERING SAUCER MAGNOLIA TREES, PLANTED WITH A FORMER FLOWER BED ALONG THE SECONDARY AXIS. SOURCE: MIG, 2023.

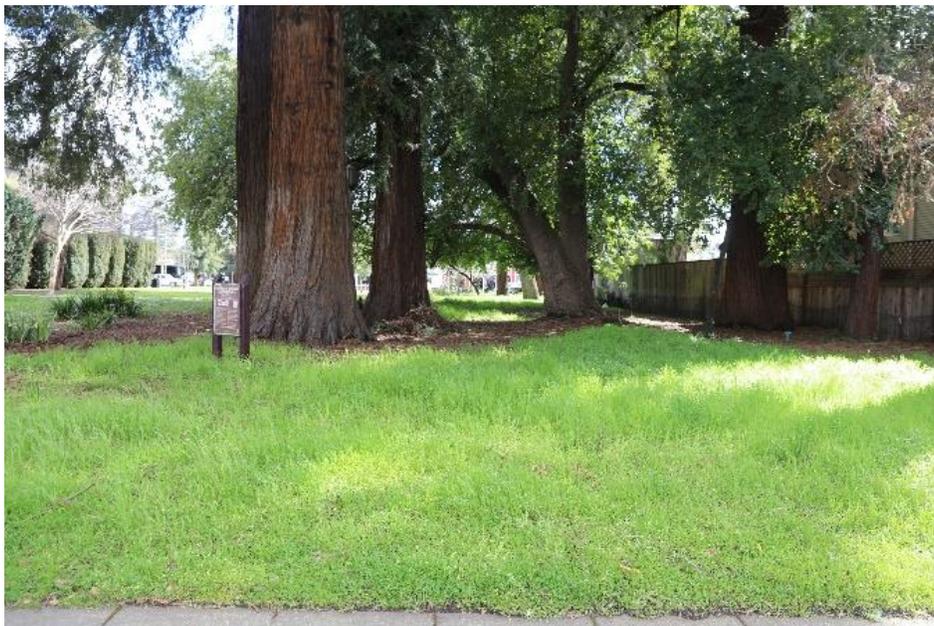
The west edge of the park features clusters of trees over an understory of lilies, grasses, and English ivy (**Figures 36, 40**). This area is clearly delineated via plant species and maintenance practices, as the understory is not mowed and exhibits more diverse textures and heights than the manicured lawn areas. The tree clusters include two stands of coast redwoods (*Sequoia sempervirens*) that were included in Gilkey's original concept for the park, as well as a California Bay tree (*Umbellularia californica*), a California buckeye (*Aesculus californica*) that also appears to date to the historic period, two desert willows (*Chitalpa x tashkentensis*), and a valley oak (*Quercus lobata*), among a mix of other species. A couple of the redwoods are in poor condition due to drought (**Figure 39**).⁵²

FIGURE 36. VIEW OF TEXTURED VEGETATION AND STAND OF COAST REDWOODS, LOOKING SOUTH ALONG THE WEST EDGE OF THE PARK FROM FIFTH STREET. SOURCE: MIG, 2023.

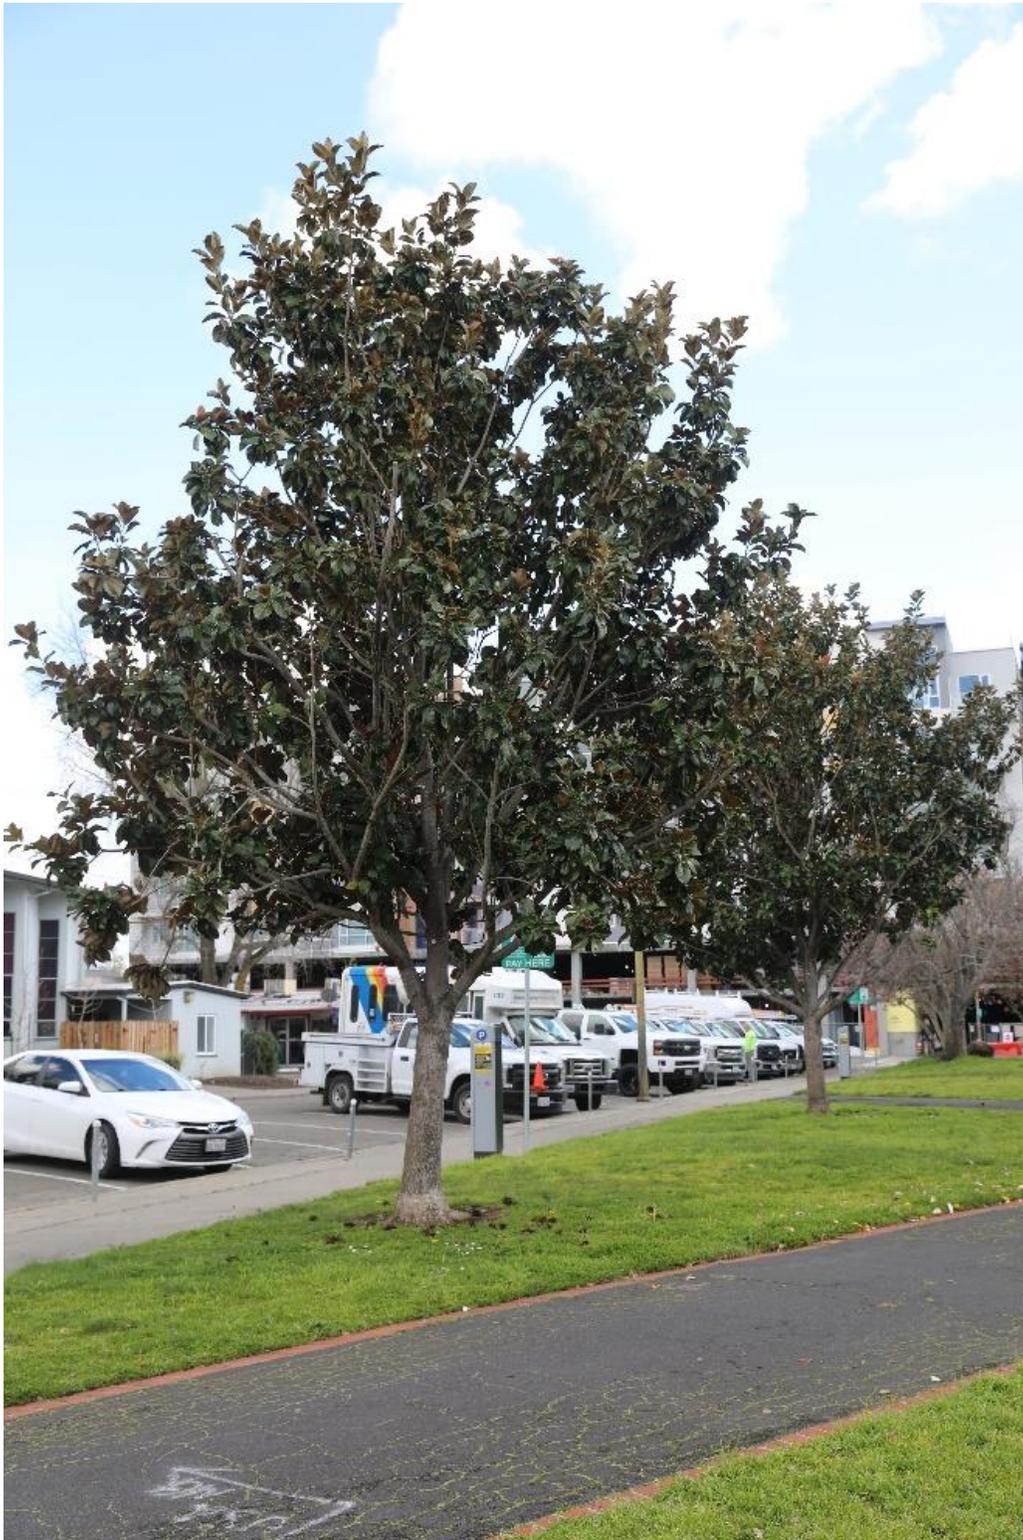
frame a memorial boulder at the corner of the intersection of Fourth and Hope streets (**Figure 41**), and the northeast quadrant which features two southern magnolias that are not specified in any historical documents (*Magnolia grandiflora*) (**Figure 38**).

FIGURE 38. TWO SOUTHERN MAGNOLIAS LOCATED WITHIN THE EAST LAWN NEAR THE HOPE STREET PERIMETER. SOURCE: MIG, 2023.

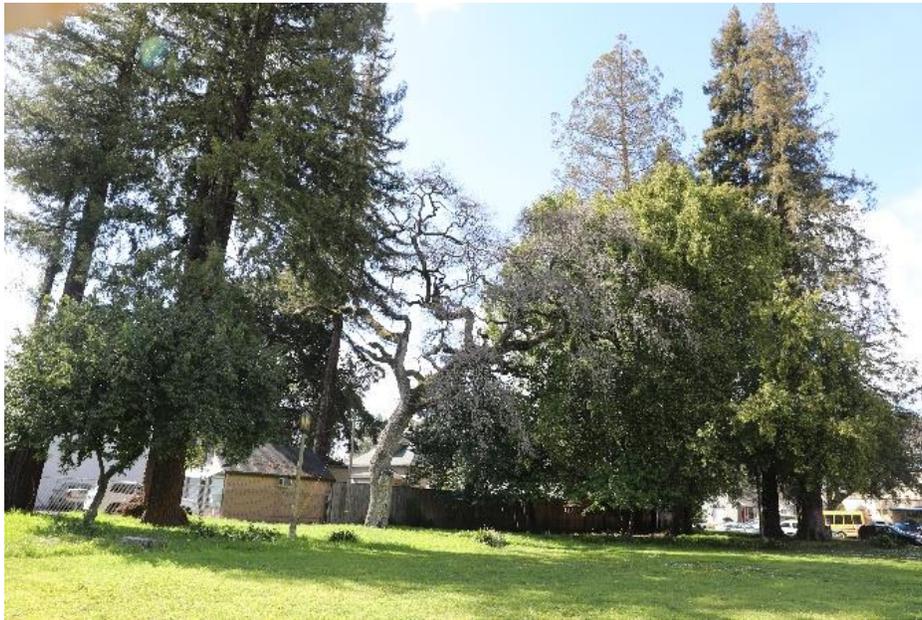
FIGURE 39. TWO STANDS OF COAST REDWOODS ALONG THE WEST EDGE OF THE PARK, LOOKING NORTHWEST. SOURCE: MIG, 2023.

⁵² Batchelder. Suggest remedies are proposed in the arborist report.

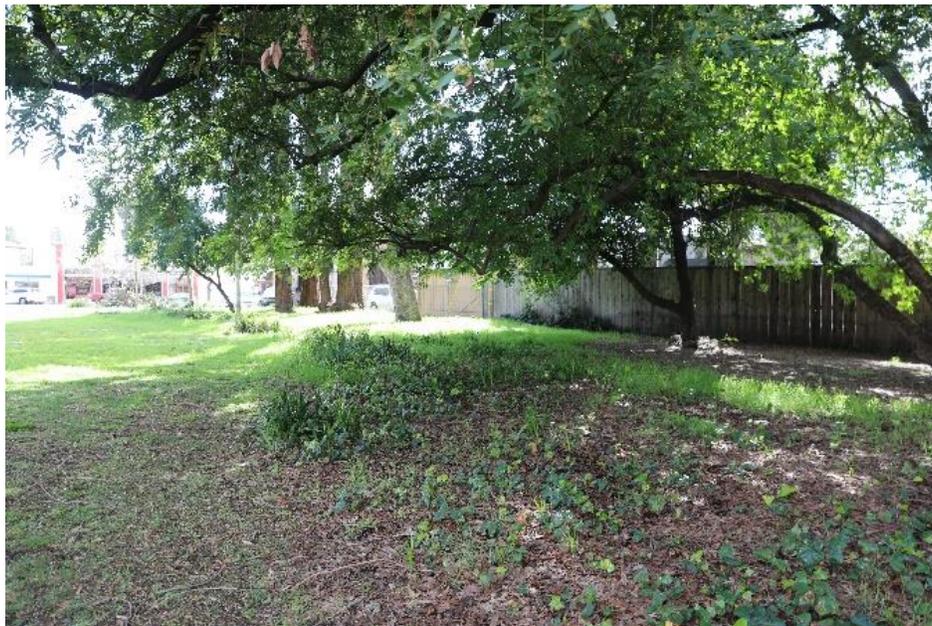
FIGURE 40. WEST BOUNDARY VEGETATION AND FENCE, LOOKING SOUTHWEST FROM THE WEST LAWN. SOURCE: MIG, 2023.

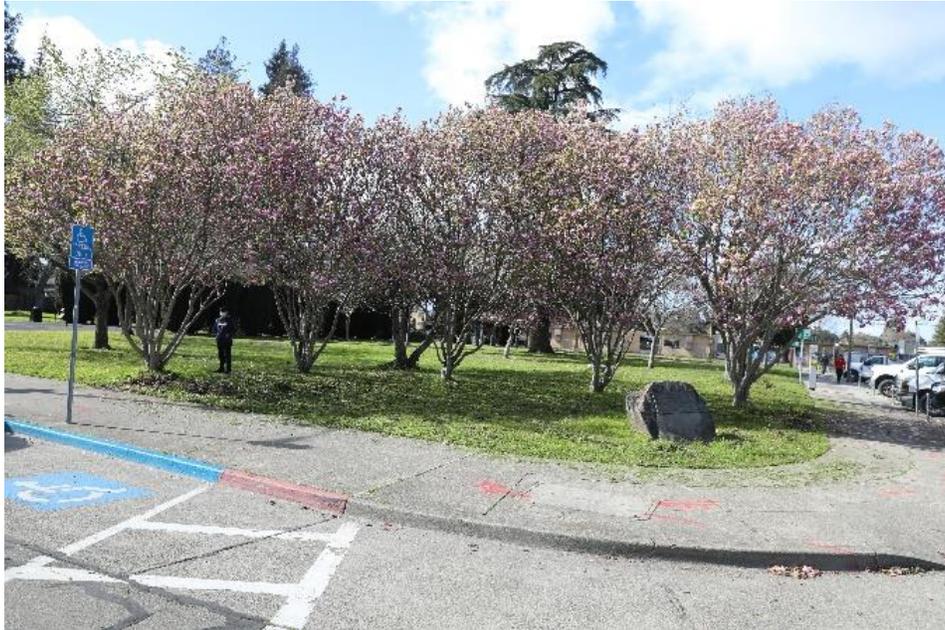
FIGURE 41. CURVED ROW OF SAUCER MAGNOLIAS AT THE SOUTHEAST CORNER OF THE PARK. SOURCE: MIG, 2023.
