**Fremont Park
Santa Rosa, California
Historic Resources Study**

October 2023

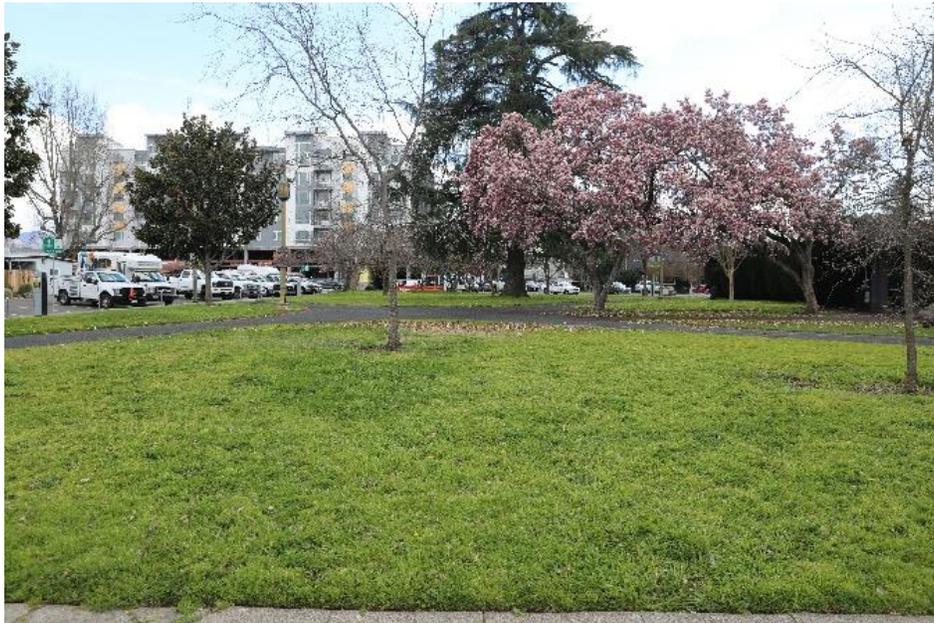
Both halves of the park, on either side of the central north-south axis, are carpeted in open lawns (**Figures 42, 43**). The lawn areas are watered with an underground irrigation system; however, they show signs of distress due to recent droughts and encampments. A rectangular lawn with rounded corners and brick edges runs along the central axis between the two rows of yews, in what appears to be the general footprint of the planned elongated reflecting pool from Gilkey's original concept that was never built. This lawn contains the Cancer Survivor's Memorial.

FIGURE 42. THE EAST LAWN, LOOKING SOUTH FROM FIFTH STREET. SOURCE: MIG, 2023.

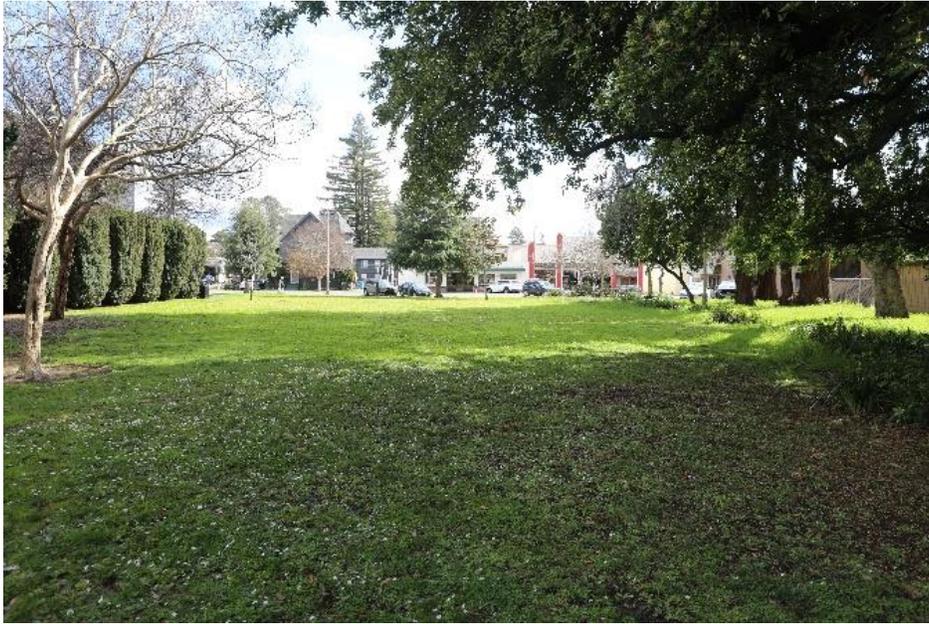
FIGURE 43. THE WEST LAWN, LOOKING SOUTH FROM FIFTH STREET. SOURCE: MIG, 2023.

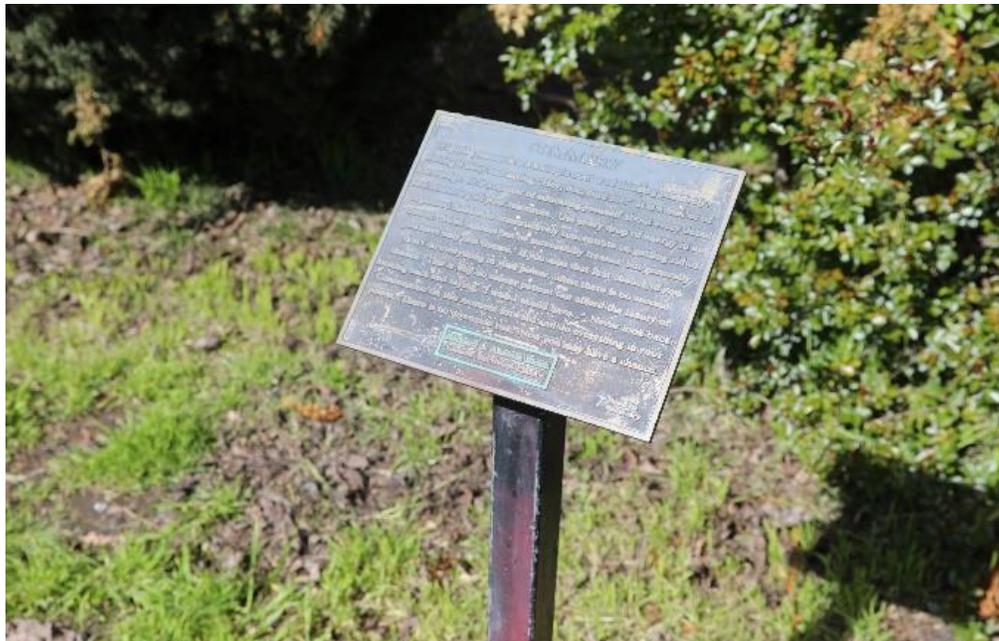
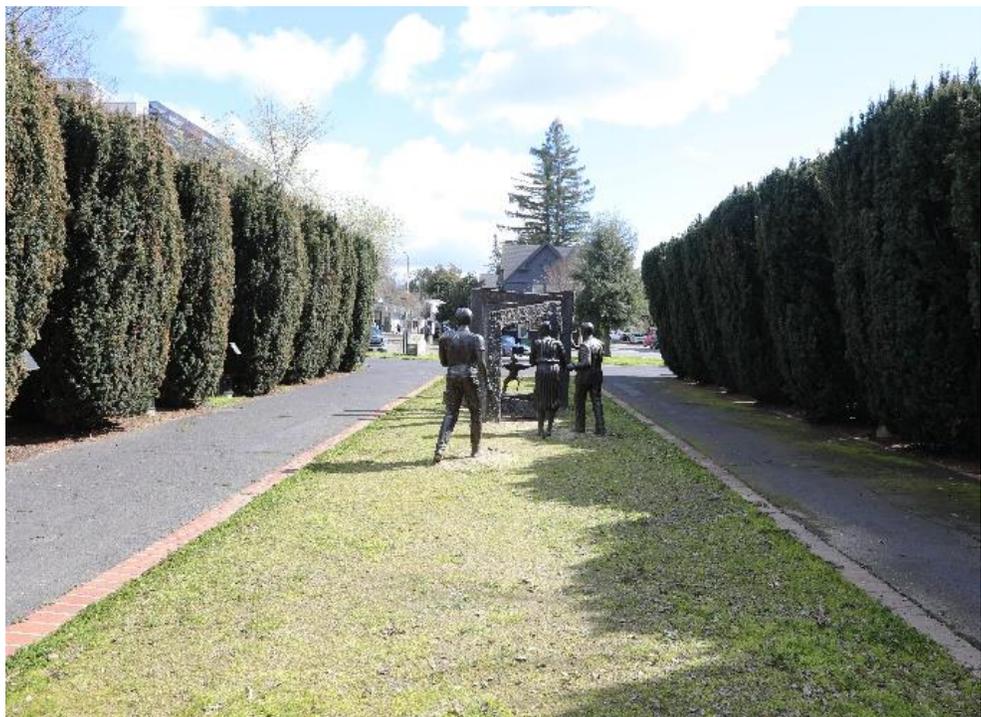
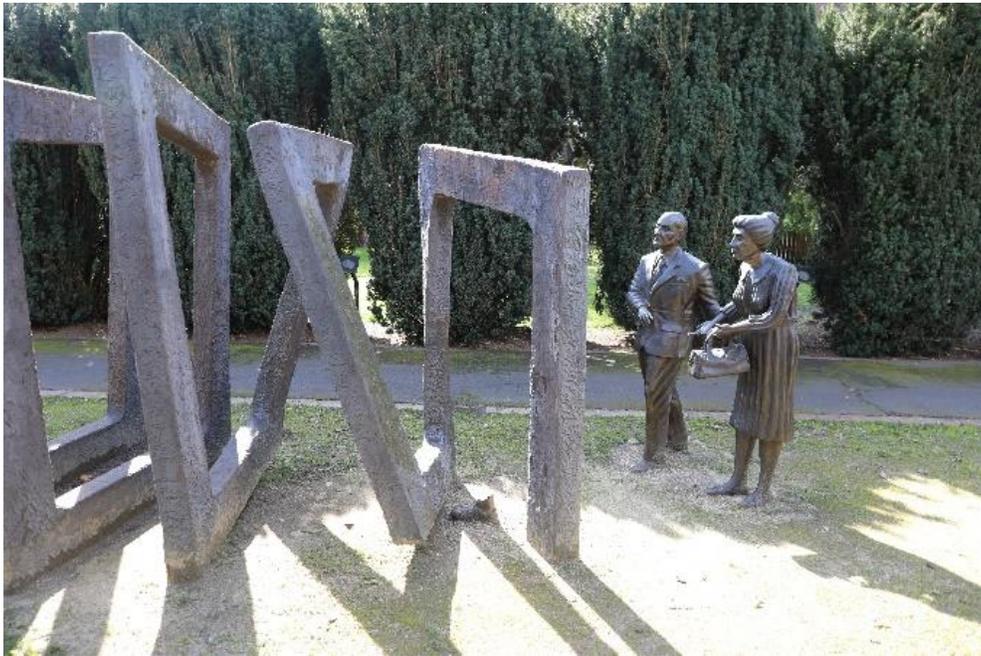
A memorial celebrating cancer survivors was installed along the central axis in 1997 and is composed of bronze and faux bronze figures moving through a series of bronze arches (**Figures 44, 46, 47**). Plaques with inspiring quotes are placed between each yew tree. Some of the plaques are missing inscriptions (**Figure 44**). A stone sign at the Fourth Street end of the allée designates the memorial site as the Richard and Annette Block Cancer Survivors Plaza (**Figure 51**).

**FIGURE 44. A PLAQUE WITH QUOTE LOCATE BETWEEN YEW TREES IN THE CENTRAL PROMENADE.
SOURCE: MIG 2023.**

FIGURE 46. THE REAR OF THE CANCER SURVIVORS MEMORIAL, LOOKING SOUTH TOWARDS FOURTH STREET. SOURCE: MIG, 2023.

FIGURE 47. DETAIL OF THE MEMORIAL. SOURCE: MIG, 2023.

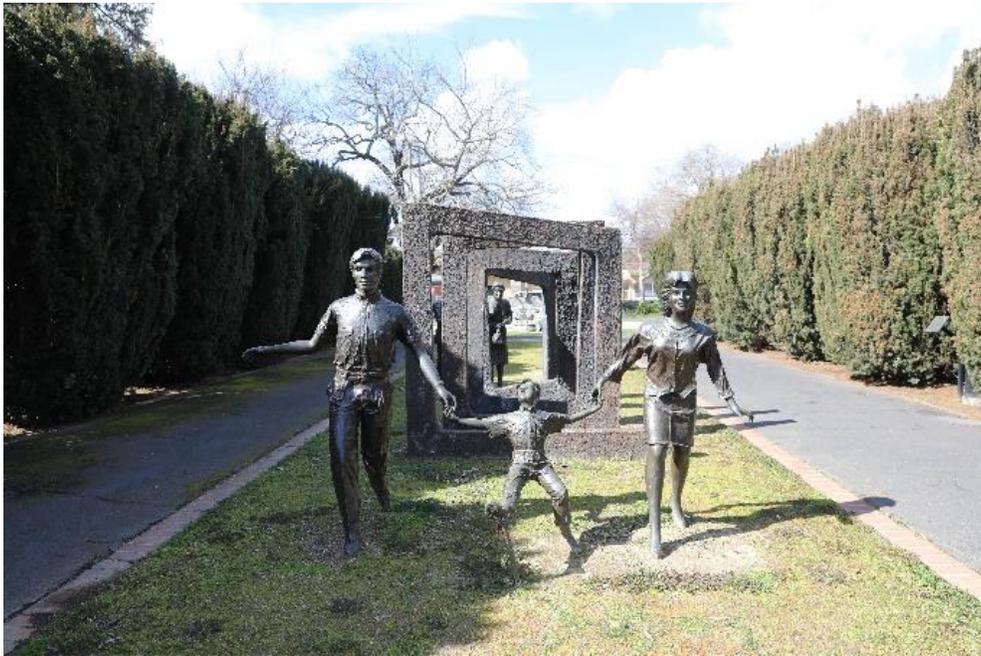
FIGURE 45. DETAIL OF THE CANCER SURVIVORS MEMORIAL, LOOKING NORTH. SOURCE: MIG, 2023.

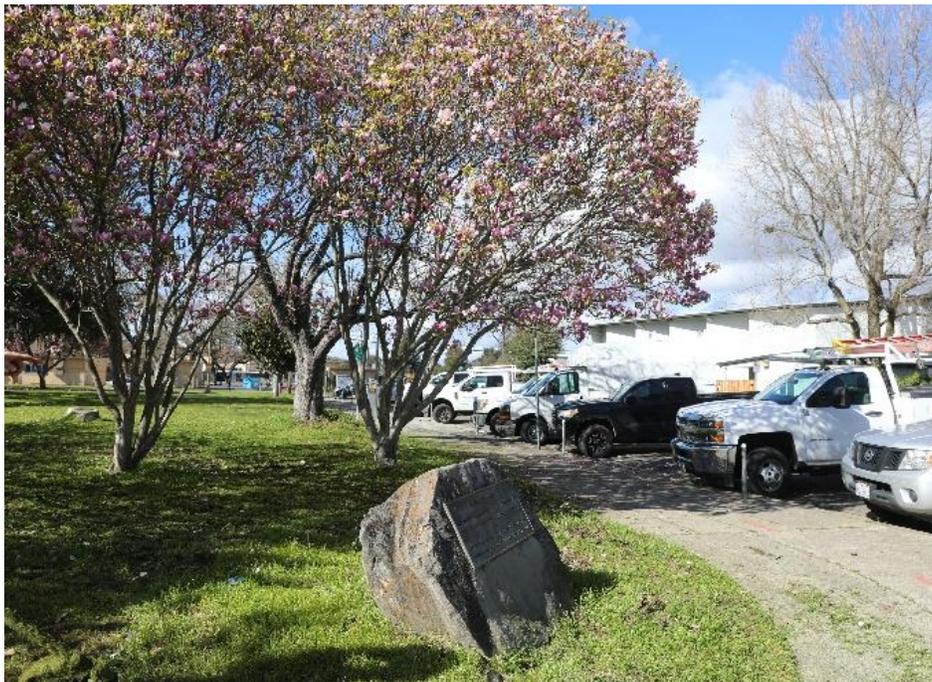
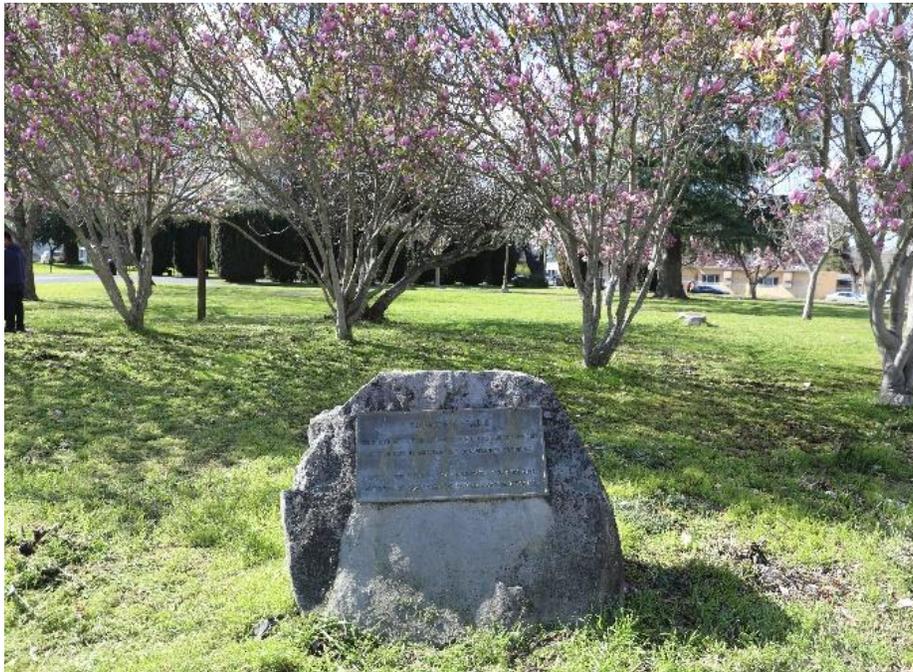
A stone memorial commemorating the founding of Fremont Park is located at the southeast corner of the park, facing outwards towards the intersection of Fourth and Hope streets (**Figures 48, 49**).

FIGURE 48. MEMORIAL ROCK AT THE SOUTHEAST CORNER OF THE PARK. SOURCE: MIG, 2023.

FIGURE 49. DETAIL OF MEMORIAL ROCK WITH PLAQUE: MIG, 2023.

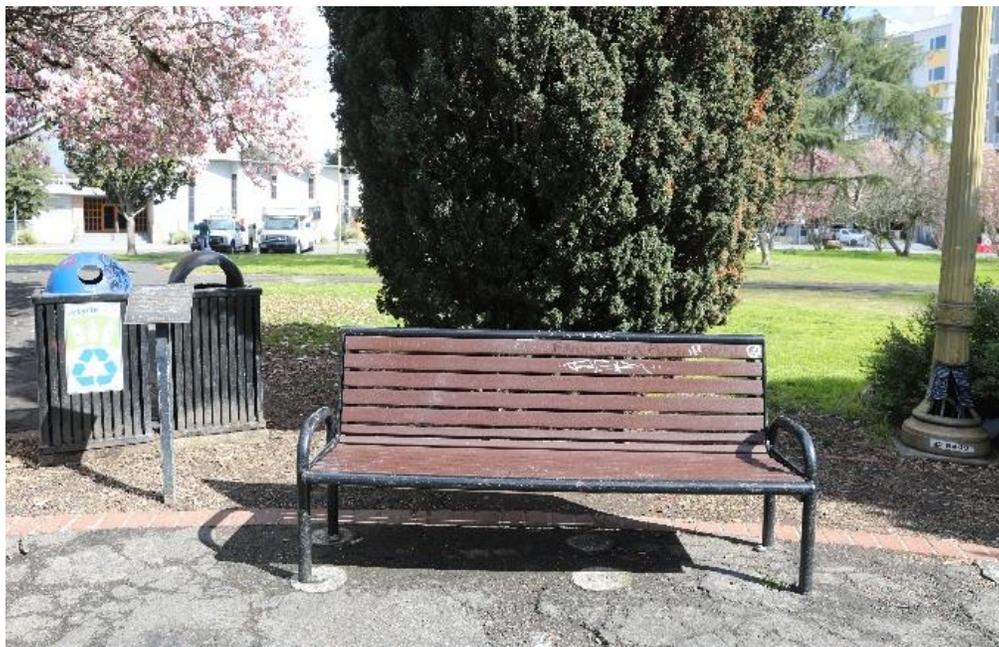
The park contains a few wood and metal benches located along the primary axis and minimal signage (**Figures 52 and 53**). Department of Parks and Recreation signs with rules and regulations are located at the northwest and southeast corners of the park. They are comprised of metal signs mounted on wood posts and are clearly differentiated from the site-specific and historic features of the park.

FIGURE 52. DETAIL OF BENCH LOCATED WITHIN THE FOUNTAIN PLAZA. SOURCE: MIG, 2023.

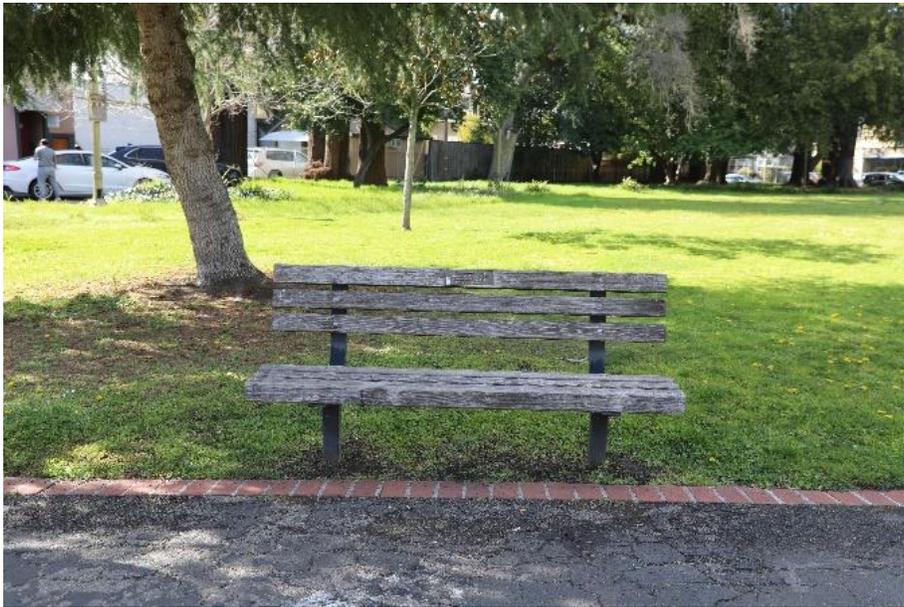
FIGURE 53. DETAIL OF BENCH LOCATED NEAR FOURTH STREET. SOURCE: MIG, 2023.

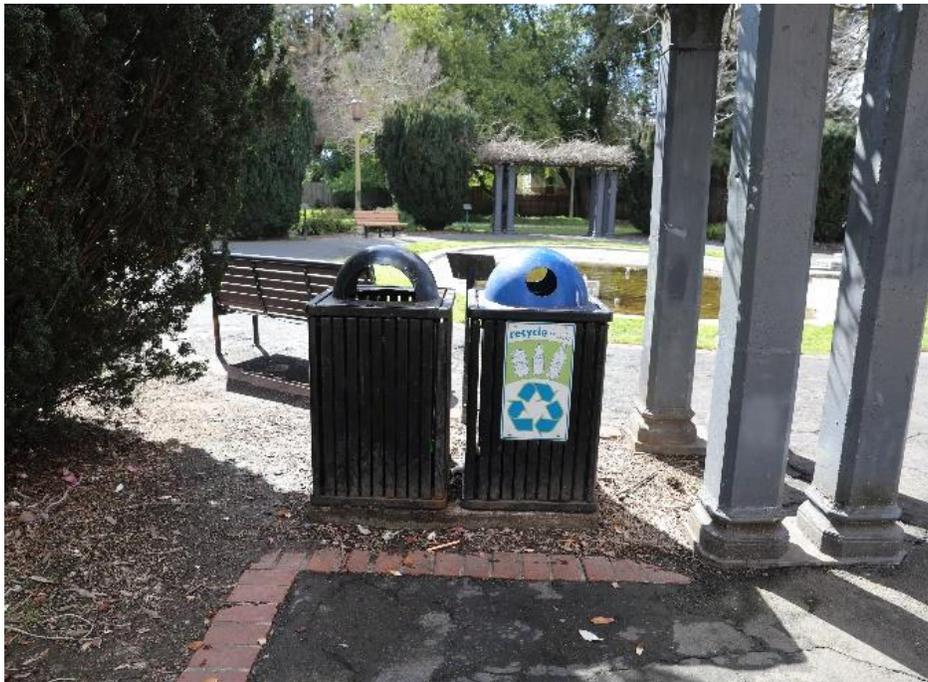
Contemporary metal trash and recycling bins and a water meter are located on concrete pads at the north and south ends of the central axis, and around the fountain plaza (**Figure 54**). Another trash bin is located along the central axis near the Fourth Street entrance to the park.

FIGURE 54. DETAIL OF TRASH AND RECYCLING BINS LOCATED IN THE FOUNTAIN PLAZA. SOURCE: MIG, 2023.

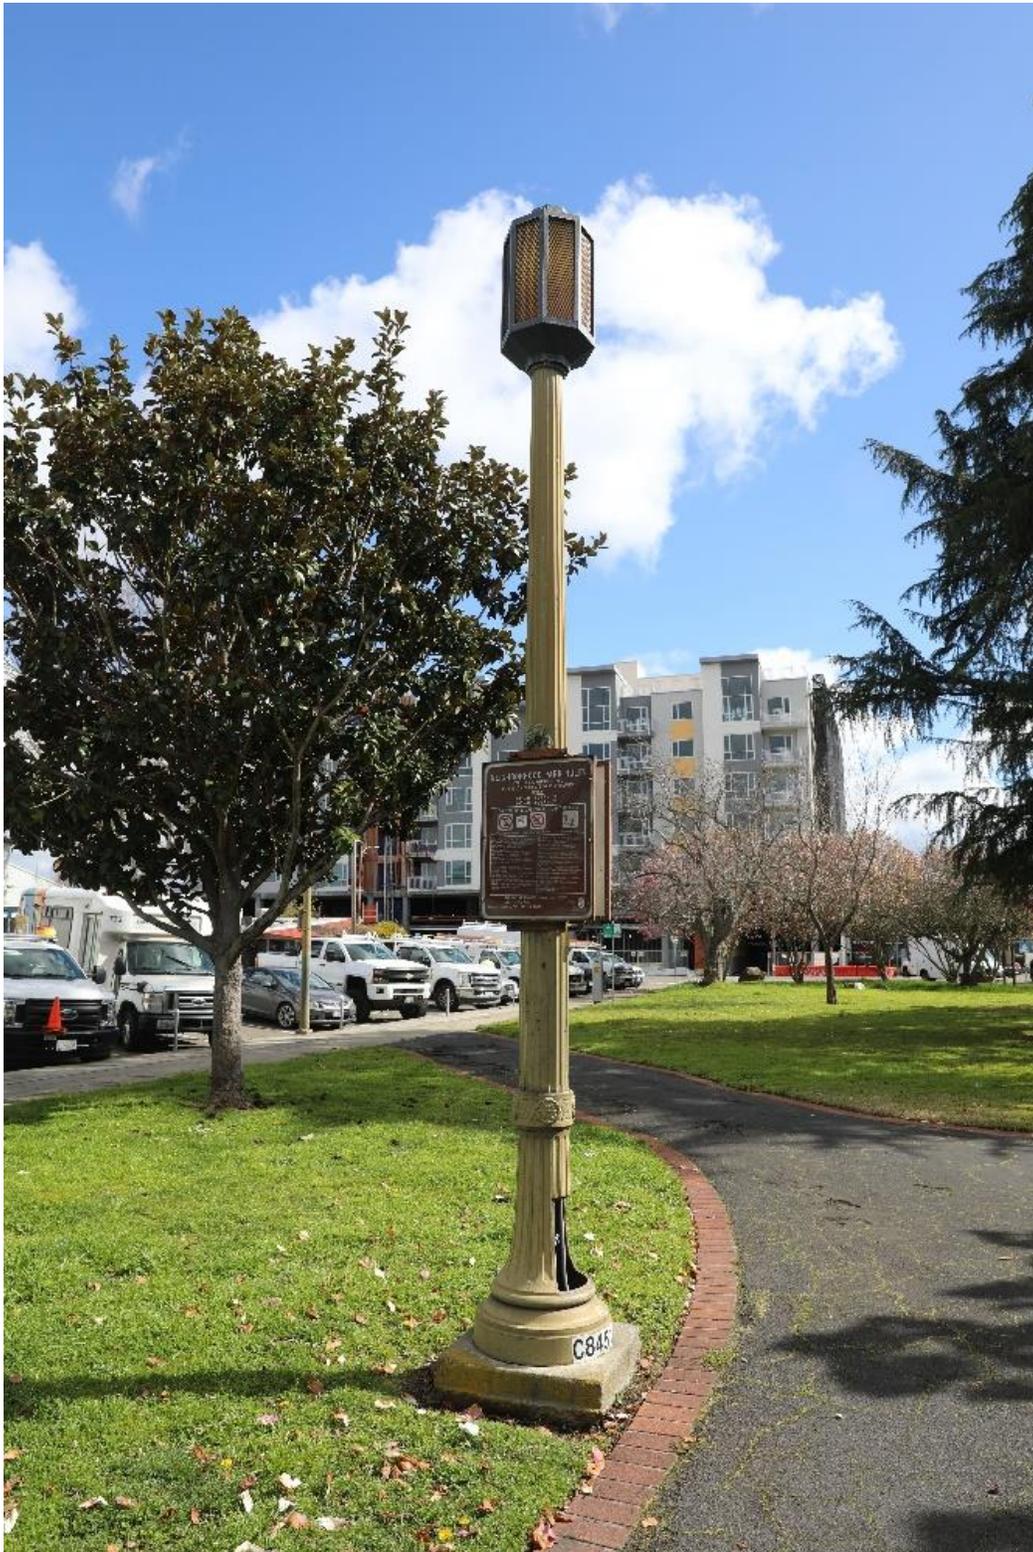
Light standards are located throughout the park. The current standards were not included in the original concept for the park and installed at an unknown date. They are comprised of a tapered column capped by an octagonal lantern. The standards are painted an oxidized forest green color and the glazing in the lantern is dark yellow (**Figure 55**). They are clustered around the fountain plaza and along the pedestrian circulation routes in the east half of the park. While the

FIGURE 55. LIGHT STANDARD LOCATED WITHIN THE EAST LAWN AREA. SOURCE: MIG, 2023.

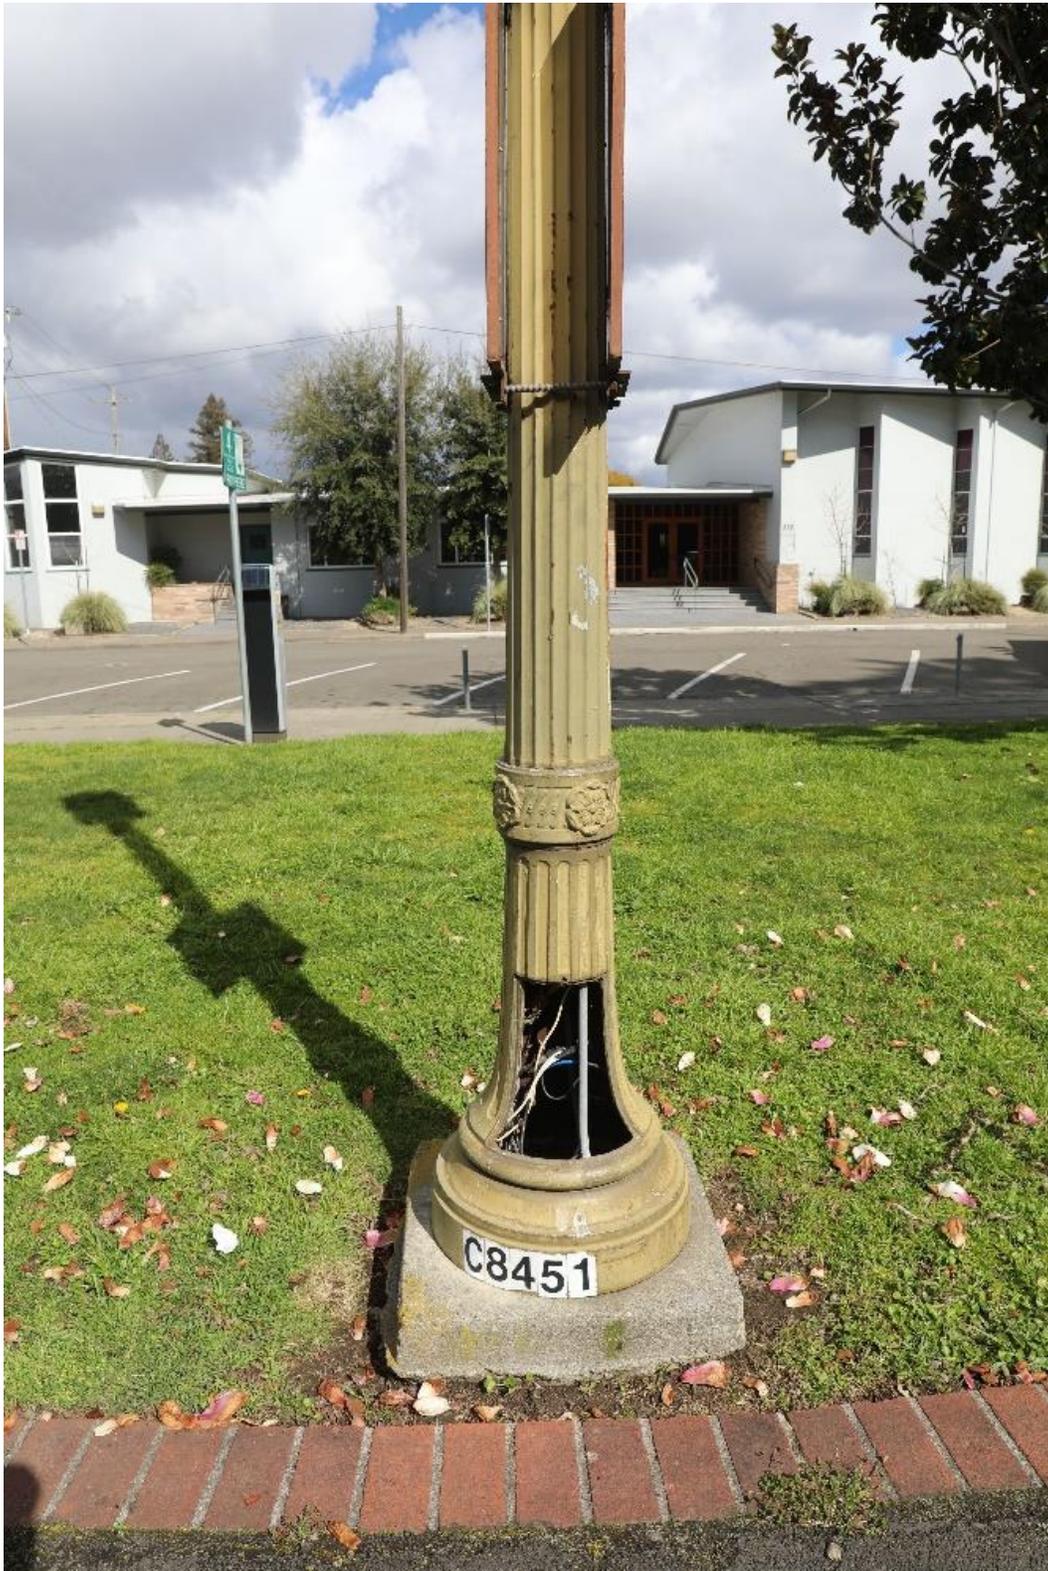
standards appear operable, they are in poor condition with broken glazing in the lanterns and graffiti and deterioration at the bases and columns (**Figure 56**). No evidence of the original flood lighting remains extant.

FIGURE 56. DETAIL OF BASE OF LIGHT STANDARD. SOURCE: MIG, 2023.
