PHASE I ENVIRONMENTAL SITE ASSESSMENT REPORT

Ryder Homes - SW Estates

2903 Dutton Meadow & 533 Bellevue Avenue Santa Rosa, California 95407

Report Date: August 13, 2020 Partner Project No. 20-288306.1

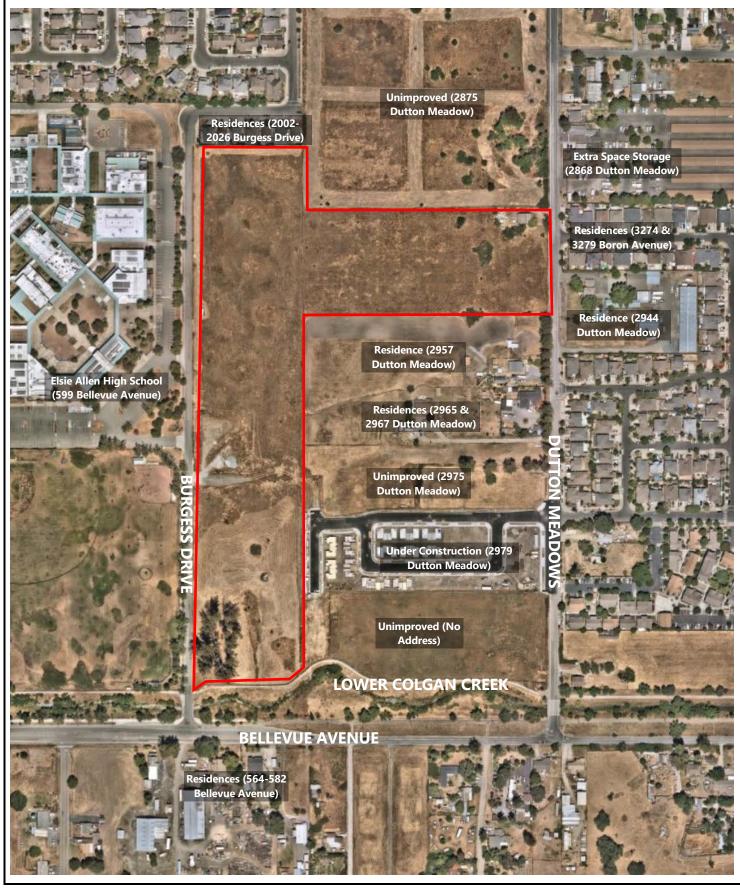
Drawing Not To Scale

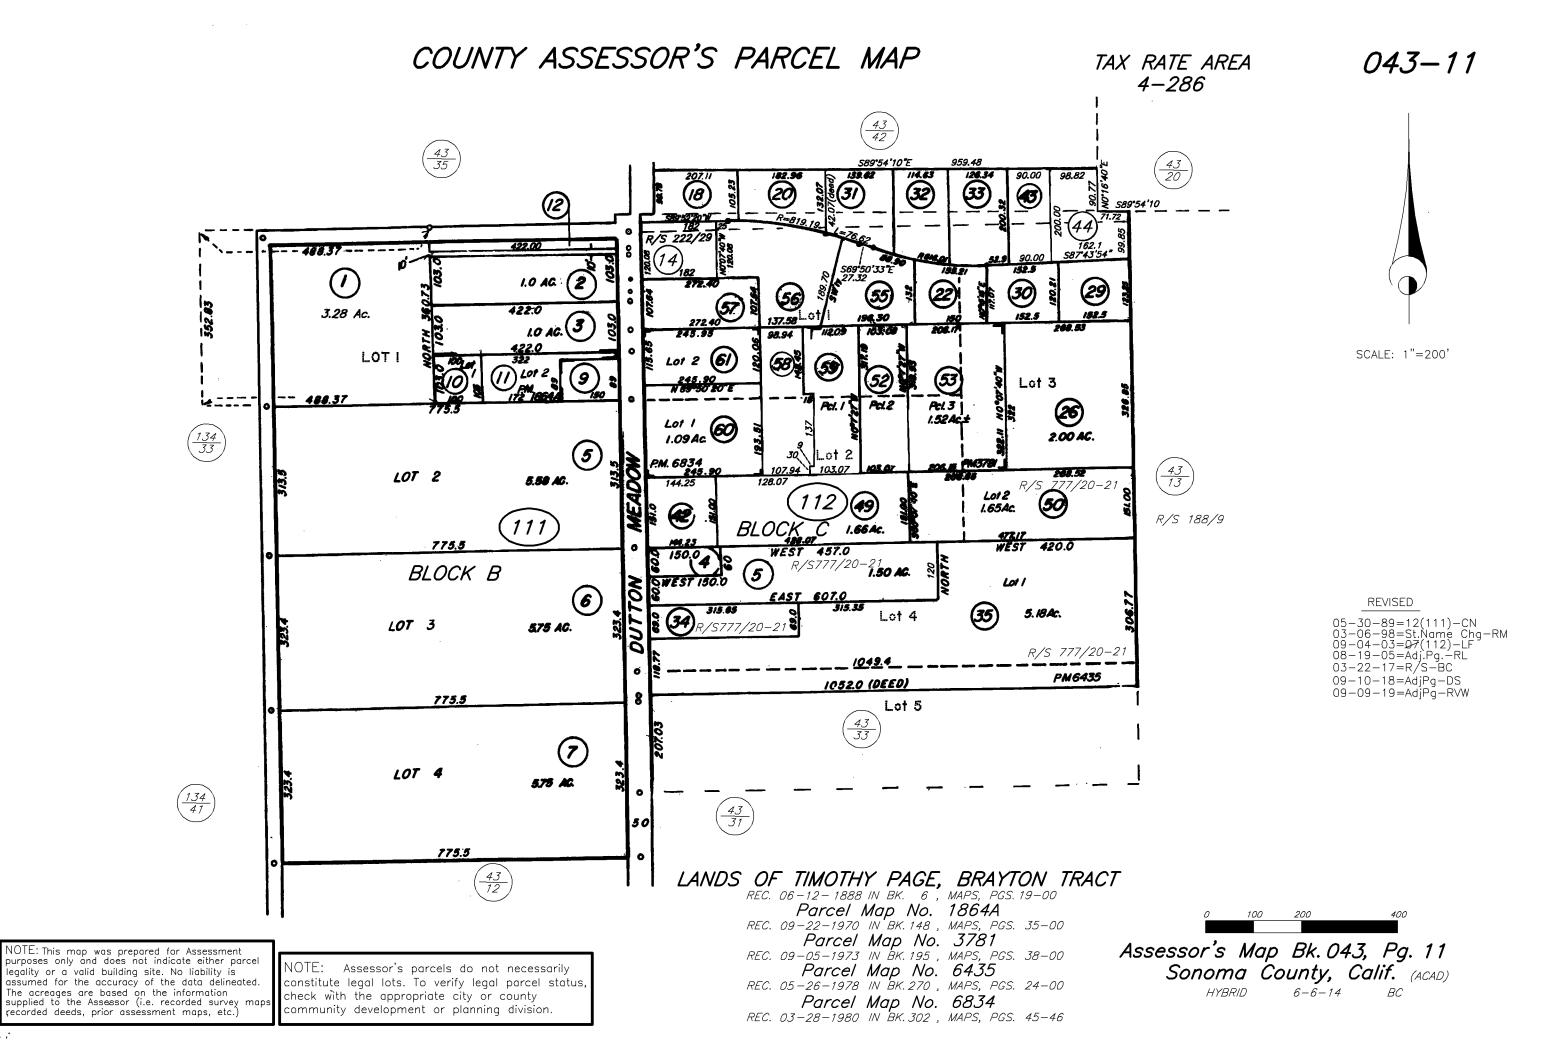
NOTE: Assessor's parcels do not necessarily constitute legal lots. To verify legal parcel status, check with the appropriate city or county community development or planning division.

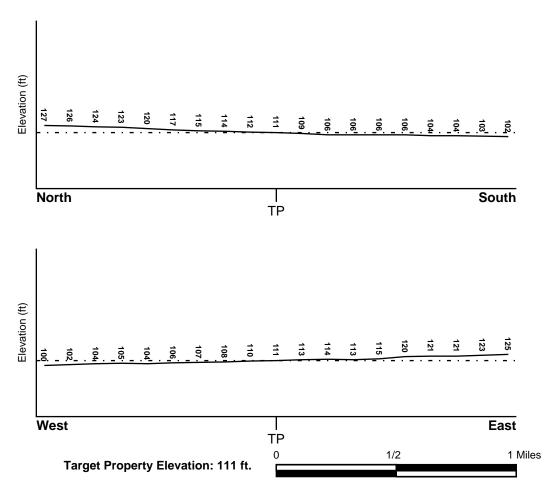
SURROUNDING TOPOGRAPHY: ELEVATION PROFILES

General Topographic Gradient: General SW

Source: Topography has been determined from the USGS 7.5' Digital Elevation Model and should be evaluated on a relative (not an absolute) basis. Relative elevation information between sites of close proximity should be field verified.
