APPENDIX A

Bellevue Ranch 7 - Sonoma-San Francisco County, Annual

REESE & ASSOCIATES CONSULTING GEOTECHNICAL ENGINEERS	Job No: <u>825.1.1</u>	<u>EXPANSION INDEX TEST RESULTS</u> BELLEVUE RANCH PHASE 7 RESIDENTIAL DEVELOPMENT SANTA ROSA, CALIFORNIA	PLATE
	Date: <u>11-13-15</u>		6
	Appr: <u>JDM</u>

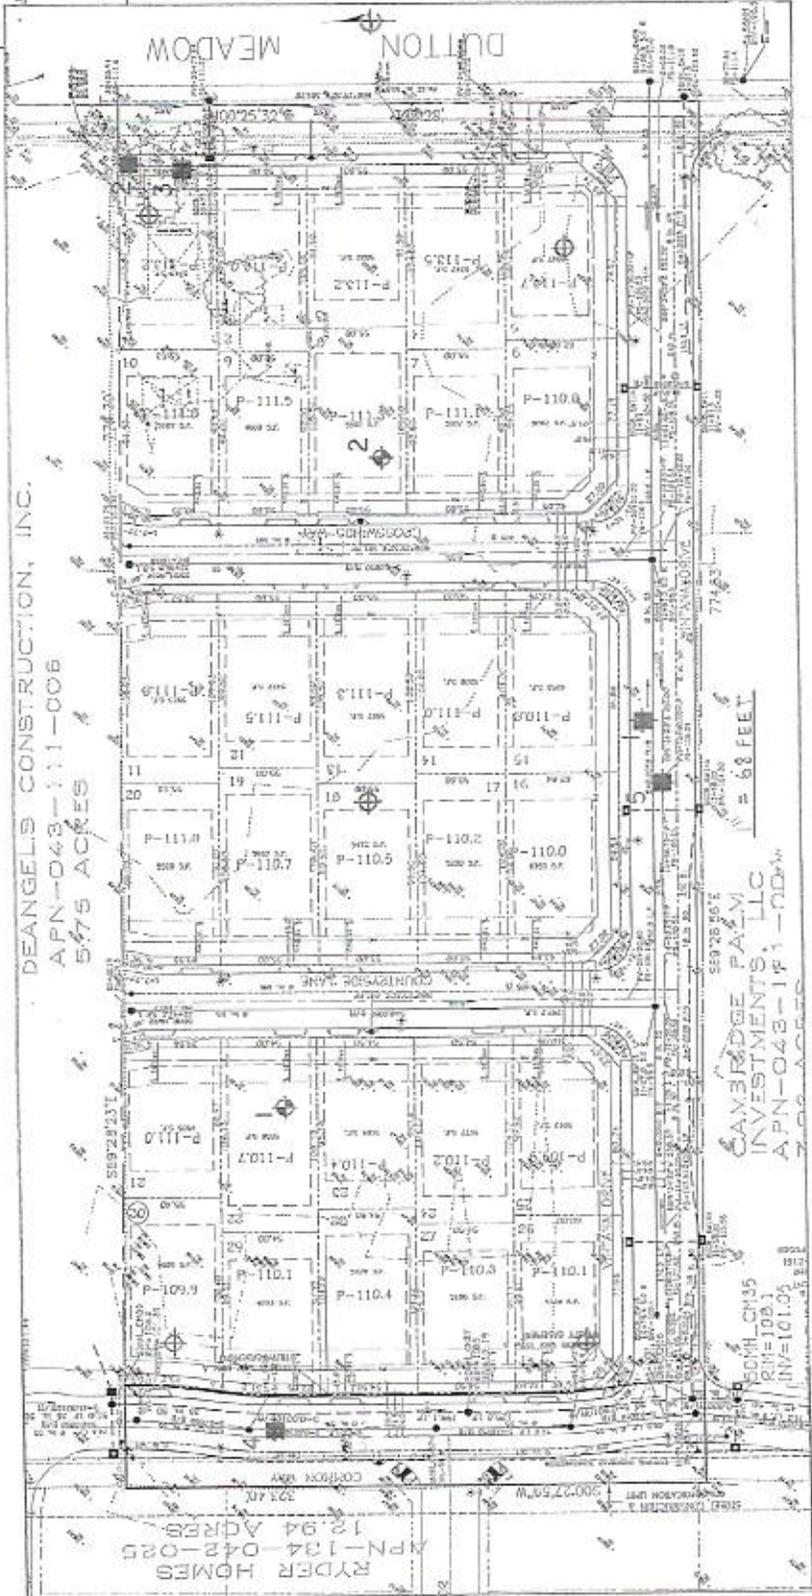
- ⊕ Approximate Test Boring Location
- ⊕ Approximate Bulk Sample Location
- ⊕ Approximate Boring Location From Previous Work

On September 8, 2015, we were at the site to observe conditions exposed and explore subsurface conditions to the extent of two test borings at the approximate locations indicated on Plate 1. The borings were drilled to depths of about 11 and 14 feet with track-mounted, auger equipment. Our geotechnical engineer located the borings, observed the drilling, logged the conditions encountered and obtained samples for visual classification and laboratory testing. Relatively undisturbed samples were obtained with a 2.5-inch (inside-diameter) split-spoon sampler driven with a 140-pound drop hammer. A Standard Penetration, split-spoon sampler was used at selected depths where granular materials were encountered. The stroke during driving was about 30 inches. The blows required to drive the samplers were recorded and converted to equivalent Standard Penetration blow counts for correlation with empirical data. Logs of the borings showing soil classifications, sample depths and converted blow counts are presented on Plates 2 and 3. The soils are classified in accordance with the Unified Soil Classification System explained on Plate 4.

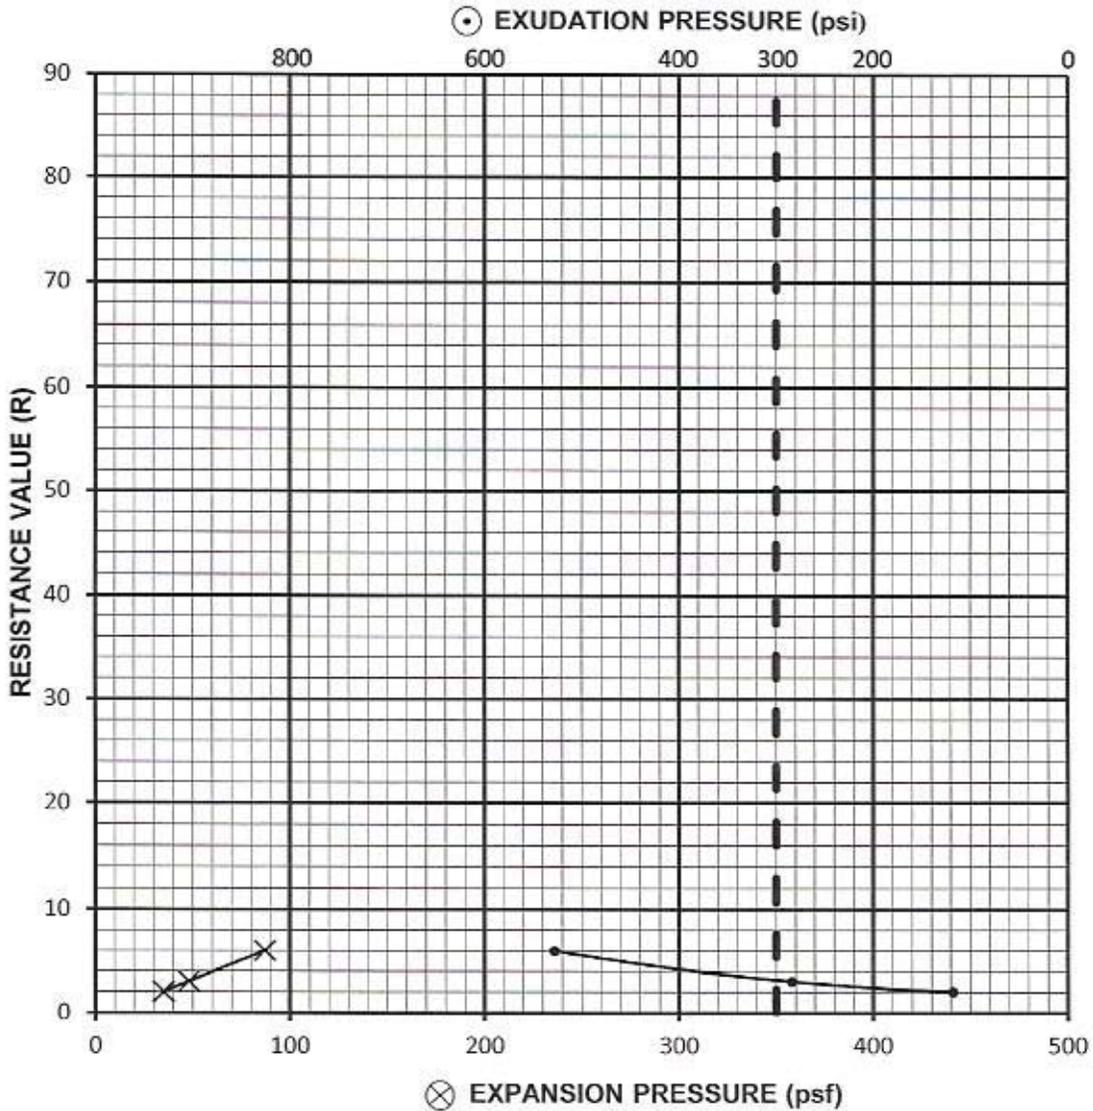
7

Specimen	A	B	C
Moisture Content (%)	28.0	32.3	35.8
Dry Density (pcf)	97	86	83
Exudation Pressure (psi)	528	284	118
Expansion Pressure (psf)	87	48	35
Resistance Value (R)	6	3	2

Sample Source	Classification	Expansion Pressure (psf)	R-Value
Bulk 1: On-site Subgrade	DARK BROWN SANDY CLAY (CH)	50	3

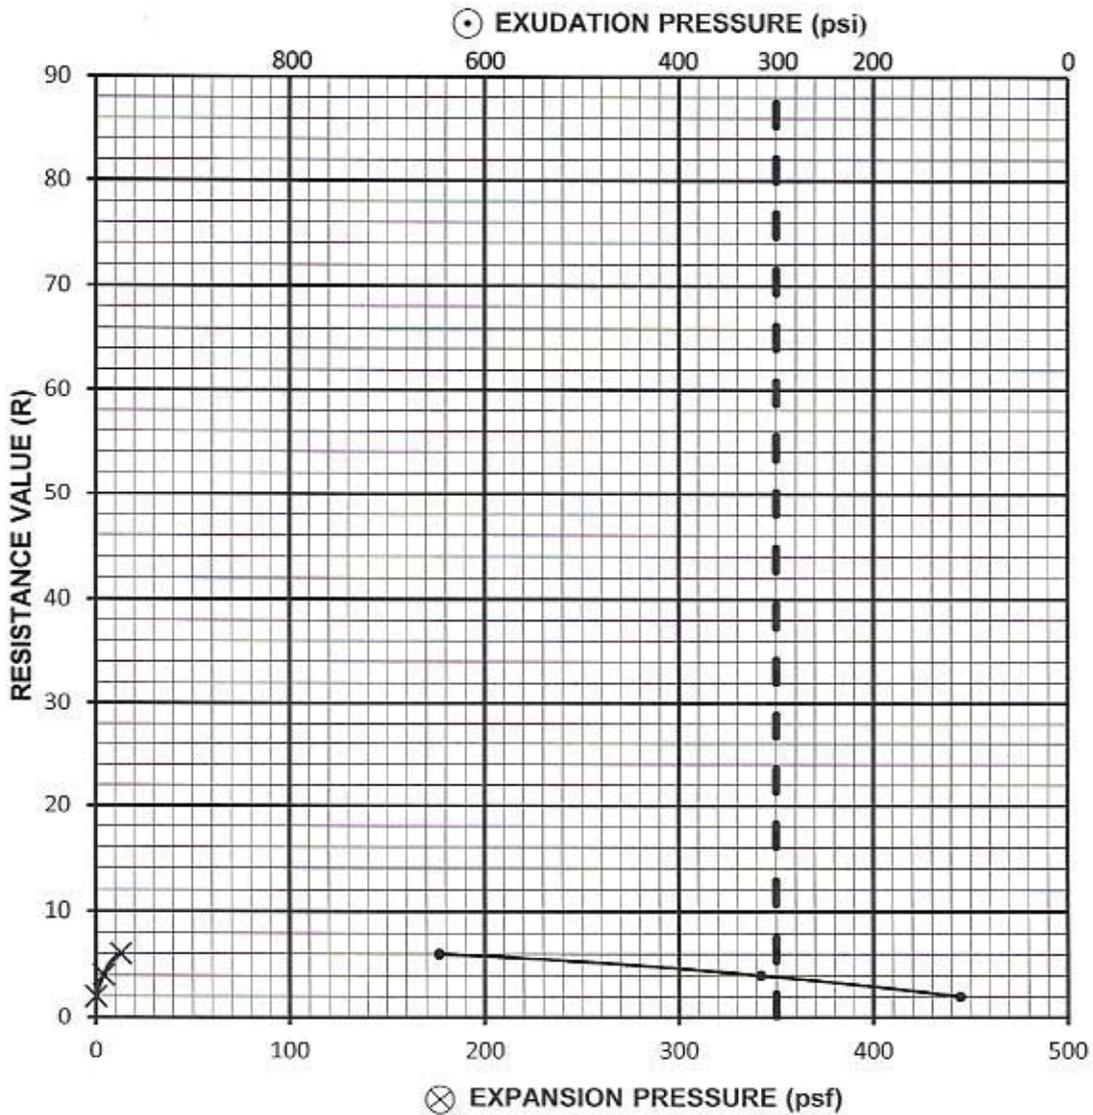
8

Specimen	A	B	C
Moisture Content (%)	26.0	32.5	36.7
Dry Density (pcf)	97	88	83
Exudation Pressure (psi)	647	316	111
Expansion Pressure (psf)	13	4	0
Resistance Value (R)	6	4	2

Sample Source	Classification	Expansion Pressure (psf)	R-Value
Bulk 2: On-site Subgrade	DARK BROWN SANDY CLAY (CH)	4	4

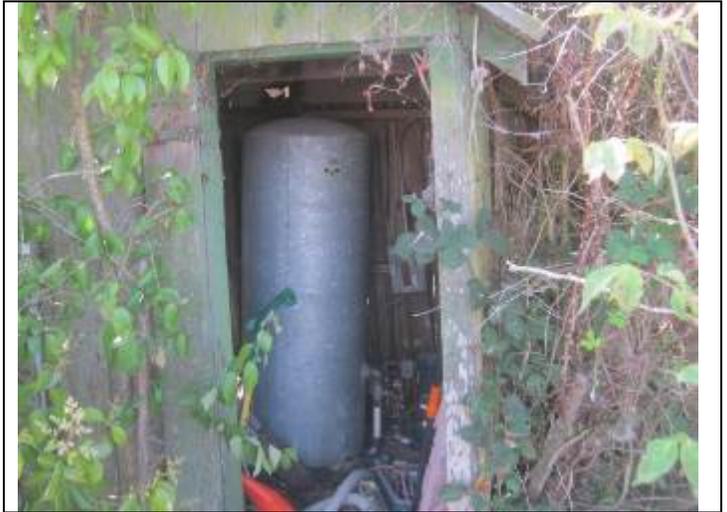
10. View of the well house

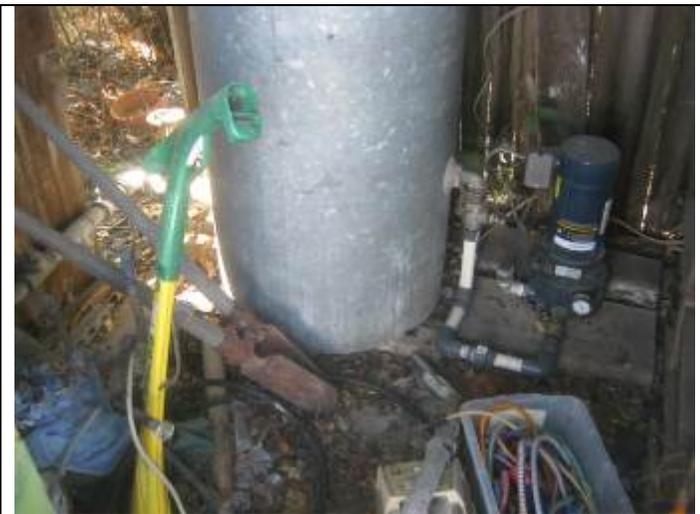
11. View of the domestic well

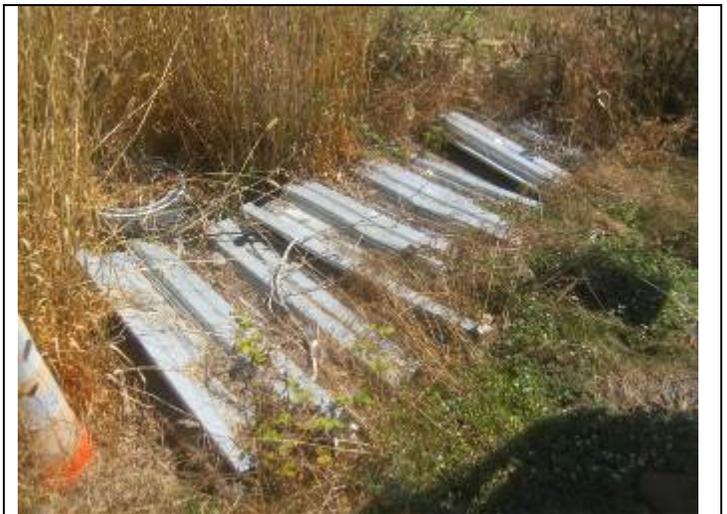
12. View of the septic tank location

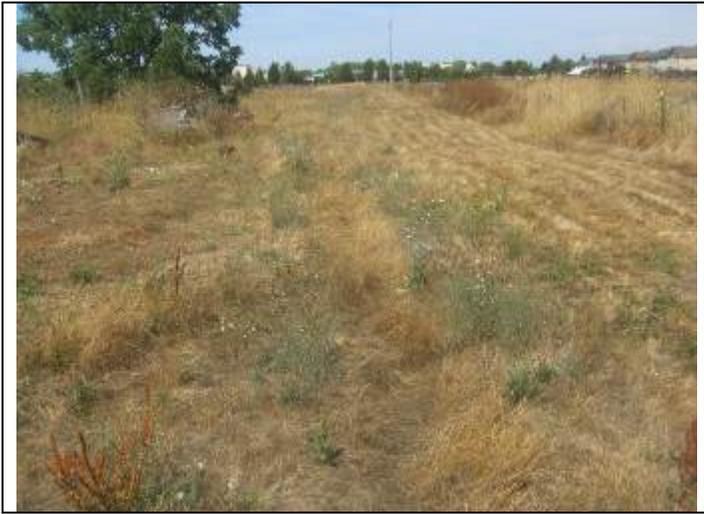
13. View of the west of the leachfield

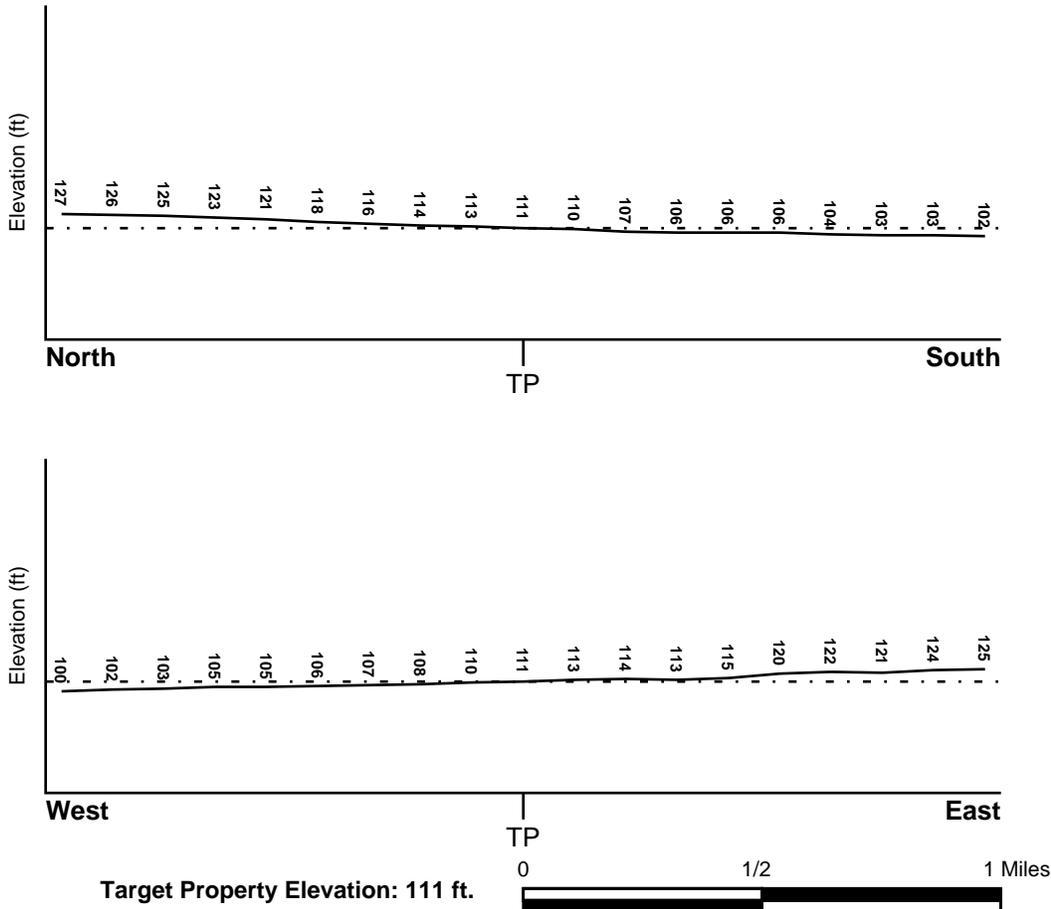
SURROUNDING TOPOGRAPHY: ELEVATION PROFILES

Source: Topography has been determined from the USGS 7.5' Digital Elevation Model and should be evaluated on a relative (not an absolute) basis. Relative elevation information between sites of close proximity should be field verified.
