City of Santa Rosa

BOARD OF COMMUNITY SERVICES REGULAR MEETING AGENDA AND SUMMARY REPORT AUGUST 24, 2022

8.1 MEASURE M - PARKS CONDITION ASSESSMENT AND PRIORITIZATION REPORT

EXECUTIVE SUMMARY

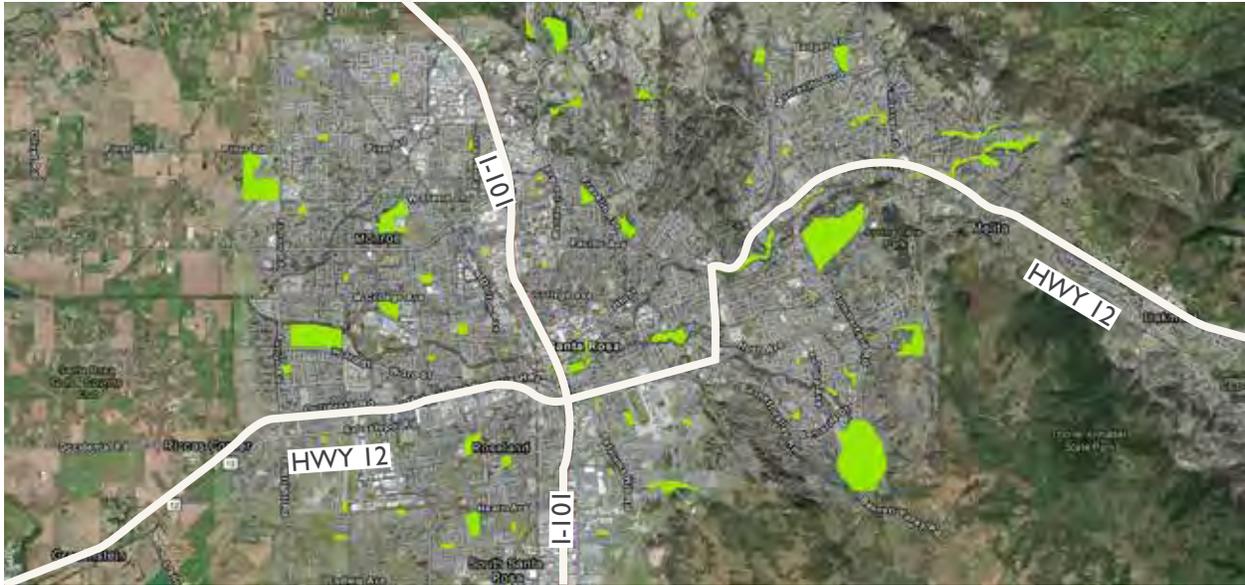
Figure 1: Citywide Parks Map

The City's park system is divided by Highways 101 and 12, creating four quadrants, and is made up of over 1,000 acres contained in over 100 park sites and over 70 acres of roadway landscapes. 85 of Santa Rosa's parks and 13 acres of roadway landscapes were assessed as a part of this report. Park sites are categorized into six park types, including neighborhood parks, community parks, special purpose parks, open spaces, public gathering areas and plazas, and trail parks. A number of city parks were not included as part of this report due to being under development. The selection of roadway landscapes that were evaluated represent a sample of the roadway landscape conditions found throughout the City to provide a general understanding of the overall condition of roadway landscapes maintained by the Recreation and Parks department.

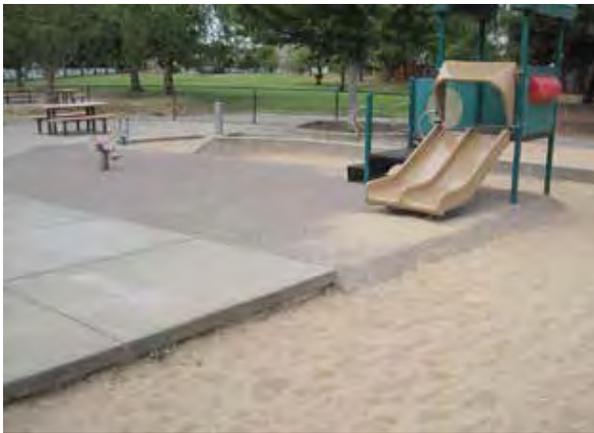
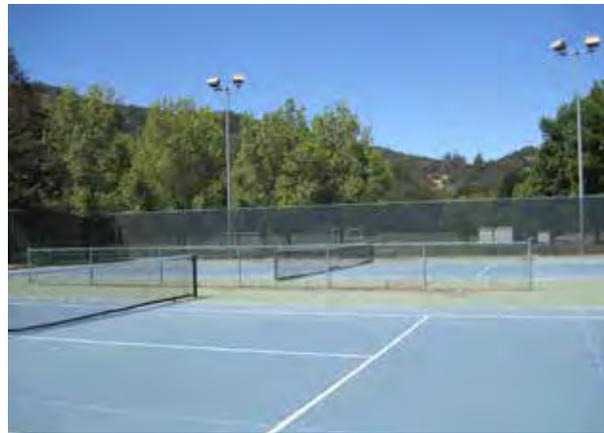
Figure 3: Example Amenities vs Assets

Amenity = Playground
 Assets = Equipment
 Curb
 Surfacing
 Furnishings
 Barriers
 Signs

Amenity = Tennis Courts
 Assets = Lighting
 Equipment
 Surfacing
 Furnishings
 Barriers
 Signs

Prior to site investigations, an asset and amenity list was developed as well as an established rating criteria for each type of asset, see Figures 9 and 10. Amenities are defined as attributes of a park that have a designated use, such as sports fields, playgrounds, and dog parks. Assets are defined as specific components that make up a park amenity. For an amenity such as a playground, the assets would be identified as the play equipment, play surfacing, perimeter fencing, and so forth, see Figure 3 for examples.

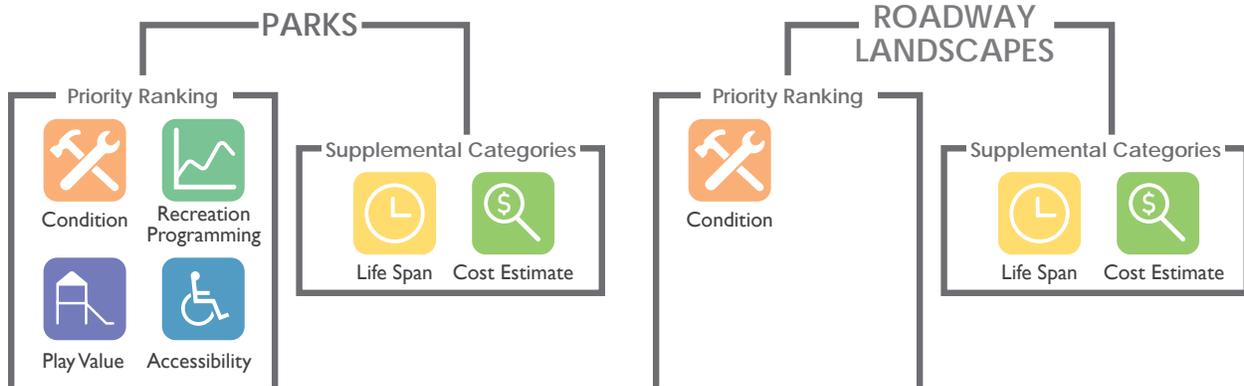
Figure 5: Park and Roadway Categories

Rankings for roadway landscapes are exclusively based on the condition ranking due to the fact that rankings within the three other categories do not vary when applied to roadway settings. Figure 5 represents the ranking system for each priority ranking category and how they impact the overall park rank. The supplemental categories provide additional information for each park amenity that do not impact the overall park ranking, this includes a cost estimate for the replacement of each amenity and the estimated life span remaining for each amenity.

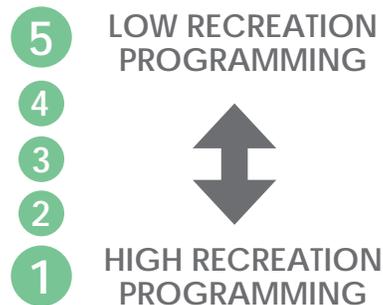
Figure 8: Recreation Programming Scale

RECREATION PROGRAMMING RANKING	REVENUE GENERATION AMOUNT
1	OVER \$50K
2	\$10K TO \$50K
3	\$5K TO \$10K
4	\$1 TO \$5K
5	\$0

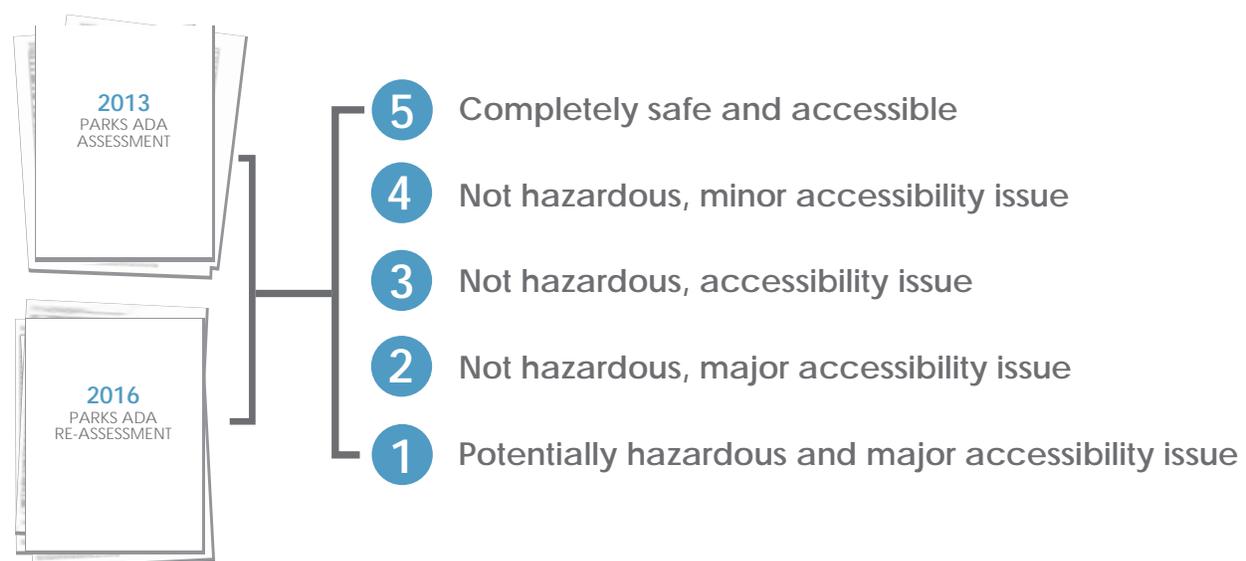
Figure 12: ADA Ranking Scale

ADA items were ranked based off of how hazardous an item is and how much the item impedes someone’s ability

to access park amenities, see Figure 13 for examples. Deficiencies that are more hazardous to users would result in a lower rank, implying the priority for replacement of this amenity is greater.

Amenities receiving a lower rank on this scale will be elevated in priority for replacement. ADA items pertaining to restrooms, interior of buildings, or face of buildings were not evaluated as part of this Report.

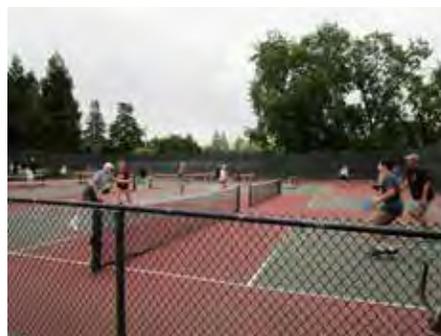
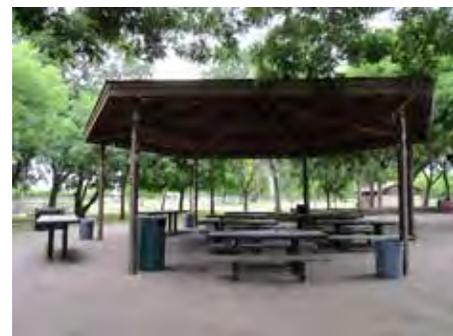
The overall condition of the park is adequate, and a majority of the amenities are fully functional. Finley Community Park has a high level of recreation programming, high play value, and has a few significantly non-compliant ADA features.

The critical condition amenities within the park are the playground and volleyball court. The playground rubber surfacing is deteriorating and peeling back in some areas and the playground equipment is showing significant wear. At the volleyball court, the net is missing and the sand surfacing has significant weed growth.

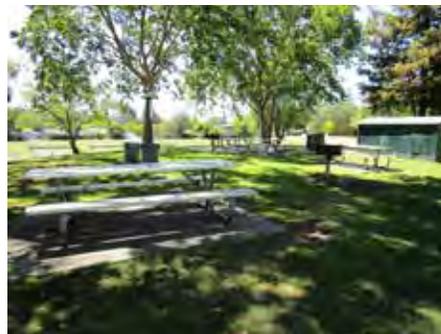
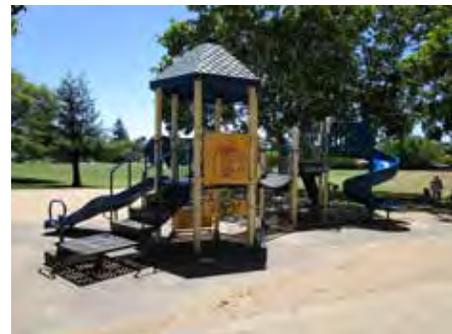
The overall condition of the park is adequate, and a majority of the amenities are fully functional. Franklin Community Park has a moderate level of recreation programming, very high play value, and has a few significantly non-compliant ADA features.

There are no critical condition amenities within the park, though the presence of temporary trash receptacles indicates a demand for more permanent receptacles.

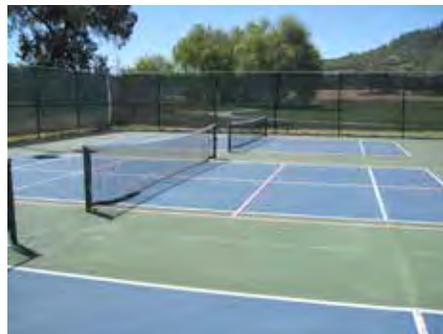
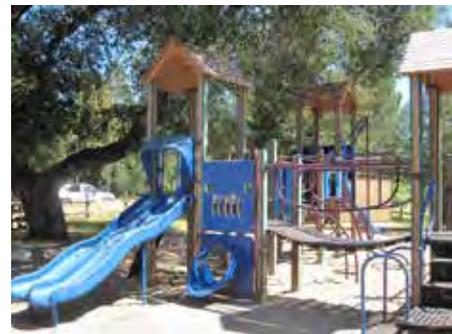
The overall condition of the park is good, with a majority of the amenities in good condition. Galvin Park has a very high level of recreation programming, very high play value, and has a few significantly non-compliant ADA features.

The critical condition amenities within the park are the tennis courts and structures. Tennis courts #9 and #10 have cracking throughout the court surfacing. The storage shed near tennis court #1 has been vandalized.

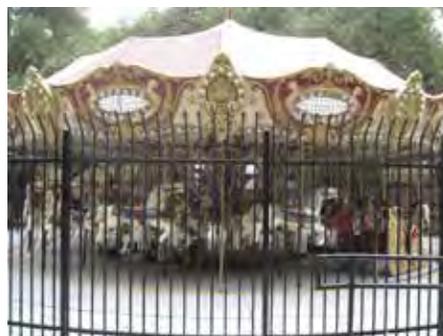
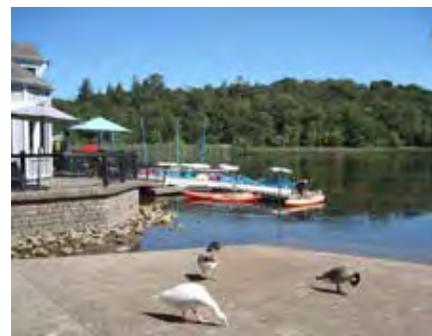
The overall condition of the park is adequate, and a majority of the amenities are fully functional. Howarth Park has a very high level of recreation programming, very high play value, and has a number of significantly non-compliant ADA elements.

The critical condition amenities within the park are the playgrounds and tennis courts. The sand play areas have low levels of sand and portions of the tennis court surfacing have substantial cracking, making those areas unplayable.

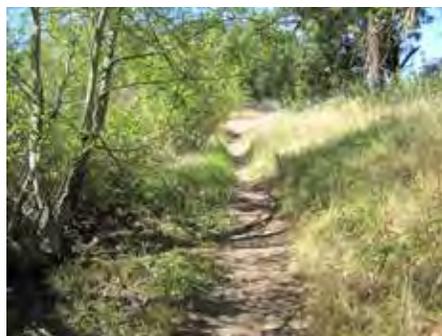
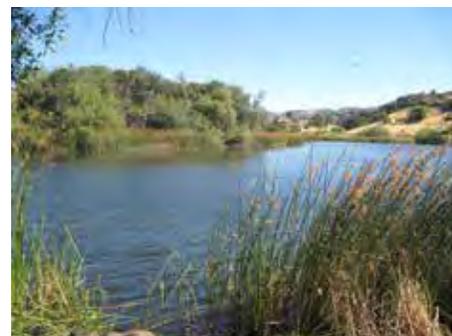
The overall condition of the park is adequate, and a majority of the amenities are fully functional. Nagasawa Community Park does not have recreation programming, has moderate play value, and has a few significantly non-compliant ADA features.

The critical condition amenity within the park is the irrigation system, which was damaged by the 2017 wildfire.

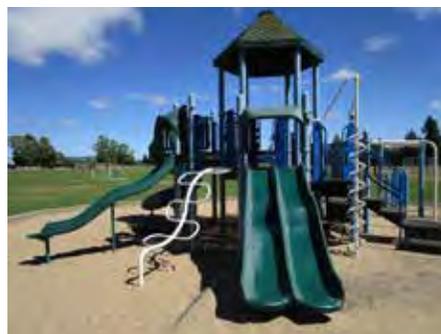
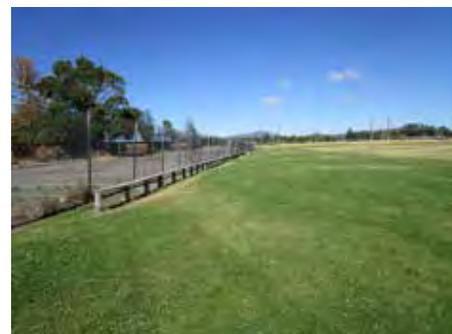
The overall condition of the park is adequate, and a majority of the amenities are fully functional. Northwest Community Park has a very high level of recreation programming, very high play value, and a number of significantly non-compliant ADA features.

The critical condition amenities within the park are the landscape, hardscape, and rugby field. The landscape has a substantial amount of weeds, the hardscape has deterioration in the asphalt pavement, and the rugby field has issues with irrigation coverage and furnishings that are worn.

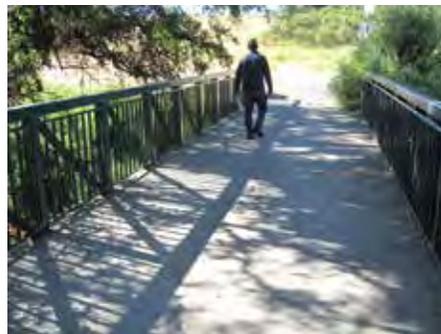
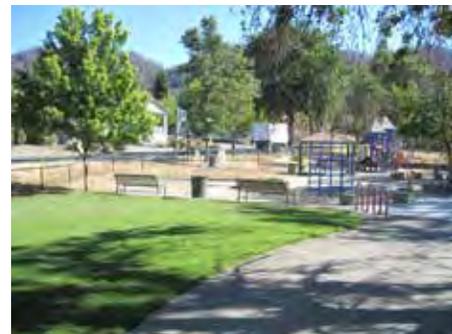
The overall condition of the park is good and a majority of the amenities are in good condition. Skyhawk Community Park does not have recreation programming, has very high play value, and has a few significantly non-compliant ADA features.

The critical condition amenity is the park's trail, which has significant cracking in the asphalt, moderate weed growth, and damaged fencing.

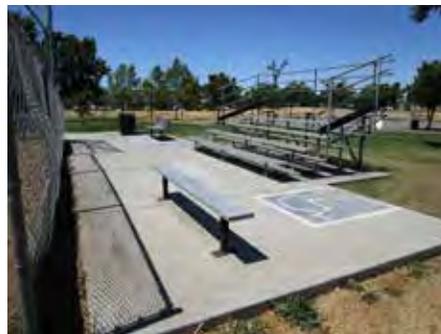
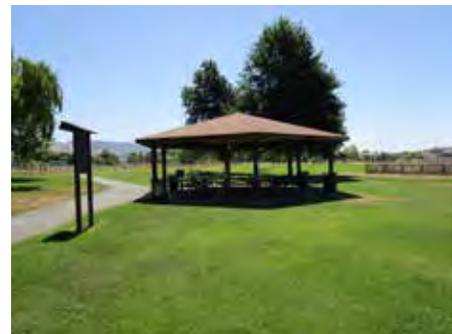
The overall condition of the park is below adequate, with a majority of the amenities fully functional, while a few others are in critical condition. Southwest Park has a moderate level of recreation programming, very high play value, and has several significantly non-compliant ADA elements.

The critical condition amenities within the park are the general hardscape and the gravel parking lot. The asphalt has major cracking, while the parking lot has uneven surfacing and substantial pot holes.

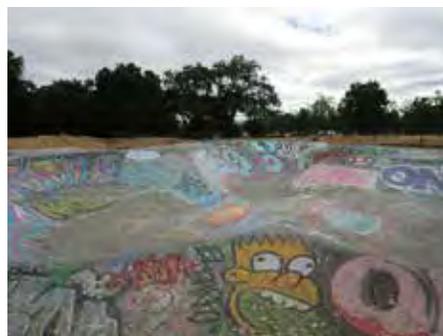
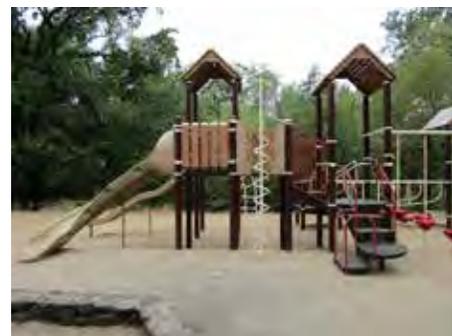
The overall condition of the park is adequate, with a majority of the amenities fully functional, while a few others are in critical condition. Youth Community Park has a very high level of recreation programming, very high play value, and has a number of significantly non-compliant ADA elements.

The critical condition amenity within the park is the trail, which has uneven surfacing throughout.

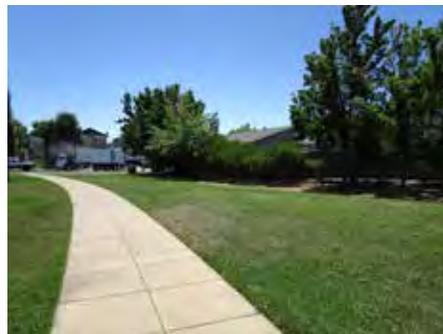
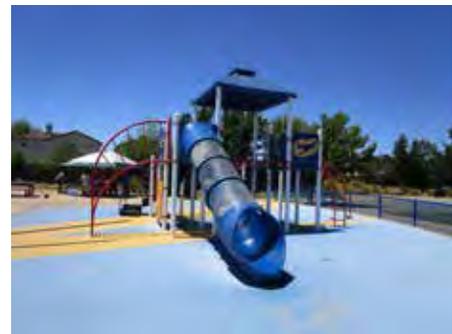
There are no critical condition amenities within the park. However, the playground has missing signage and the trees around the picnic areas have died or been removed.

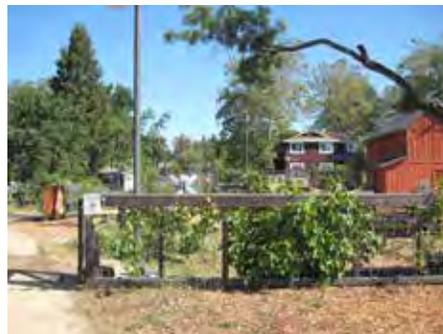
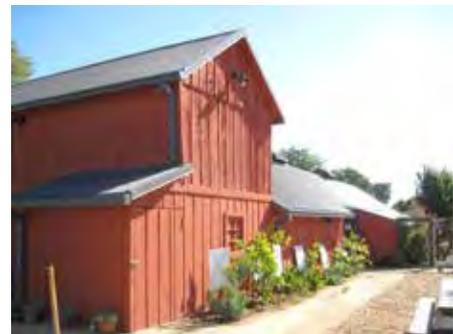
There are no critical condition amenities within the park. However, the playground mulch will soon need replenishing and the volleyball court does not have a net.

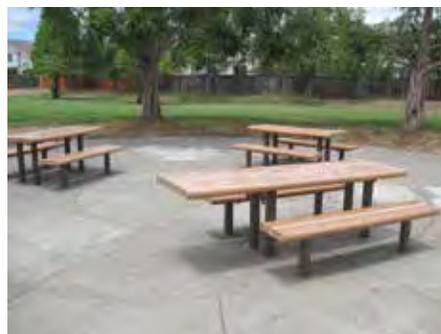
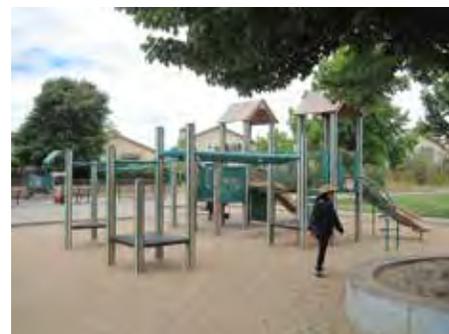
The critical condition amenities within the park are the ornamental landscape areas, which have large gaps in vegetation, significant weeds and no mulch, and furnishings where there is a deficient quantity of trash receptacles.

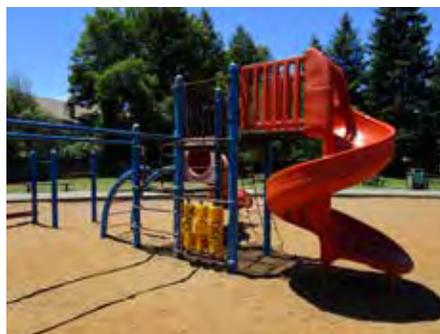
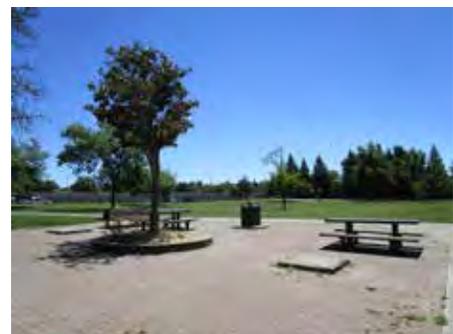
The critical condition amenities within the park are the playground and horseshoe pit. The playground equipment is missing components and the wood fiber surfacing requires replenishing. The horseshoe pit has damaged equipment and excessive wear in the sand and paver surfacing.

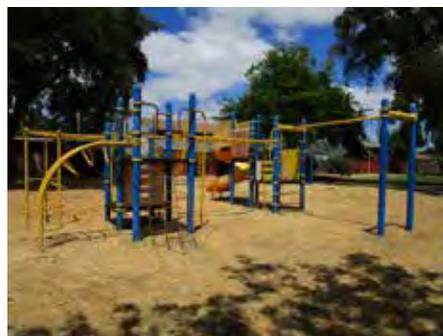
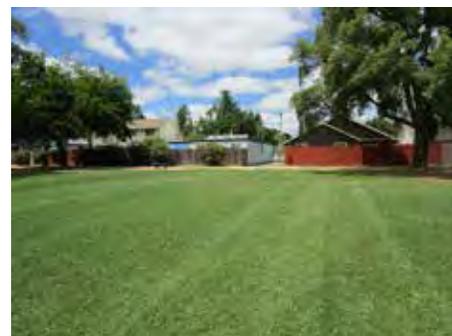
The critical condition amenities within the park are the playground, volleyball court and hardscape. The playground has sand surfacing that is weedy and heavily compacted and play equipment that is showing excessive wear. The volleyball court net is missing and therefore unplayable. Asphalt and concrete pavement throughout the site have severe cracking, and there is a deficient quantity of trash receptacles.

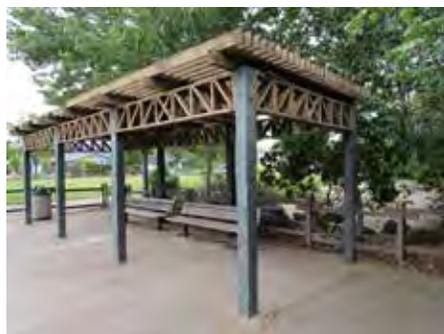
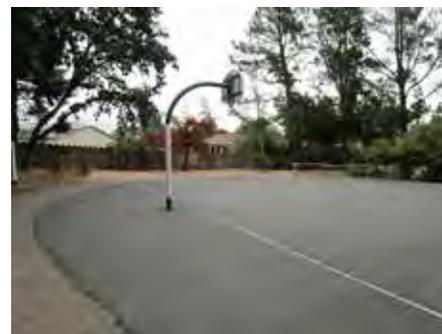
The critical condition amenities within the park are the picnic areas, which have uneven surfacing within the concrete pavement and pavers.

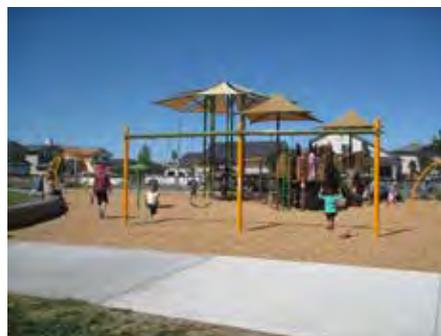
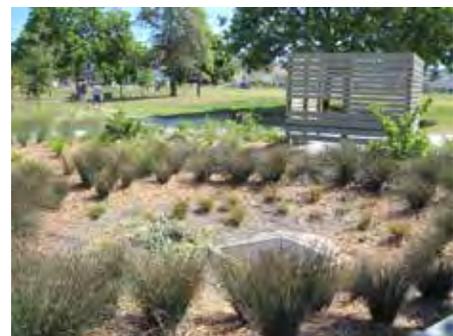
There are no critical condition amenities within the park, though portions of dried turf imply there is deficient coverage by the irrigation system.

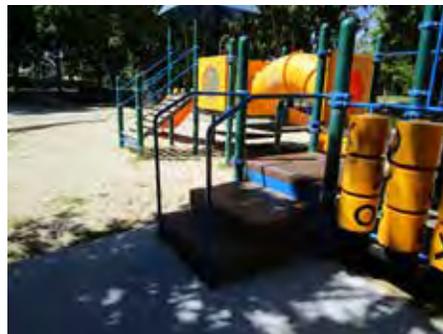
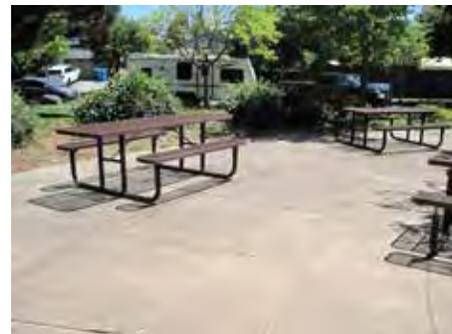
The critical condition amenities within the park are the playground and trails. The playground equipment shows signs of excessive wear and broken components with weeds growing in the sand surfacing. The trails have major cracking throughout the asphalt pavement.

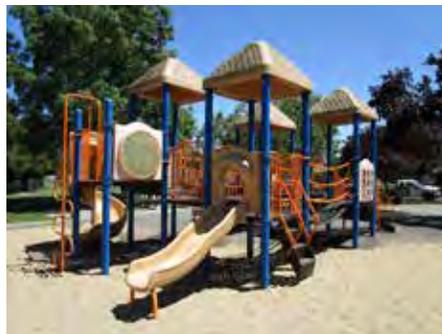
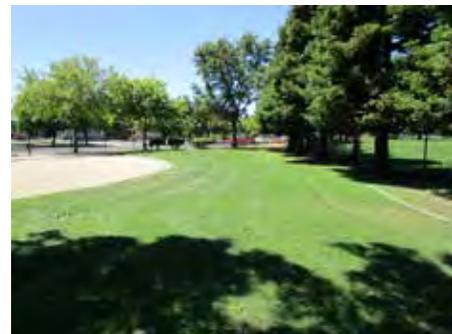
The critical condition amenities within the park are the signage, which is illegible due to wear, and a deficient quantity of trash receptacles.

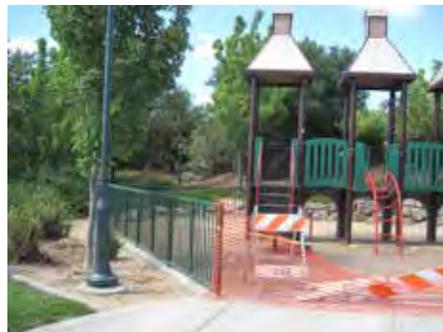
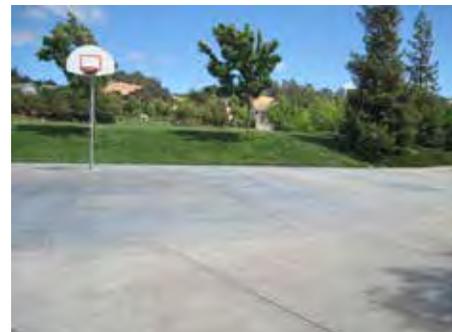
There are no critical condition amenities at the park, though the basketball court lacks court striping.

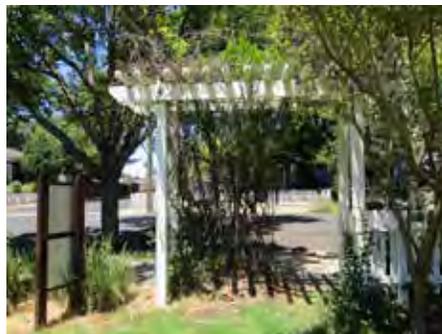
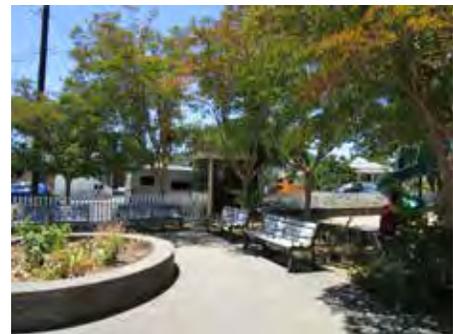
There are no critical condition amenities within the park, though there appears to be a deficient quantity of trash receptacles.

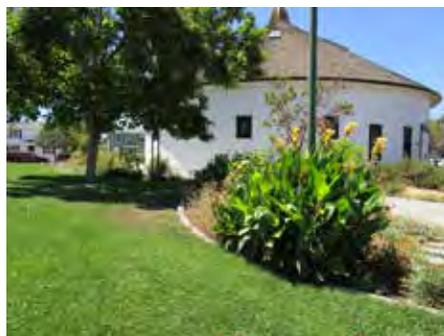
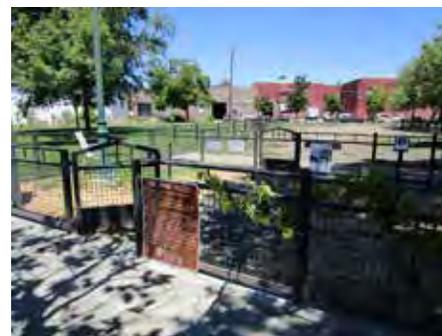
The critical condition amenities within the park are the signage, which is illegible due to wear, and a deficient quantity of trash receptacles.

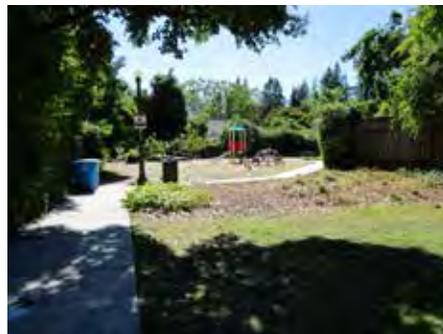
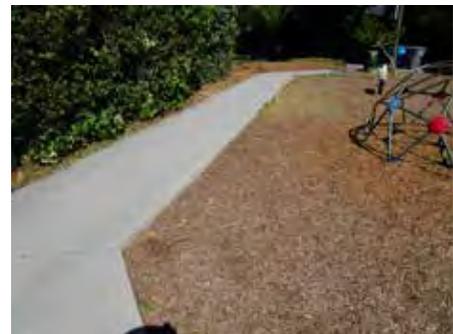
The critical condition amenities within the park are the signage, which is illegible due to wear, and a deficient quantity of trash receptacles.

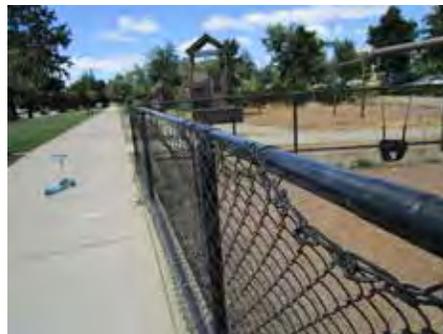
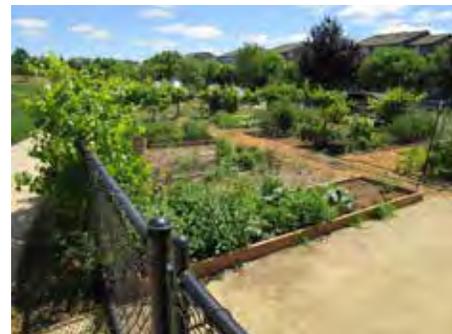
There are no critical conditions amenities at this park. However, the wood fiber at the playgrounds will soon require replenishing and the ornamental planting areas have weeds and require additional mulch.

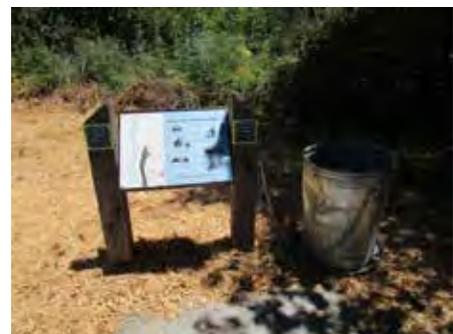
The critical condition amenities within the park include deficient trash receptacles, dense weeds in the natural landscapes, missing bollards, deficient signage and significant cracking in the asphalt pavement.

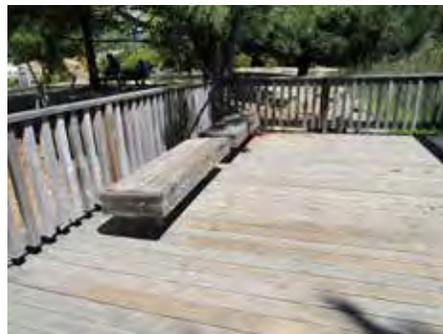
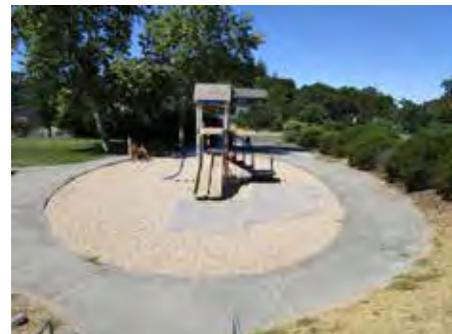
The overall condition of the park is good, with a majority of the amenities in good condition. Frances Nielsen Ranch Park does not have recreation programming, has very high play value, and has a few significantly non-compliant ADA features.

There are no critical condition amenities within the park, though the required signage at the playground is deficient.

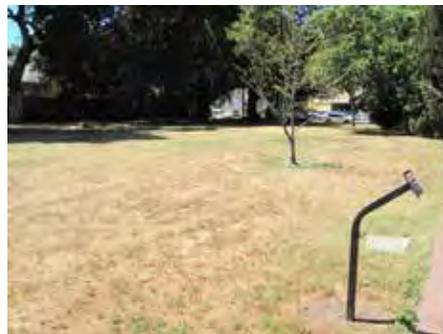
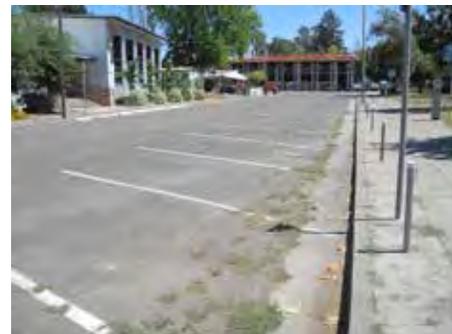
The overall condition of the park is below adequate, with a few of the amenities broken and not functioning. Fremont Park does not have recreation programming, has low play value, and has a few significantly non-compliant ADA features.

The critical condition amenities within the park are the turf areas, which are experiencing significant dieback, the irrigation system, which does not appear to be operating, and the water feature, which is not functioning.

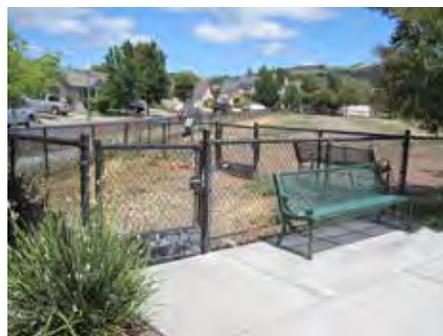
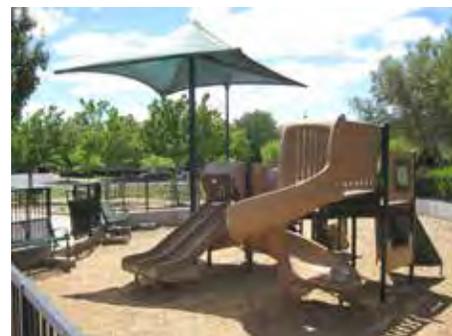
The overall condition of the park is adequate, and a majority of the amenities are fully functional. Harvest Park does not have recreation programming, has very high play value, and has a few significantly non-compliant ADA features.

The critical condition amenity within the park is the dog park, which has substantial weeds and holes in the mulch surfacing, broken components within the gate, and a deficient quantity of trash receptacles. The playgrounds also have a deficient level of wood fiber surfacing.

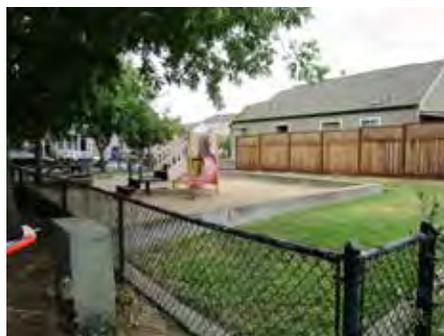
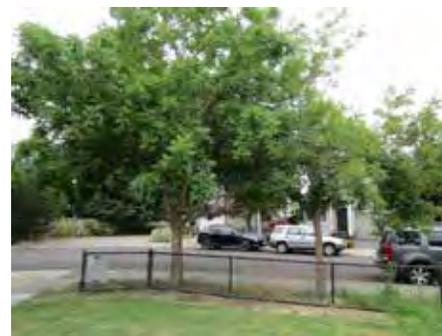
The overall condition of the park is good, and a majority of the amenities are fully functional. Haydn Park does not have recreation programming, has low play value, and has a few non-compliant ADA features.

The critical condition amenity within the park is the playground equipment, which is showing excessive wear due to its age.

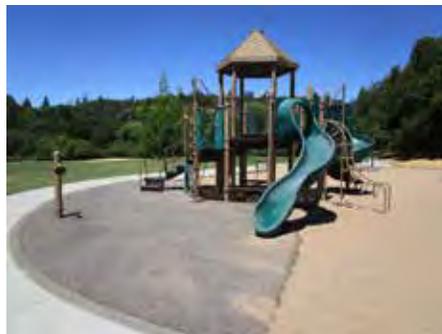
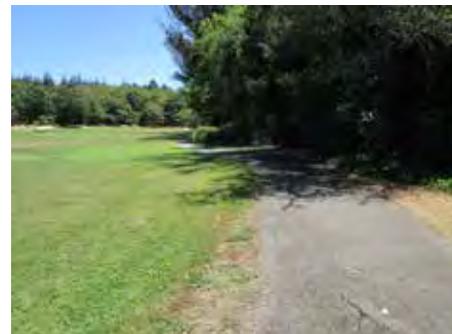
The overall condition of the park is adequate, and a majority of the amenities are fully functional. Hidden Valley Park does not have recreation programming, has very high play value, and has a few significantly non-compliant ADA features.

There are no critical condition amenities within the park, though the gravel paths on the trails have uneven surfacing, noxious weeds were found within the natural landscape, and trash receptacles appear to be deficient.

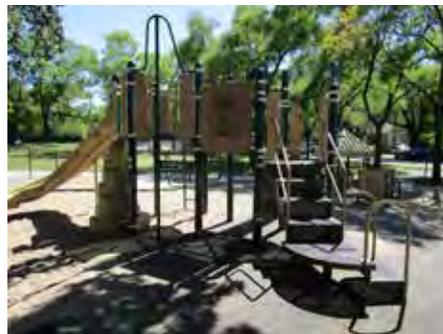
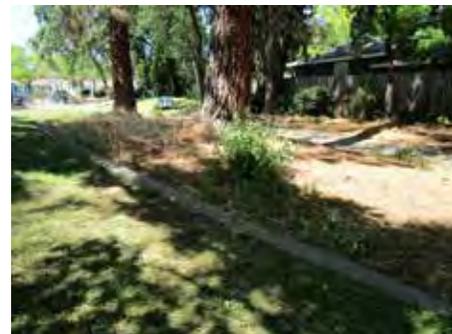
The overall condition of the park is adequate, and a majority of the amenities are fully functional. Humboldt Park does not have recreation programming, has very high play value, and has a few significantly non-compliant ADA features.

There are no critical condition amenities within the park, though the presence of temporary trash receptacles indicates a deficient number of permanent receptacles in the park.

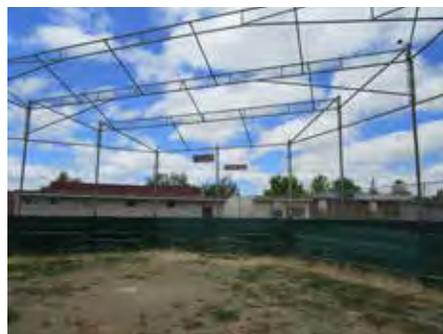
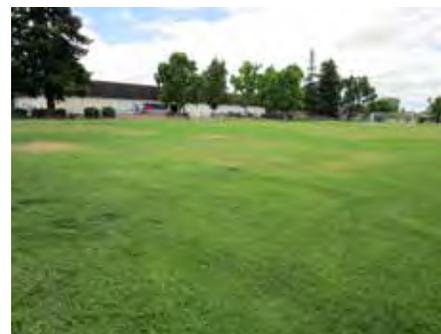
The overall condition of the park is adequate, and a majority of the amenities are fully functional. Jennings Park has minimal recreation programming, very high play value, and does not have non-compliant features identified by the 2013 and 2016 ADA assessments.

The critical condition amenity within the park is the irrigation system, where extensive dieback is observable within the natural turf. Temporary trash receptacles are present, which suggests a deficient number of permanent receptacles in the park.

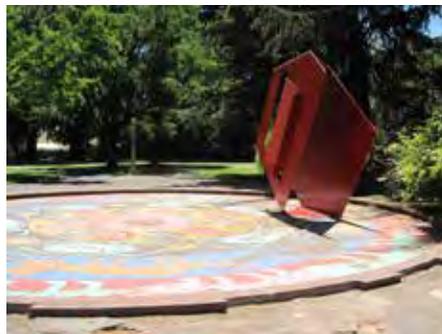
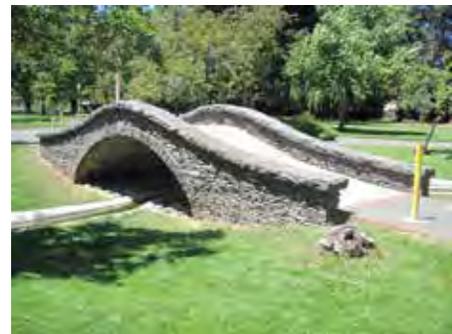
The overall condition of the park is adequate, and a majority of the amenities are fully functional. Juilliard Park has a high level of recreation programming, very high play value, and has a few significantly non-compliant ADA features.

The park does not have critical condition amenities, though the stone pavers are cracked and damaged, and the stone veneer around the flag pole has minor damage.

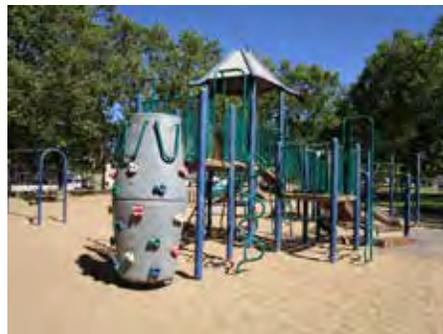
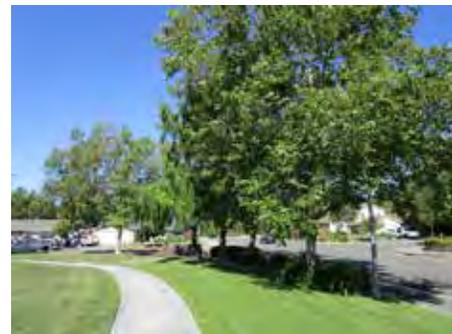
The overall condition of the park is below adequate, with a few of the amenities broken and not functioning. Live Oak Park has minimal recreation programming, very high play value, and has a few significantly non-compliant ADA features.

The critical condition amenity within the park is the playground, which has a damaged equipment component and is unsafe to use.

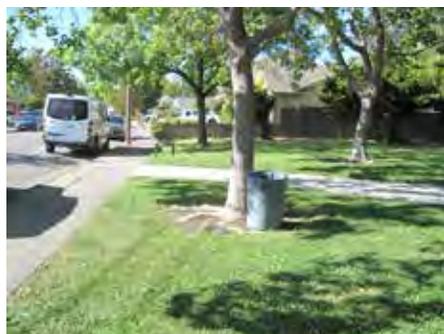
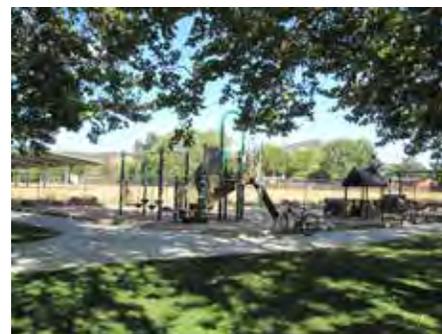
The overall condition of the park is good, and a majority of the amenities are in good condition. Matanzas Park does not have recreation programming, has very high play value, and has a few significantly non-compliant ADA features.

The critical condition amenities within the park are the site furnishings. The presence of temporary trash receptacles suggest a deficient number of permanent receptacles in the park.

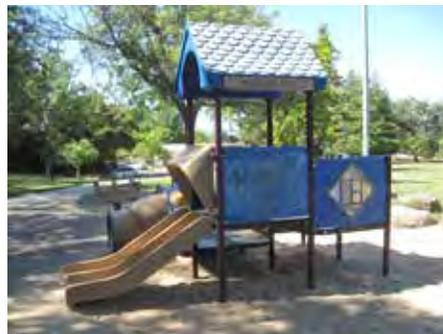
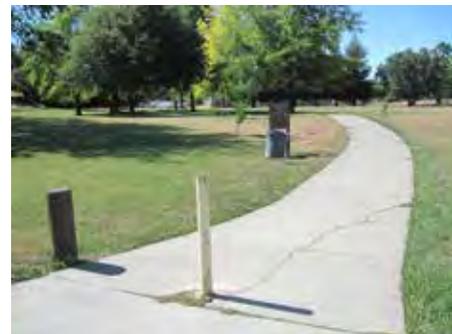
The overall condition of the park is adequate, and a majority of the amenities are fully functional. Mesquite Park does not have recreation programming, has very high play value, and has a few significantly non-compliant ADA features.

There are no amenities in critical condition at the park. However, the rubber surfacing at the playground is experiencing wear, and the irrigation for the natural turf has coverage issues.

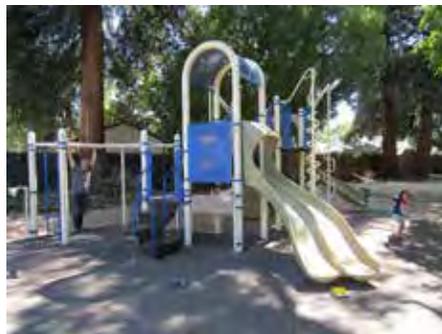
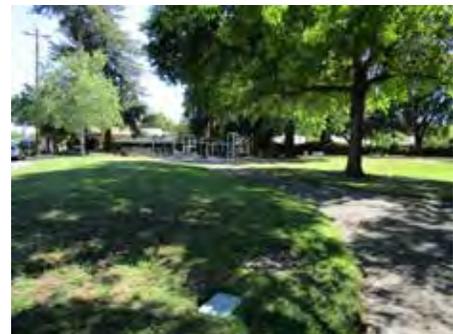
The overall condition of the park is adequate, and a majority of the amenities are fully functional. North Park does not have recreation programming, has very high play value, and has a few significantly non-compliant ADA features.

The critical condition amenity within the park is the hardscape, which has significant cracking and uneven surfaces.

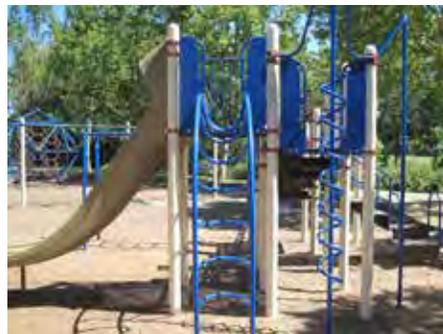
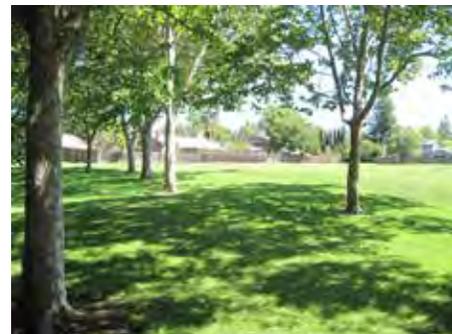
The overall condition of the park is adequate, and a majority of the amenities are fully functional. Oaklake Green Park does not have recreation programming, has very high play value, and has a few significantly non-compliant ADA features.

The critical condition amenities within the park are the furnishings due to graffiti and deficiency. A number of light poles have been damaged. The playground is below adequate due to insufficient mulch surfacing, damaged play area curb, and drainage issues.

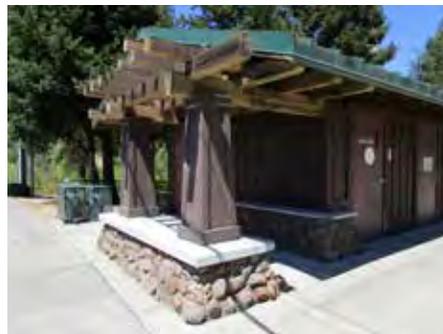
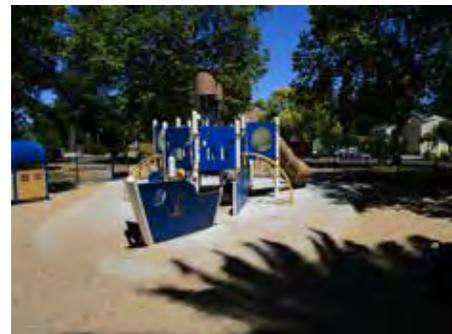
The overall condition of the park is adequate, and a majority of the amenities are fully functional. Olive Park does not have recreation programming, has very high play value, and has a few significantly non-compliant ADA features.

The critical condition amenities within the park are the site furnishings, due to non-operational drinking fountains and a deficient quantity of trash receptacles.

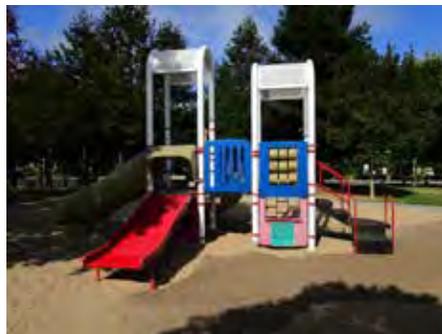
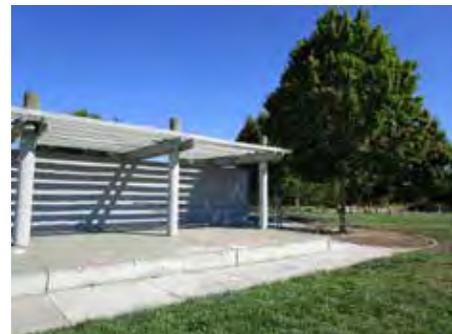
The overall condition of the park is adequate, and a majority of the amenities are fully functional. Pearblossom Park does not have recreation programming, has very high play value, and has a number of significantly non-compliant ADA features.

The park does not have critical condition amenities, though there are portions of the ornamental landscape that are dead or missing and the spray irrigation for the natural turf has coverage issues.

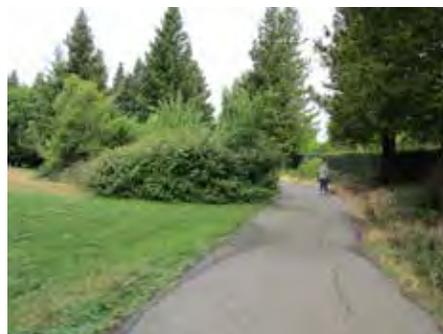
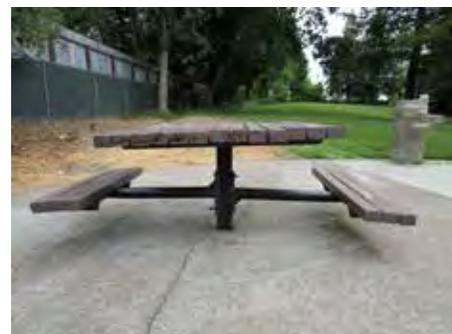
The critical condition amenities within the park are the barriers, playground, picnic area, and fitness equipment. The barriers have missing bollards, the playground has low levels of mulch surfacing, the fitness equipment has excessive wear, and the picnic areas have damaged furnishings.

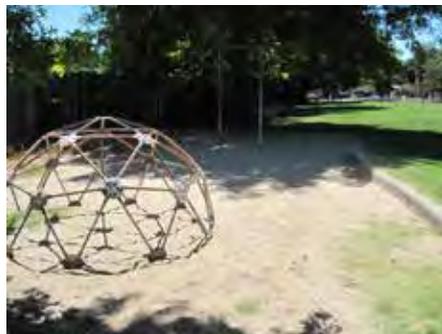
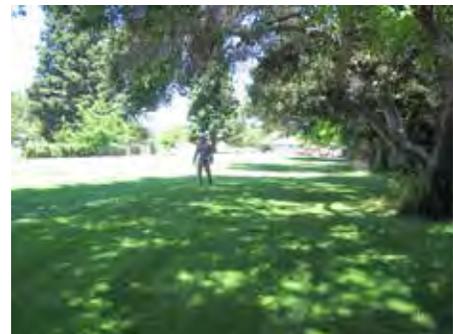
The critical condition amenity within the park is the playground, due to the play equipment missing a swing and experiencing excessive wear and the sand surfacing level being low and having weeds.

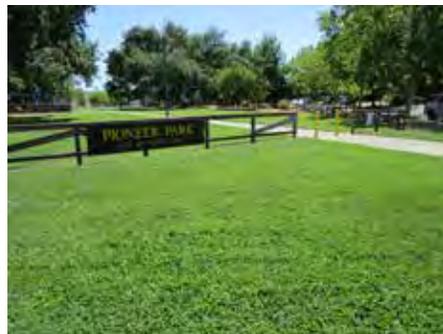
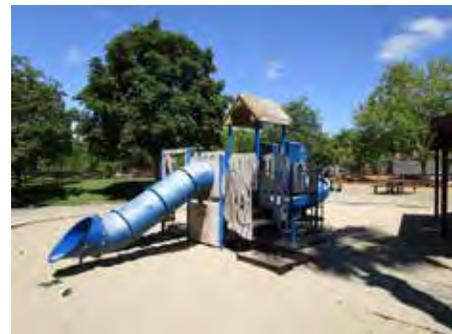
The critical condition amenity within the park is the horseshoe pit, which has deteriorating lumber, aged surfacing, and pavement uplifting due to tree roots.

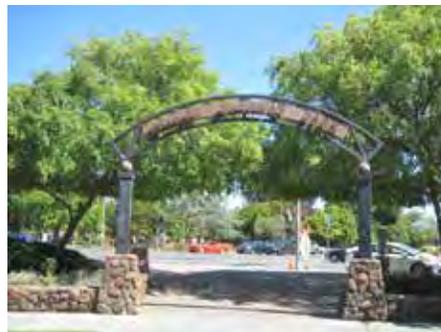
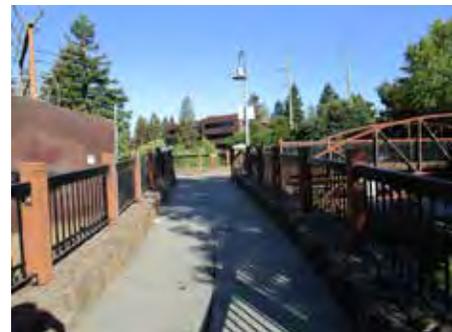
The park does not have critical condition amenities, though the sprayground's UV light was identified as outdated.

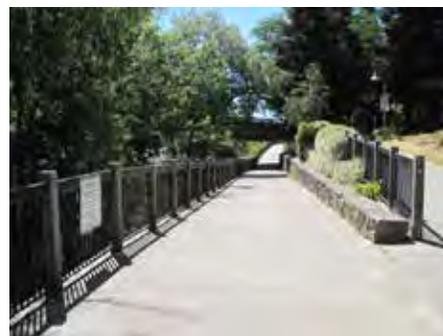
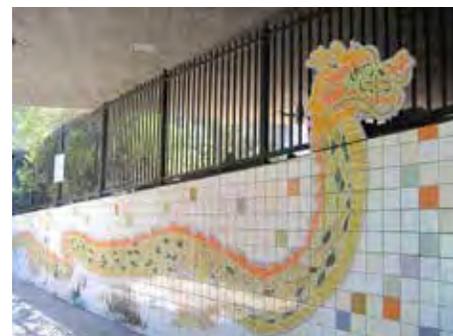
The critical condition amenity within the park is the irrigation system, which was indicated to be non-operational due to the lack of mainline and backflow installation.

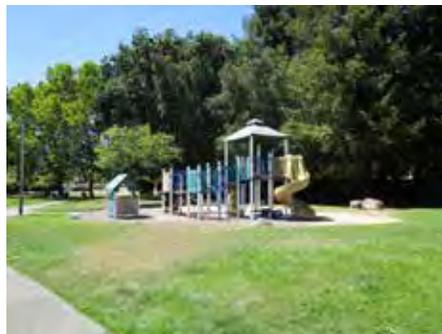
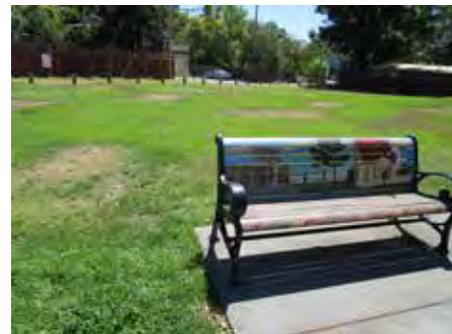
There are no critical condition amenities within the park, though the irrigation system is identified by maintenance staff as below adequate.

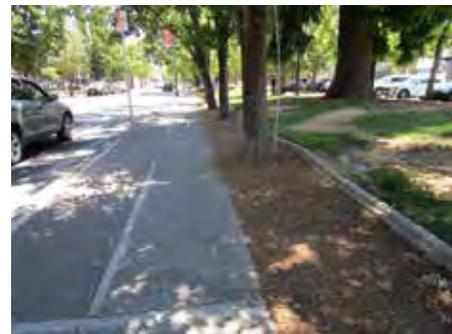
There are no critical condition amenities within the park, though the park rules sign is in a poor location. The monument sign is frequently vandalized.

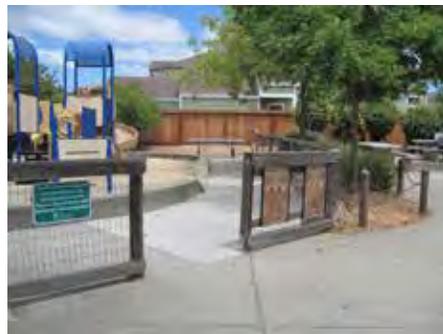
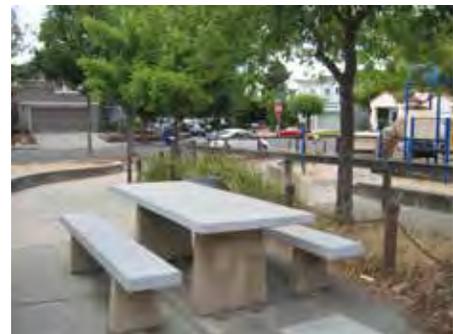
There are no critical condition amenities within the park though the presence of temporary trash receptacles suggests a deficient number of permanent receptacles in the park.

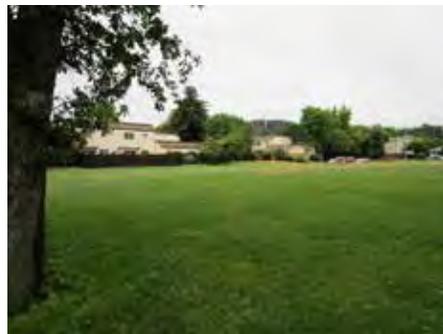
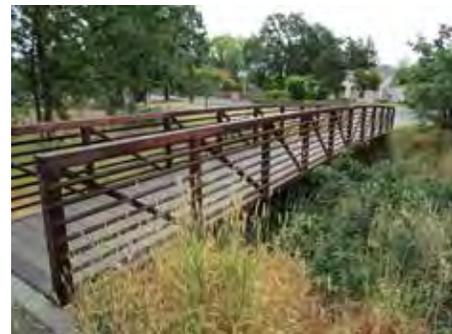
RINCONADA PARK

The overall condition of the park is below adequate, with a few amenities broken and not functioning. Rinconada Park does not have recreation programming, has moderate play value, and has a few significantly non-compliant ADA features.

The critical condition amenities within the park are the general hardscape, trail surfacing, and site furnishings. The hardscape has cracking and lifting and there is a deficient number of benches and trash receptacles.

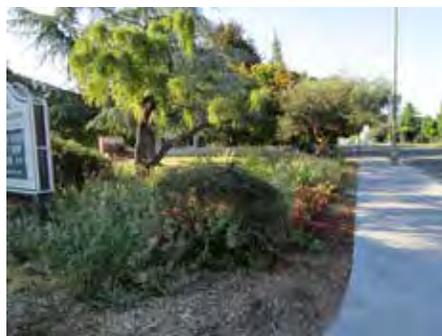
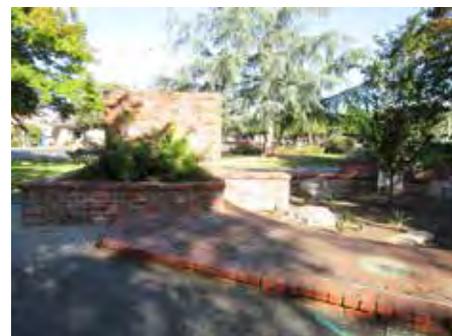
SONOMA AVENUE PARK

The overall condition of the park is adequate, with some amenities being functional and others being deficient. Sonoma Avenue Park does not have recreation programming, has low play value, and has a number of significantly non-compliant ADA elements.

The critical condition amenities within the park are the irrigation system and the water feature. The irrigation system uses battery powered nodes and has coverage issues, while the water feature is functioning but the water and basin are polluted.

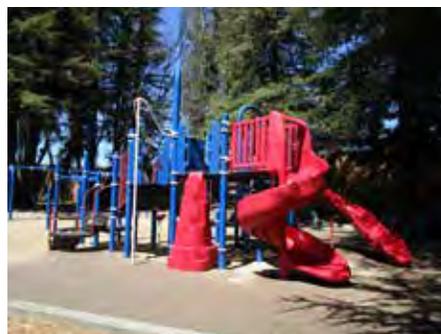
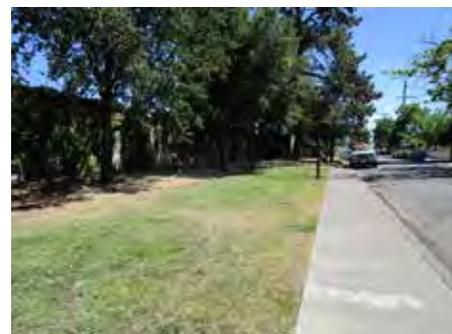
SOUTH DAVIS PARK

The overall condition of the park is below adequate, with a number of the amenities nearing critical condition. South Davis Park has minimal recreation programming, very high play value, and a number of significantly non-compliant ADA elements.

The critical condition amenity is the basketball court due to the uneven and cracking asphalt surfacing and the heavily-weathered equipment.
