City of Santa Rosa

BOARD OF COMMUNITY SERVICES REGULAR MEETING AGENDA AND SUMMARY REPORT AUGUST 24, 2022

8.1 MEASURE M - PARKS CONDITION ASSESSMENT AND PRIORITIZATION REPORT

EXECUTIVE SUMMARY

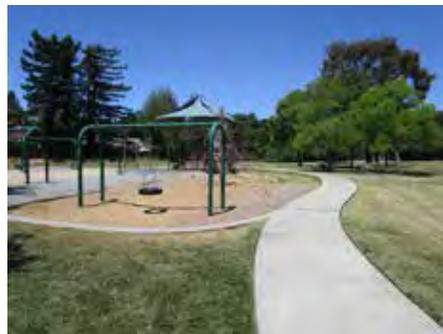
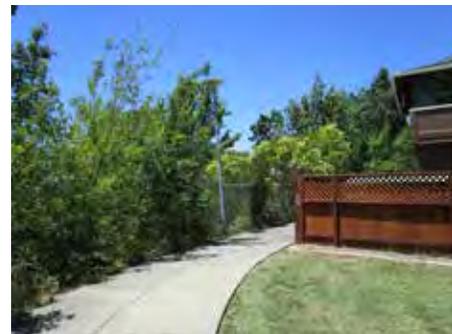
STEELE LANE PARK

The overall condition of the park is adequate, and a majority of the amenities are fully functional. Steele Lane Park does not have recreation programming, has very high play value, and generally complies with ADA standards with the exception of having a few non-compliant items.

There are no critical condition amenities within the park, but the general irrigation and general landscape are in below adequate condition. The irrigation overspray causes weed growth within the play area, and there are substantial weeds in the landscape areas.

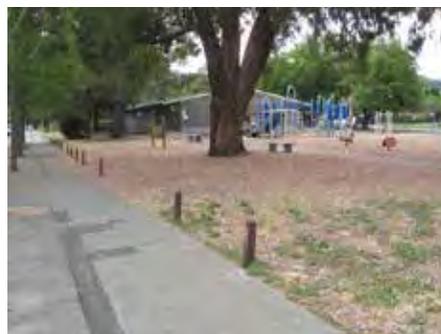
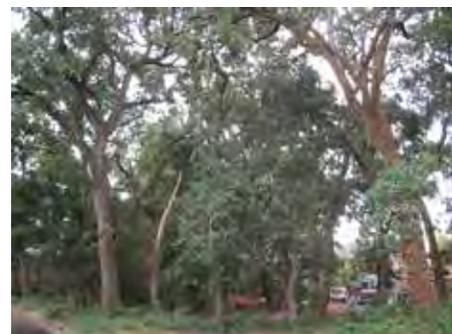
STRAWBERRY PARK

The overall condition of the park is good, and a majority of the amenities are in good condition. Strawberry Park does not have recreation programming, has moderate play value, and does not have non-compliant features identified by the 2013 and 2016 ADA assessments.

There are no critical condition amenities within the park, but the general hardscape is in below adequate condition due to cracking in both the concrete and asphalt pavement.

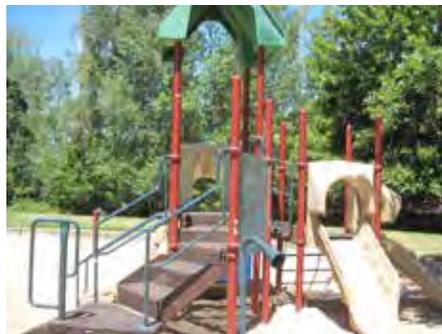
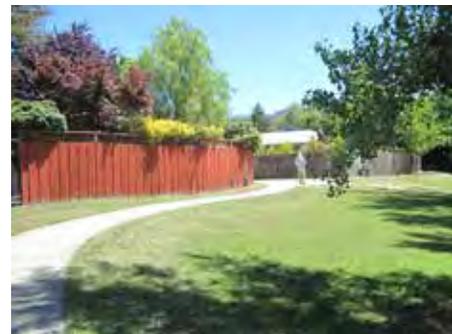
TANGLEWOOD PARK

The overall condition of the park is adequate, with a majority of the amenities being functional and a few being in need of servicing. Tanglewood Park does not have recreation programming, has very high play value, and has a few significantly non-compliant ADA elements.

The critical condition amenity within the park is the basketball court, which has major cracking, uneven pavement, faded striping, and severe weed growth within the surfacing.

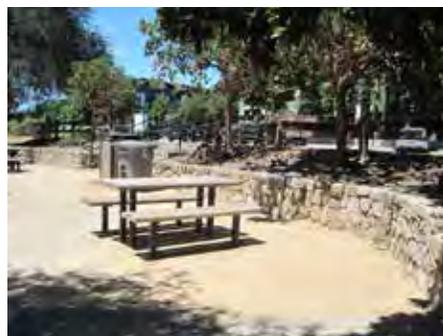
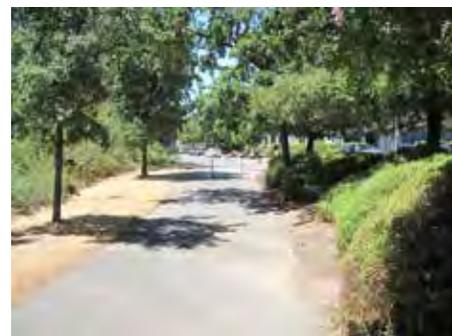
TRAILHEAD PARK

The overall condition of the park is good, and a majority of the amenities are in good condition. Trailhead Park does not have recreation programming, has moderate play value, and does not have non-compliant features identified by the 2013 and 2016 ADA assessments.

There are no amenities in critical condition at the park. However, the landscape areas require mulch replenishing.

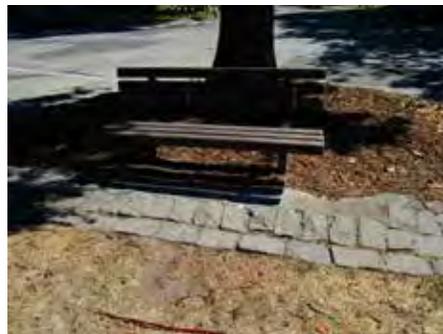
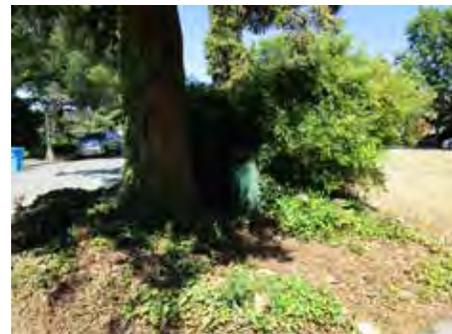
The overall condition of the park is good, and a majority of the amenities are in good condition. Triangle Park does not have recreation programming, has low play value, and does not have non-compliant features identified by the 2013 and 2016 ADA assessments.

There are no critical condition amenities within the park, but the natural turf is dead, potentially due to drought measures.

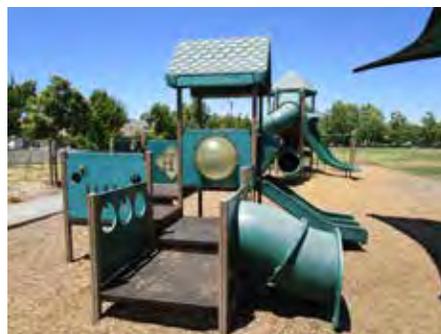
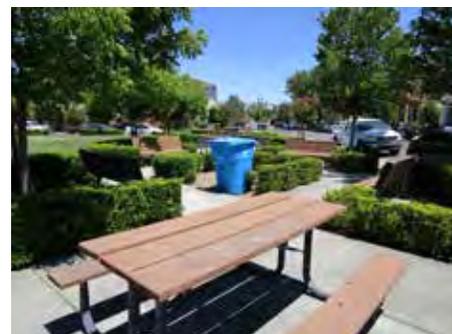
The overall condition of the park is adequate, and a majority of the amenities are fully functional. Village Green Park does not have recreation programming, has very high play value, and does not have non-compliant features identified by the 2013 and 2016 ADA assessment.

There are no critical condition amenities within the park, though a portion of the concrete pavement has significant cracking, and the quantity of trash receptacles throughout the park is deficient.

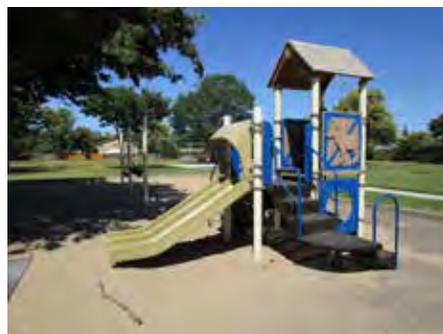
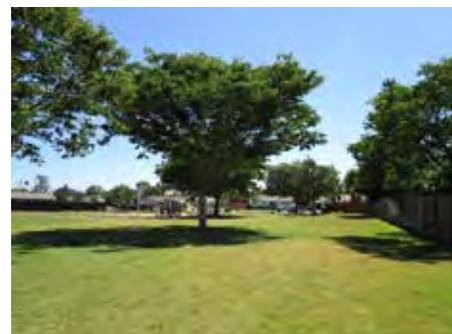
The overall condition of the park is adequate. Westgate Park does not have recreation programming, has very high play value, and has a few significantly non-compliant ADA elements.

There are no critical condition amenities within the park, though there are a few general amenities that are nearing the end of their life span, such as the bollards and park signage.

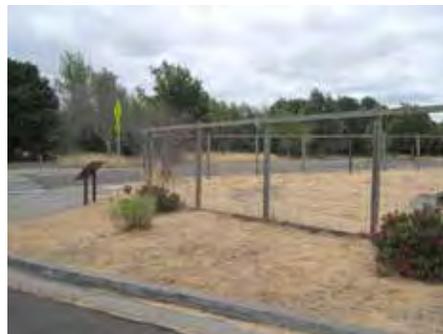
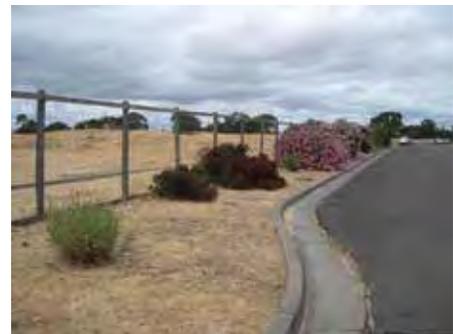
The overall condition of the park is good. Airfield Fresno Open Space does not have recreation programming, has low play value, and does not have non-compliant features identified by the 2013 and 2016 ADA assessment.

There are no critical condition amenities within the park. However, the locking mechanism for the entry gate is damaged.

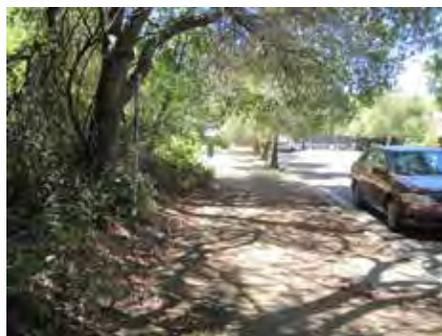
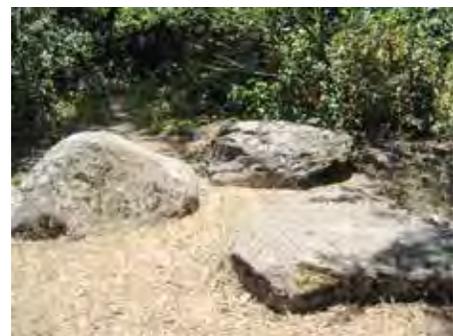
The overall condition of the park is adequate. Boas Village Creek Open Space does not have recreation programming, has low play value, and does not have non-compliant features identified by the 2013 and 2016 ADA assessment.

The critical condition amenities within the park is the irrigated groundcover landscape, which is weedy and partially dead.

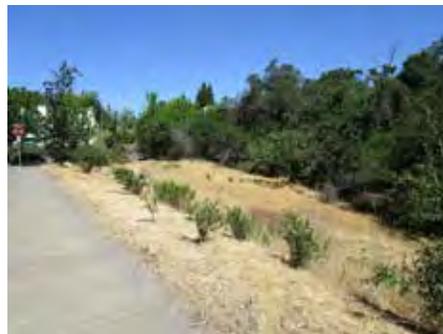
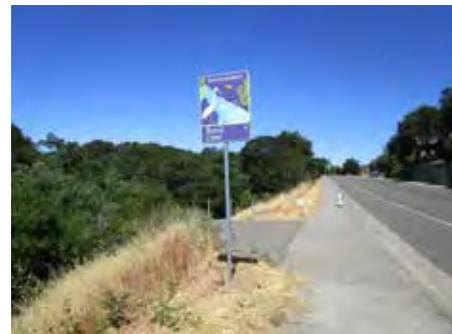
The overall condition of the park is poor. Frances Nielsen Open Space does not have recreation programming, has moderate play value, and does not have non-compliant features identified by the 2013 and 2016 ADA assessment.

The critical condition amenities within the park are the natural landscape and signage. There were noxious weeds and a deficient amount of park signage.

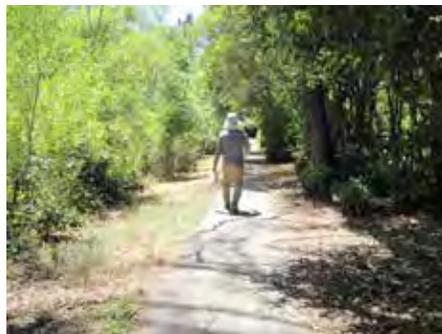
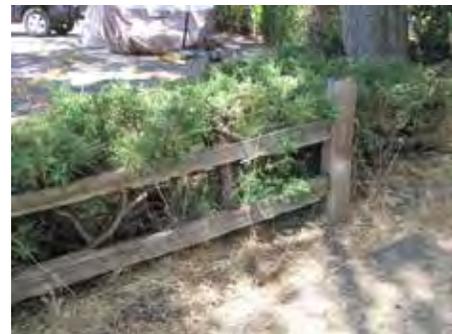
The overall condition of the park is below adequate. Fravel Lane Open Space does not have recreation programming, has low play value, and does not have non-compliant features identified by the 2013 and 2016 ADA assessment.

The critical condition amenity within the park is the asphalt pavement, which has major buckling across the surface.

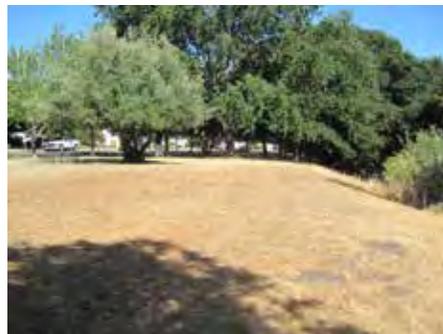
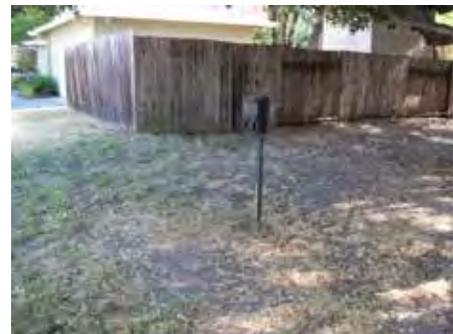
The overall condition of the park is good. Mary Traverso Open Space does not have recreation programming, has low play value, and does not have non-compliant features identified by the 2013 and 2016 ADA assessment.

The park does not have critical condition amenities, though a trash receptacle has been damaged and is no longer functional.

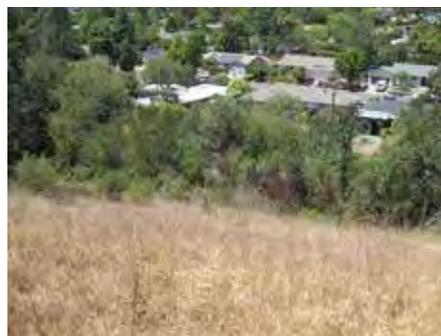
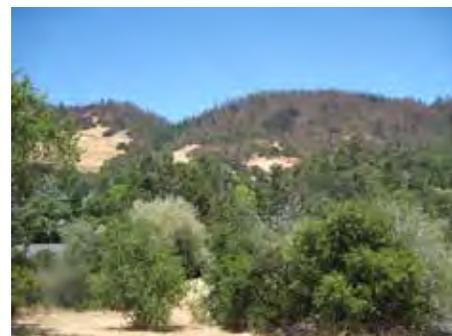
The overall condition of the park is below adequate. Owls Nest Open Space does not have recreation programming, has low play value, and does not have non-compliant features identified by the 2013 and 2016 ADA assessment.

The critical condition amenity within the park is the natural landscape, which include portions of tall, overgrown grasses that pose a fire hazard and require mowing.

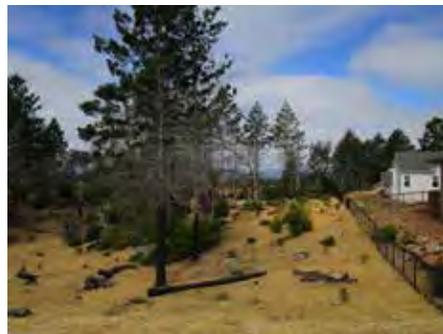
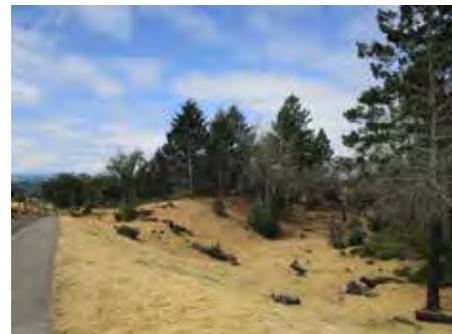
The overall condition of the park is below adequate. Parker Hill Open Space does not have recreation programming, has low play value, and does not have non-compliant features identified by the 2013 and 2016 ADA assessment.

There are no amenities in critical condition at the park. However, a number of trees and portions of the landscape have been impacted due to fire damage from the 2017 wildfires.

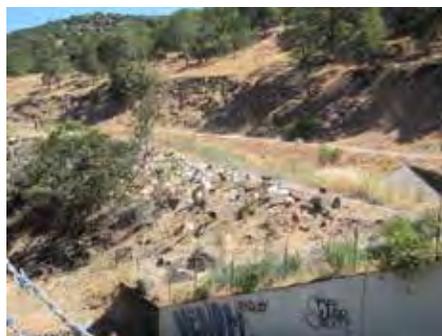
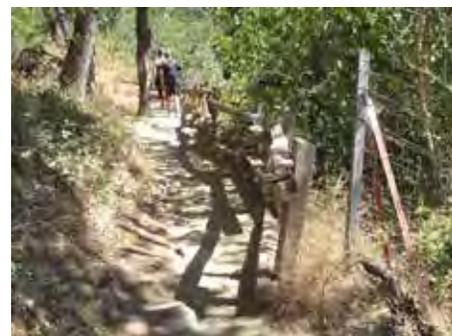
The overall condition of the park is below adequate, primarily due to the trail condition. Parktrail Open Space does not have recreation programming, has moderate play value, and does not have non-compliant features identified by the 2013 and 2016 ADA assessment.

The critical condition amenities within the park are the trail and the site furnishings. The trail surface is uneven with frequent rocks and boulder obstructing the path, the site furnishings are severely worn, and the quantity of trash receptacles is deficient.

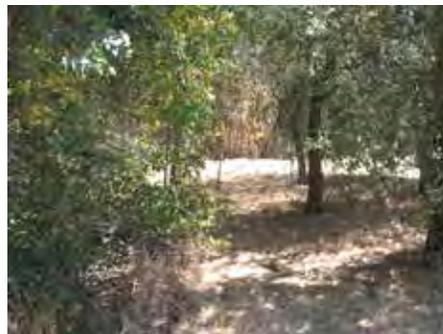
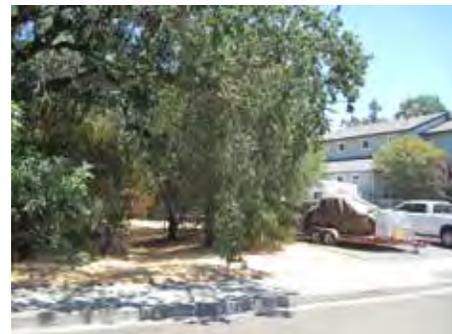
The overall condition of the park is adequate. Skyhawk Creek Open Space does not have recreation programming, has low play value, and does not have non-compliant features identified by the 2013 and 2016 ADA assessments.

There are no amenities in critical or poor condition at the park. However, a number of trees have been impacted due to fire damage from the 2017 wildfires.

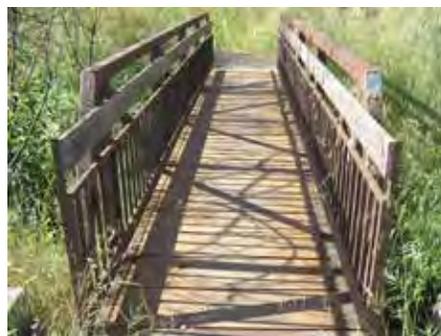
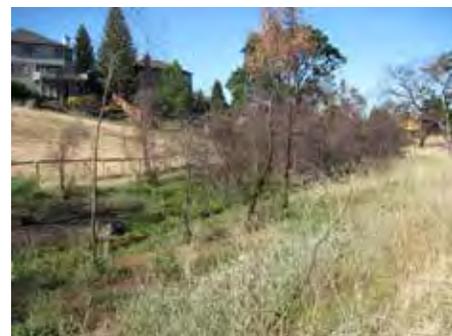
The overall condition of the park is good. Skyhawk Open Space does not have recreation programming, has low play value, and does not have non-compliant features identified by the 2013 and 2016 ADA assessments.

There are no amenities in critical or poor condition at the park. However, a number of trees have been impacted due to fire damage from the 2017 wildfires.

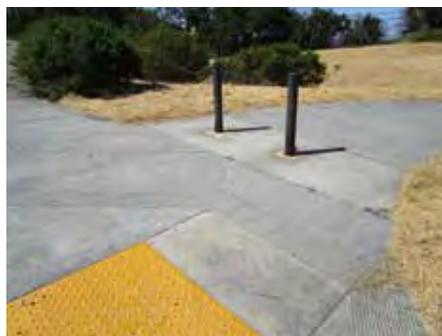
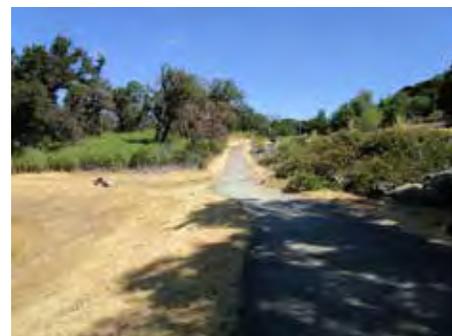
The overall condition of the park is adequate, and a majority of the amenities are fully functional. Thomas Lake Harris Open does not have recreation programming, has low play value, and does not have non-compliant features identified by the 2013 and 2016 ADA assessments.

The critical condition amenity within the park is the general landscape due to the dense invasive plants observed within the natural landscape.

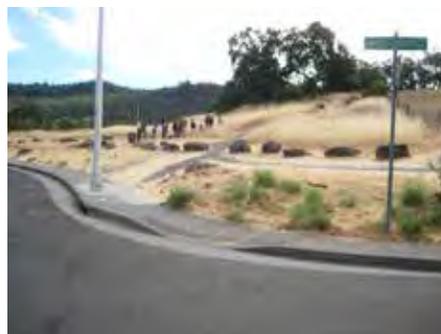
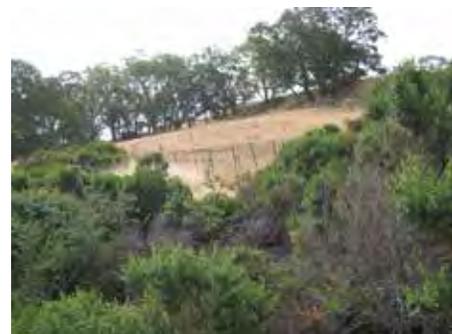
The overall condition of the park is adequate, a with a few site furnishings in poor condition. Vietnam Veterans Memorial Trail does not have recreation programming, has moderate play value, and does not have non-compliant features identified by the 2013 and 2016 ADA assessment.

The critical condition amenities within the park are the site furnishings. Site furnishings are severely worn, and the quantity of trash receptacles is deficient.

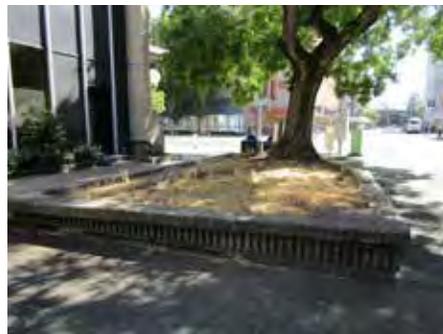
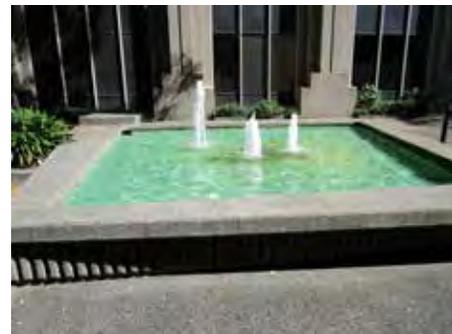
COMSTOCK MALL

The overall condition of the park is adequate, and a majority of the amenities are fully functional. Comstock Mall does not have recreation programming, has low play value, and does not have non-compliant features identified by the 2013 and 2016 ADA assessments.

The critical condition amenity within the park is the irrigation system, which does not appear to be operational.

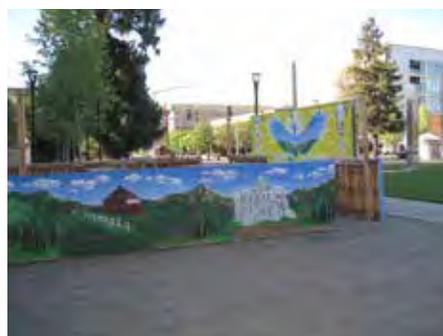
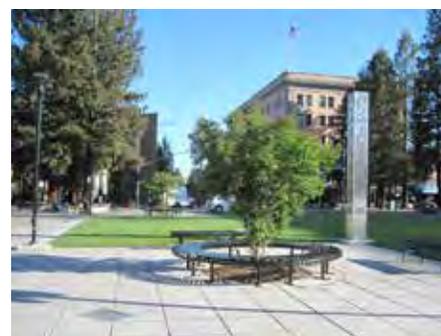
COURTHOUSE SQUARE

The overall condition of the park is very good, a majority of the amenities are functional, and the park is not anticipated to need major improvements in the near-term. Courthouse Square does not have recreation programming, has low play value, and does not have non-compliant features identified by the 2013 and 2016 ADA assessments.

There are no critical condition amenities at the park.

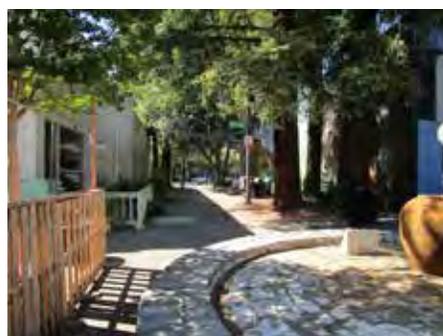
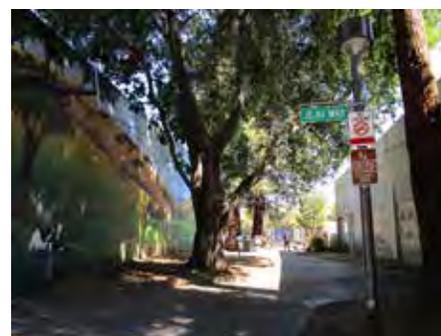
JEJU WAY

The overall condition of the park is adequate, and a majority of the amenities are fully functional. Jeju Way does not have recreation programming, has low play value, and does not have non-compliant features identified by the 2013 and 2016 ADA assessments.

The park does not have critical condition amenities, though a number of broken irrigation heads were identified and do not appear to be functional.

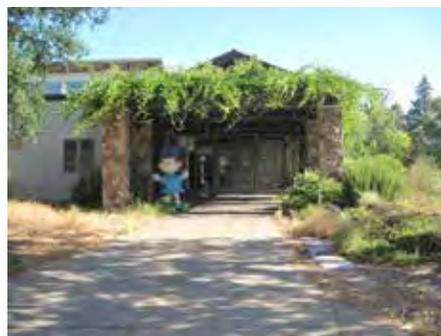
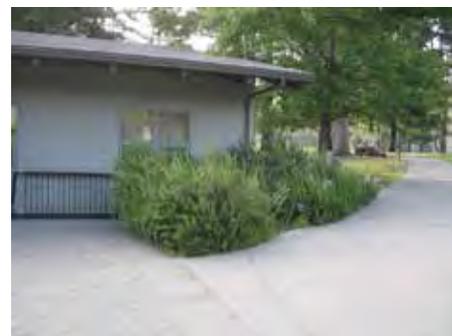
The overall condition of the park is very good. Bennett Valley Golf Course does not have recreation programming managed by the Recreation and Parks Department, has very high play value, and has a few significantly non-compliant ADA features.

The critical condition amenities within the park are the irrigation and lighting. The irrigation is outdated and does not meet current best practices, and there are a few light posts that have been damaged.

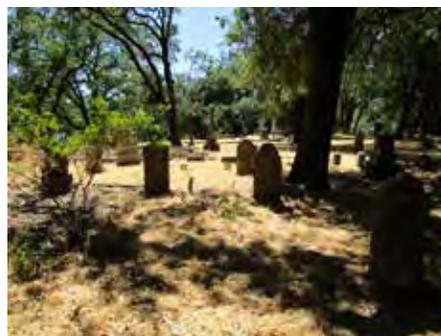
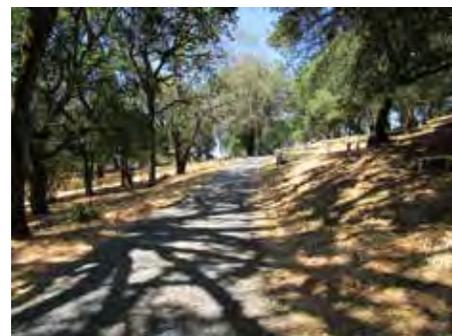
SANTA ROSA RURAL CEMETERY

The overall condition of the park is good, and a majority of the amenities are in good condition. Santa Rosa Rural Cemetery does not have recreation programming, has low play value, and generally complies with ADA standards with only a few minor non-compliant items.

There are no amenities in critical condition except for the general furnishings due to a deficient quantity of trash receptacles.

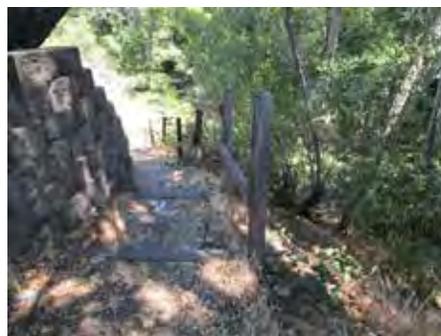
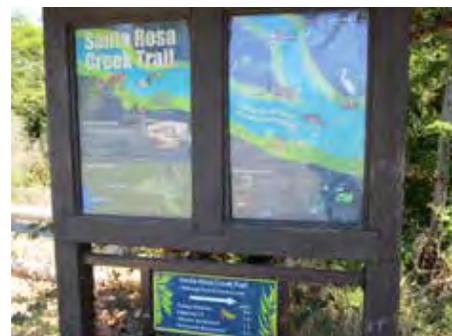
The overall condition of the park is adequate, aside from a few deficient amenities. Fourth and Farmers Creek Trail does not have recreation programming, has moderate play value, and does not have non-compliant features identified by the 2013 and 2016 ADA assessment.

The critical condition amenity within the park is the trail, where portions of the dirt surfacing are substantially uneven and concrete debris obstructs the path.

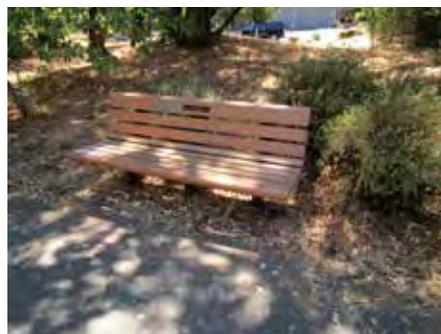
HAMPTON WOODS TRAIL

The overall condition of the park is below adequate. Hampton Woods Trail does not have recreation programming, has moderate play value, and does not have non-compliant features identified by the 2013 and 2016 ADA assessment.

The critical condition amenities within the park are the site furnishings due to a deficient quantity of trash receptacles, and the irrigation, which does not appear to be operational.

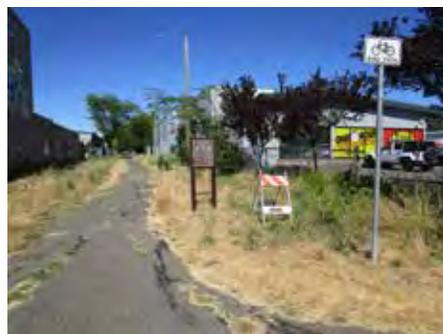
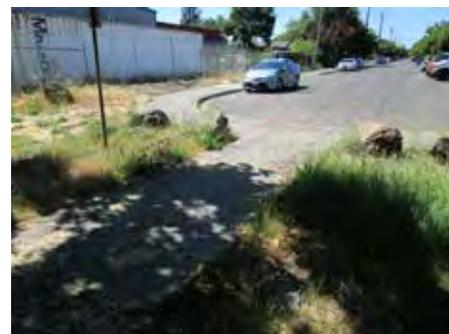
NEWHALL BIKE TRAIL

The overall condition of the park is below adequate due to the trail condition. Newhall Bike Trail does not have recreation programming, has moderate play value, and does not have non-compliant features identified by the 2013 and 2016 ADA assessments.

The critical condition amenity within the park is the hardscape, which has severe cracking and weed growth within the pavement.

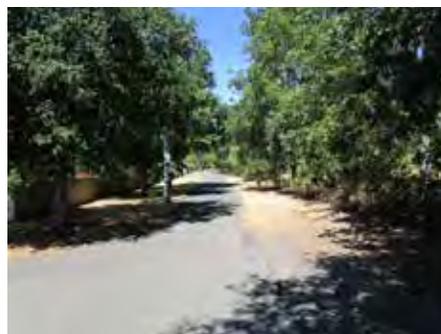
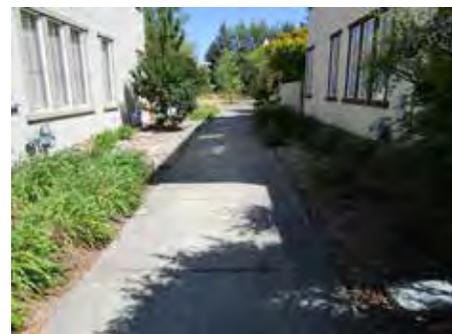
PEARBLOSSOM TRAIL

The overall condition of the park is adequate, and a majority of the amenities are fully functional. Pear Blossom Trail does not have recreation programming, has moderate play value, and has moderate non-compliant ADA features based off the of the condition ranking.

The park does not have critical condition amenities, though there are portions of the ornamental landscape that are dead or missing, and the spray irrigation for the natural turf has coverage issues.

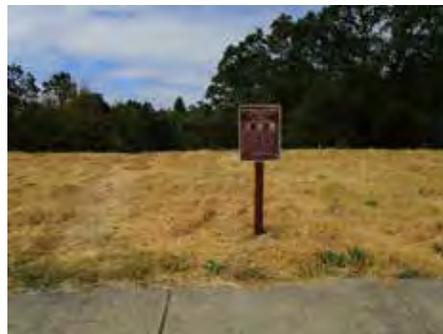
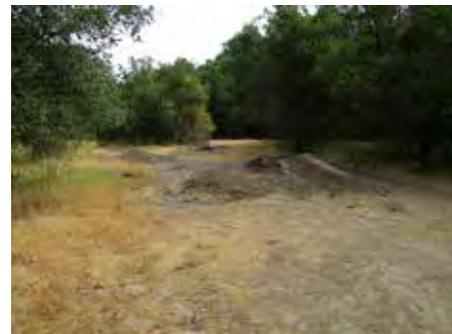
UPPER BRUSH CREEK TRAIL PARK

The overall condition of the park is adequate. Upper Brush Creek Trail Park does not have recreation programming, has moderate play value, and does not have non-compliant features identified by the 2013 and 2016 ADA assessments.

The critical condition amenity within the park is the trail due to a number of holes throughout the park, a lack of signage, and the informal bike jumps created near Wild Lilac Lane.

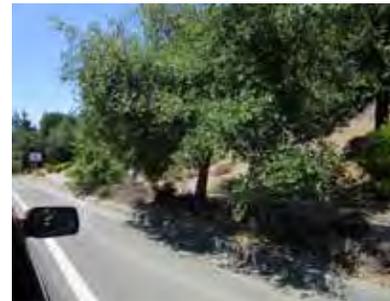
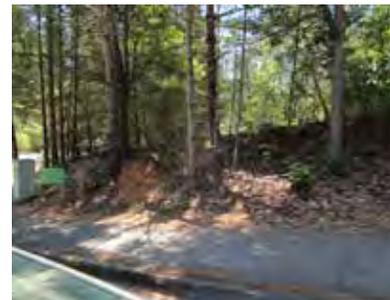
100003NW

Amenities	Priority Ranking Category	Supplemental Categories	
	Condition 	Lifespan 	Cost Estimate
	3.0	18.4	\$ 147,558
General Landscape	3.0	13	\$ 50,093
General Trees	4.0	38	\$ 5,217
General Irrigation	2.0	6	\$ 65,222
General Drainage	3.0	18	\$ 27,026

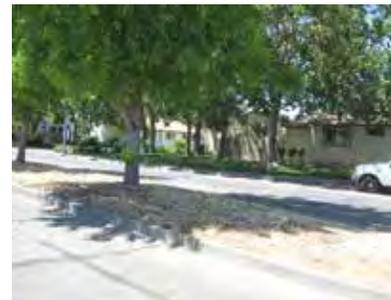
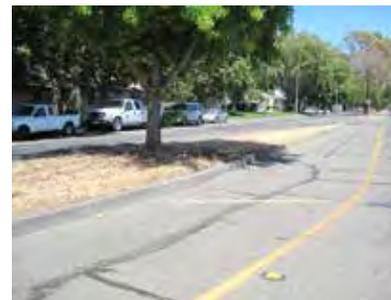
100005SE

Amenities	Priority Ranking Category	Supplemental Categories	
	Condition	Lifespan	Cost Estimate
	2.0	12.5	\$ 8,739
General Landscape	1.0	0	\$ 3,632
General Trees	4.0	38	\$ 378
General Irrigation	1.0	0	\$ 4,729

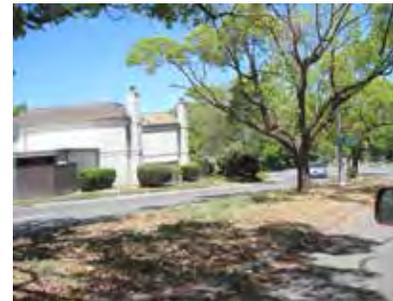
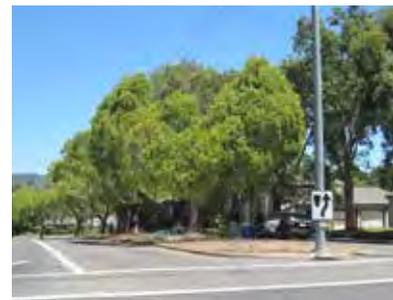
100008NE

Amenities	Priority Ranking Category	Supplemental Categories	
	Condition 	Lifespan 	Cost Estimate
	2.7	17.6	\$ 33,389
General Landscape	1.0	0	\$ 11,335
General Trees	4.0	38	\$ 1,180
General Irrigation	1.0	0	\$ 14,758
General Drainage	4.8	33	\$ 6,115

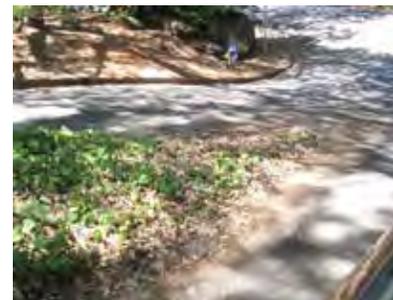
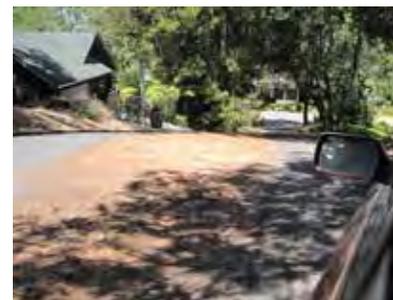
1000 | INW

Amenities	Priority Ranking Category	Supplemental Categories	
	Condition	Lifespan	Cost Estimate
	2.3	14.6	\$ 8,250
General Landscape	2.0	6	\$ 3,429
General Trees	4.0	38	\$ 357
General Irrigation	1.0	0	\$ 4,464

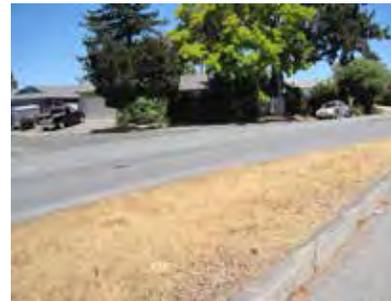
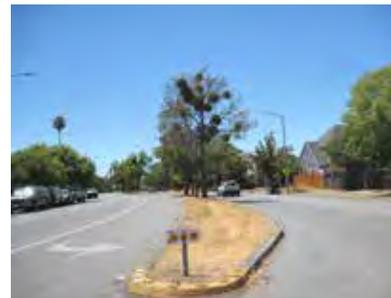
1000 | 2SE

Amenities	Priority Ranking Category	Supplemental Categories	
	Condition	Lifespan	Cost Estimate
	1.7	8.3	\$ 36,079
General Landscape	1.0	0	\$ 14,994
General Trees	3.0	25	\$ 1,562
General Irrigation	1.0	0	\$ 19,523

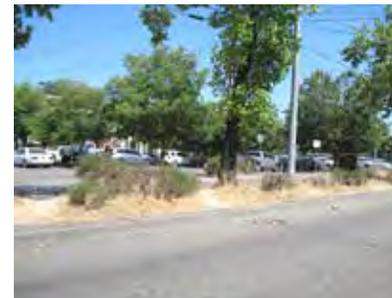
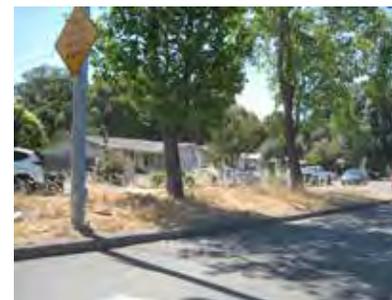
1000 I 5SE

Amenities	Priority Ranking Category	Supplemental Categories	
	Condition	Lifespan	Cost Estimate
	2.8	15.8	\$ 27,055
General Landscape	1.0	0	\$ 9,185
General Trees	4.0	38	\$ 957
General Hardscape	4.0	15	*see note
General Irrigation	1.0	0	\$ 11,959
General Drainage	4.0	26	\$ 4,955

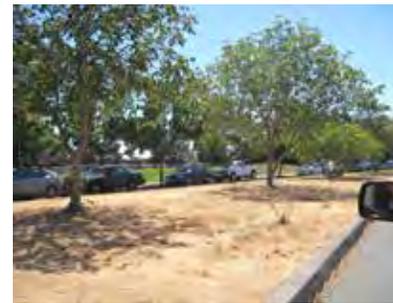
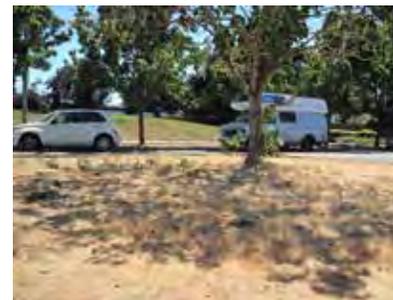
1000 I 7NW

Amenities	Priority Ranking Category	Supplemental Categories	
	Condition 	Lifespan 	Cost Estimate
	3.5	22.8	\$ 46,847
General Landscape	2.0	6	\$ 15,904
General Trees	4.0	38	\$ 1,656
General Irrigation	3.0	13	\$ 20,707
General Drainage	5.0	35	\$ 8,580

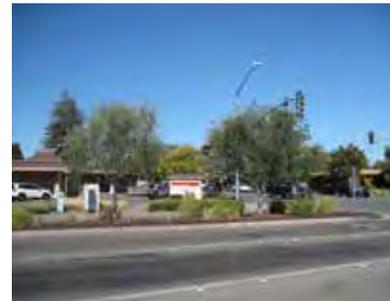
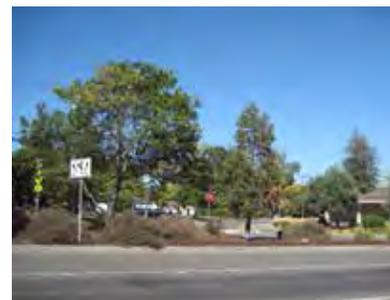
1000 | 9SE

4.0	25.0	\$ 35,251
General Landscape	4.0	19	\$ 14,650
General Trees	4.0	38	\$ 1,526
General Irrigation	4.0	19	\$ 19,075

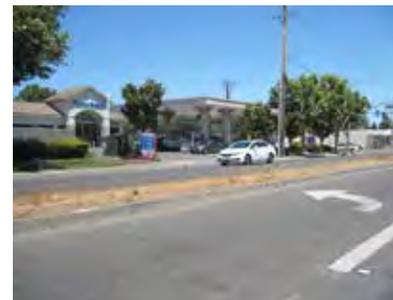
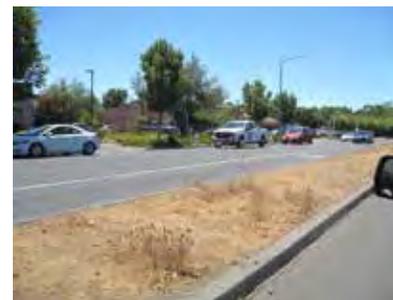
100022SE

Amenities	Priority Ranking Category	Supplemental Categories	
	Condition	Lifespan	Cost Estimate
	1.0	0.0	\$ 12,765
General Landscape	1.0	0	\$ 5,545
General Irrigation	1.0	0	\$ 7,220

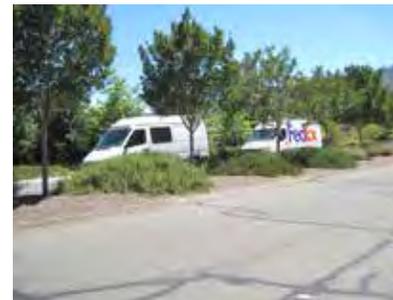
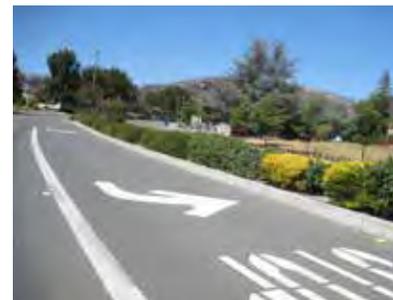
100023NW

Amenities	Priority Ranking Category	Supplemental Categories	
	Condition 	Lifespan 	Cost Estimate
	3.6	20.3	\$ 270,709
General Landscape	4.0	19	\$ 91,900
General Trees	4.0	38	\$ 9,571
General Hardscape	4.0	15	*see note
General Irrigation	3.0	13	\$ 119,657
General Drainage	3.0	18	\$ 49,581

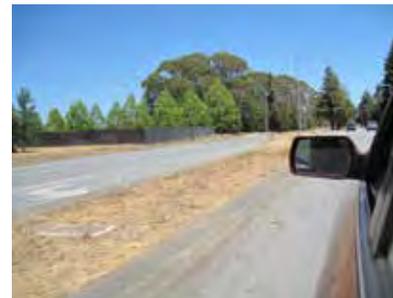
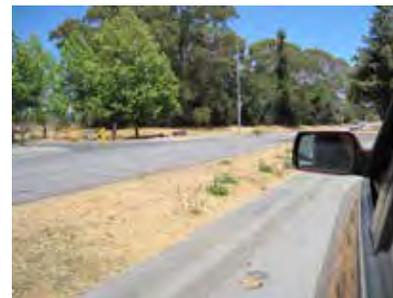
I 00025NE

Amenities	Priority Ranking Category	Supplemental Categories	
	Condition	Lifespan	Cost Estimate
	1.0	0.0	\$ 19,326
General Landscape	1.0	0	\$ 8,395
General Irrigation	1.0	0	\$ 10,931

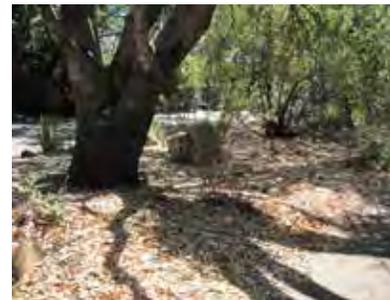
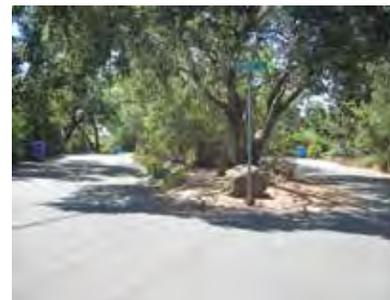
100028NE

Amenities	Priority Ranking Category	Supplemental Categories	
	Condition 	Lifespan 	Cost Estimate
	3.0	18.8	\$ 56,758
General Landscape	3.0	13	\$ 23,588
General Trees	4.0	38	\$ 2,457
General Irrigation	2.0	6	\$ 30,713

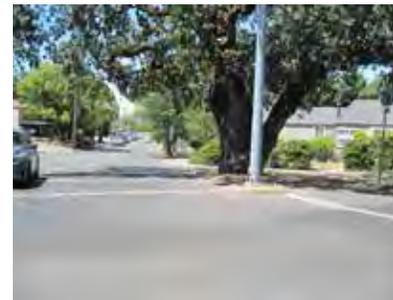
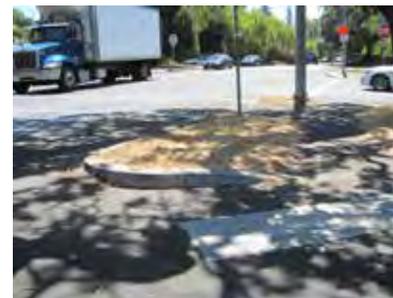
100032NE

Amenities	Priority Ranking Category	Supplemental Categories	
	Condition 	Lifespan 	Cost Estimate
	3.8	23.4	\$ 2,049
General Landscape	2.0	6	\$ 1,247
General Trees	4.0	38	\$ 130
General Hardscape	4.0	15	*see note
General Drainage	5.0	35	\$ 673

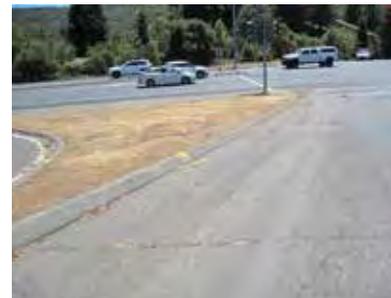
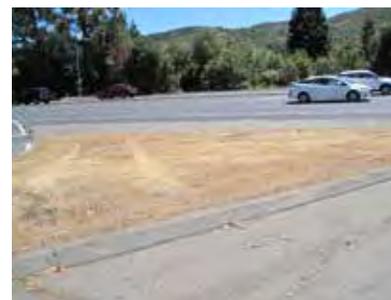
100042NE

Amenities	Priority Ranking Category	Supplemental Categories	
	Condition 	Lifespan 	Cost Estimate
	2.0	7.9	\$ 15,185
General Landscape	2.0	6	\$ 5,344
General Irrigation	1.0	0	\$ 6,958
General Drainage	3.0	18	\$ 2,883

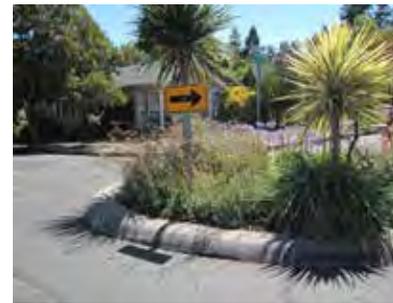
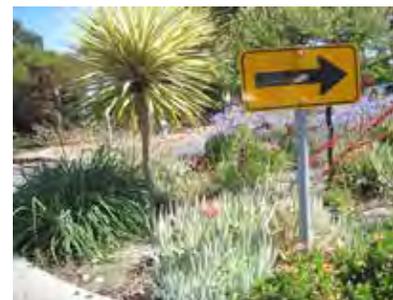
M0000 ISW

Amenities	Priority Ranking Category	Supplemental Categories	
	Condition	Lifespan	Cost Estimate
	4.5	21.9	\$ 2,172
General Landscape	5.0	25	\$ 944
General Irrigation	4.0	19	\$ 1,229

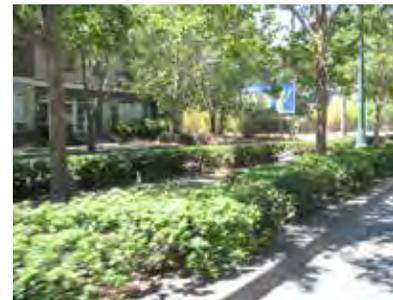
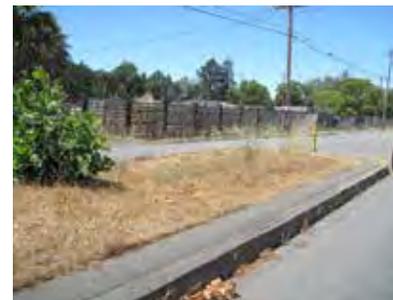
M00002NW

Amenities	Priority Ranking Category	Supplemental Categories	
	Condition 	Lifespan 	Cost Estimate
	3.5	19.4	\$ 134,637
General Landscape	3.0	13	\$ 24,706
General Trees	4.0	38	\$ 2,573
General Hardscape	4.0	15	\$ 75,191
General Irrigation	3.0	13	\$ 32,168

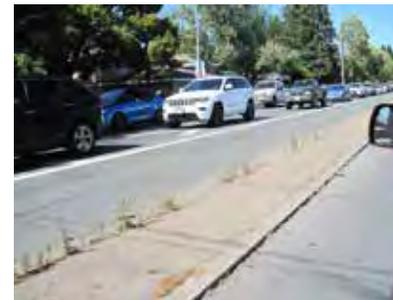
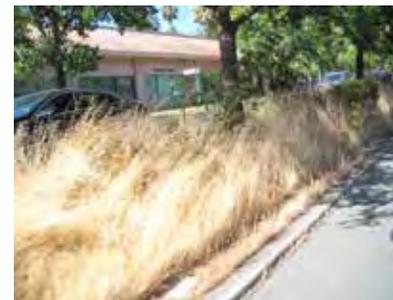
M00006SE

Amenities	Priority Ranking Category	Supplemental Categories	
	Condition	Lifespan	Cost Estimate
	3.8	20.9	\$ 208,304
General Landscape	4.0	19	\$ 28,117
General Trees	4.0	38	\$ 2,928
General Hardscape	4.0	15	\$ 140,650
General Irrigation	3.0	13	\$ 36,609

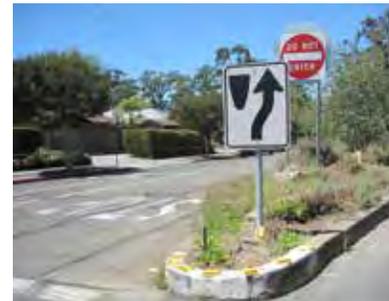
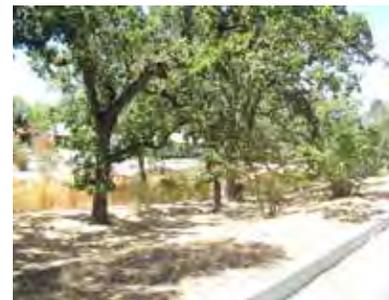
Amenities	Priority Ranking Category	Supplemental Categories	
	Condition	Lifespan	Cost Estimate
	3.5	20.6	\$ 673,072
General Landscape	2.0	6	\$ 226,262
General Trees	4.0	38	\$ 23,563
General Hardscape	4.0	15	\$ 6,309
General Irrigation	2.5	9	\$ 294,600
General Drainage	5.0	35	\$ 122,337

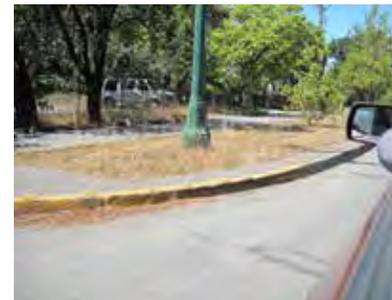
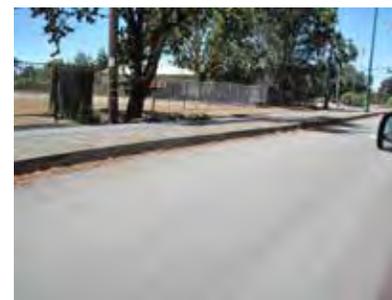
Amenities	Priority Ranking Category	Supplemental Categories	
	Condition 	Lifespan 	Cost Estimate
	2.5	13.1	\$ 104,664
General Landscape	1.0	0	\$ 11,090
General Trees	4.0	38	\$ 1,155
General Hardscape	4.0	15	\$ 77,980
General Irrigation	1.0	0	\$ 14,439

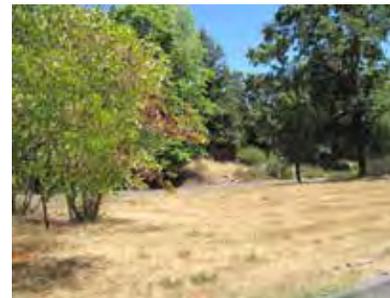
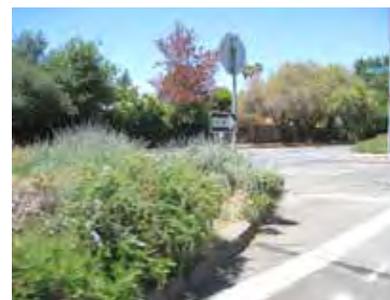
Amenities	Priority Ranking Category	Supplemental Categories	
	Condition 	Lifespan 	Cost Estimate
	3.5	20.6	\$ 127,740
General Landscape	2.0	6	\$ 39,878
General Trees	4.0	38	\$ 4,153
General Hardscape	4.0	15	\$ 9,857
General Irrigation	2.5	9	\$ 51,922
General Drainage	5.0	35	\$ 21,930

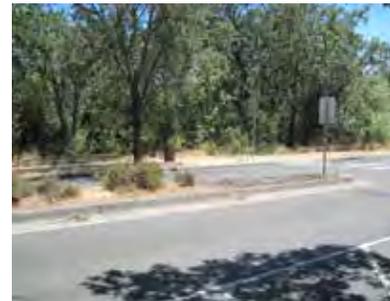
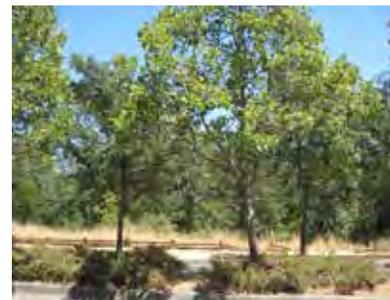
Amenities	Priority Ranking Category	Supplemental Categories	
	Condition	Lifespan	Cost Estimate
	3.5	19.6	\$ 16,761
General Landscape	3.0	13	\$ 1,036
General Trees	4.0	38	\$ 108
General Hardscape	4.0	15	\$ 13,153
General Irrigation	3.5	16	\$ 1,350
General Drainage	3.0	18	\$ 1,113

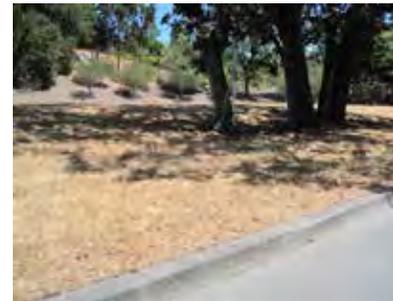
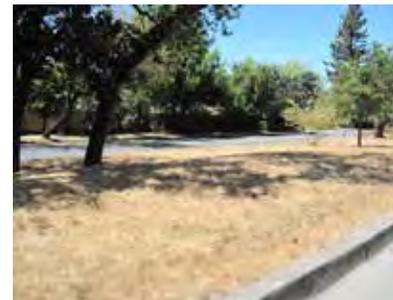
Amenities	Priority Ranking Category	Supplemental Categories	
	Condition	Lifespan	Cost Estimate
	3.5	20.6	\$ 191,443
General Landscape	2.0	6	\$ 63,065
General Trees	4.0	38	\$ 6,568
General Hardscape	4.0	15	\$ 5,444
General Irrigation	2.5	9	\$ 82,113
General Drainage	5.0	35	\$ 34,254

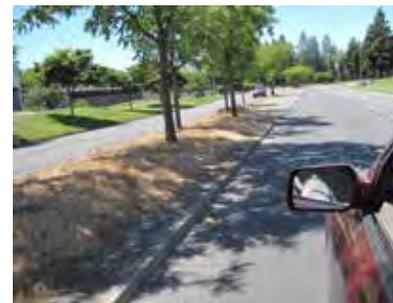
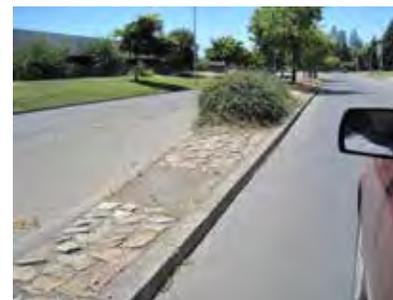
Amenities	Priority Ranking Category	Supplemental Categories	
	Condition	Lifespan	Cost Estimate
	2.3	11.9	\$ 85,907
General Landscape	1.0	0	\$ 7,007
General Trees	4.0	38	\$ 730
General Hardscape	3.0	10	\$ 69,048
General Irrigation	1.0	0	\$ 9,123

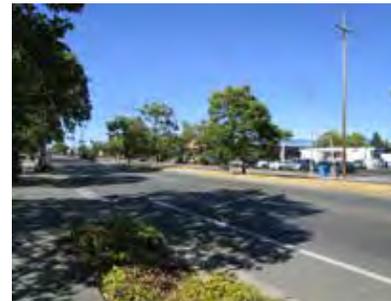
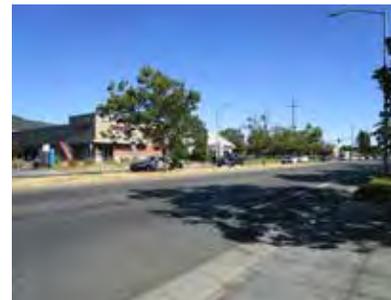
Amenities	Priority Ranking Category	Supplemental Categories	
	Condition 	Lifespan 	Cost Estimate
	3.1	18.5	\$ 100,722
General Landscape	2.0	6	\$ 15,239
General Trees	4.0	38	\$ 1,587
General Hardscape	2.5	8	\$ 53,574
General Irrigation	2.0	6	\$ 19,842
General Drainage	5.0	35	\$ 10,479

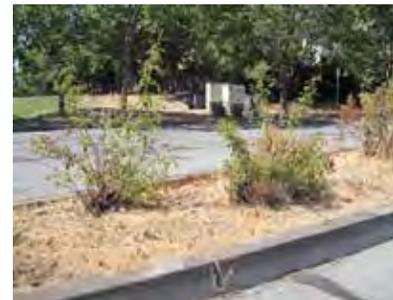
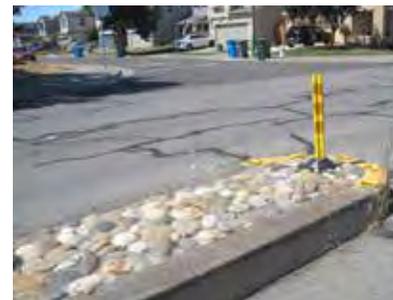
Amenities	Priority Ranking Category	Supplemental Categories	
	Condition 	Lifespan 	Cost Estimate
	4.0	23.3	\$ 143,071
General Landscape	4.0	19	\$ 15,592
General Trees	4.0	38	\$ 1,624
General Hardscape	4.0	15	\$ 93,214
General Irrigation	4.0	19	\$ 20,301
General Drainage	4.0	26	\$ 12,340

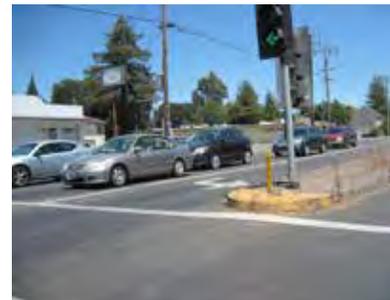
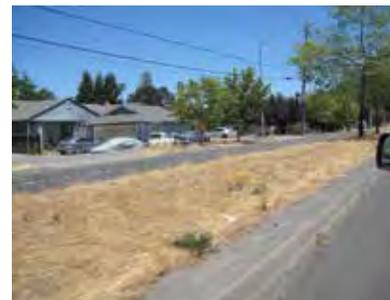
Amenities	Priority Ranking Category	Supplemental Categories	
	Condition 	Lifespan 	Cost Estimate
	2.5	13.1	\$ 259,721
General Landscape	1.0	0	\$ 27,547
General Trees	4.0	38	\$ 2,869
General Hardscape	4.0	15	\$ 193,440
General Irrigation	1.0	0	\$ 35,866

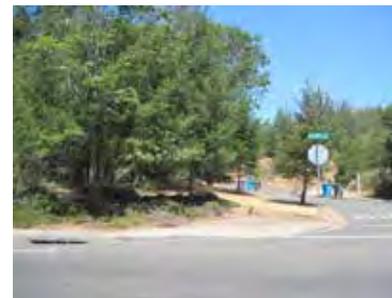
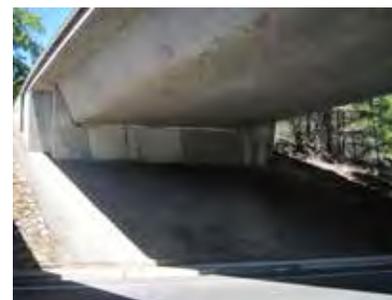
Amenities	Priority Ranking Category	Supplemental Categories	
	Condition 	Lifespan 	Cost Estimate
	3.0	16.5	\$ 821,708
General Landscape	3.0	13	\$ 133,068
General Trees	4.0	38	\$ 13,858
General Hardscape	4.0	15	\$ 412,356
General Irrigation	1.0	0	\$ 173,259
General Drainage	3.0	18	\$ 89,167

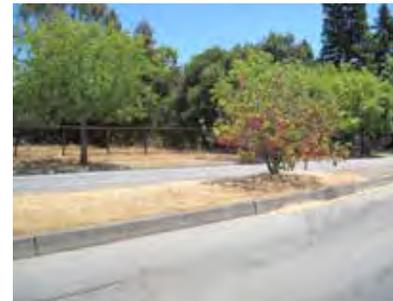
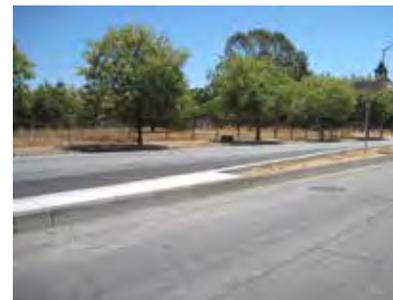
Amenities	Priority Ranking Category	Supplemental Categories	
	Condition 	Lifespan 	Cost Estimate
	2.5	13.1	\$ 62,048
General Landscape	1.0	0	\$ 9,513
General Trees	4.0	38	\$ 991
General Hardscape	4.0	15	\$ 39,157
General Irrigation	1.0	0	\$ 12,387

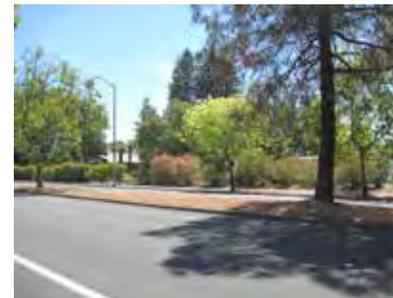
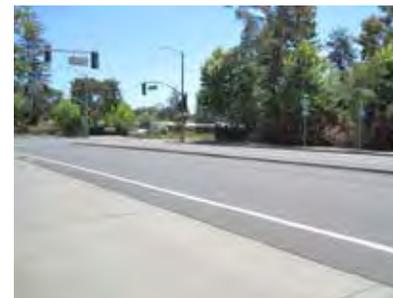
Amenities	Priority Ranking Category	Supplemental Categories	
	Condition	Lifespan	Cost Estimate
	2.6	14.0	\$ 18,729
General Landscape	1.0	0	\$ 5,942
General Trees	4.0	38	\$ 619
General Hardscape	4.0	15	\$ 1,176
General Irrigation	1.0	0	\$ 7,737
General Drainage	3.0	18	\$ 3,255

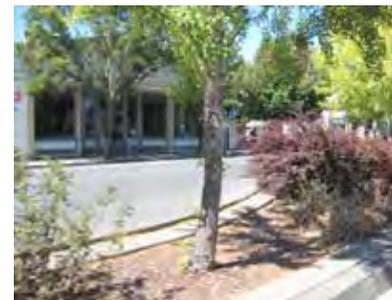
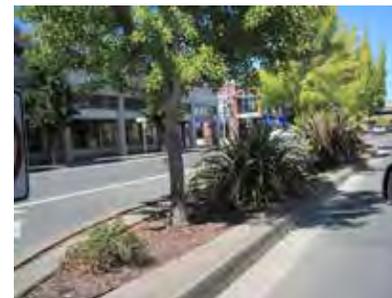
Amenities	Priority Ranking Category	Supplemental Categories	
	Condition	Lifespan	Cost Estimate
	4.2	25.0	\$ 56,137
General Landscape	4.0	19	\$ 4,852
General Trees	4.0	38	\$ 505
General Hardscape	4.0	15	\$ 40,151
General Irrigation	4.0	19	\$ 6,318
General Drainage	5.0	35	\$ 4,310

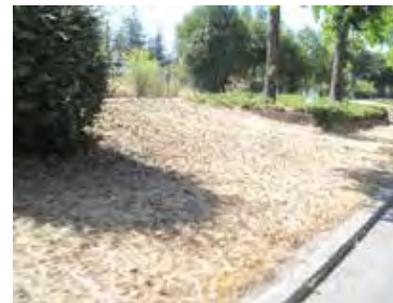
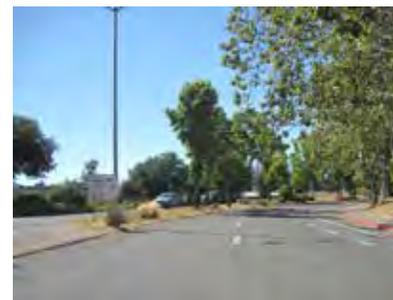
Amenities	Priority Ranking Category	Supplemental Categories	
	Condition	Lifespan	Cost Estimate
	3.4	20.3	\$ 142,888
General Landscape	3.0	13	\$ 41,175
General Trees	4.0	38	\$ 4,288
General Hardscape	3.0	10	\$ 20,725
General Irrigation	2.0	6	\$ 53,612
General Drainage	5.0	35	\$ 23,088

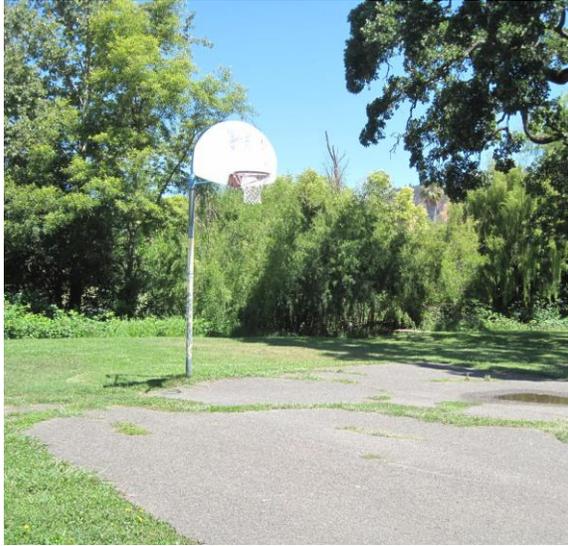
Cracks and weeds in surfacing. Potential trip hazard.

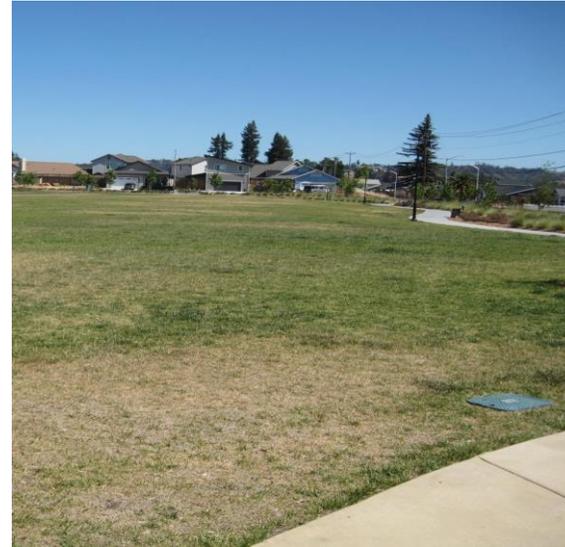
Dying turf due to broken or deficient irrigation

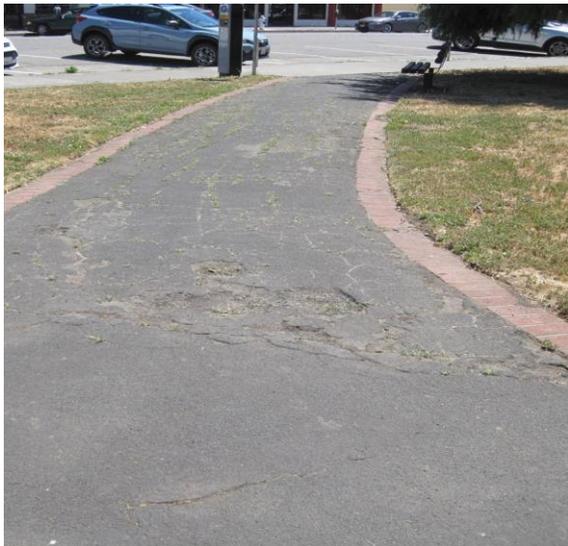
Cracks and potholes creating uneven surfacing.

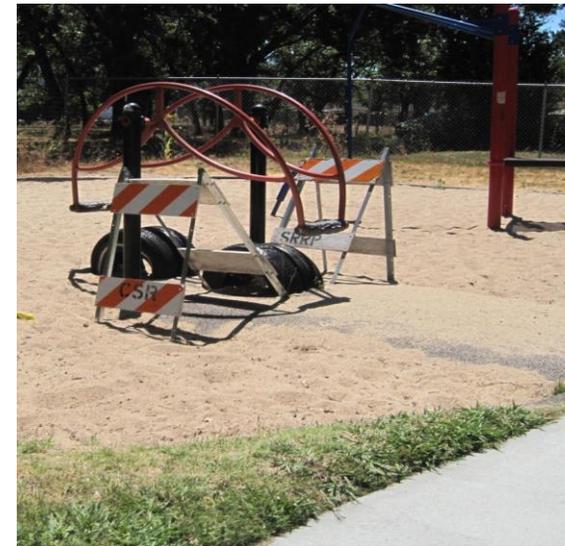
Broken and unsafe playground equipment
