PRIMARY RECORD

*Resource Name or # (Assigned by recorder) 631 5th Street

*P11. Report Citation: (Cite survey report and other sources or enter "none".) ARG, "Downtown Station Area Historic Resource Evaluation" (prepared for the City of Santa Rosa, 2022).

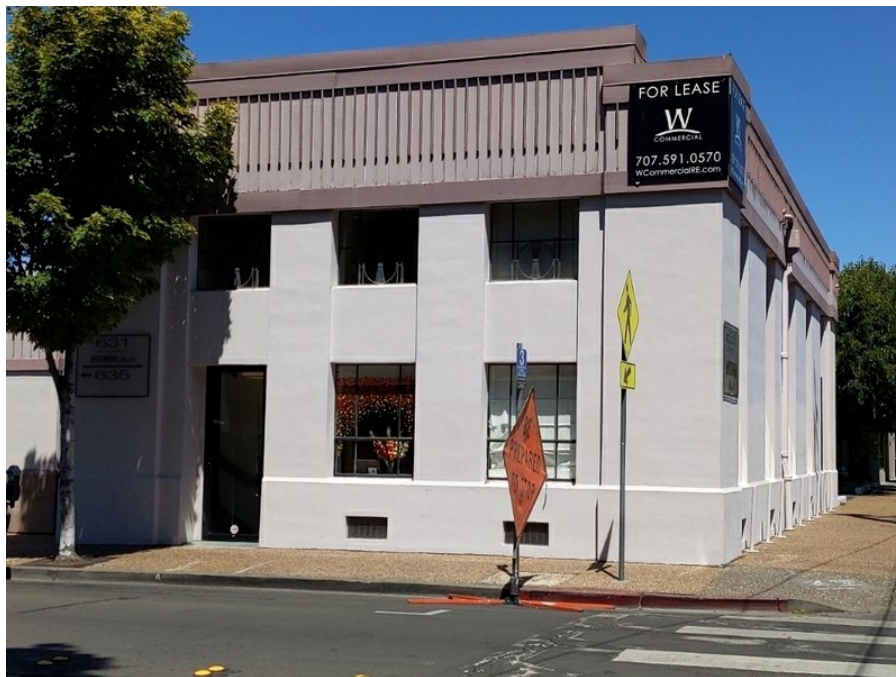
Primary Architectural Style: PWA Moderne/Stripped Classical

Plan/Primary Facade: Rectangular; Symmetrical

Construction/Foundation: Reinforced concrete; Concrete

Cladding: Smooth stucco

Details: Applied decoration, Pilasters, Punched window openings set in vertically oriented recessed bays; 1970s wood slat frieze/cornice at parapet

Window 1: Grouped; Fixed, Casement, Hopper; Steel; Multi-light - all, Decorative circular muntin details

P5b. Description of Photo: (view, date, accession #)
View north, 6/23/2021

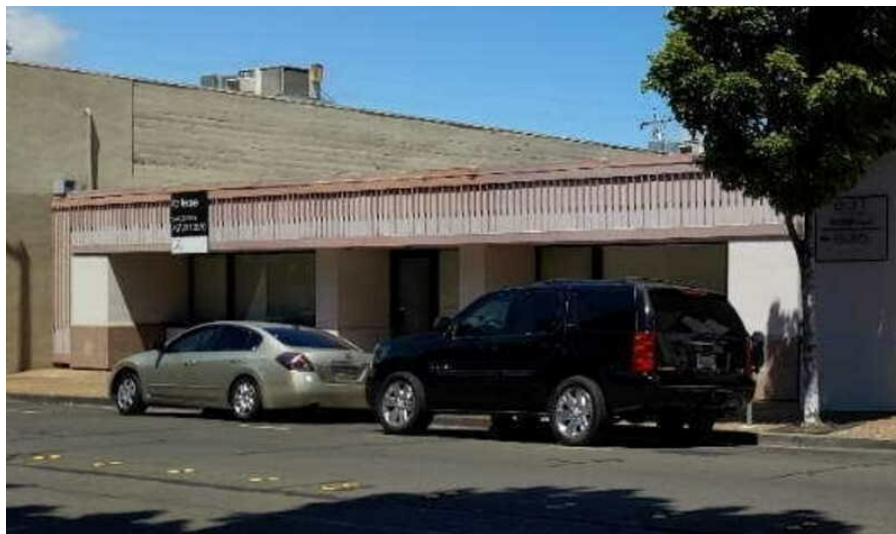
Alterations: Other Alterations-Door replaced - primary, Signage added/replaced

P5b. Description of Photo: (view, date, accession #)
View north, 10/19/2021

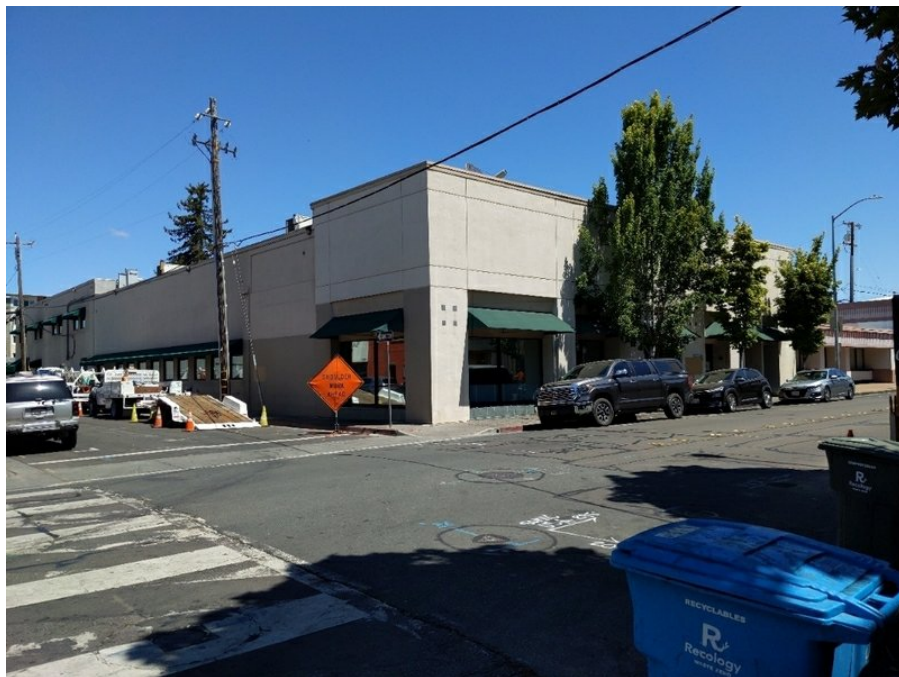
Alterations: Other Alterations-Completely altered

Integrity: The property does not retain sufficient integrity to convey any historical association and/or architectural character.

P5b. Description of Photo: (view, date, accession #)
View northeast, 6/23/2021

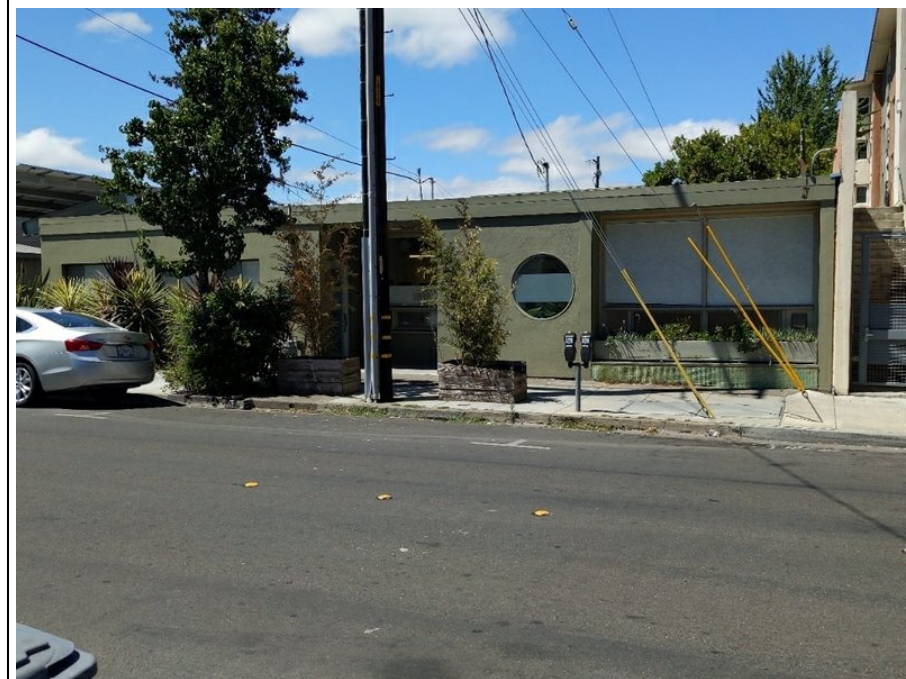
Alterations: Additions-Rear; Other Alterations-Decorative elements added, Door replaced - primary, Door replaced - secondary, Entrance altered - primary

Integrity: The property does not retain sufficient integrity to convey any historical association and/or architectural character.

P5b. Description of Photo: (view, date, accession #)
View west, 6/23/2021
