NOVEMBER 2020 APPLICATION FOR PROJECT-BASED VOUCHERS

Project Summary		
<i>Project Name</i> The Cannery at Railroad Square		
<i>Project Address</i> 3 West 3rd Street and a portion of 60 West 6th Street Santa Rosa, CA 95401		
<p>Please indicate the additional funding source(s) and planned application date for which the project will compete:</p> <p>Santa Rosa CDBG-DR Funds - Application submitted on 12/3/2020 TCAC 4% Tax Credits - Application will be submitted in February 2021 CDLAC Tax-exempt Bonds - Application will be submitted in February 2021</p> <p><i>The final award of PBVs is contingent upon the project's successful application for the funding listed above within two application rounds, or another funding source that will allow the project to follow a substantially similar timeline.</i></p>		
Project Type: <input type="checkbox"/> Existing Housing <input type="checkbox"/> Rehabilitation <input checked="" type="checkbox"/> New Construction	Estimated Date of Occupancy: June 2023 (anticipated TCO date)

BRIEF PROJECT SUMMARY FOR APPLICATION FOR PROJECT-BASED VOUCHER FUNDING
NOVEMBER 2020

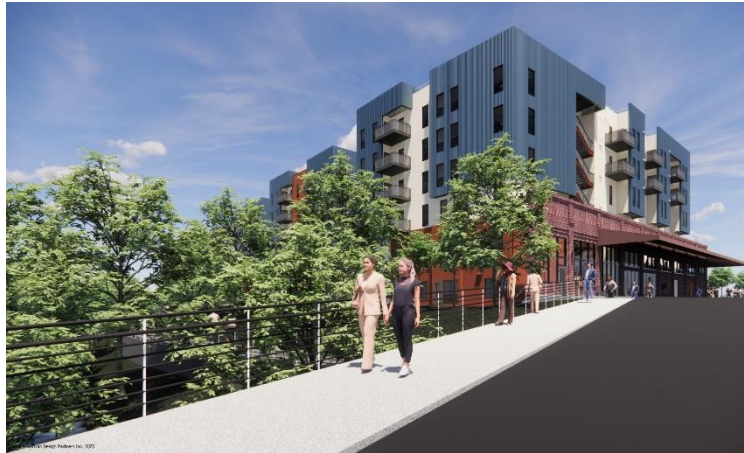
The Cannery at Railroad Square is a six-story building with 7 studios, 48 one-bedroom, and 74 two-bedroom units. The Project will include a set-aside of 25% of the units (33 units) for special needs households (formerly homeless families), for which we are applying for Project Based Vouchers. The improvements also include management and services offices, indoor and outdoor resident amenity spaces, as well as bicycle parking for 50 bikes and voluntary vehicular parking consisting of 52 standard spaces, including 3 EV spaces and 3 accessible spaces. Resident amenity spaces will include a computer lab, a community meeting room with warming kitchen and adjacent outdoor patio, two courtyards with different characteristics, and laundry rooms with access to the exterior and adjacent tot lot.

Common outdoor space will be provided along the north and west frontages of the new building. The spaces will provide picnic and BBQ areas, children's play areas and general gathering spaces. The Project will construct a pedestrian promenade from Sonoma-Marín Area Transit (SMART) Railroad Square Station, allowing residents access to high-quality transit within this Priority Development Area (PDA) identified in regional *Plan Bay Area 2040*. The pedestrian and bicycle corridor will extend the 4th Street spine from the SMART site to the Prince Memorial Greenway along the Santa Rosa Creek trail adjacent to the west. Several elements of the original historic Cannery, including the brick wall, canopy, original water tower, and loading dock facing east are incorporated into the design.

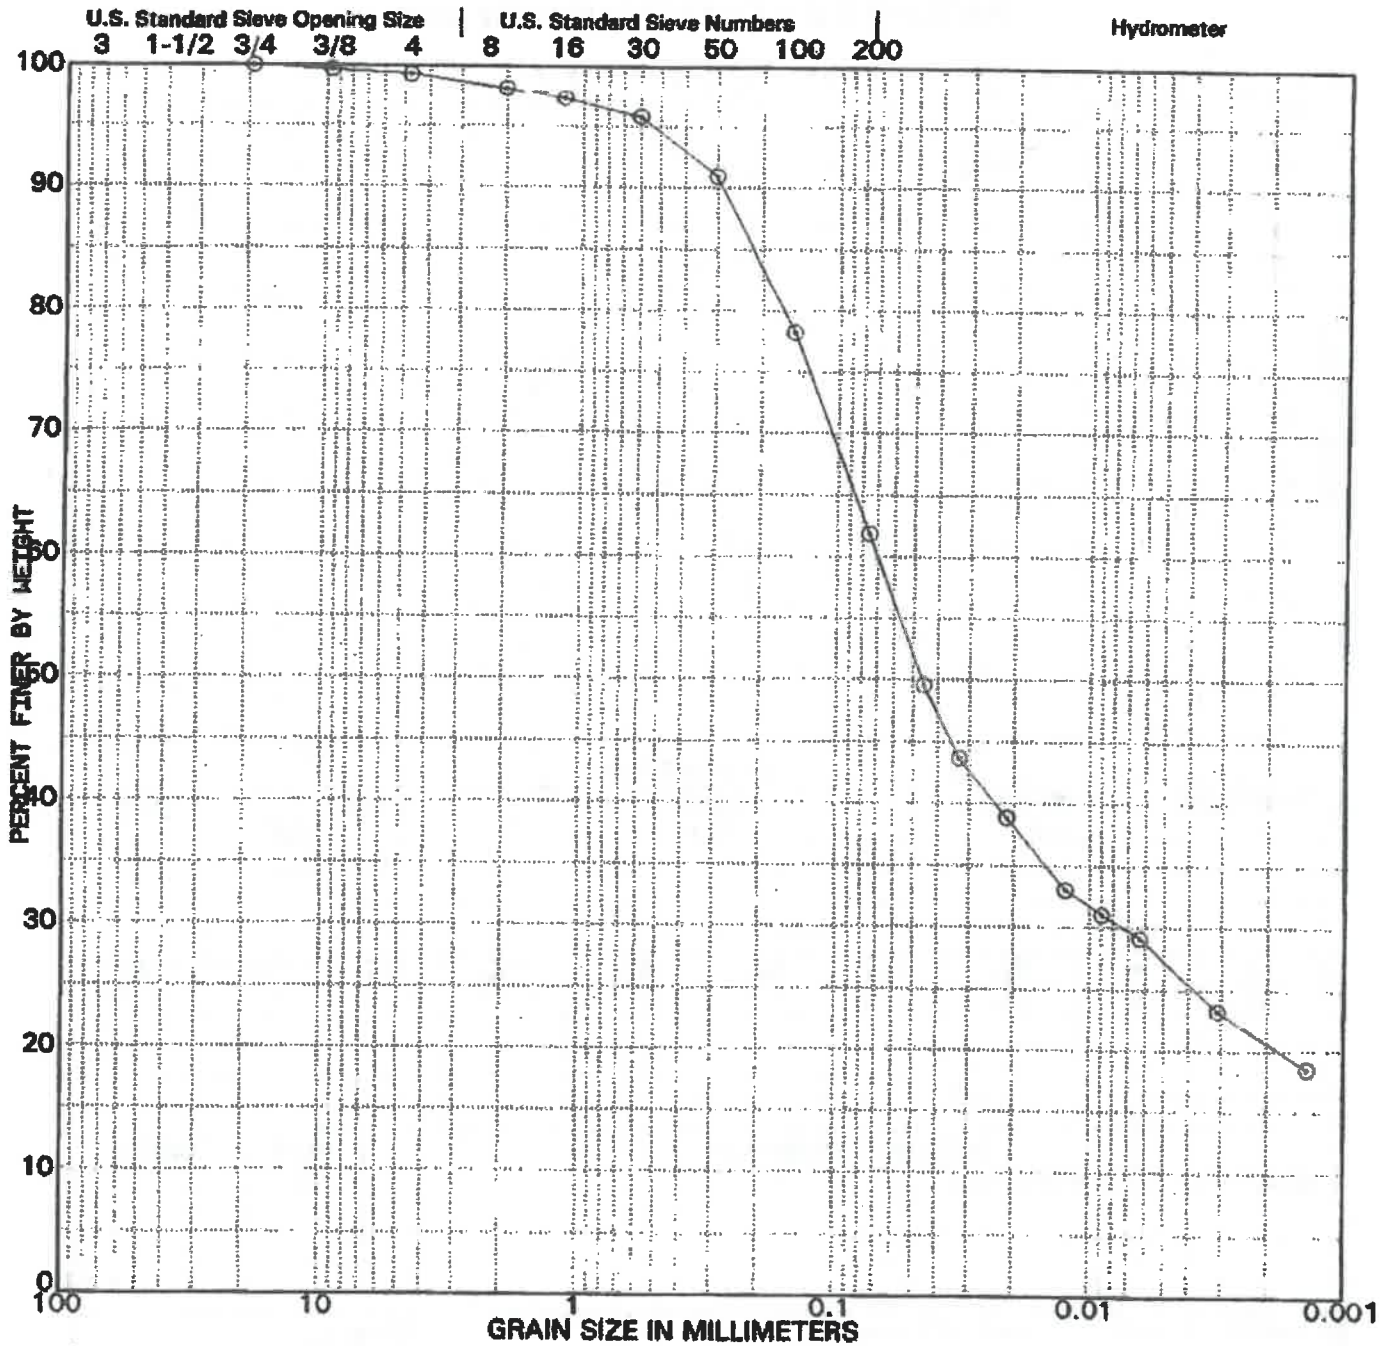
Cobbles	GRAVEL		SAND			SILT	CLAY
	COARSE	FINE	COARSE	MEDIUM	FINE		
SYMBOL	SAMPLE SOURCE					CLASSIFICATION	
⊙	B-1 @ 14.5'					Brown Sandy Lean Clay (CL)

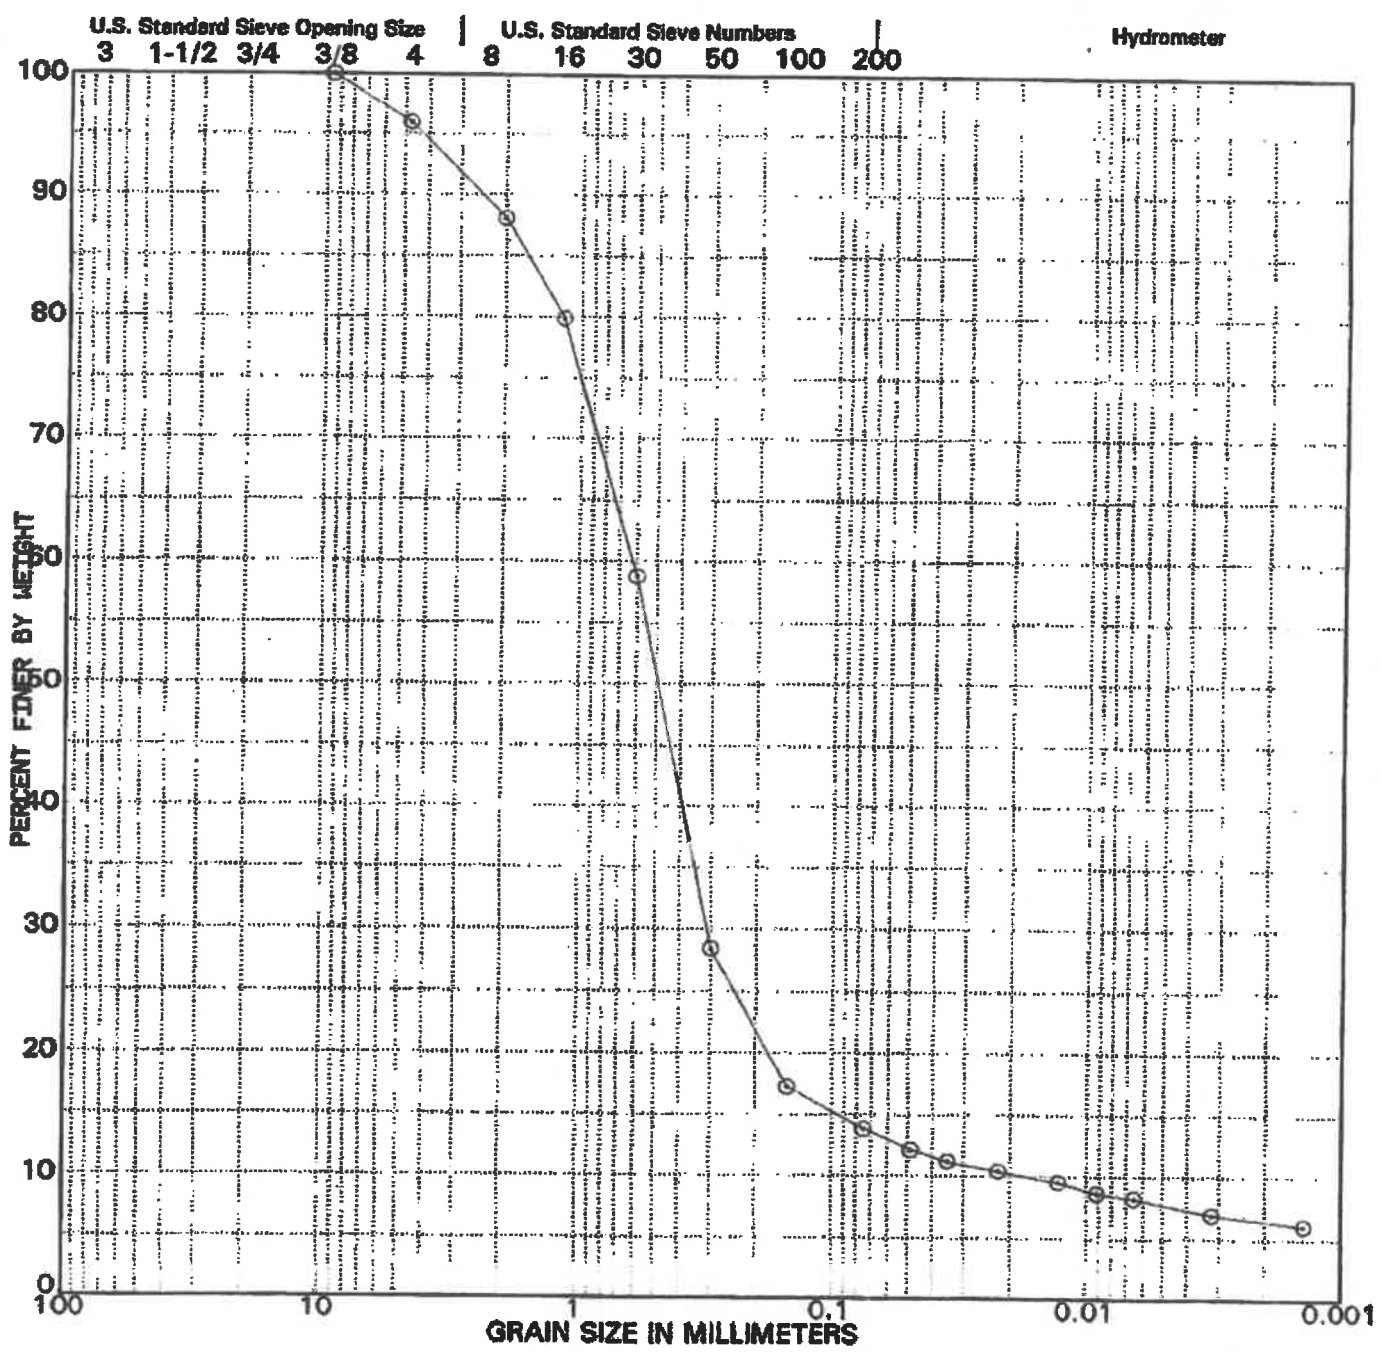
Cobbles	GRAVEL		SAND			SILT	CLAY
	COARSE	FINE	COARSE	MEDIUM	FINE		
⊙							
SYMBOL	SAMPLE SOURCE					CLASSIFICATION	
⊙	B-2 @ 16.0'					Brown Clayey Sand (SC)

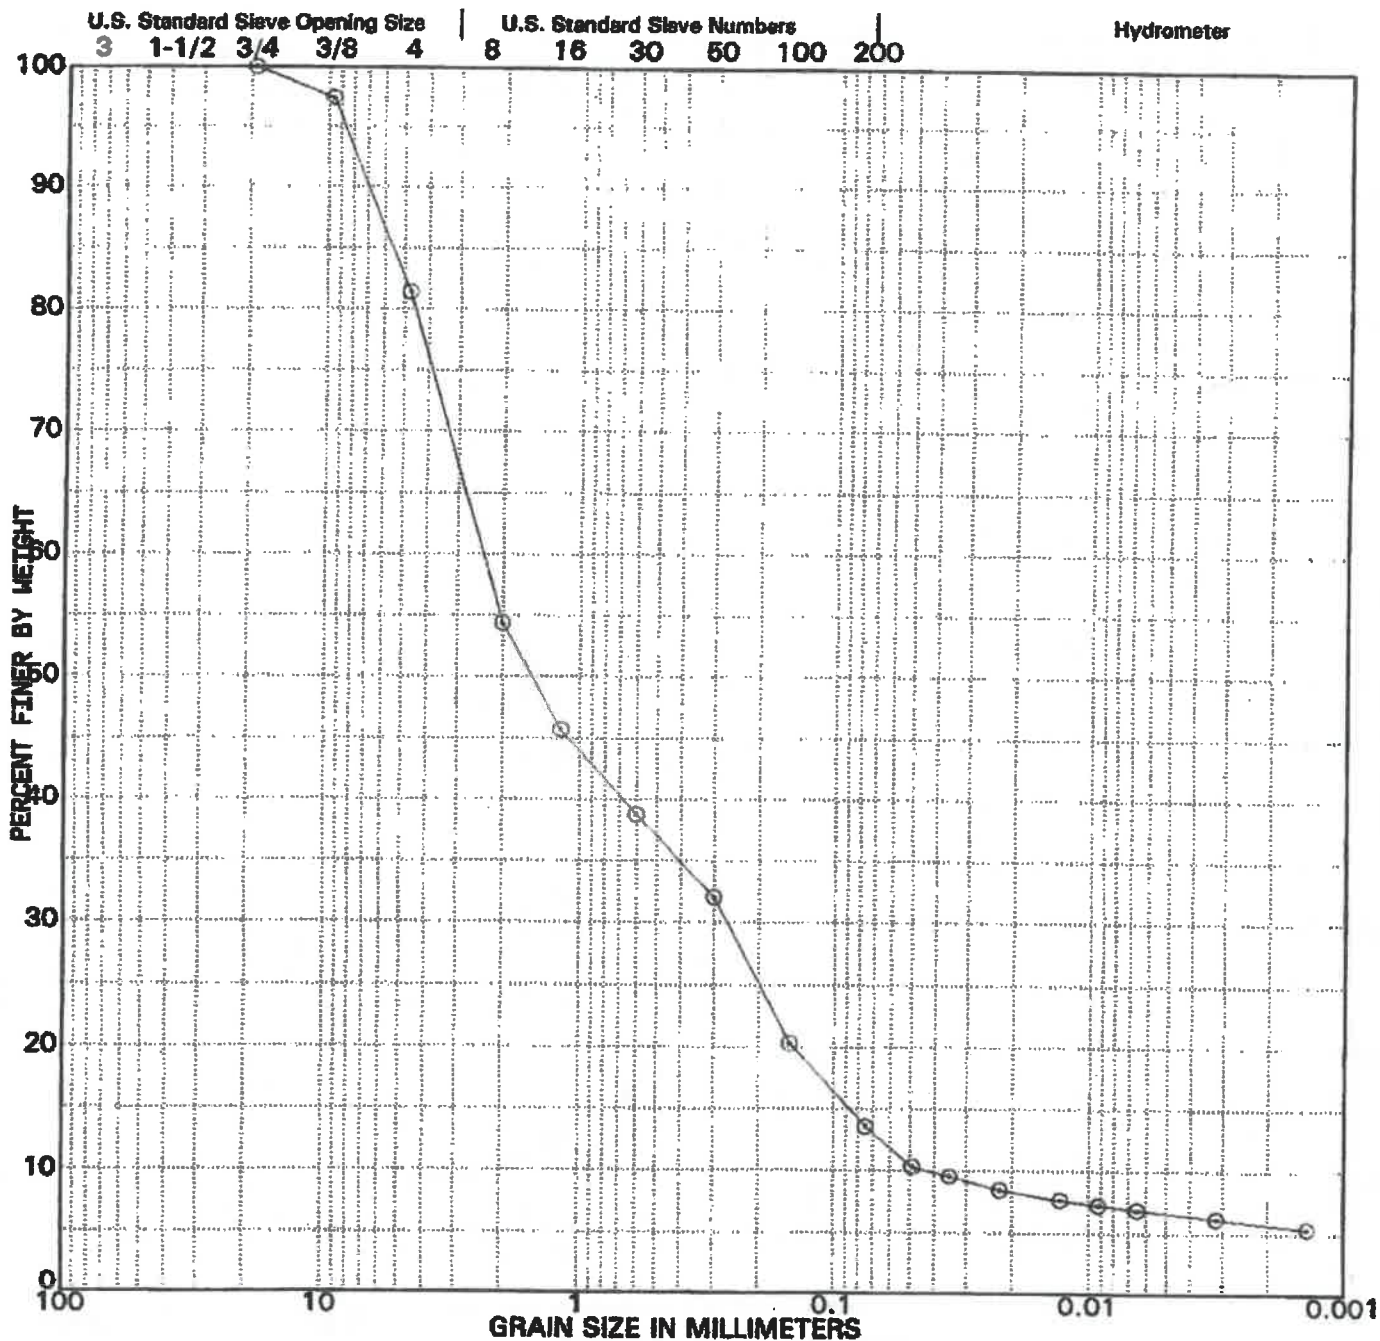
Cobbles	GRAVEL		SAND			SILT	CLAY
	COARSE	FINE	COARSE	MEDIUM	FINE		
○							
SYMBOL	SAMPLE SOURCE					CLASSIFICATION	
○	B- 2 @ 25.5'					Grey Clayey Sand (SC)

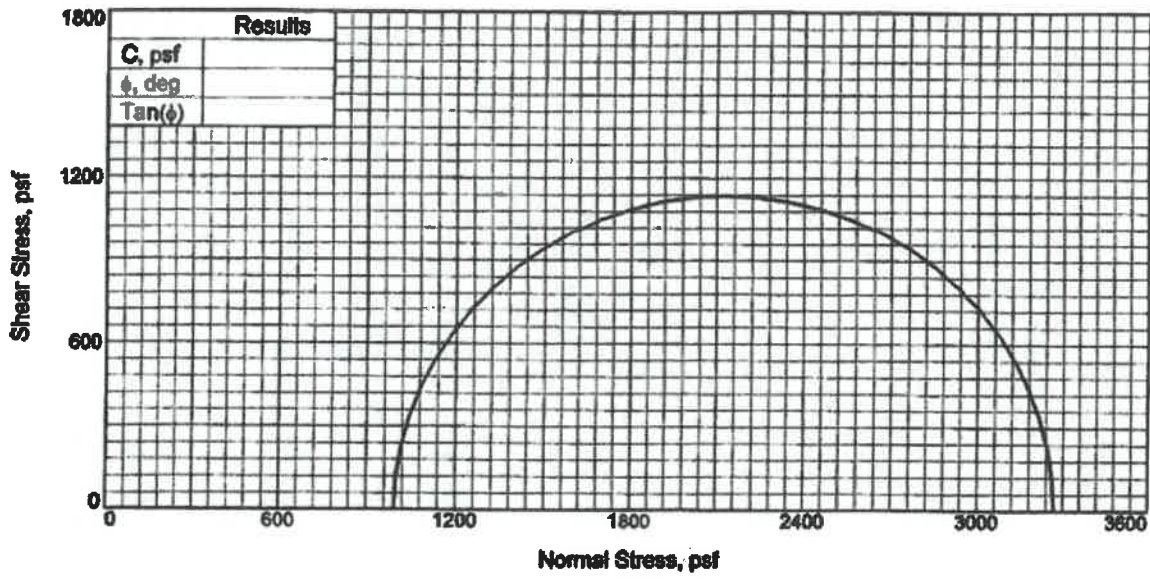
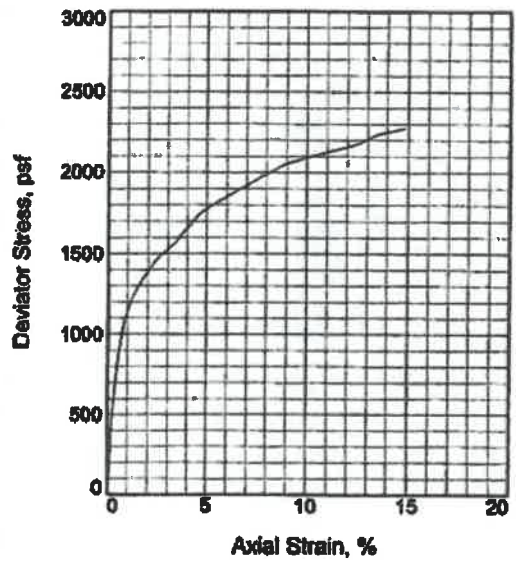
Sample No.	1	
Initial	Water Content,	22.3
	Dry Density, pcf	99.9
	Saturation,	87.9
	Void Ratio	0.6865
	Diameter, in.	2.43
At Test	Height, in.	5.80
	Water Content,	22.3
	Dry Density, pcf	99.9
	Saturation,	87.9
	Void Ratio	0.6865
Strain rate, in./min.		0.08
	Back Pressure, psf	0.0
Cell Pressure, psf		993.6
Fail. Stress, psf		2272.9
Strain, %		14.8
Ult. Stress, psf		
Strain, %		
σ_1 Failure, psf		3266.5
σ_3 Failure, psf		993.6

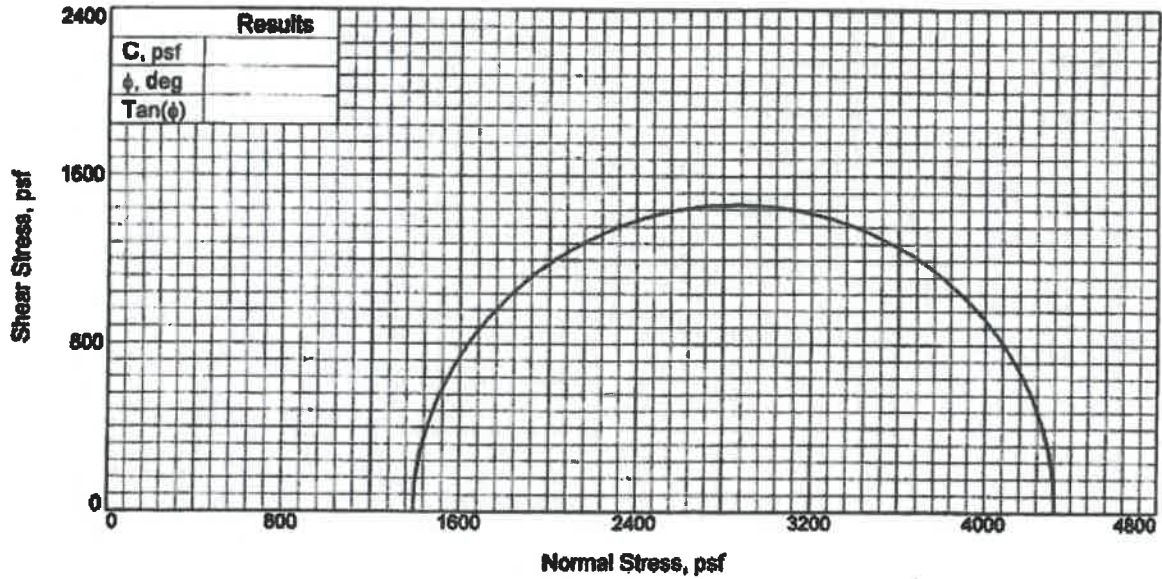
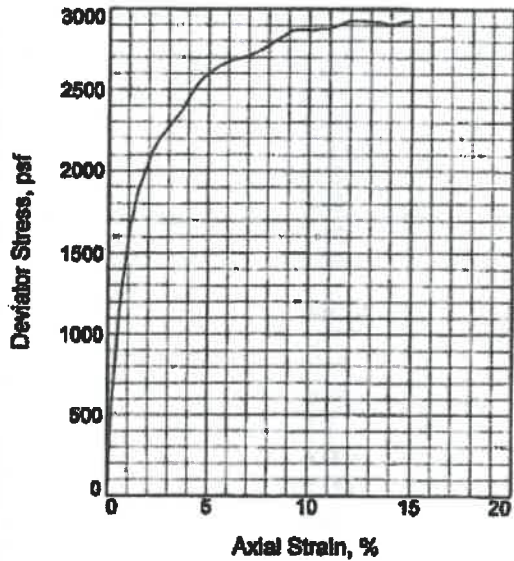
Sample No.	1	
Initial	Water Content,	18.5
	Dry Density, pcf	106.3
	Saturation,	85.2
	Void Ratio	0.5860
	Diameter, in.	2.43
	Height, in.	5.50
At Test	Water Content,	18.5
	Dry Density, pcf	106.3
	Saturation,	85.2
	Void Ratio	0.5860
	Diameter, in.	2.43
	Height, in.	5.50
Strain rate, in./min.	0.08	
Back Pressure, psf	0.0	
Cell Pressure, psf	1396.8	
Fail. Stress, psf	2928.1	
Strain, %	12.0	
Ult. Stress, psf		
Strain, %		
σ_1 Failure, psf	4324.9	
σ_3 Failure, psf	1396.8

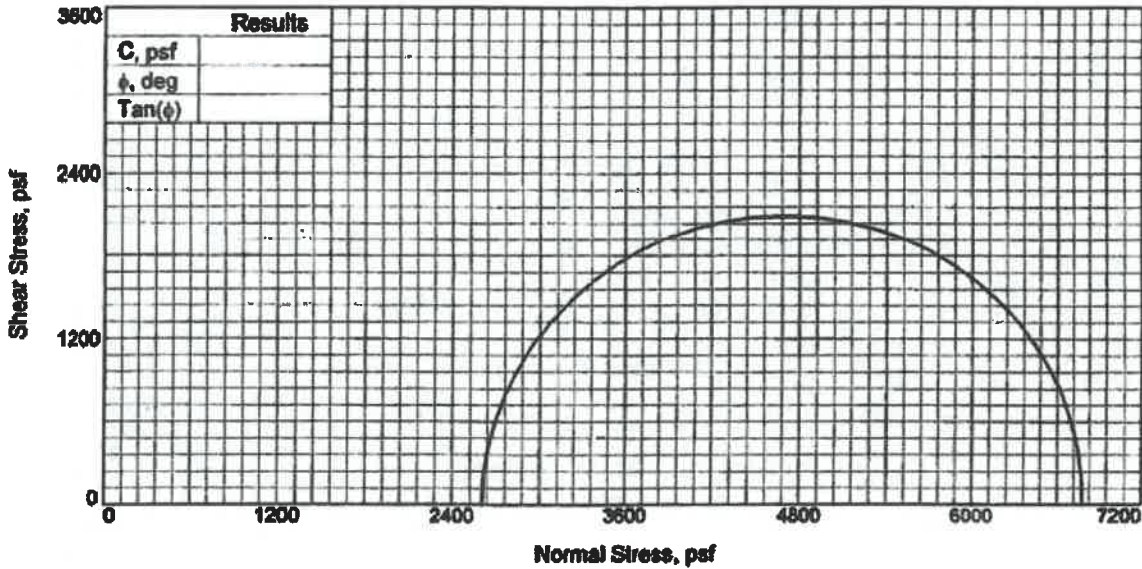
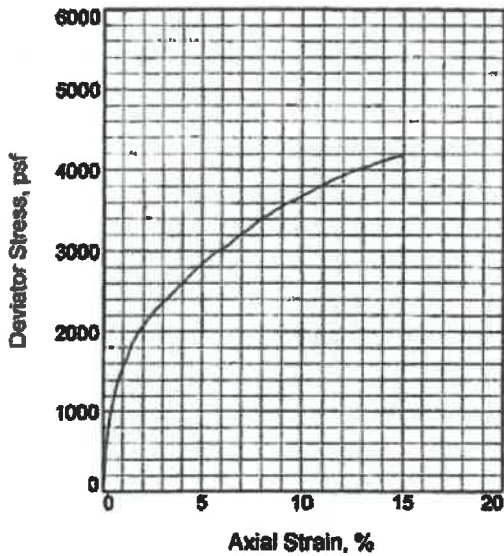
Sample No.	1	
Initial	Water Content,	20.8
	Dry Density, pcf	104.1
	Saturation,	90.9
	Void Ratio	0.6185
	Diameter, in.	2.43
At Test	Height, in.	6.00
	Water Content,	20.8
	Dry Density, pcf	104.1
	Saturation,	90.9
	Void Ratio	0.6185
Strain rate, in./min.		0.08
	Back Pressure, psf	0.0
Cell Pressure, psf		2606.4
Fail. Stress, psf		4185.4
Strain, %		15.0
Ult. Stress, psf		
Strain, %		
σ_1 Failure, psf		6791.8
σ_3 Failure, psf		2606.4

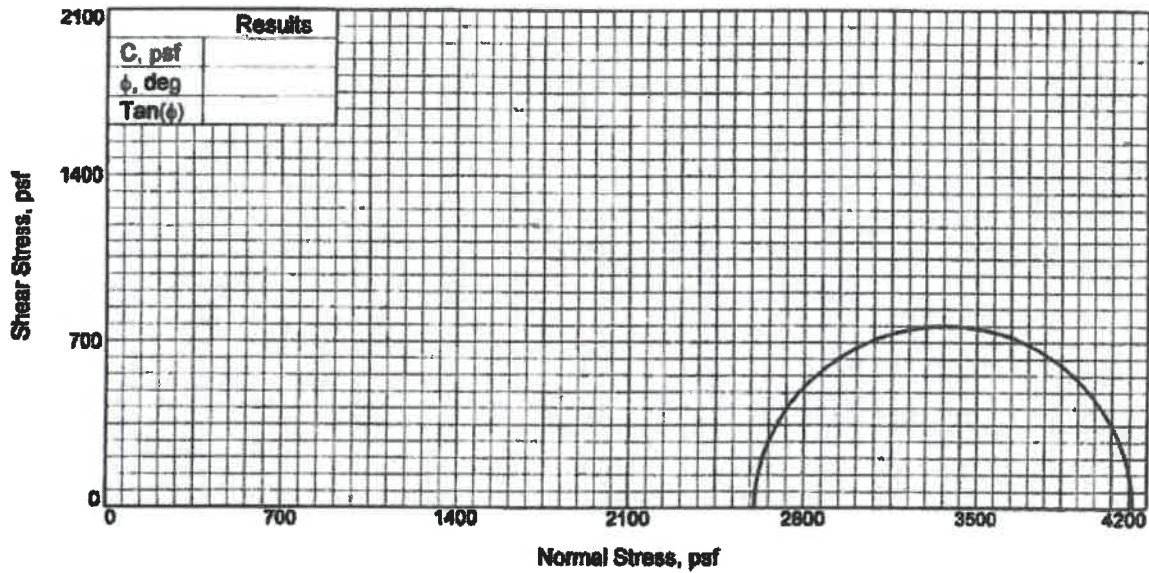
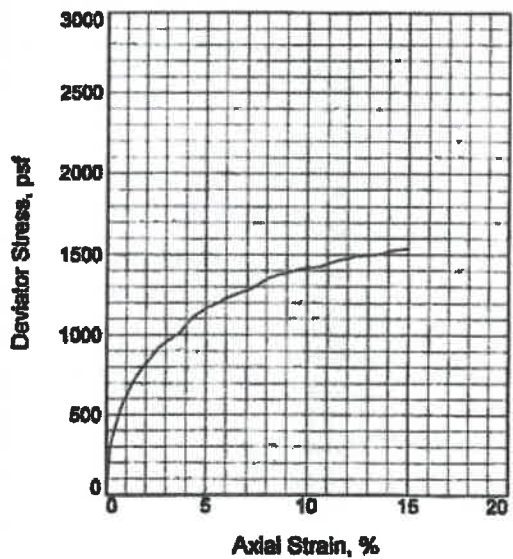
Sample No.	1	
Initial	Water Content,	17.2
	Dry Density, pcf	106.6
	Saturation,	80.1
	Void Ratio	0.5806
	Diameter, in.	2.43
	Height, in.	6.00
At Test	Water Content,	17.2
	Dry Density, pcf	106.6
	Saturation,	80.1
	Void Ratio	0.5806
	Diameter, in.	2.43
	Height, in.	6.00
Strain rate, in./min.	0.08	
Back Pressure, pcf	0.0	
Cell Pressure, pcf	2606.4	
Fail. Stress, pcf	1537.5	
Strain, %	15.0	
Ult. Stress, pcf		
Strain, %		
σ_1 Failure, pcf	4143.9	
σ_3 Failure, pcf	2606.4

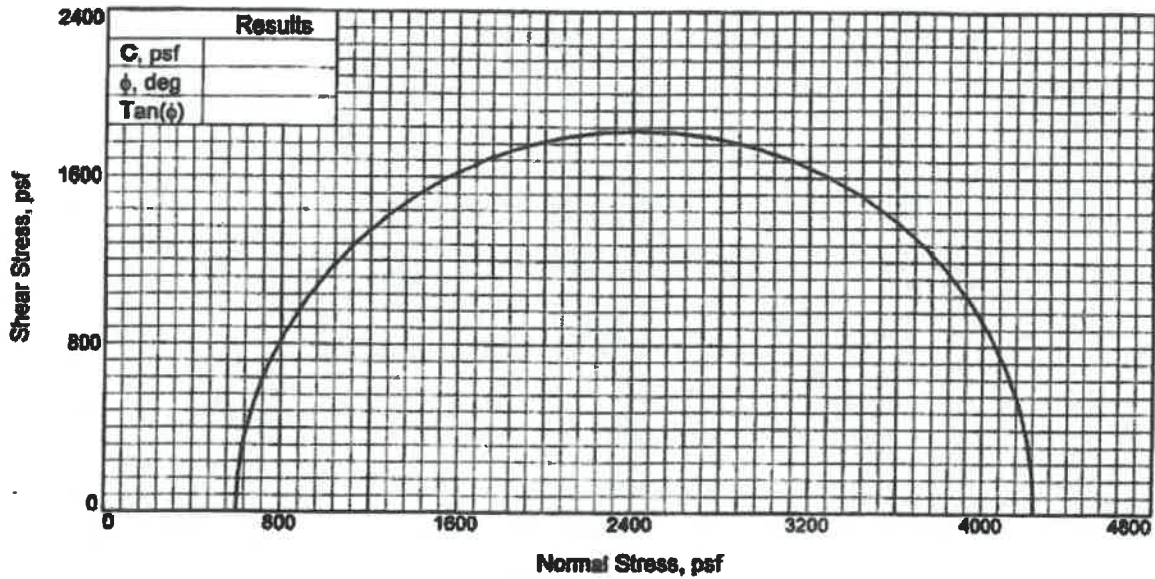
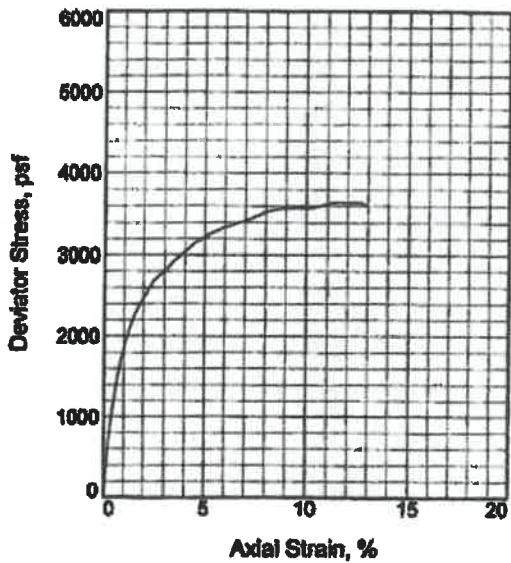
Sample No.		1
Initial	Water Content,	27.0
	Dry Density, pcf	96.8
	Saturation,	98.6
	Void Ratio	0.7405
	Diameter, in.	2.43
At Test	Height, in.	5.70
	Water Content,	27.0
	Dry Density, pcf	96.8
	Saturation,	98.6
	Void Ratio	0.7405
Diameter, in.		2.43
Height, in.		5.70
Strain rate, in./min.		0.08
Back Pressure, psf		0.0
Cell Pressure, psf		604.8
Fail. Stress, psf		3643.5
Strain, %		12.3
Ult. Stress, psf		
Strain, %		
σ_1 Failure, psf		4248.3
σ_3 Failure, psf		604.8

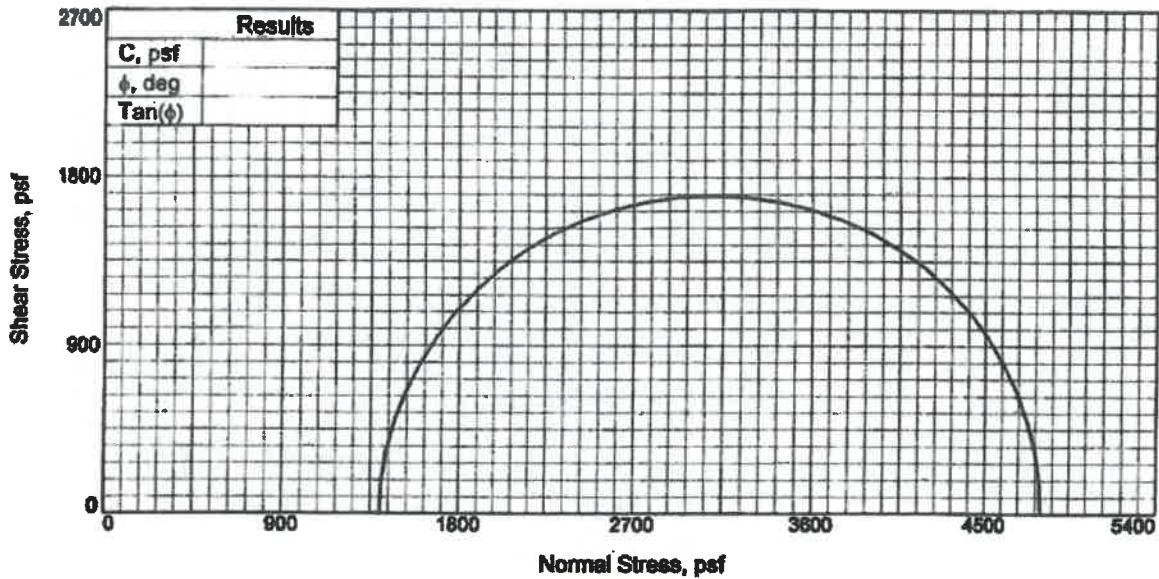
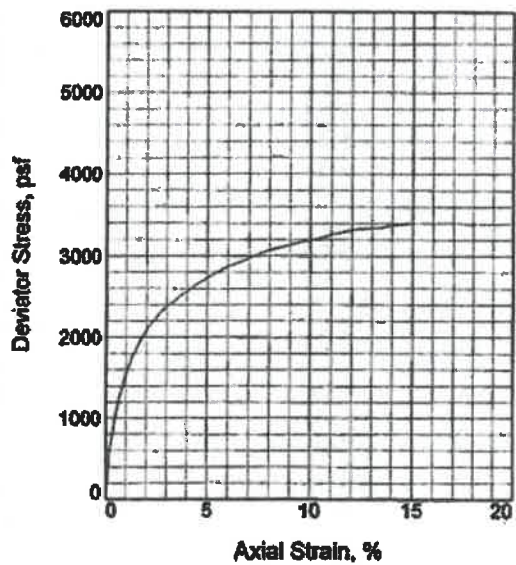
Sample No.	1	
Initial	Water Content,	27.3
	Dry Density, pcf	96.9
	Saturation,	99.7
	Void Ratio	0.7395
	Diameter, in.	2.43
At Test	Height, in.	5.93
	Water Content,	27.3
	Dry Density, pcf	96.9
	Saturation,	99.7
	Void Ratio	0.7395
	Diameter, in.	2.43
	Height, in.	5.93
Strain rate, in./min.	0.08	
Back Pressure, psf	0.0	
Cell Pressure, psf	1396.8	
Fail. Stress, psf	3404.1	
Strain, %	14.8	
Ult. Stress, psf		
Strain, %		
σ_1 Failure, psf	4800.9	
σ_3 Failure, psf	1396.8

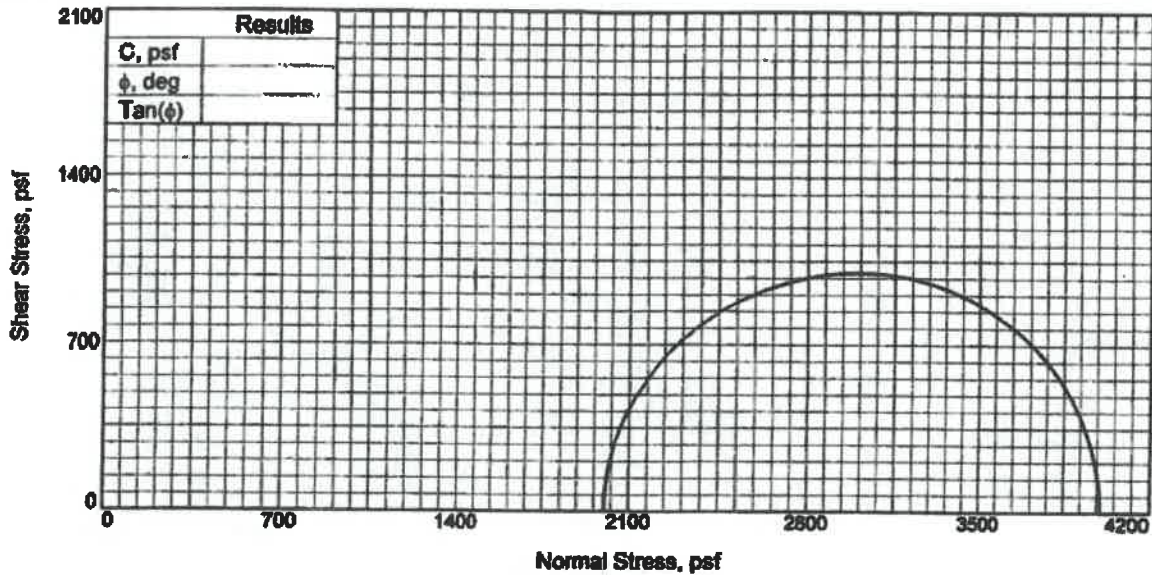
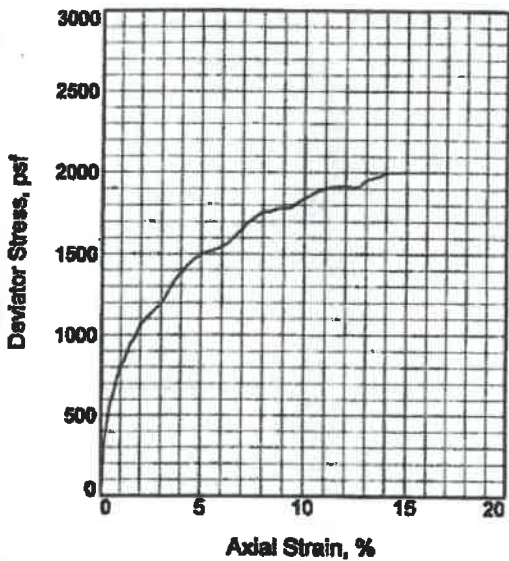
Sample No.	1	
Initial	Water Content, %	20.8
	Dry Density, pcf	106.2
	Saturation, %	95.5
	Void Ratio	0.5873
	Diameter, in.	2.43
At Test	Height, in.	6.00
	Water Content, %	20.8
	Dry Density, pcf	106.2
	Saturation, %	95.5
	Void Ratio	0.5873
	Diameter, in.	2.43
	Height, in.	6.00
	Strain rate, in./min.	0.08
	Back Pressure, psf	0.0
	Cell Pressure, psf	2001.6
Fail. Stress, psf	2002.5	
Strain, %	15.0	
Ult. Stress, psf		
Strain, %		
σ_1 Failure, psf	4004.1	
σ_3 Failure, psf	2001.6

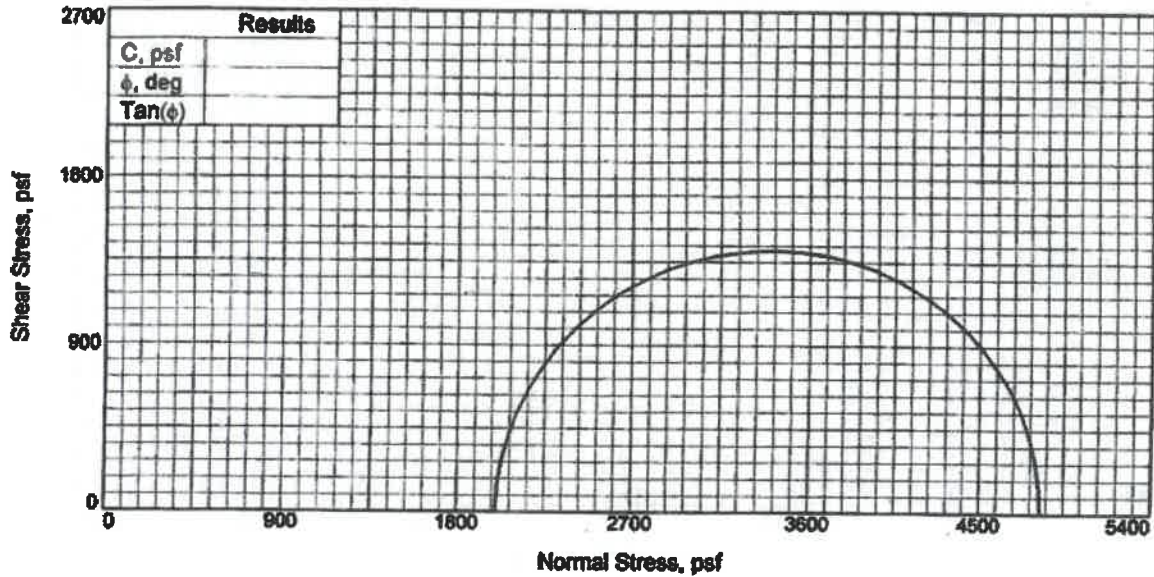
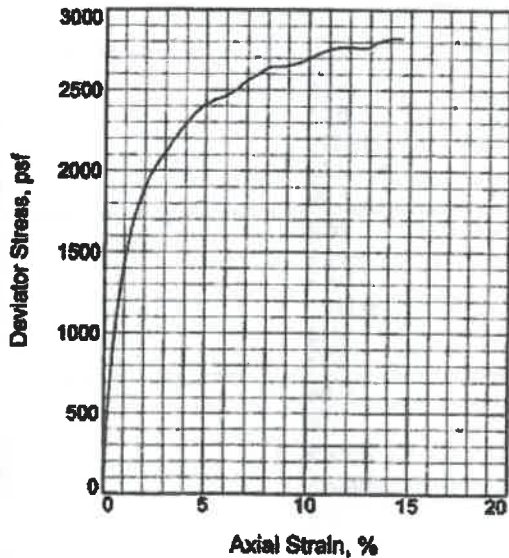
Sample No.	1	
Initial	Water Content,	25.3
	Dry Density, pcf	100.1
	Saturation,	99.9
	Void Ratio	0.6841
	Diameter, in.	2.43
At Test	Height, in.	5.89
	Water Content,	25.3
	Dry Density, pcf	100.1
	Saturation,	99.9
	Void Ratio	0.6841
Strain rate, in./min.	Diameter, in.	2.43
	Back Pressure, psf	0.0
	Cell Pressure, psf	2001.6
	Fail. Stress, psf	2824.1
	Strain, %	14.3
Ult. Stress, psf	Strain, %	
	σ_1 Failure, psf	4825.7
	σ_2 Failure, psf	2001.6

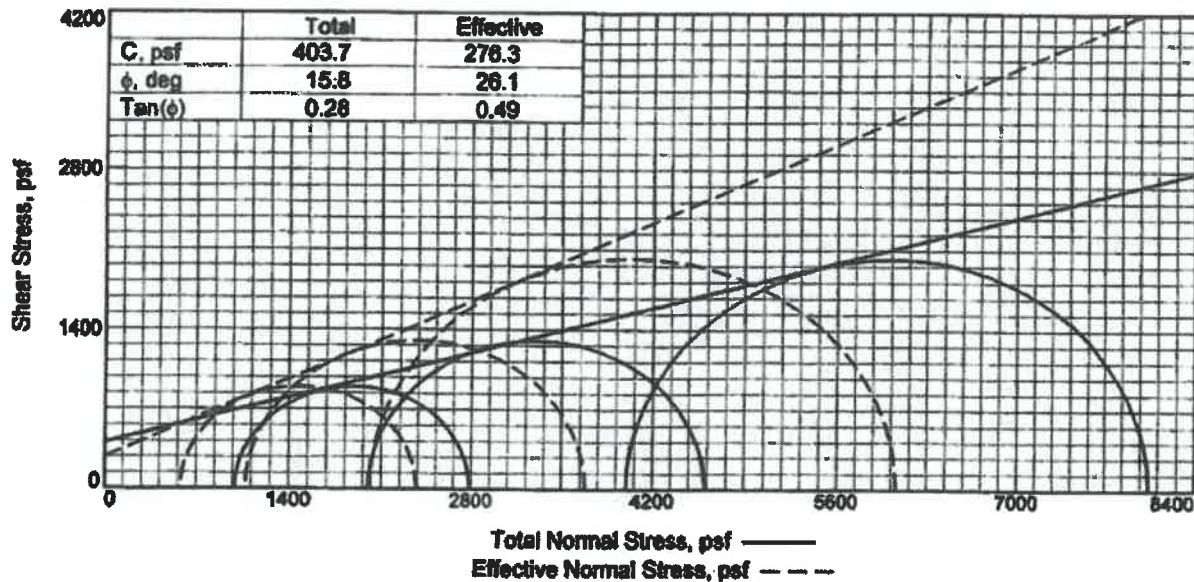
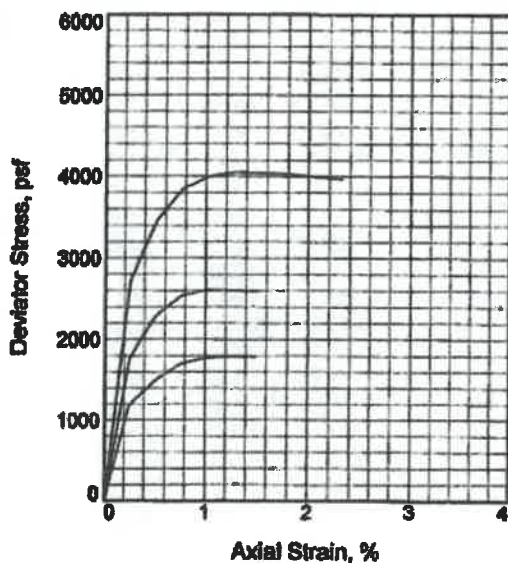
Sample No.	1	2	3
Initial			
Water Content,	14.7	14.7	14.7
Dry Density, pcf	113.3	113.3	113.3
Saturation,	81.4	81.4	81.4
Void Ratio	0.4880	0.4880	0.4880
Diameter, in.	2.43	2.43	2.43
Height, in.	5.00	5.00	5.00
At Test			
Water Content,	22.3	21.4	20.2
Dry Density, pcf	105.3	106.9	109.0
Saturation,	100.0	100.0	100.0
Void Ratio	0.6012	0.5769	0.5459
Diameter, in.	2.52	2.53	2.54
Height, in.	5.02	4.88	4.75
Strain rate, in./min.	0.01	0.01	0.01
Eff. Cell Pressure, psf	999.4	2000.2	4000.3
Fail. Stress, psf	1788.3	2605.7	4047.4
Total Pore Pr., psf	9345.6	9849.6	10915.2
Strain, %	1.3	1.0	1.3
Ult. Stress, psf			
Total Pore Pr., psf			
Strain, %			
$\bar{\sigma}_1$ Failure, psf	2370.0	3684.2	6060.5
$\bar{\sigma}_3$ Failure, psf	581.8	1078.6	2013.1

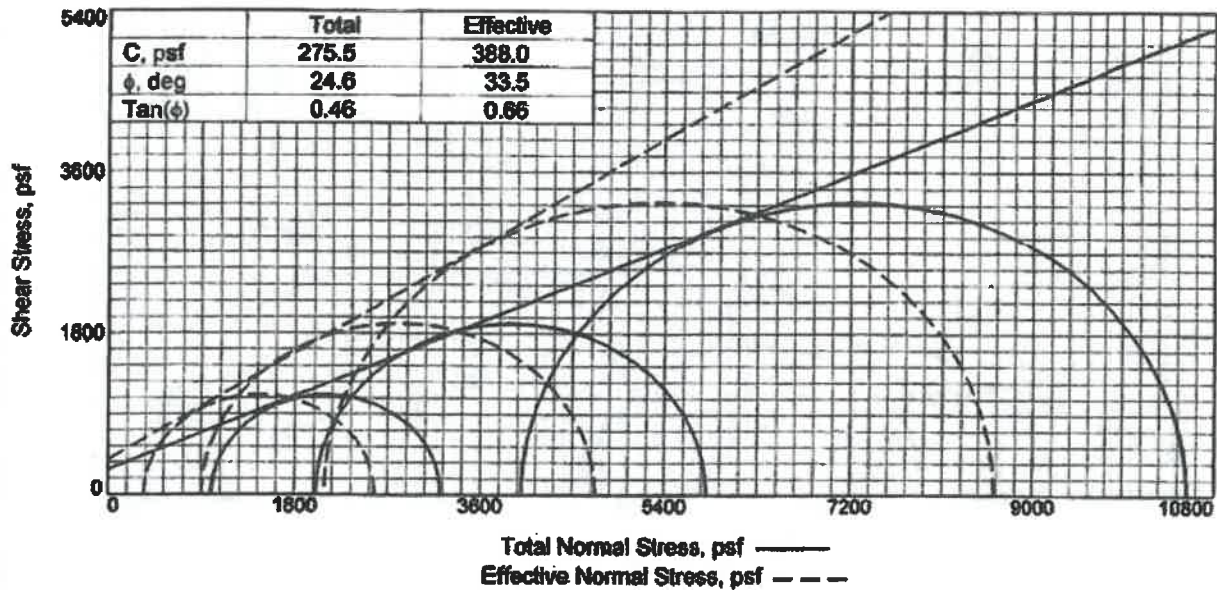
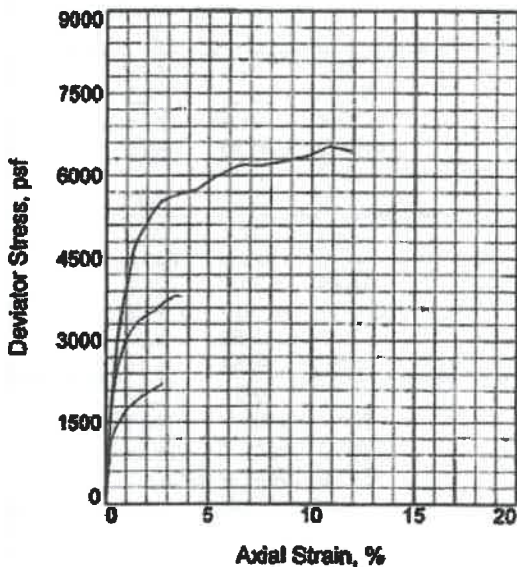
Sample No.	1	2	3
Initial			
Water Content,	21.7	21.7	21.7
Dry Density, pcf	101.5	101.5	101.5
Saturation,	88.7	88.7	88.7
Void Ratio	0.6609	0.6609	0.6609
Diameter, in.	2.41	2.41	2.41
Height, in.	5.65	5.65	5.65
At Test			
Water Content,	24.9	23.8	22.4
Dry Density, pcf	100.7	102.5	105.0
Saturation,	100.0	100.0	100.0
Void Ratio	0.6736	0.6437	0.6052
Diameter, in.	2.44	2.48	2.53
Height, in.	5.56	5.29	4.95
Strain rate, in./min.	0.00	0.00	0.00
Eff. Cell Pressure, psf	999.4	2000.2	4000.3
Fail. Stress, psf	2220.1	3814.6	6535.1
Total Pore Pr., psf	9576.0	10022.4	10843.2
Strain, %	2.8	3.4	10.8
Ult. Stress, psf			
Total Pore Pr., psf			
Strain, %			
$\bar{\sigma}_1$ Failure, psf	2571.4	4720.4	8620.3
$\bar{\sigma}_3$ Failure, psf	351.4	905.8	2085.1

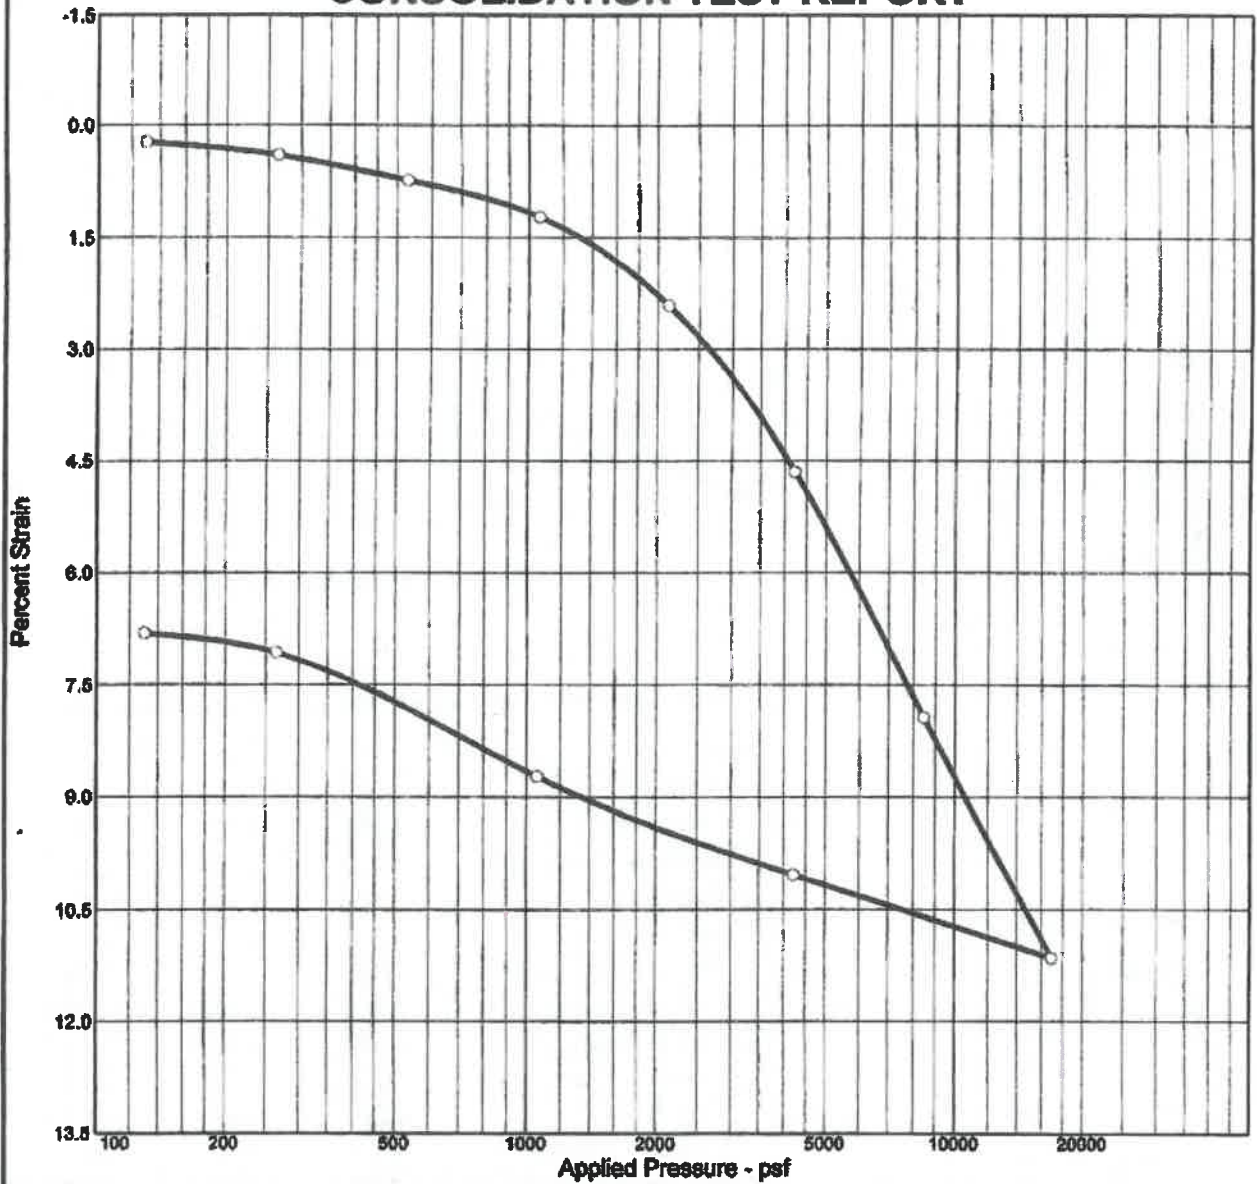
CONSOLIDATION TEST REPORT

Natural Sat.	Natural Moist.	Dry Dens. (pcf)	LL	PI	Sp. Gr.	Overburden (psf)	P _c (psf)	C _c	C _r	Swell Press. (psf)	Swell %	e ₀
87.8 %	25.3 %	94.9			2.70		2359	0.19	0.03			0.779

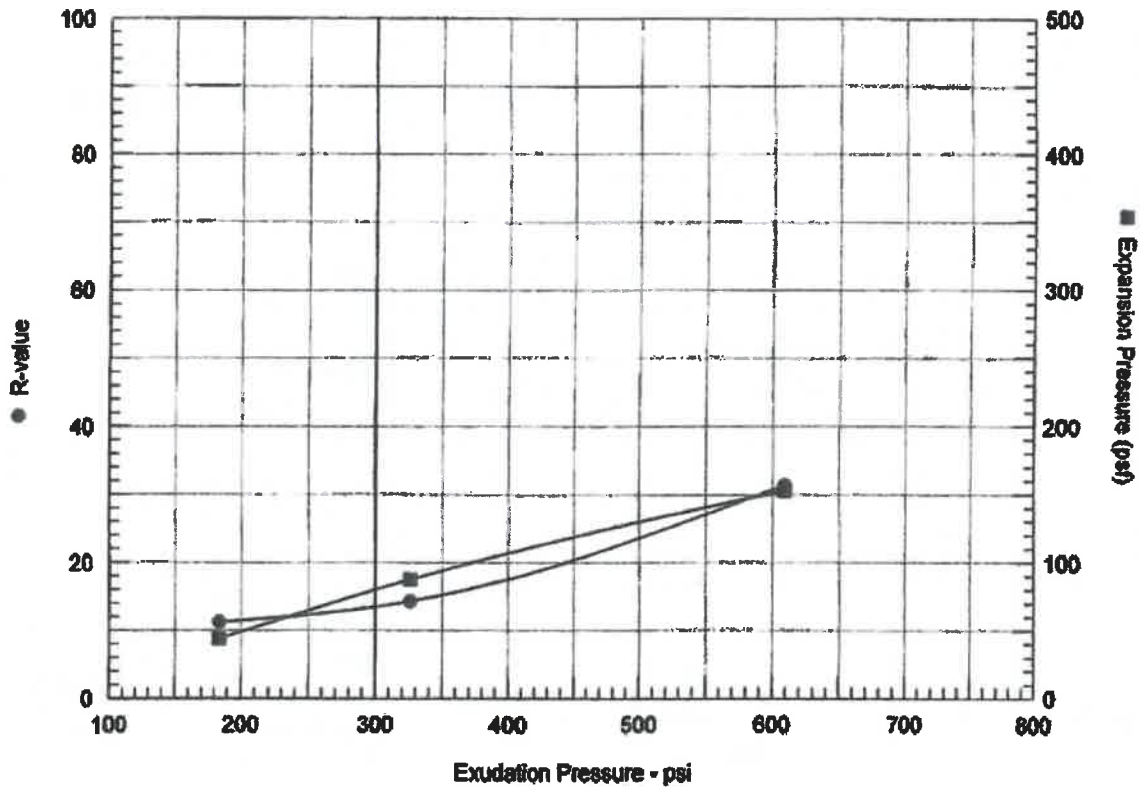
R-VALUE TEST REPORT

Resistance R-Value and Expansion Pressure - ASTM D 2844

Test Results	Material Description
<p>R-value at 300 psi exudation pressure = 13</p> <p>Exp. pressure at 300 psi exudation pressure = 80 psf</p>	<p style="text-align: center;">Brown Sandy Lean Clay W/Gravel (CL)</p>
<p>Project No.: 2184.1.5.1</p> <p>Project: Santa Rosa Cannery, Santa Rosa</p> <p>Source of Sample: FI, BI Composite Depth: 0.0'</p> <p>Date: 2/4/2005</p>	
<p>R-VALUE TEST REPORT</p> <p>RGH Geotechnical</p>	<p>Tested by: DP</p> <p>Checked by: TMc</p> <p>Remarks: Expansion Index = 79 Medium</p>
