# ARCHITECTURAL History Services

September 15, 2021 [Revised November 5, 2021]

RE: Review of 34 6<sup>th</sup> Street, Santa Rosa, Sonoma County, California – APN 010-166-00

## **Summary**

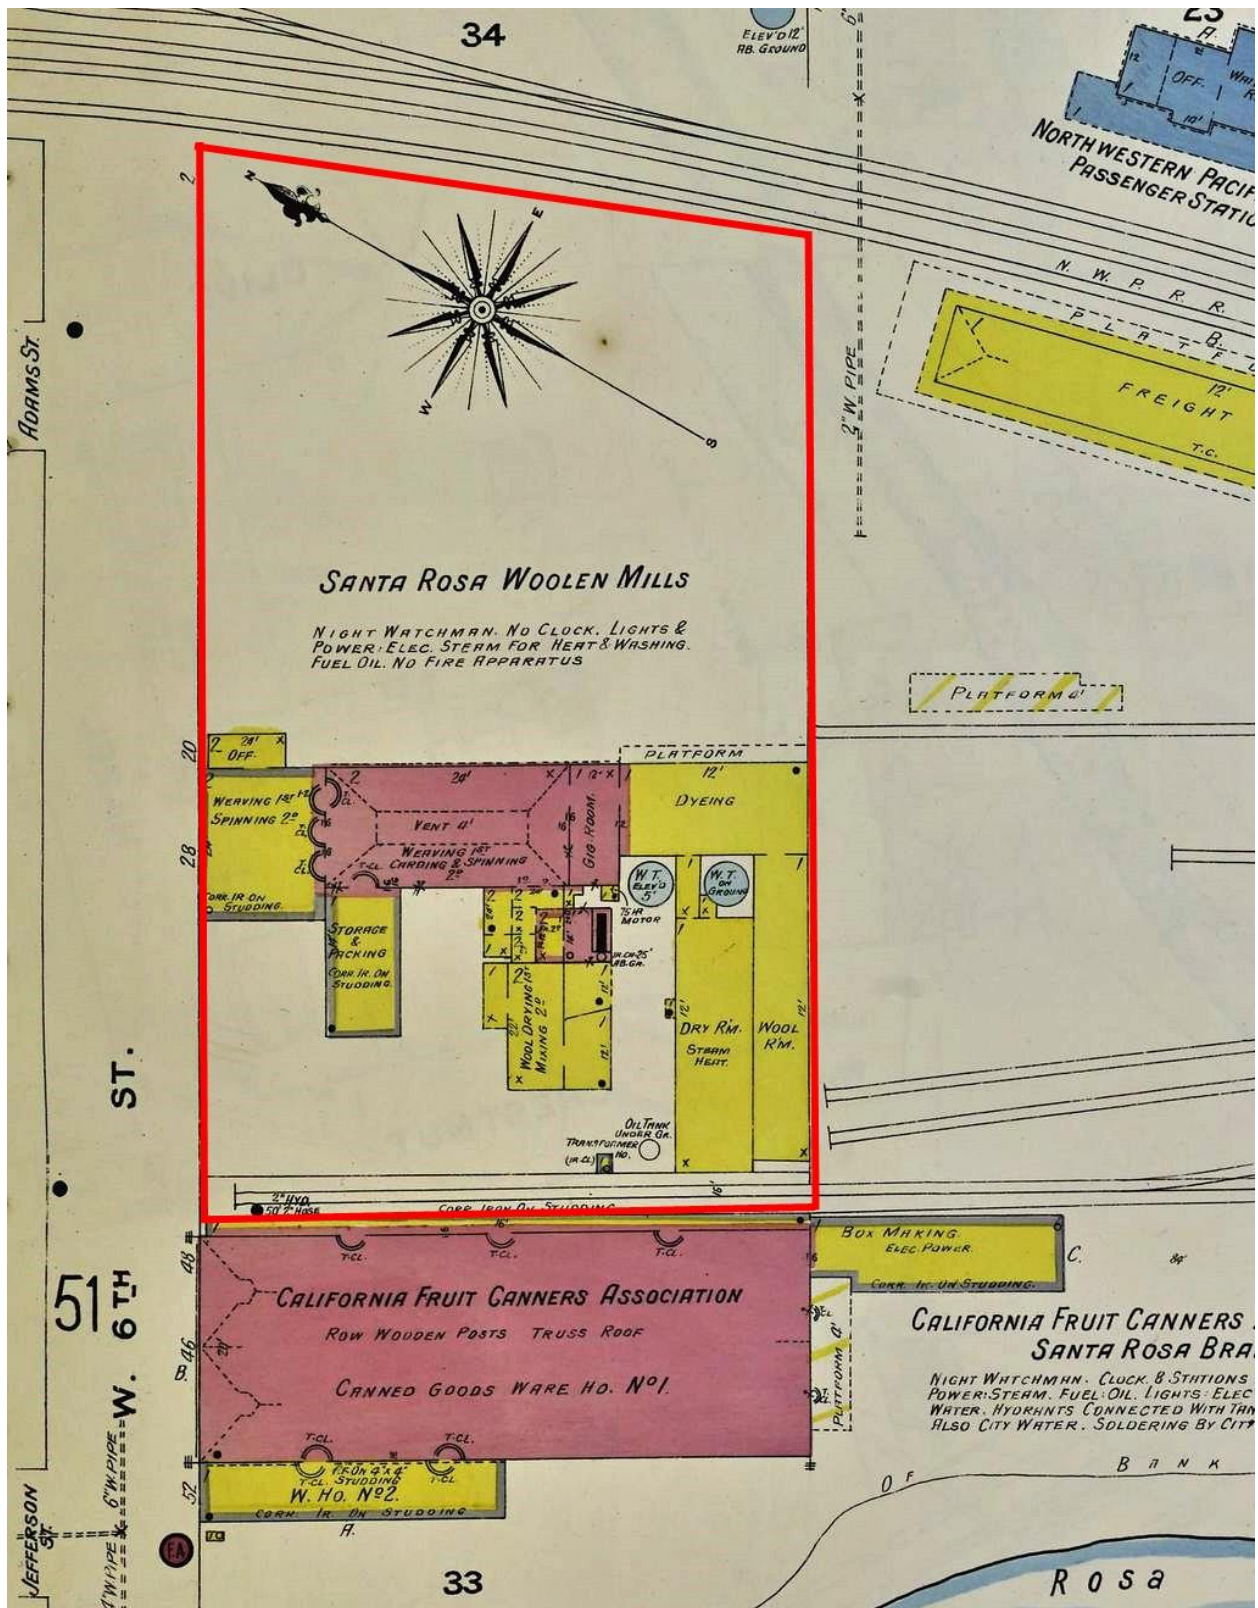
Figure 2: 1908 Santa Rosa Sanborn Fire Insurance Map, Sheet 52.

The site connects historically with the development of the Northwestern Pacific Railroad railyard complex. The 1908 Sanborn Fire Insurance map shows the western half of the parcel occupied by the Santa Rosa Woolen Mills (Figure 2). Established in 1897 by W. B. Humbert, the woolen mills were an important contributor to Santa Rosa's railroad economy.

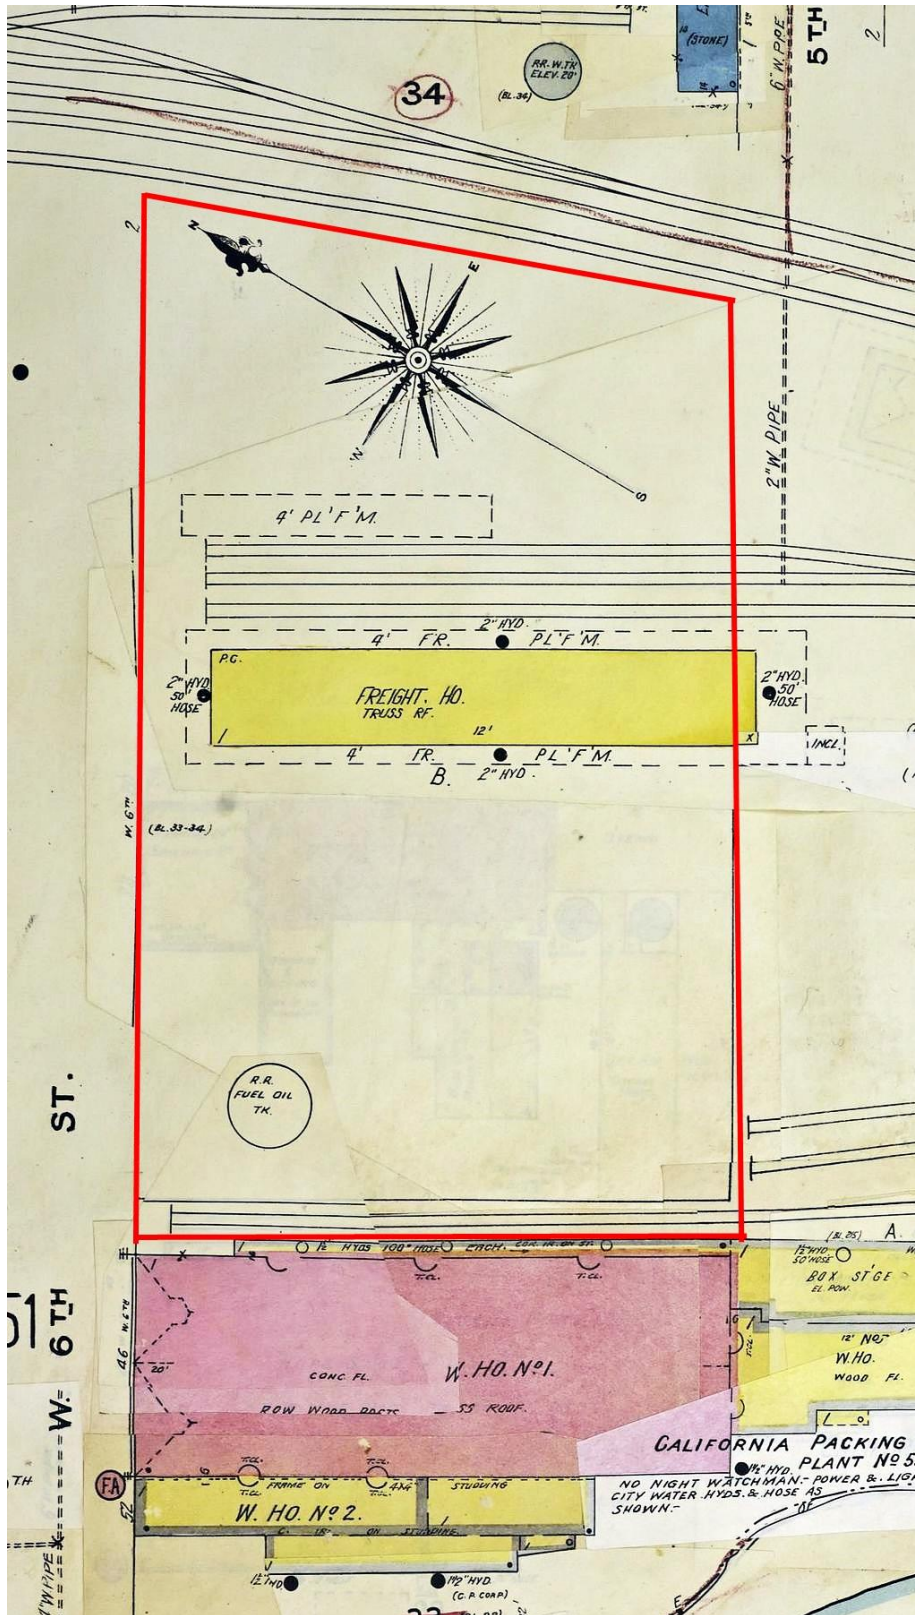
Figure 3: 1950 Santa Rosa Sanborn Fire Insurance Map, Sheet 52.

A fire destroyed the mills in July 1909. After that, the parcel held (as captured in a 1950 Sanborn map) a track-side warehouse (Figure 3). Based on aerial photographs, the warehouse remained on the site through at least the late 1980s (Figures 4 & 5).

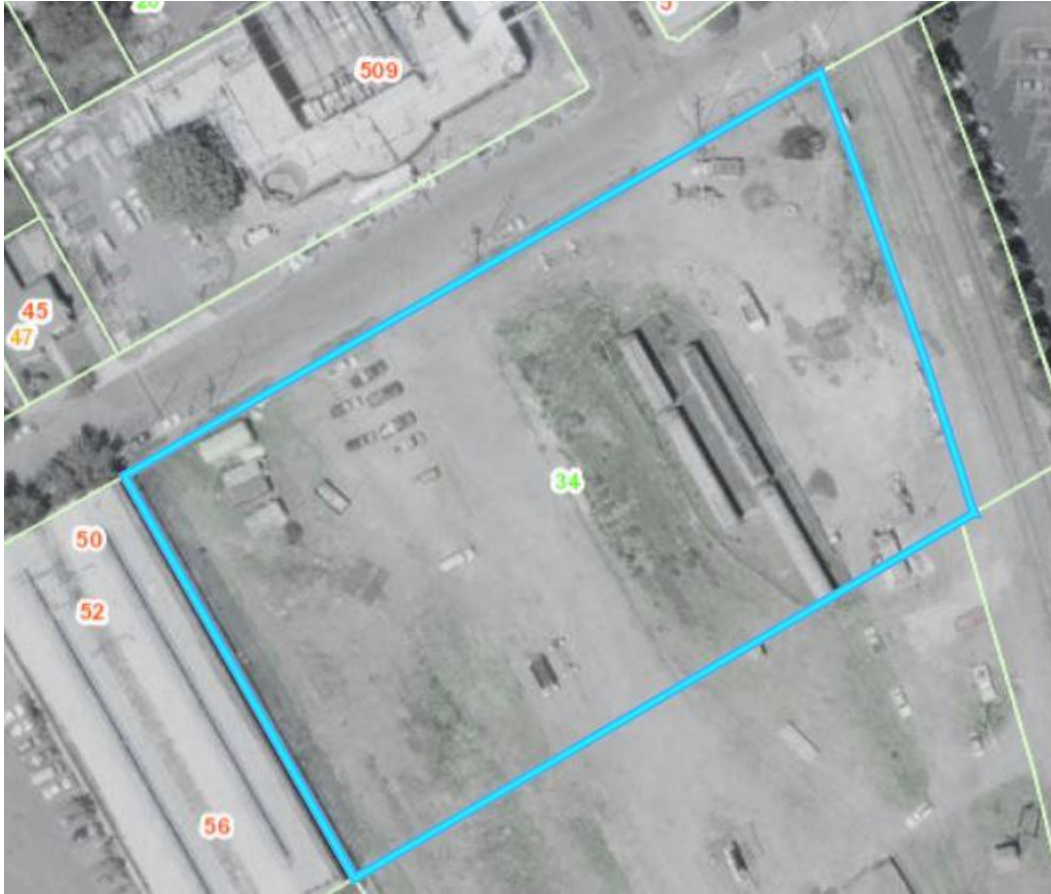
Figure 6: 2001 aerial photograph.  
Courtesy City of Santa Rosa Geographic Information System.

By 2001, the lot had been cleared of all fixed structures (Figure 6).

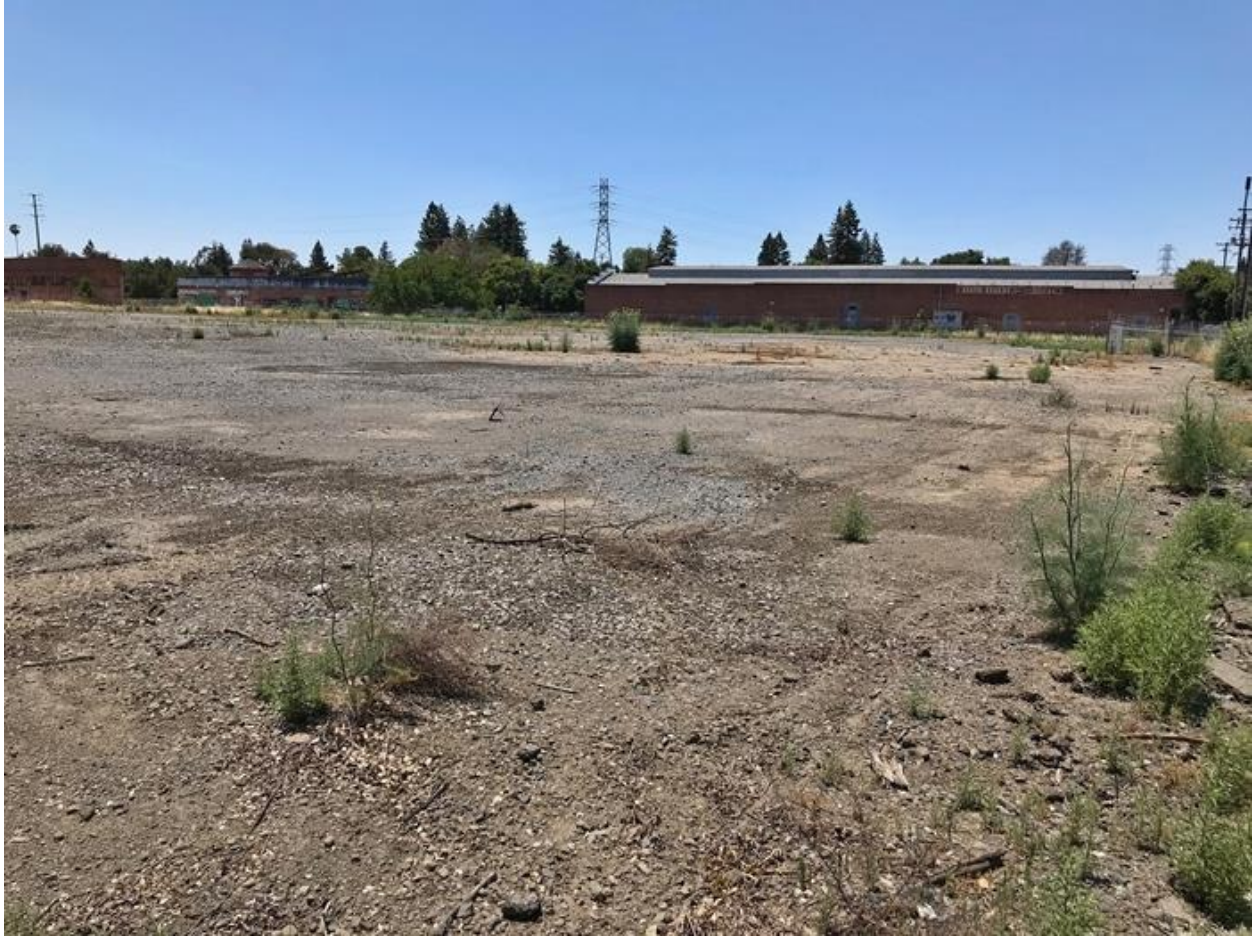
The area was covered with gravel, train-track ballast, and small sections of broken asphalt. One piece of above-ground concrete may correspond to the foundation or footing of an earlier structure. No standing structures were observed.

Figure 9: Northeast corner, view to southwest.  
June 18, 2021.  
John W. Murphey.

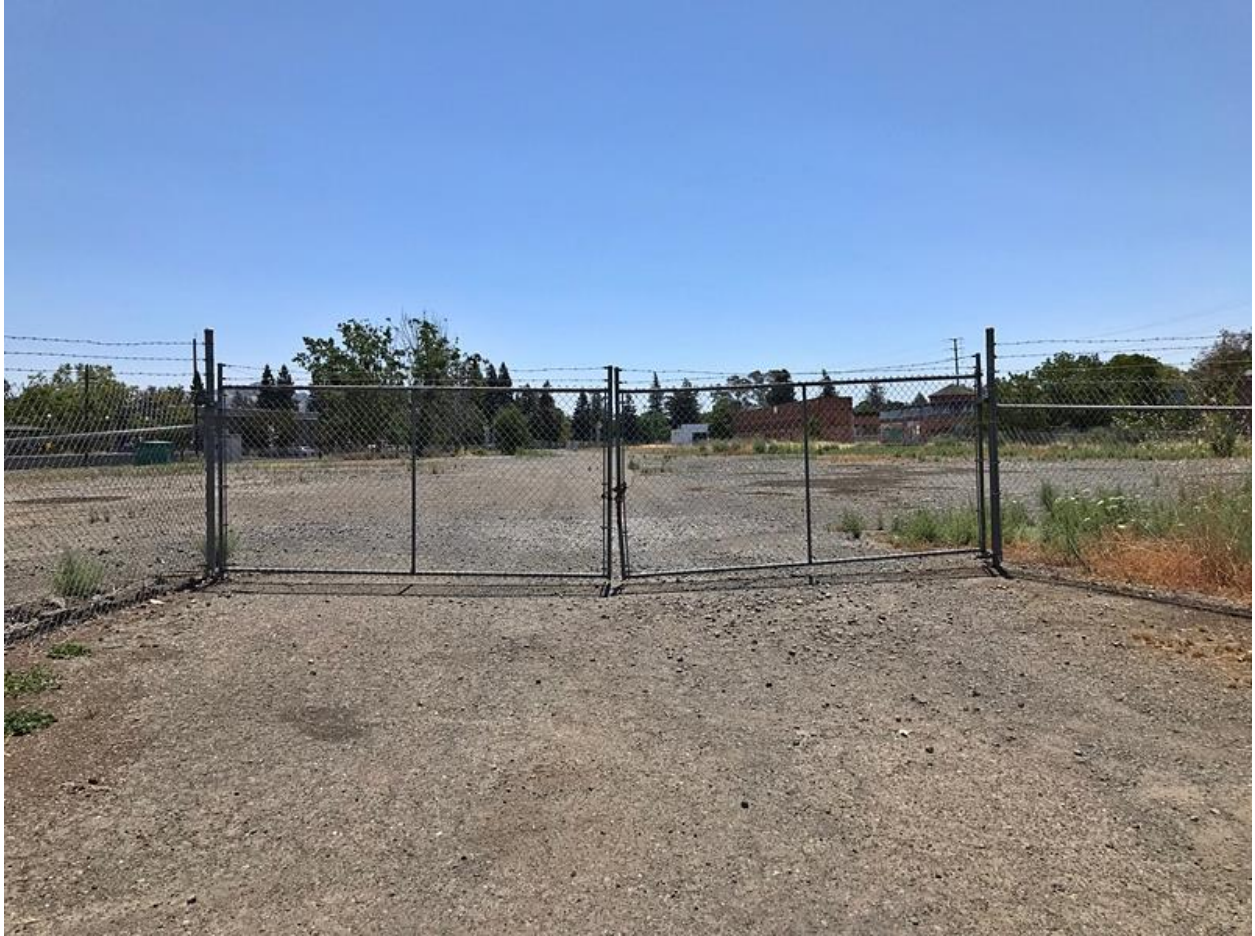
Figure 10: North access gate on West 6<sup>th</sup> Street, view to south.  
June 18, 2021.  
John W. Murphey.

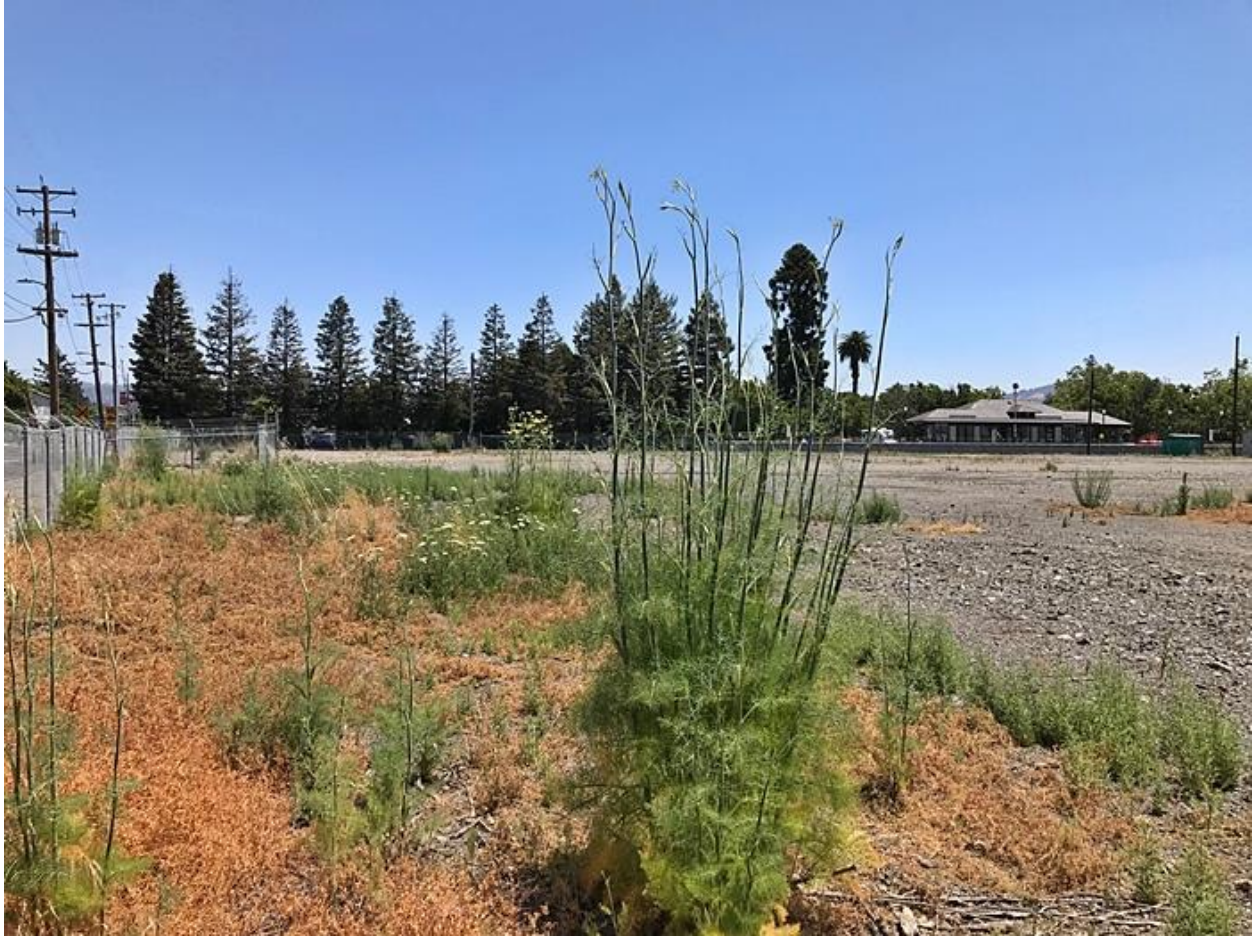
Figure 11: Northwest corner, view to southeast.  
June 18, 2021.  
John W. Murphey.

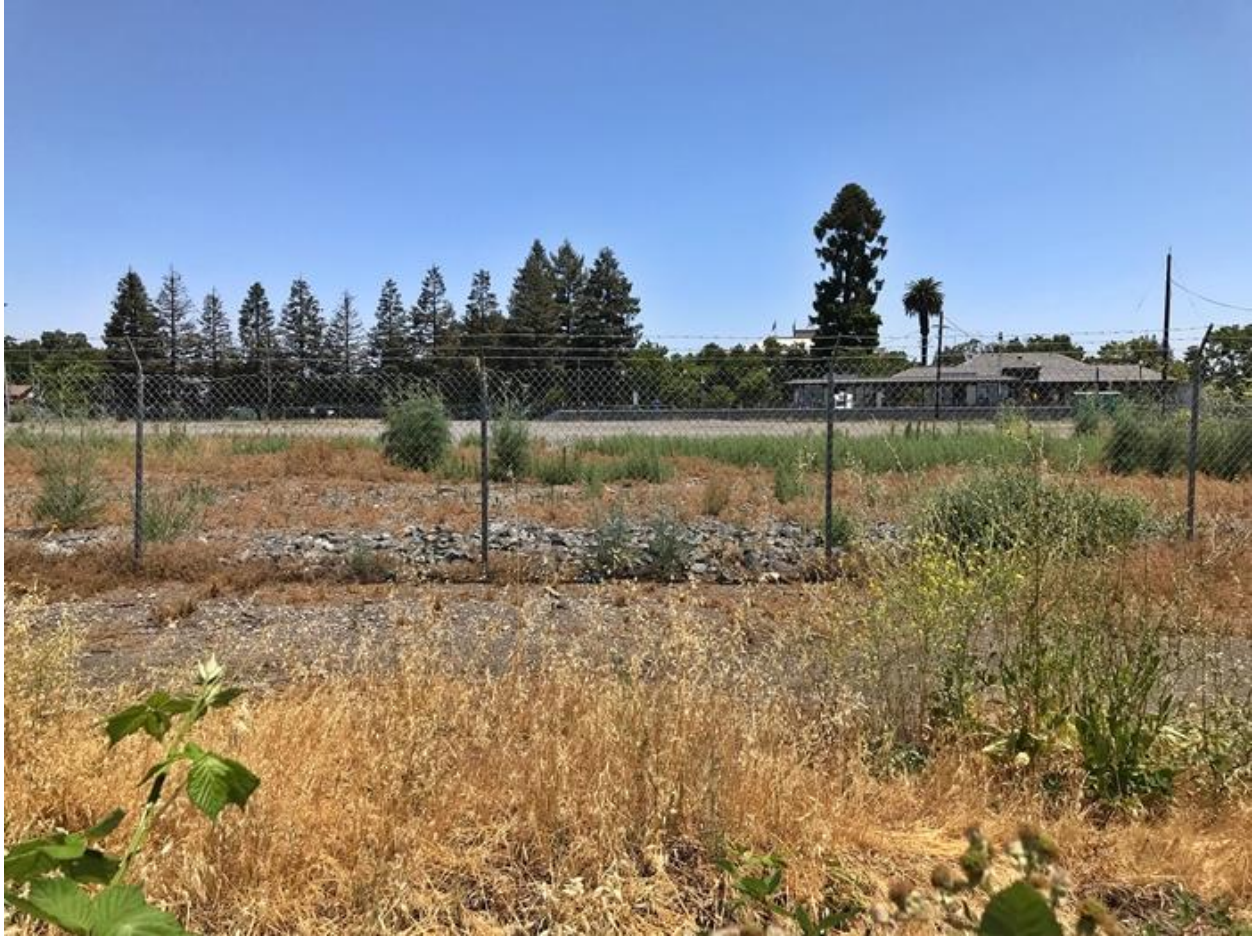
Figure 12: Southwest corner, view to northeast.  
June 18, 2021.  
John W. Murphey.

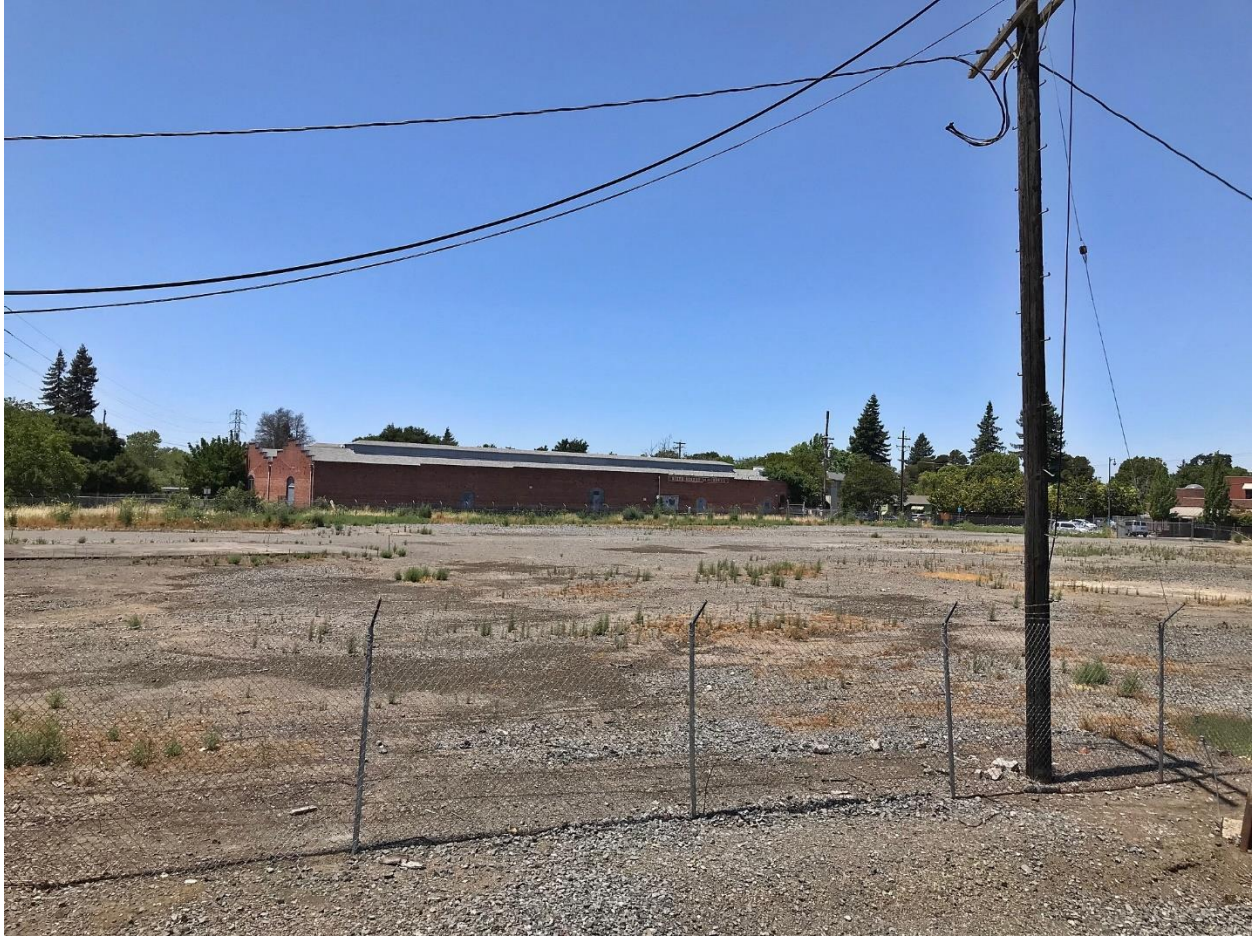
The only observed feature was a few utility poles of unknown vintage, carrying lines near the east edge of the property.

Figure 13: Relative southeast corner, view to northwest.  
June 18, 2021.  
John W. Murphey.

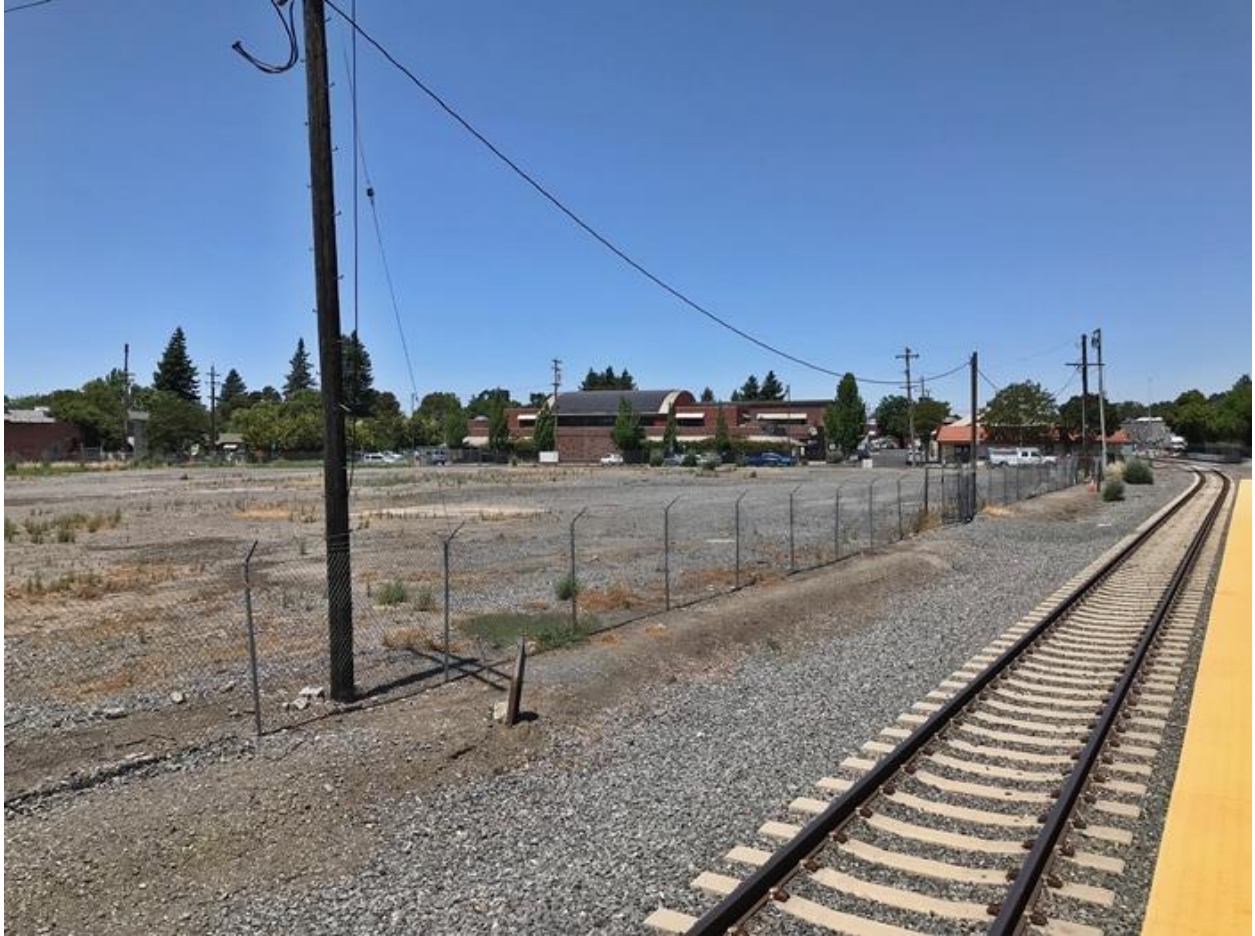
Figure 14: View from SMART platform, view to north.  
June 18, 2021.  
John W. Murphey.
