RESOLUTION NO. 11972

RESOLUTION OF THE PLANNING COMMISSION OF THE CITY OF SANTA ROSA ADOPTING A MITIGATED NEGATIVE DECLARATION, INCLUDING A MITIGATION MONITORING PROGRAM, FOR RECESS SELF-STORAGE (A MIXED-USE DEVELOPMENT), LOCATED AT 4200 AND 4224 SONOMA HIGHWAY; ASSESSOR'S PARCEL NUMBERS 032-010-005 AND 032-010-023; FILE NO. PRJ18-050

The Recess Storage Project (Project) will construct a four-story, 124,000-square foot, self-storage facility and two multi-family residential structures; one structure will have six dwelling units and one structure will have eight dwelling units. The Project entitlements include a Prezoning to the CG (General Commercial) zoning district for Annexation to the City of Santa Rosa; a Tentative Parcel Map to subdivide an approximately 2.68-acre parcel into three separate lots; a minor Conditional Use Permit for a self-storage facility and multi-family housing; a Design Review for the construction of a commercial building greater than 10,000 square feet and attached housing; and a Hillside Development Permit for development on slopes greater than 10 percent.

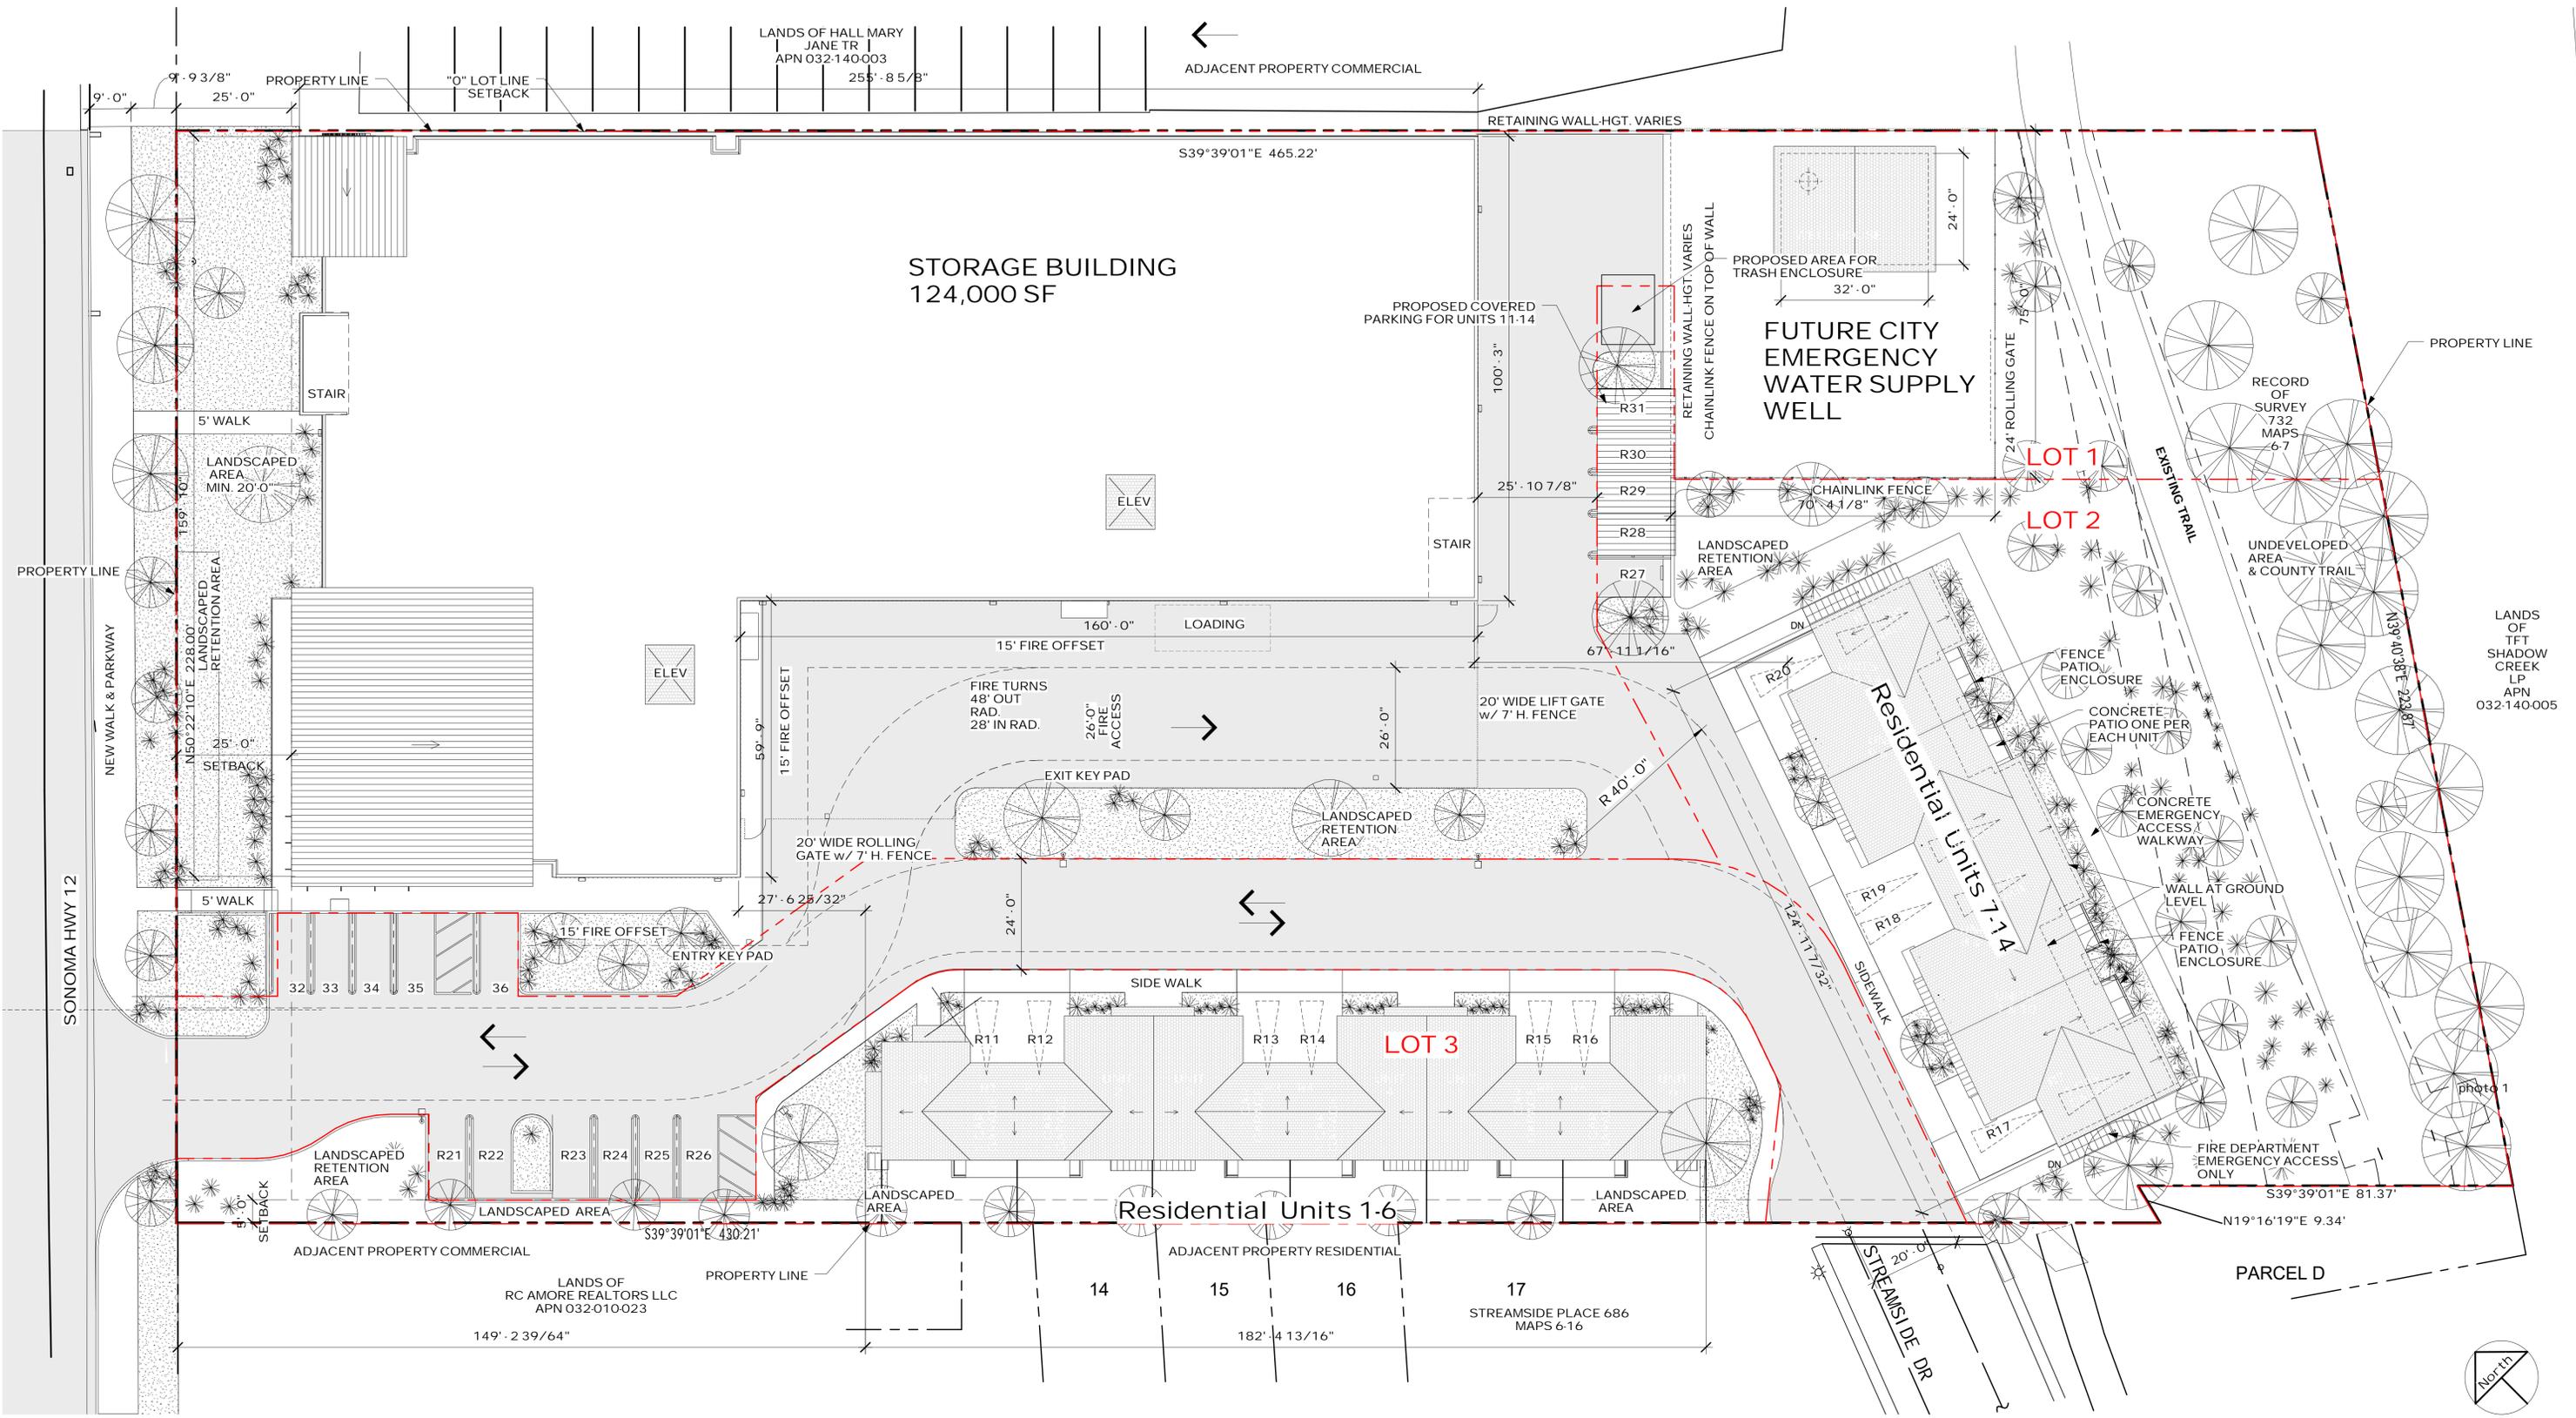
Site Plan/ Roof Plan

As shown in Figure 2 Site Plan, the storage structure will be setback 25 feet from the property line. The residential structure on the southwestern property line will be setback approximately 150 feet from the interior side of the sidewalk, which will not readily visible from Sonoma Highway. The Project will be setback approximately 150 feet from Santa Rosa Creek (Figure 4). All three structures will have a variety of exterior siding materials, varied roof lines, and landscaping.

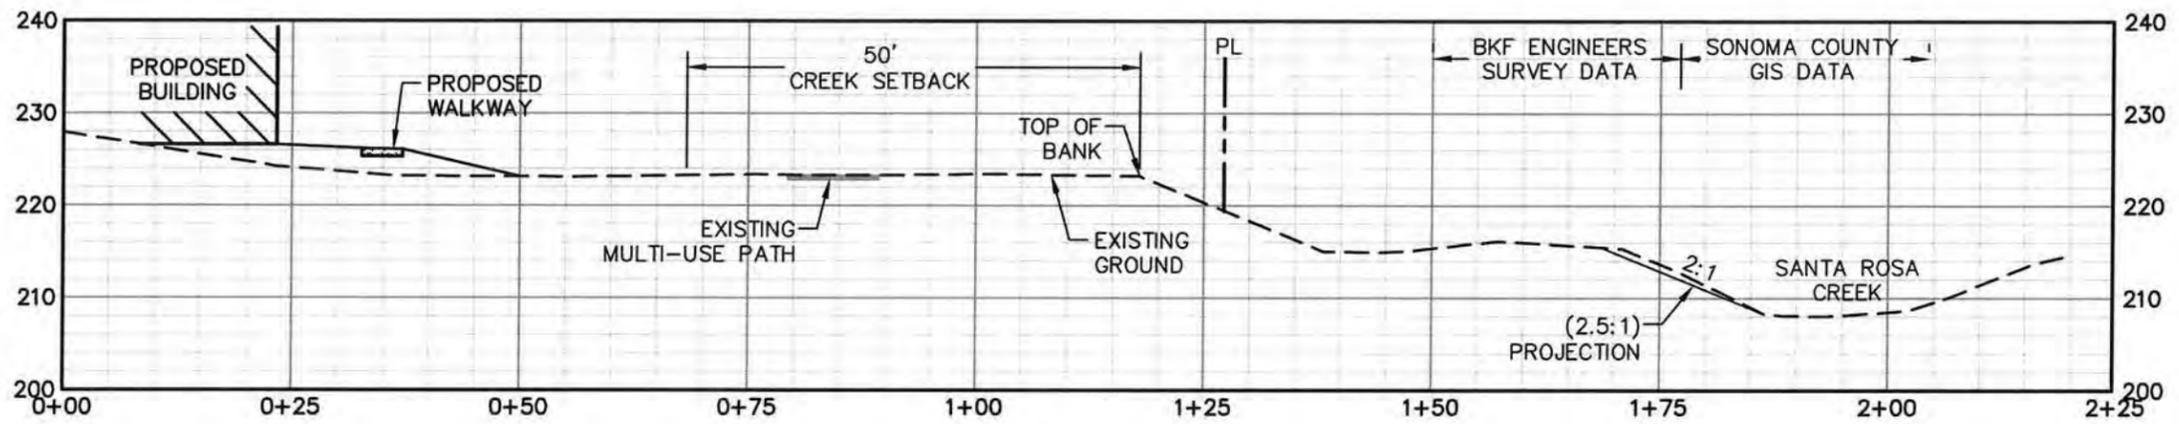
SECTION 1
 H: 1"=20'
 V: 1"=20'

CREEK SETBACK SECTIONS

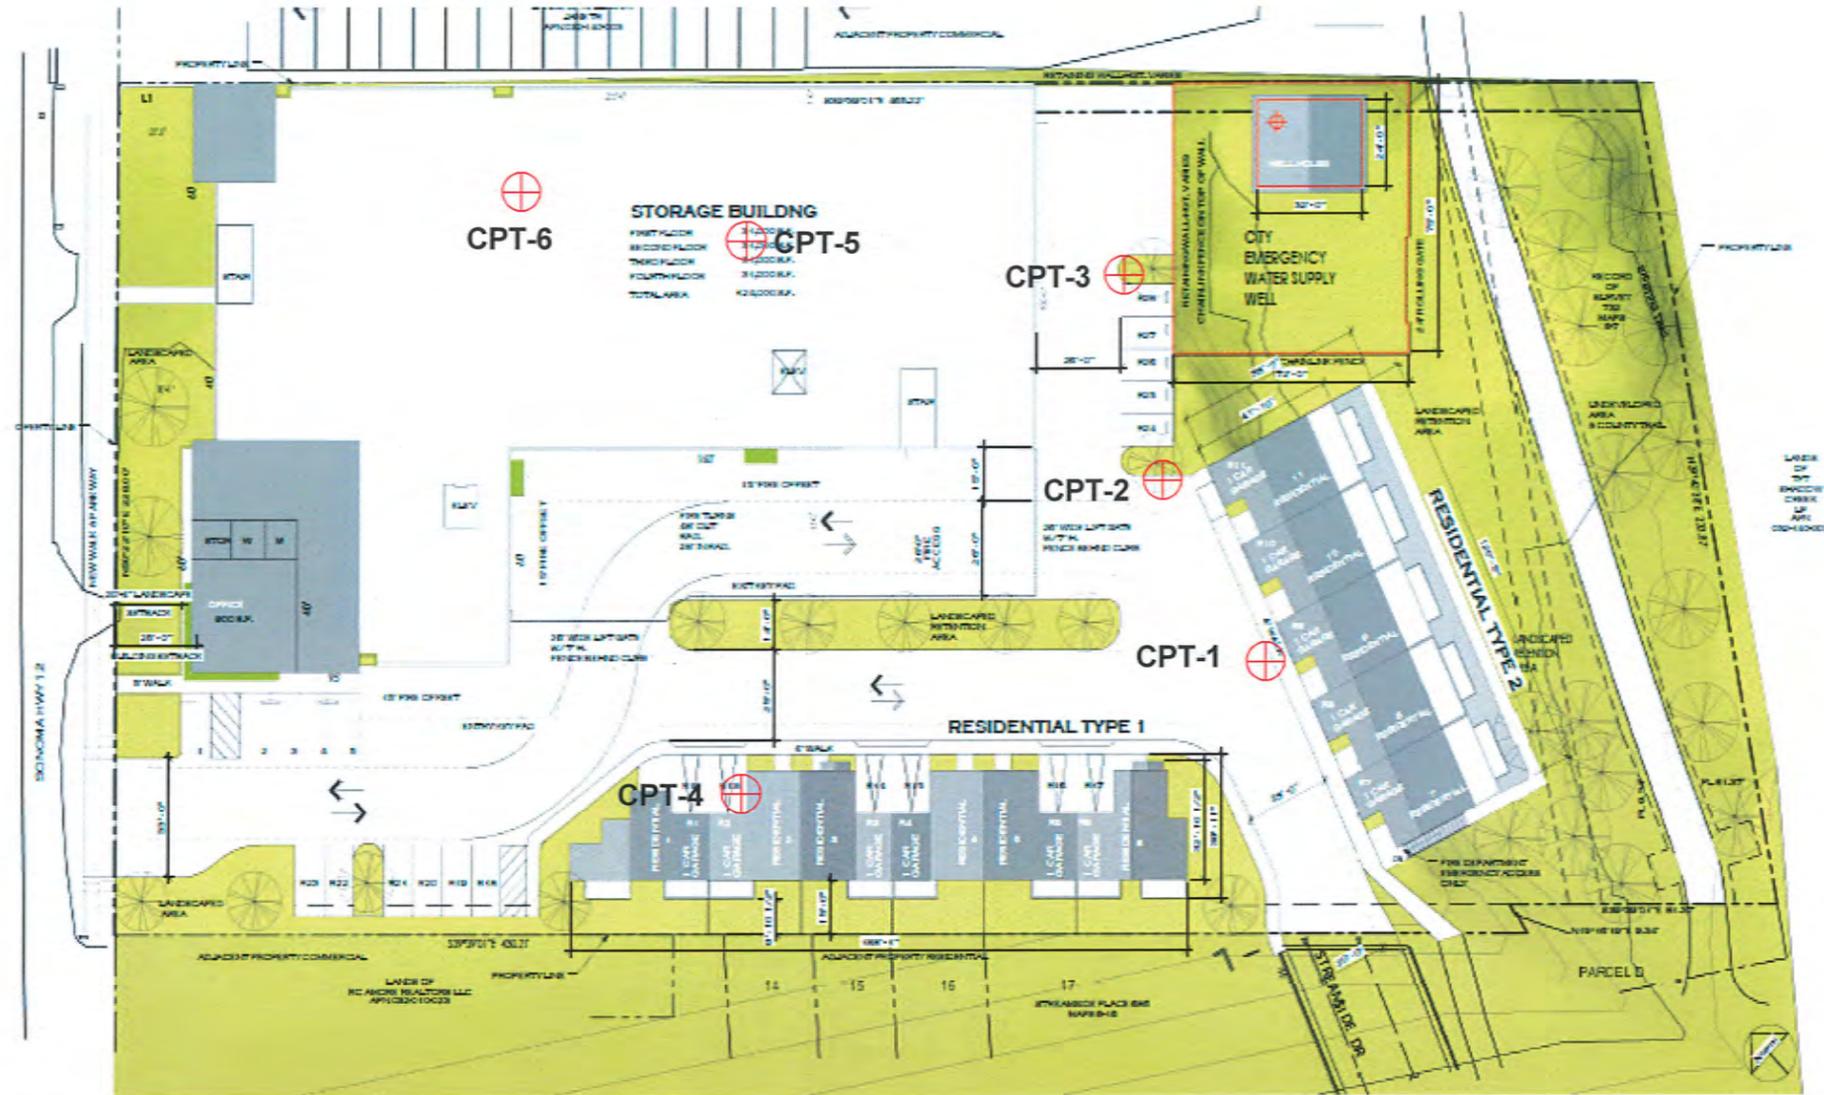
⊕ Indicates approximate location of CPT probe.
CPT-6

NOTES	DATE	AUGUST 2018	PRA GROUP, INC. Geotechnical, Environmental & Materials Testing SITE PLAN WITH CPT PROBE LOCATIONS PROPOSED SELF STORAGE FACILITY SANTA ROSA, CALIFORNIA CLIENT AMERICAN RECESS	FIGURE NO.
	JOB NO.	G407-01		2
	DWG. NO.	G407-01.FIG2		
	DRAWN	JJA		REV. NO.
	CHK'D			
	APP'D	DJR

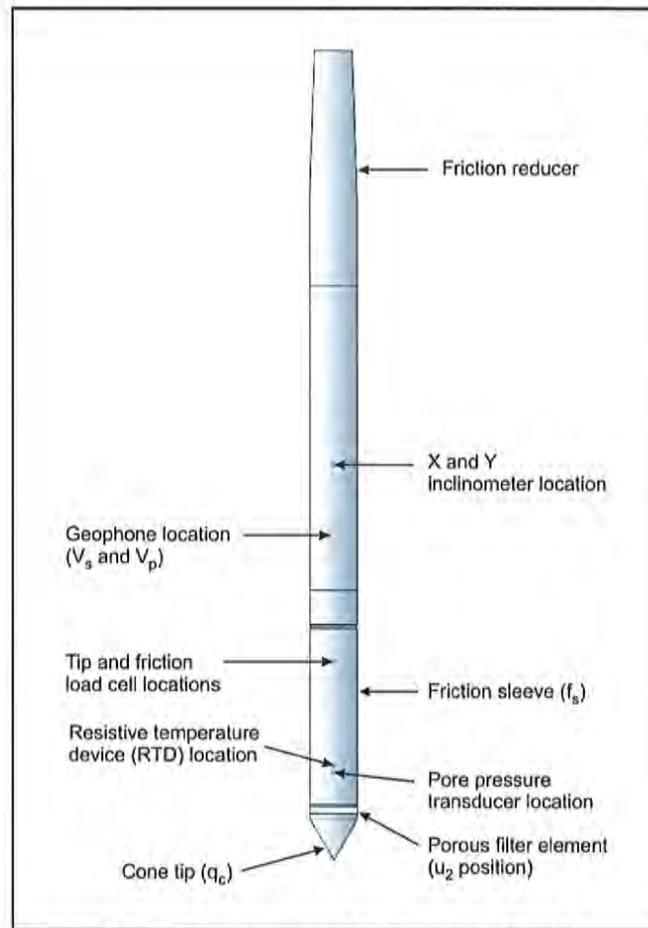
The piezocone penetrometers are manufactured with dimensions, tolerances and sensor characteristics that are in general accordance with the current ASTM D5778 standard. Our calibration criteria also meet or exceed those of the current ASTM D5778 standard. An illustration of the piezocone penetrometer is presented in Figure CPTu.

Figure CPTu. Piezocone Penetrometer (15 cm²)

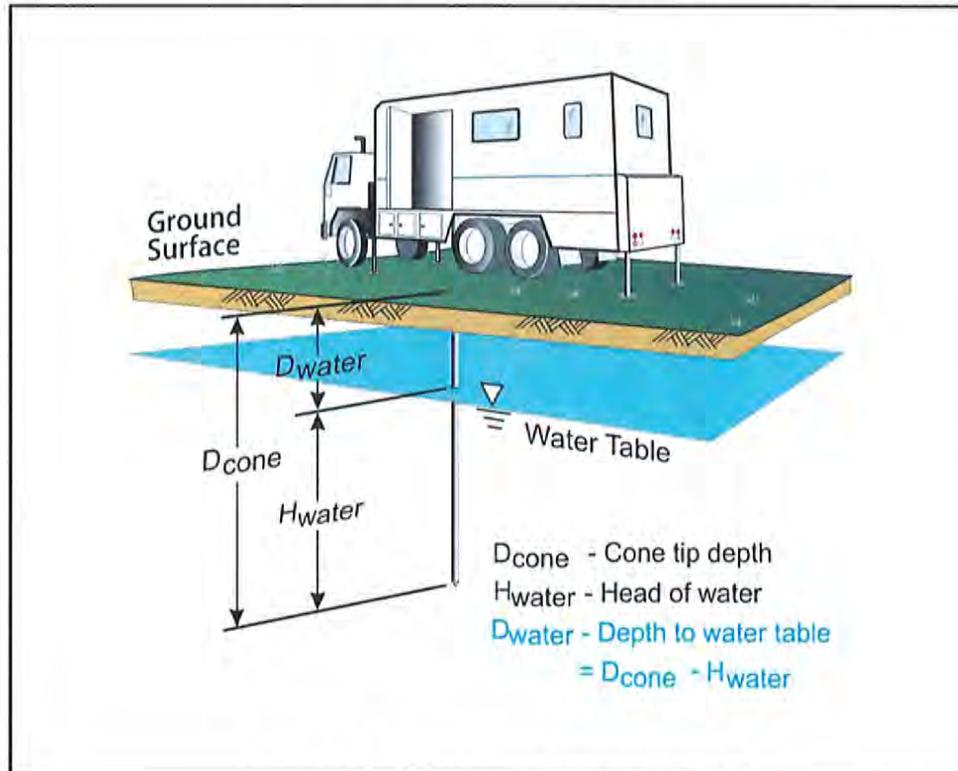
The cone penetration test is halted at specific depths to carry out pore pressure dissipation (PPD) tests, shown in Figure PPD-1. For each dissipation test the cone and rods are decoupled from the rig and the data acquisition system measures and records the variation of the pore pressure (u) with time (t).

Figure PPD-1. Pore pressure dissipation test setup

Pore pressure dissipation data can be interpreted to provide estimates of ground water conditions, permeability, consolidation characteristics and soil behavior.

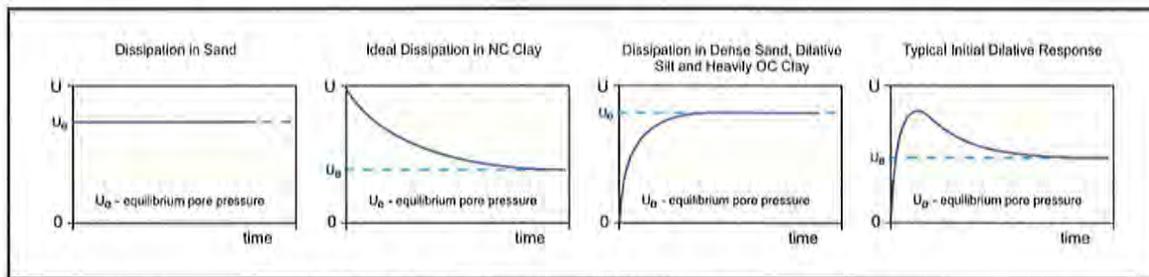
Figure PPD-2. Pore pressure dissipation curve examples

In order to interpret the equilibrium pore pressure (u_{eq}) and the apparent phreatic surface, the pore pressure should be monitored until such time as there is no variation in pore pressure with time as shown for each curve of Figure PPD-2.

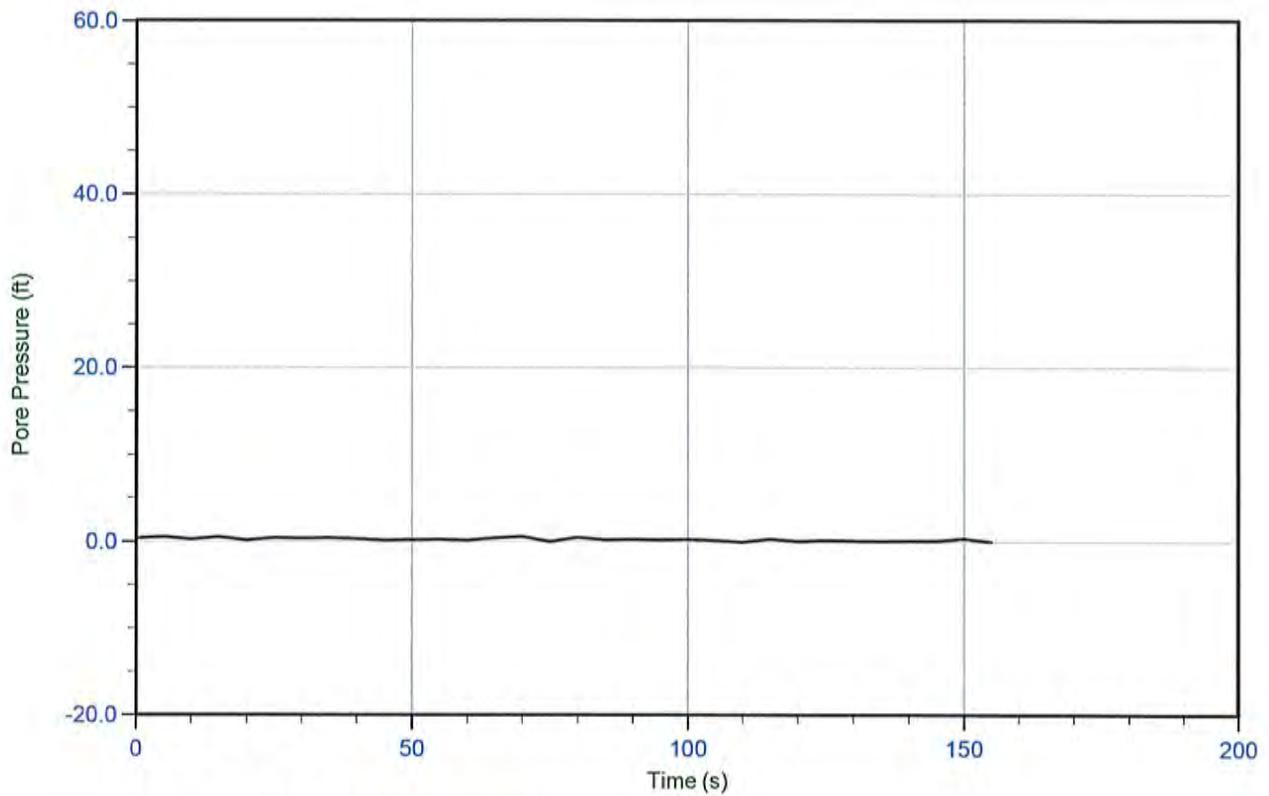
Trace Summary: Filename: 18-56099_CP01.PPF U Min: -0.1 ft
 Depth: 7.350 m / 24.114 ft U Max: 0.6 ft
 Duration: 155.0 s

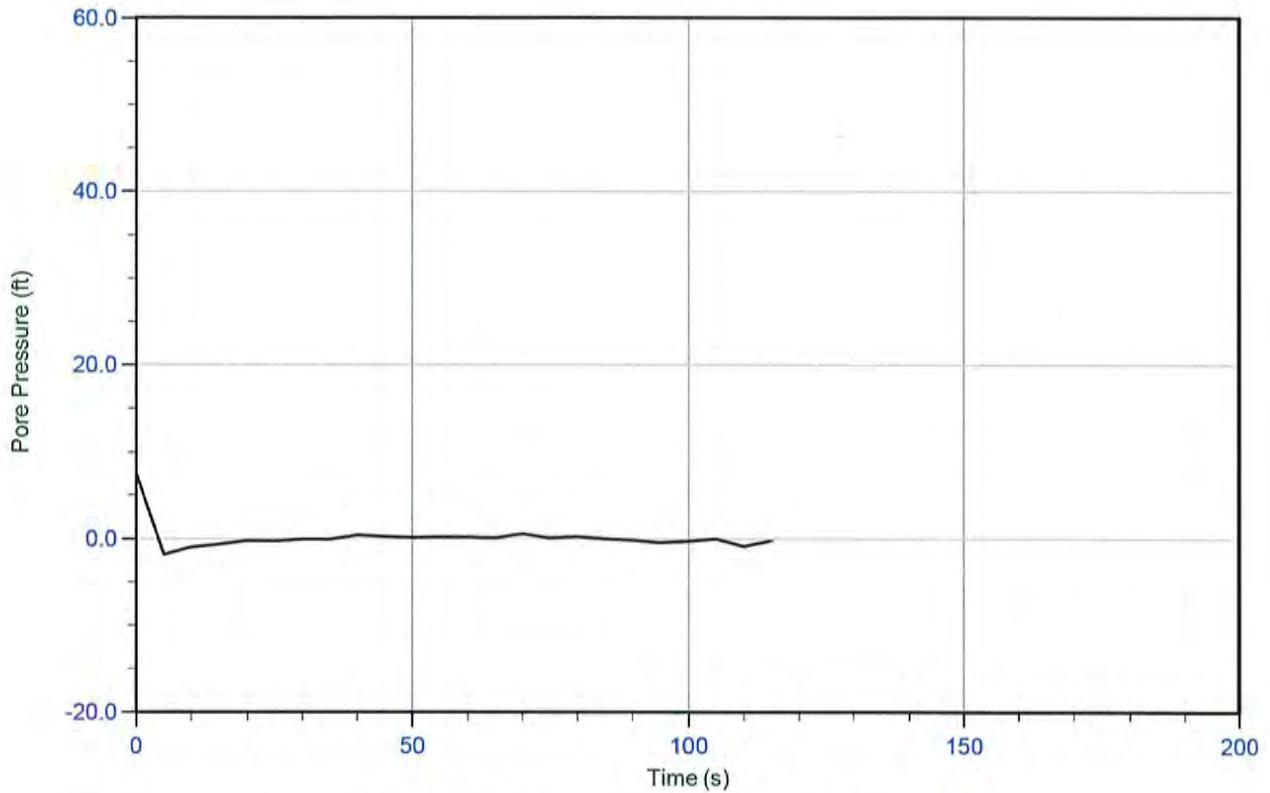
Trace Summary: Filename: 18-56099_CP03.PPF U Min: -1.8 ft WT: 5.550 m / 18.208 ft
Depth: 5.550 m / 18.208 ft U Max: 7.4 ft Ueq: 0.0 ft
Duration: 115.0 s
