Historic Resource Evaluation
80 & 6 College Ave., Santa Rosa,
Sonoma County, California

(APN 010-121-025-000, 010-121-024 & 010-121-020-000)

APD Preservation LLC

November 2016

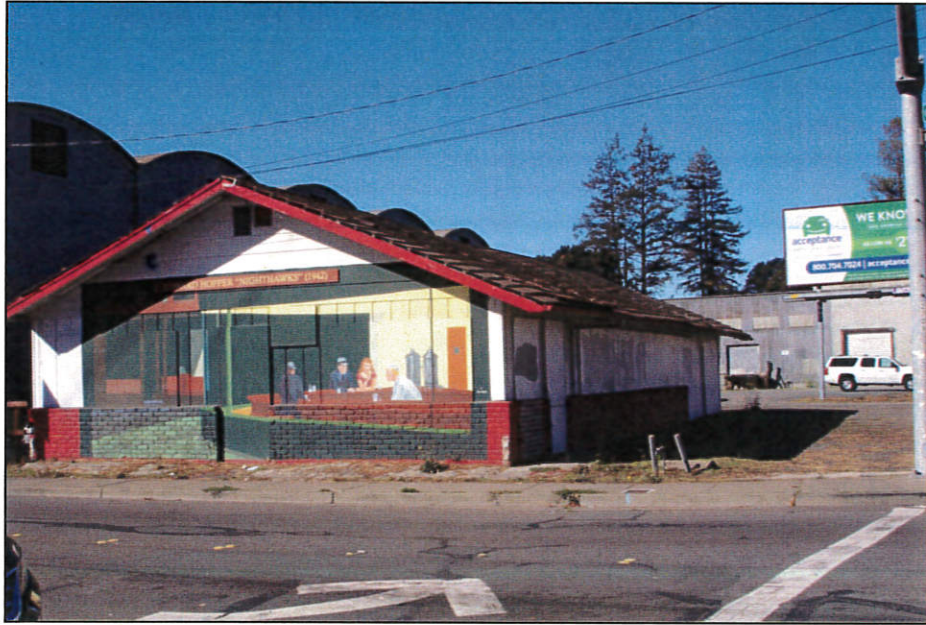
Figure 1: East and North facades. Viewed from Cleveland Ave.

The commercial building at 80 College Avenue (formerly 1023 Cleveland Avenue) is a 1-story, gable-roofed building on a concrete slab foundation. Deteriorating synthetic shingles cover the roof.

One gable end faces Cleveland Avenue on the east, with a former entrance centered on the elevation. This doorway, like the windows flanking it, have been boarded up with plywood. The base of the building is faced in running bond bricks to the level of the former window sills. The remainder of the cladding is vertical wood siding below the pitch of the gable, and horizontal wood siding in the pitch of the gable. A louvered, metal attic vent sits at the peak of the gable under the eave, which has exposed rafter ends. A modern mural copying Edward Hopper's 1942 "Nighthawks" covers the majority of this elevation (see figures 1 & 2).

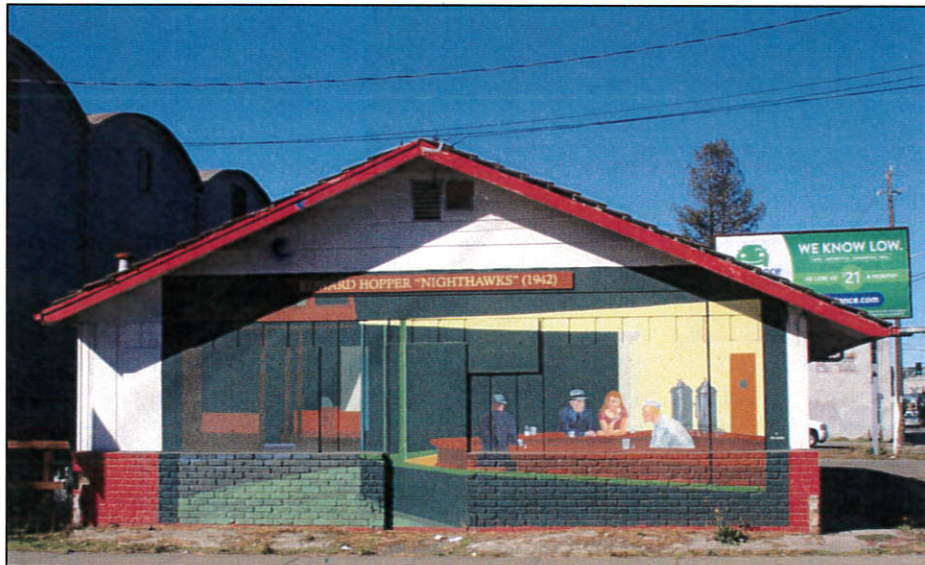
Figure 2: East facade.

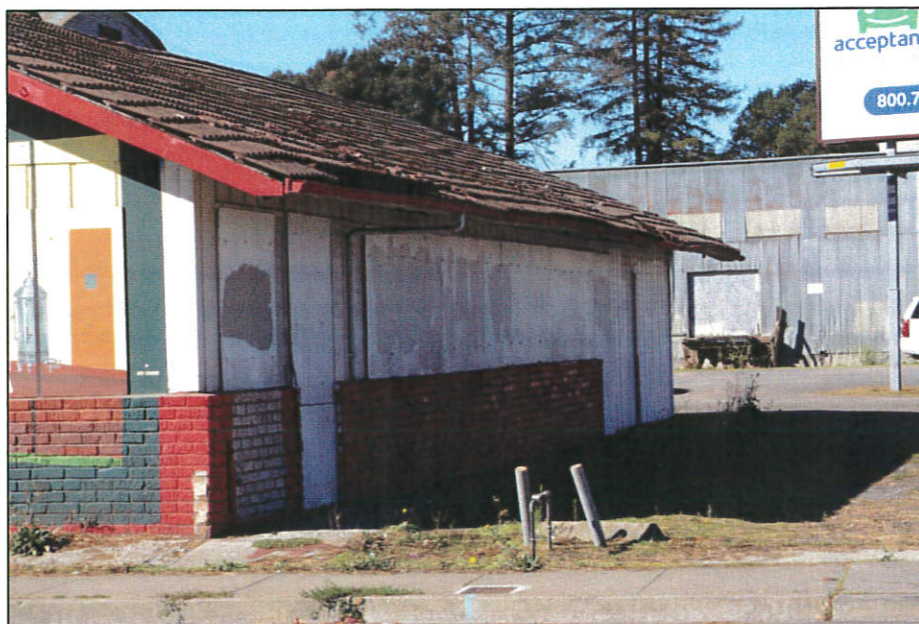
Figure 3: North elevation, looking west.

On the north side, facing College Avenue, the brick veneer continues approximately three-quarters the length of the building, to the height of former window sills. A single door at the northeast corner is boarded up, as well as a bank of windows across the center of the elevation and a single window east of the door. The siding above the brick facing is vertical wood siding (see figure 3).

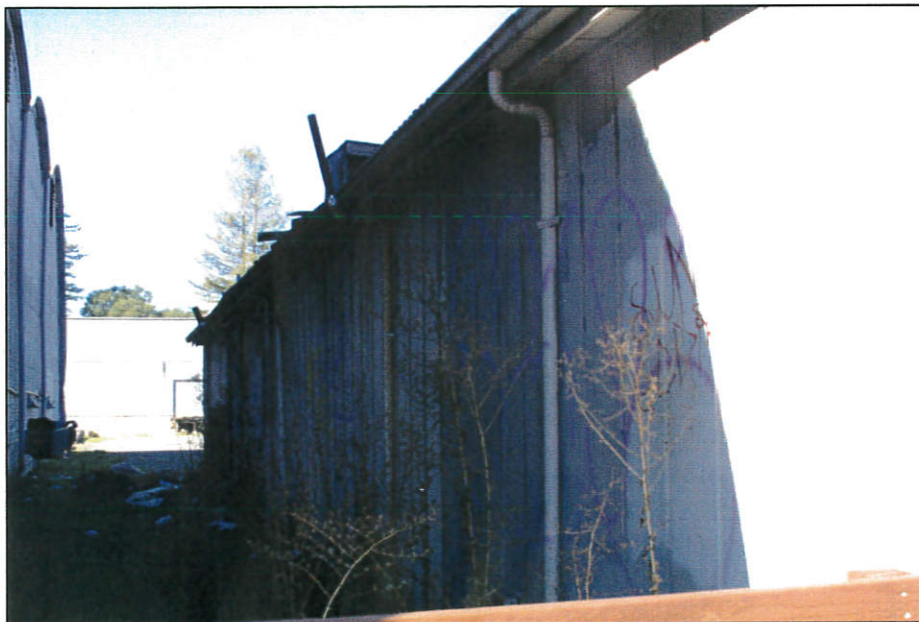
Figure 8: South elevation, looking west.

The rear, or south elevation, sits close to the adjacent warehouse property on Cleveland Avenue. Like the east elevation, this side of the building is a solid wall of modern vertical wood siding (see figure 8).

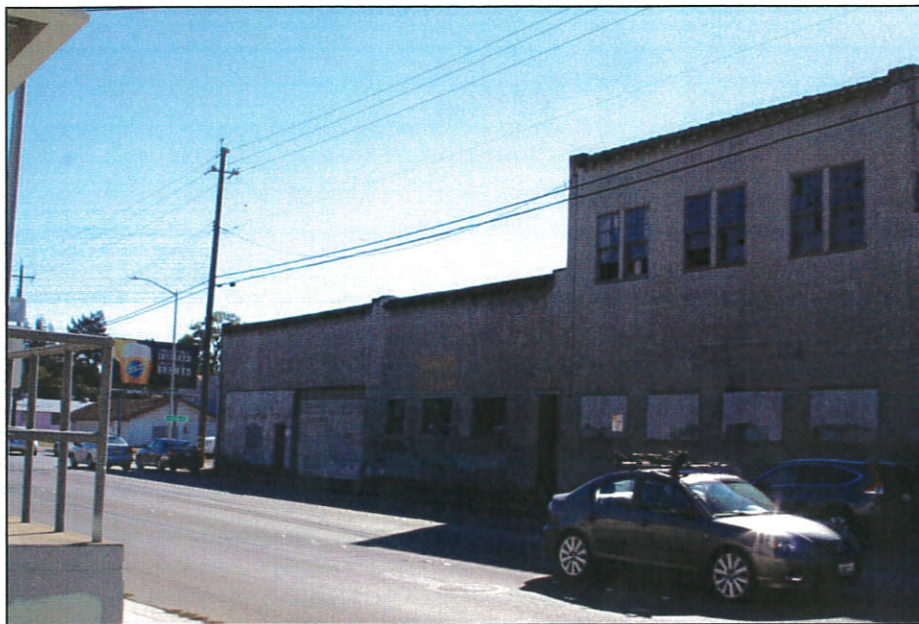
Figure 10: North facade (east and center sections).

The center section of the north façade rises to two stories. Four modern, aluminum sash windows are evenly spaced across the lower level of the block. Three large, double-hung, 6-over-6, metal sash windows with broken panes are evenly spaced along the second level of this block (see figures 10, 11 & 12).

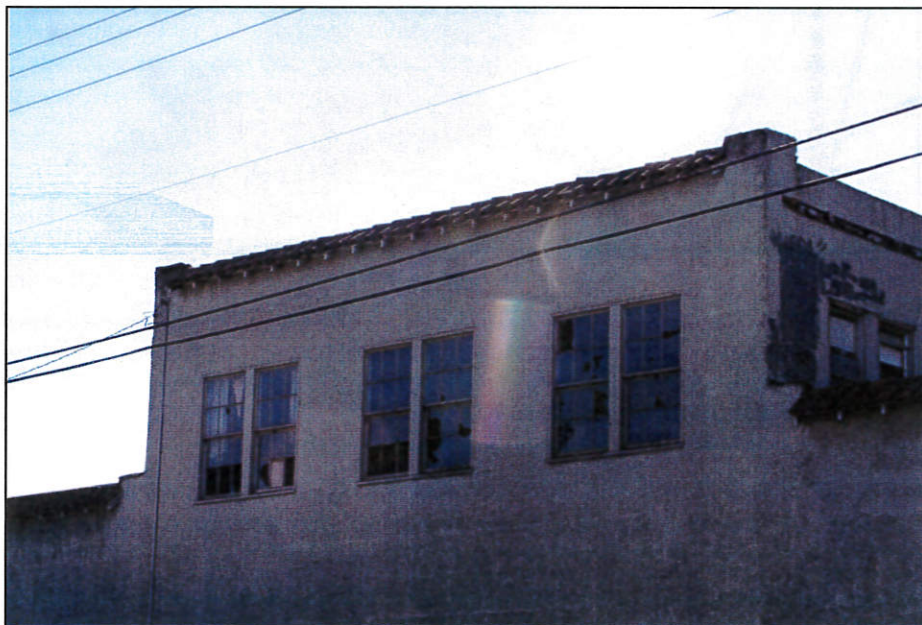
Figure 12: North facade. 2nd story of center section.

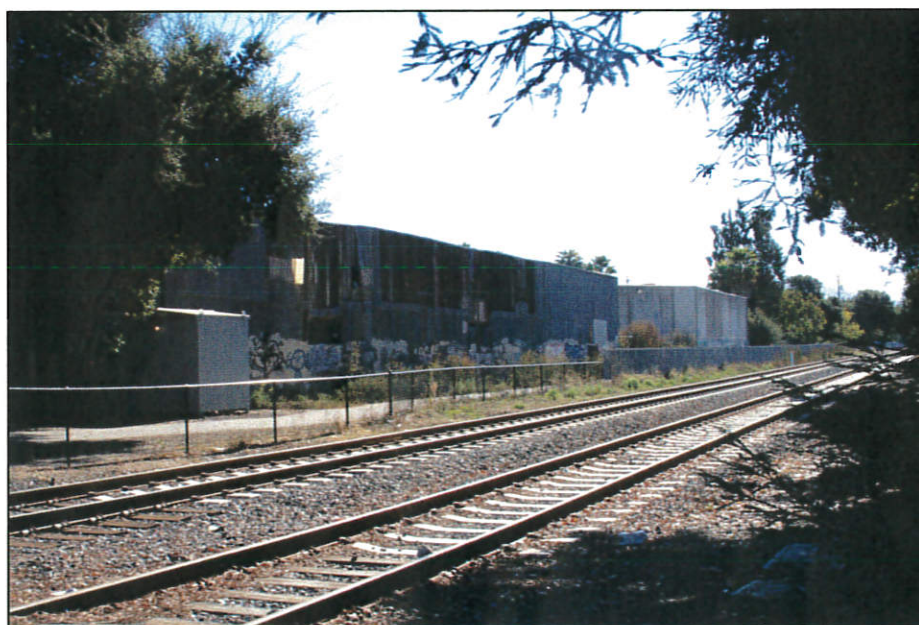
Figure 15: West elevation, looking southeast.

The west elevation of the structure faces the railroad tracks and multi-use/bike path. Corrugated metal sheeting covers the length of the elevation, though large sections of it have been detached or are missing altogether, revealing vertical wood siding underneath (see figures 15, 16 & 18). Corrugated metal panels cover most of the original windows. Where visible, the windows are wood frame, fixed sash, 6-paned units that appear to have been evenly spaced along the length of the elevation (see figure 18). Interior metal bars are evident on many of the exposed windows openings. Several loading bays are fully or partially covered by the corrugated metal siding (see figure 20).

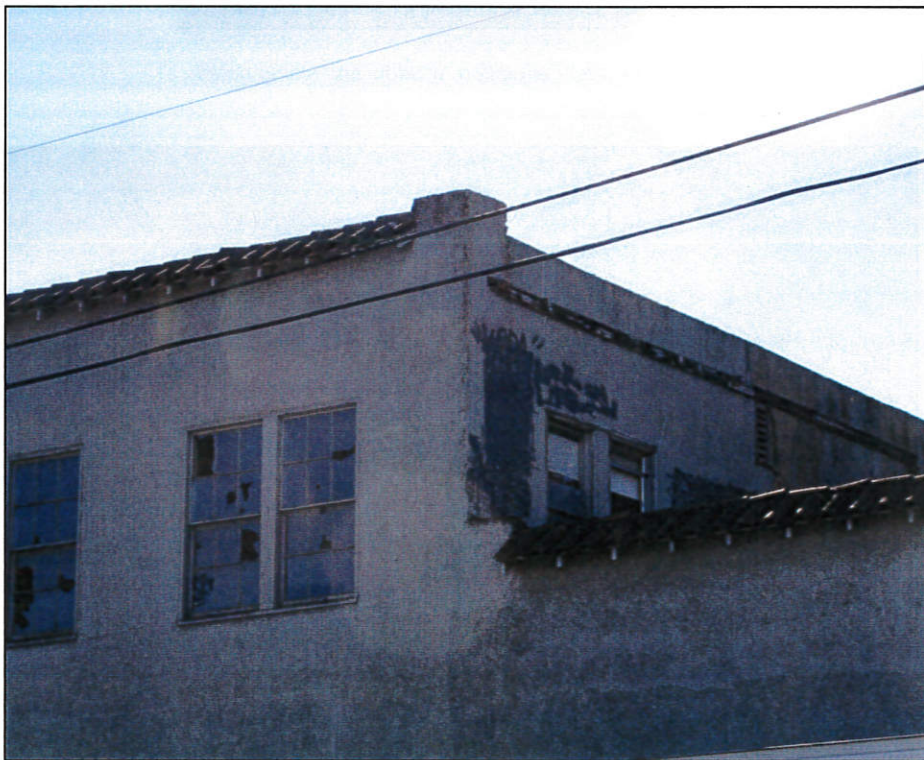
Figure 17: West side of 2nd story.

The second story of the center block is partially visible, showing a pair of 1-over-1, double-hung wood sash windows and a wooden louvered vent, as well as wooden stringcourse running the length of the block (see figure 17).

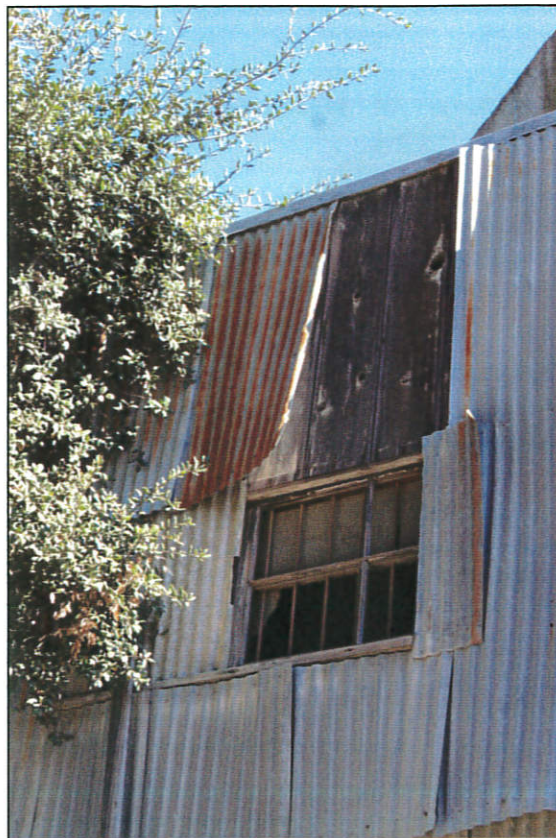
Figure 18: West elevation, window and siding detail.

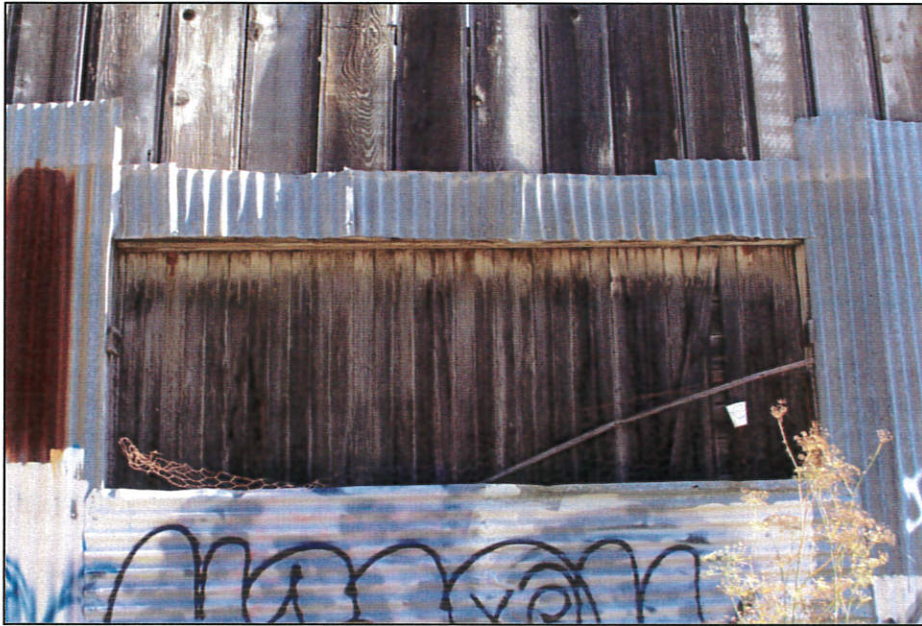
Figure 20: West elevation, loading dock door.

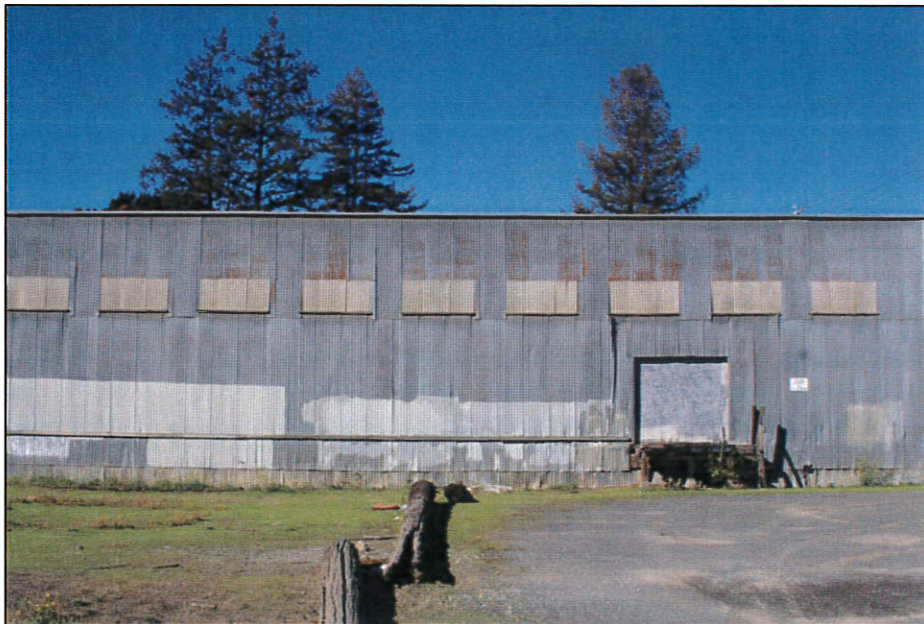
Figure 25: East elevation, loading dock.

The east elevation faces the parking lot that separates the warehouse from the 1-story commercial building from the commercial building at the other end of the project area (80 College Avenue). This long expanse of building is faced in corrugated metal sheeting up to the northern quarter, which is faced in patched stucco. Seventeen pairs of windows, presumably identical to the fixed sash windows on the west elevation, appear through the corrugated metal, near the roofline. Two loading bays provide access to the interior, with the southern bay having a deteriorated wooden dock on concrete footings. (see figures 26 & 27).

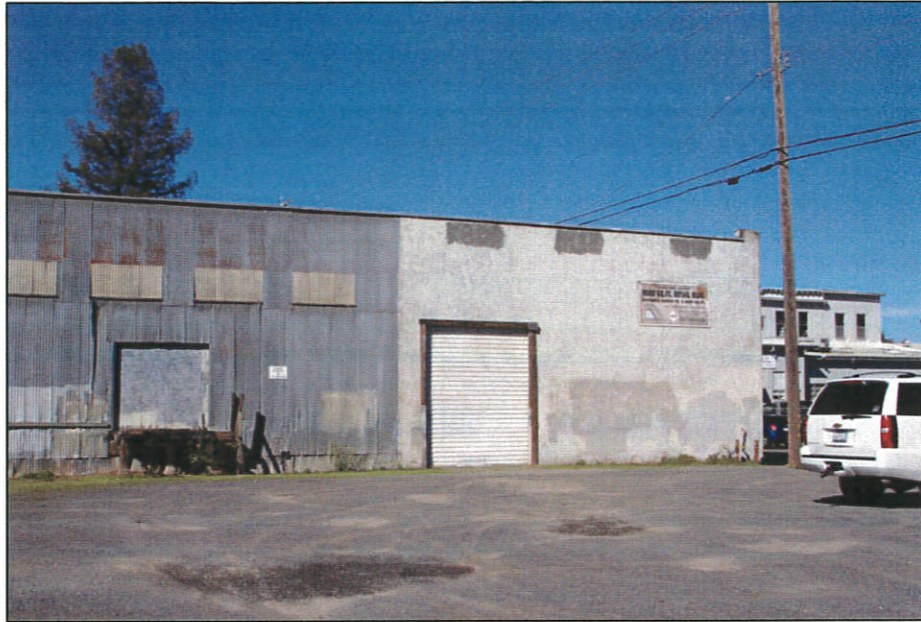
Figure 26: East elevation (northeast corner), loading bays.

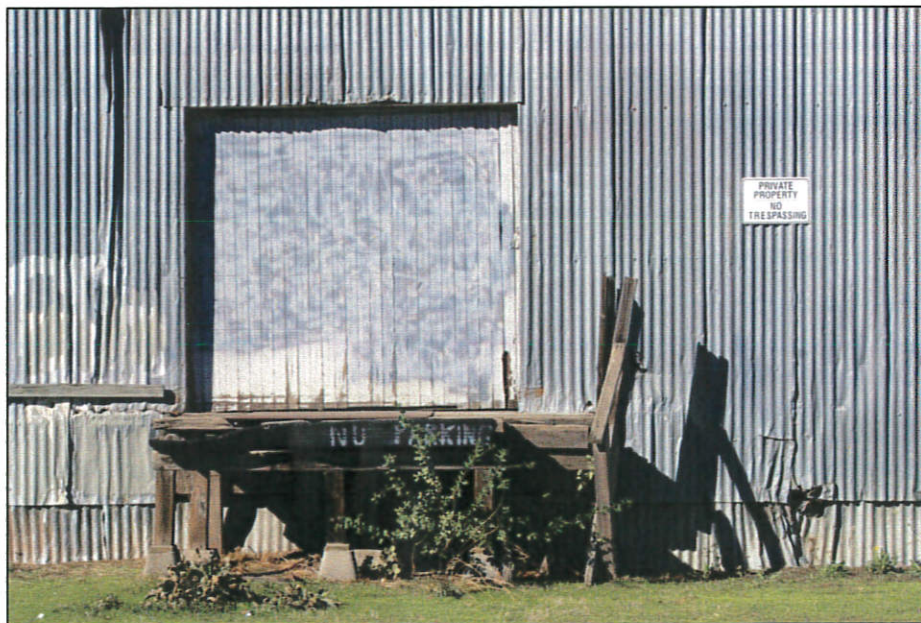
Figure 27: East elevation, loading dock detail.
