Historic District Approval Application

800 McDonald Avenue 95404, Santa Rosa
Completed building 1983
Original Owner/Architect-Gary Jensen; owner until death October 2016
Purchased by Broker/Seller: Bruce and Cindy Tonacasia (2016)
Purchased by Mary Patricia O’Day/John Grabowski (July 2017)

This Landmark Alteration Permit provides Project Description, Site Plan, and Existing and Proposed Elevations. It includes legalization of previously undertaken modifications and proposed improvement. In some instances, e.g. fencing, replacement or removal is essential for safety and aesthetics due to deterioration.

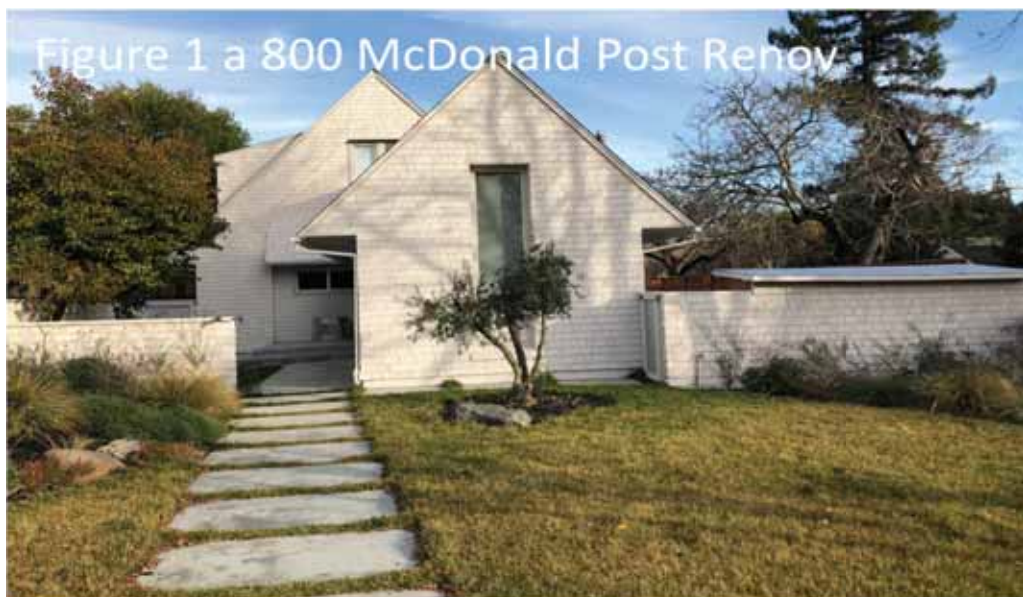
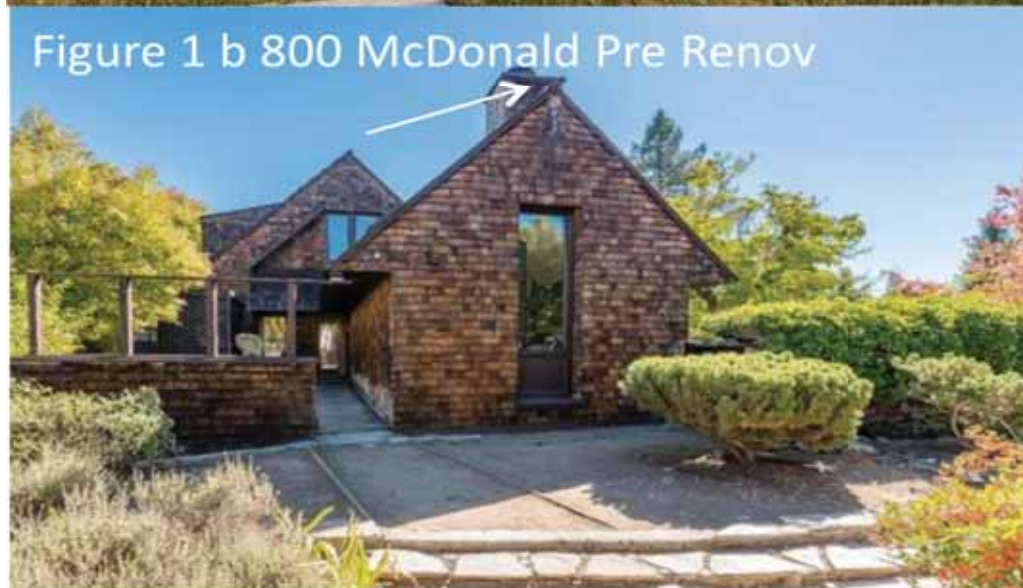
Figure 1 (a) post renovation (b) pre renovation.

-Exterior of house was brown/gray natural wood. Seller painted house and all fences white;

-Chimney (and internal free standing fire stove) removed **Figure 1 (b)/arrow**

11. Proposed Improvement -- painting to approximate original brown/gray color (Figure 1)

-Repaint house to approximate natural gray/brown (See Figure 1 b).

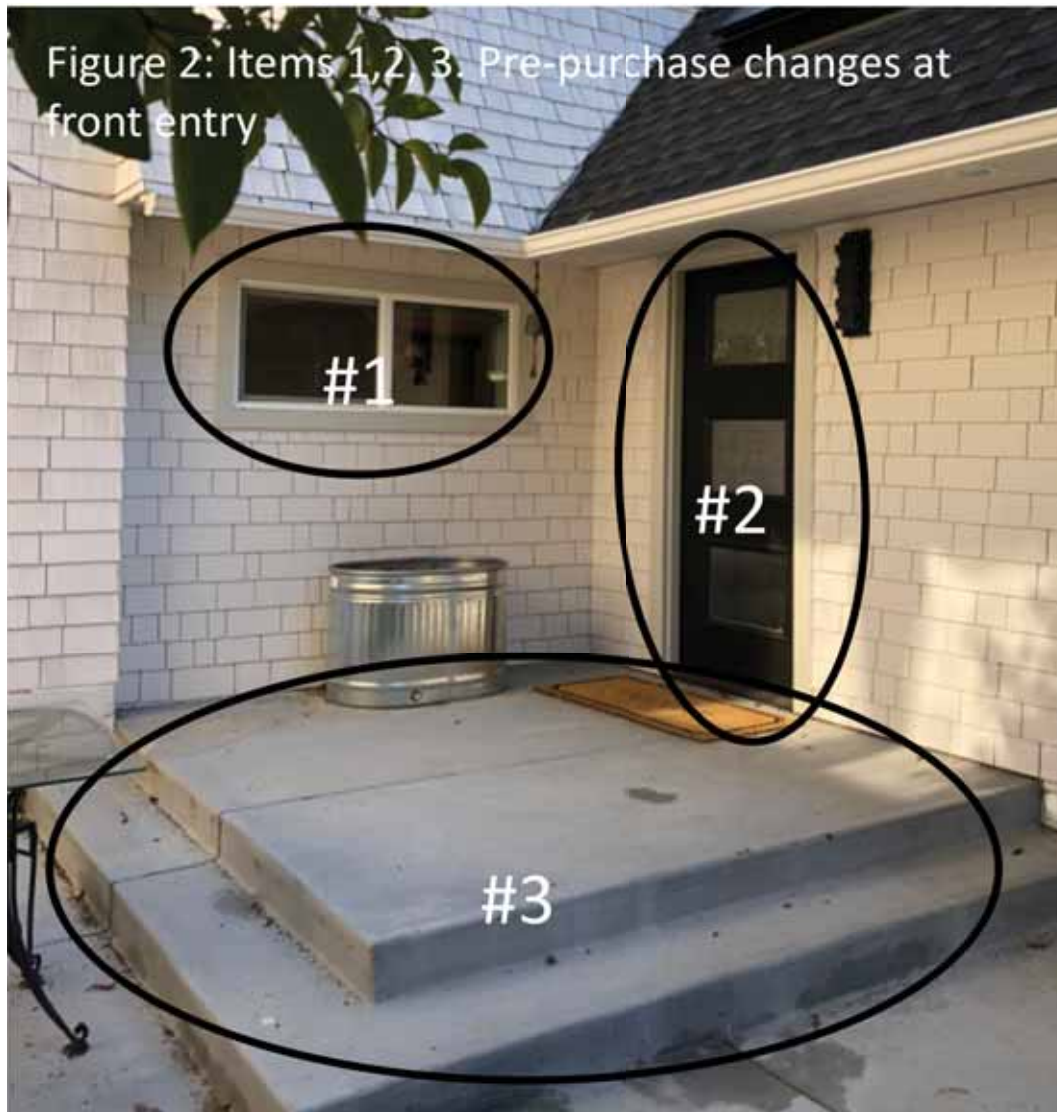
- Horizontal window replaced front door at house set back; **circled 1-Figure 2.**
- Front door was moved to side of main front body of house; **circled 2-Figure 2.**
- Front decking/steps replaced with concrete; **circled 3-Figure 2.**

1. Legalization of unpermitted modification – front door replaced with window (Figure 2)
2. Legalization of unpermitted modification – relocation of and installation of new front door (Figure 2)

3. Legalization of unpermitted modification – modification to front deck and steps (Figure 2)
4. Legalization of unpermitted modification – closure of permitted window and replacement of permitted window (north side) Figure 3)

1. The location of the front door was moved from east to north facing.

3. Concrete steps and decking replacing the previous redwood decking are identical in dimensions/size to that represented in the original approved house plan.

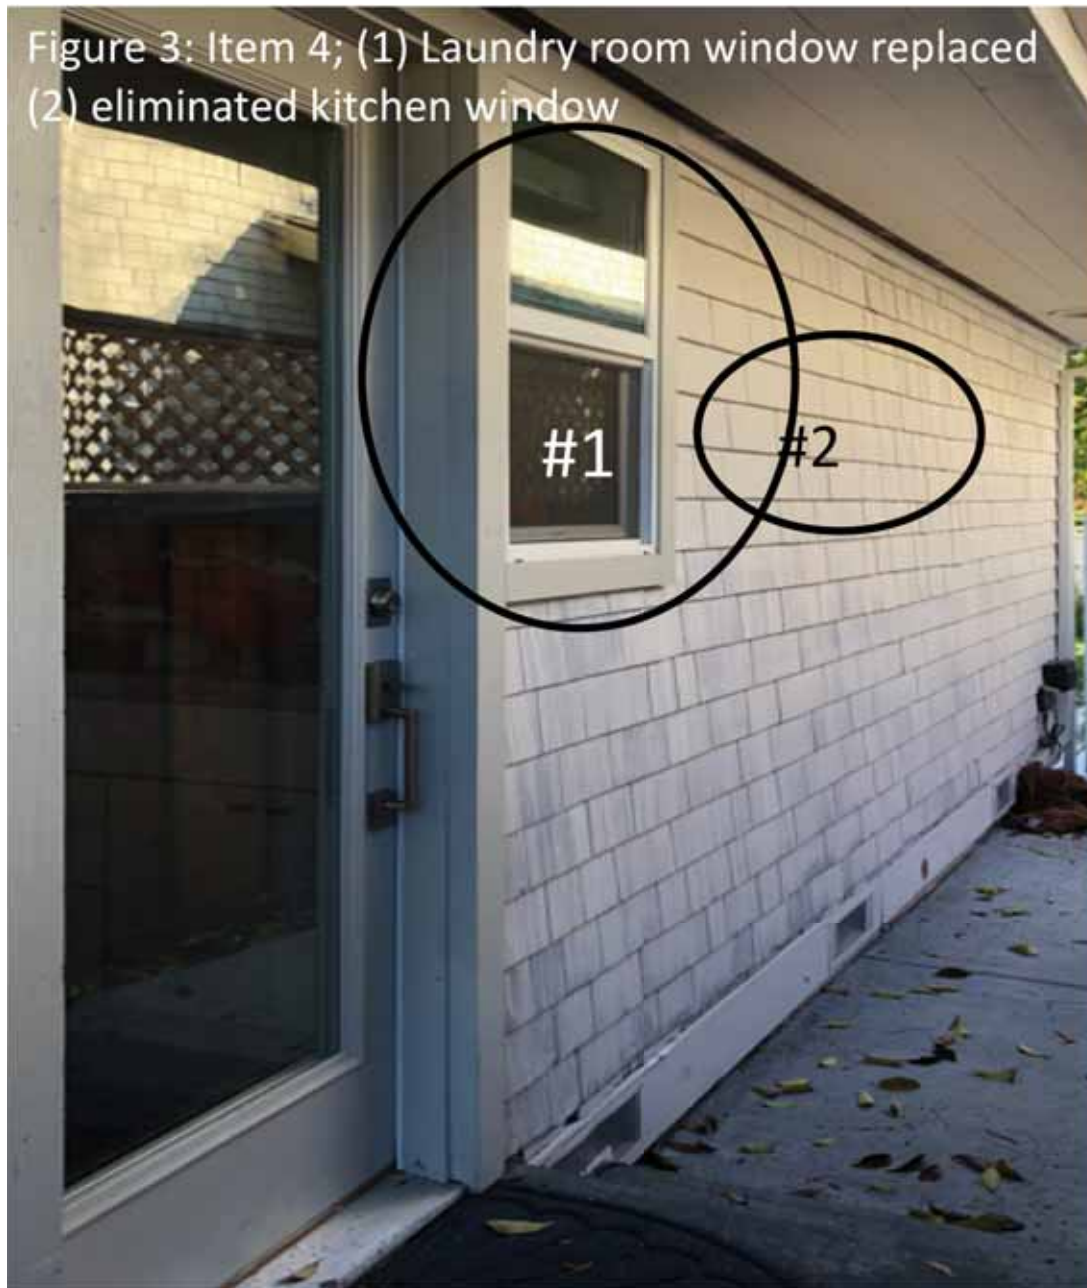
-Laundry room window (circled #1) replaced; window in kitchen removed (circle #2), north side.
Figure 3

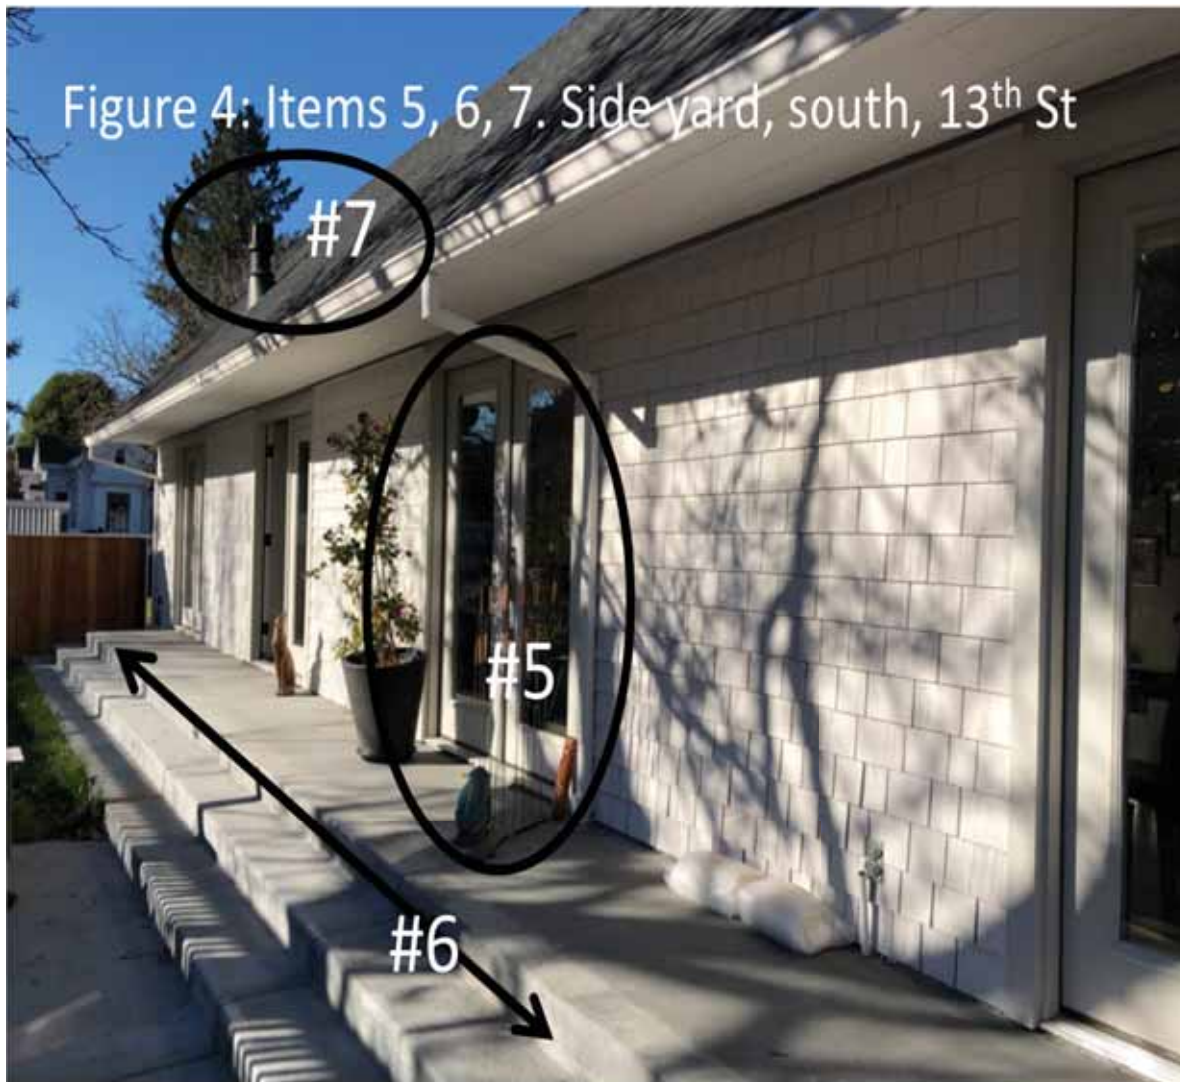
-Five sliding glass doors, south side courtyard (not visible from 13th street), replaced with double inward swinging doors ("French Doors", with similar single large glass surface (example circle #5). **Figure 4**

-South side wooden deck spanning length of house (not visible from 13th street) and accessed from glass doors replaced by equivalent height concrete deck. Double arrow, #6. **Figure 4**

-Fire feature installed on south living room wall; metal chimney installed on south facing (13th street) roof; circled. #7 **Figure 4**

5. Legalization of unpermitted modification – replacement of existing doors (Figure 4)
6. Legalization of unpermitted modification – modification to side deck and steps (Figure 4)

7. Legalization of unpermitted modification – relocation of existing chimney (Figure 4)
8. Legalization of unpermitted modification – closure of permitted window opening and window replacement (east side-back) (Figure 5)

2. Five sliding glass doors (south side) were replaced with dual opening doors ("French Doors") of equivalent size and glass appearance (Approx 3 per side less glass).

5. The original wood burning, free standing stove, with pipe to brick chimney was removed. A gas fire feature was installed at south wall of living room and a stovepipe type chimney meeting code was installed through roof on south below roof peak.

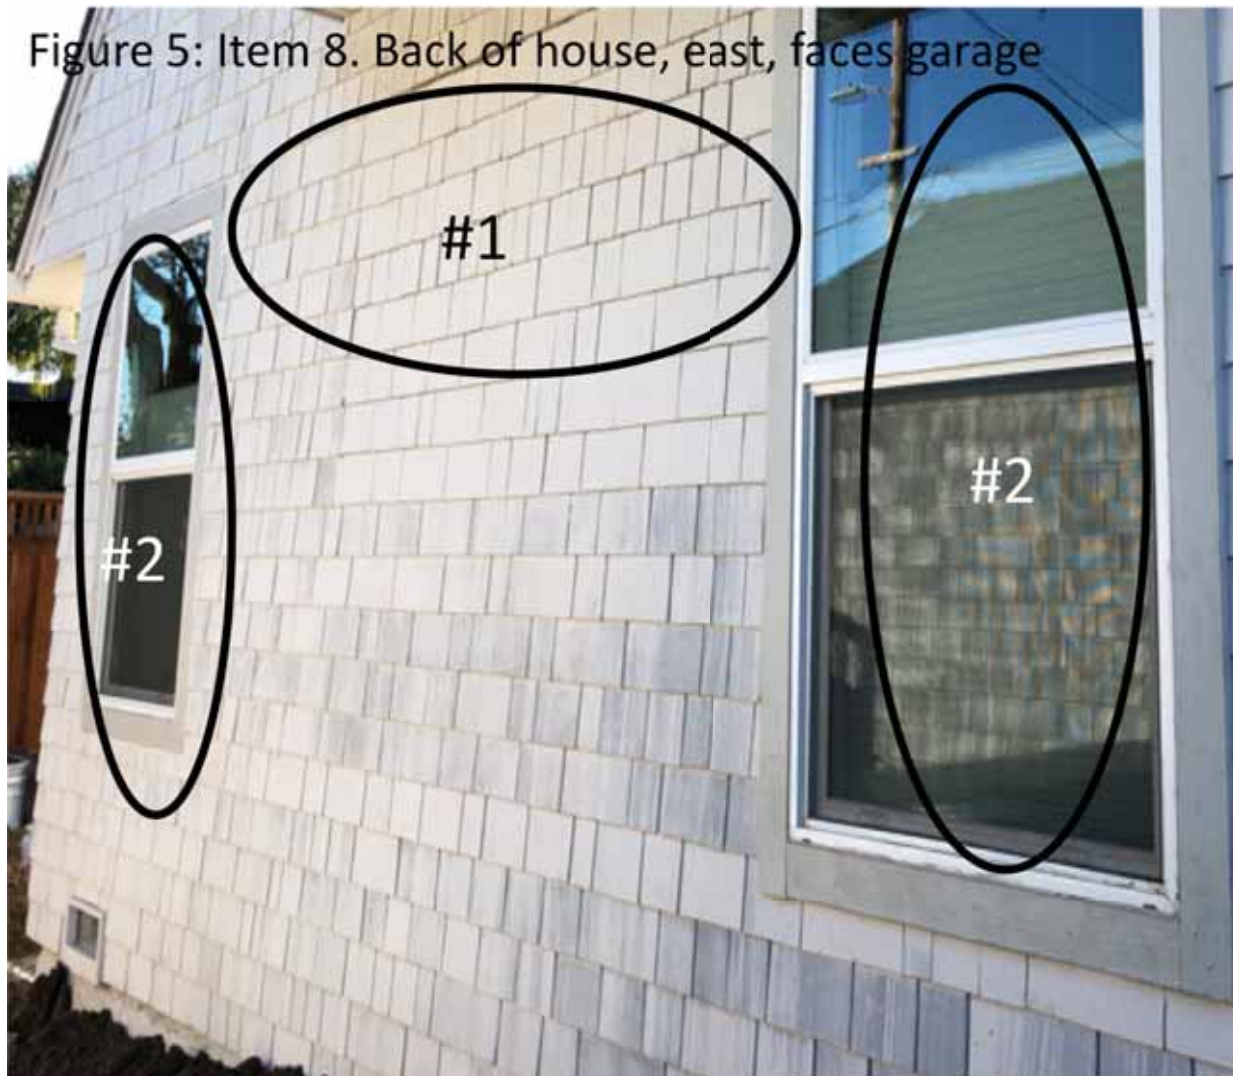
-Single window in master bedroom (approx H=2ft, W=6ft, centered 5 feet off floor) was removed (**circle #1**). Replaced by two standard windows placed left and right (**circled #2**). This east outside wall faces side of garage and is not visible from street. **Figure 5**

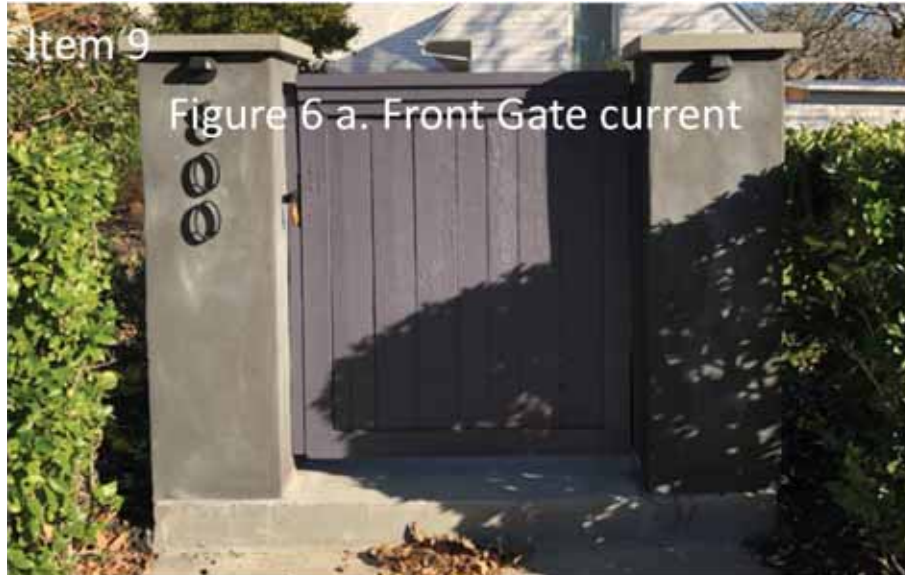
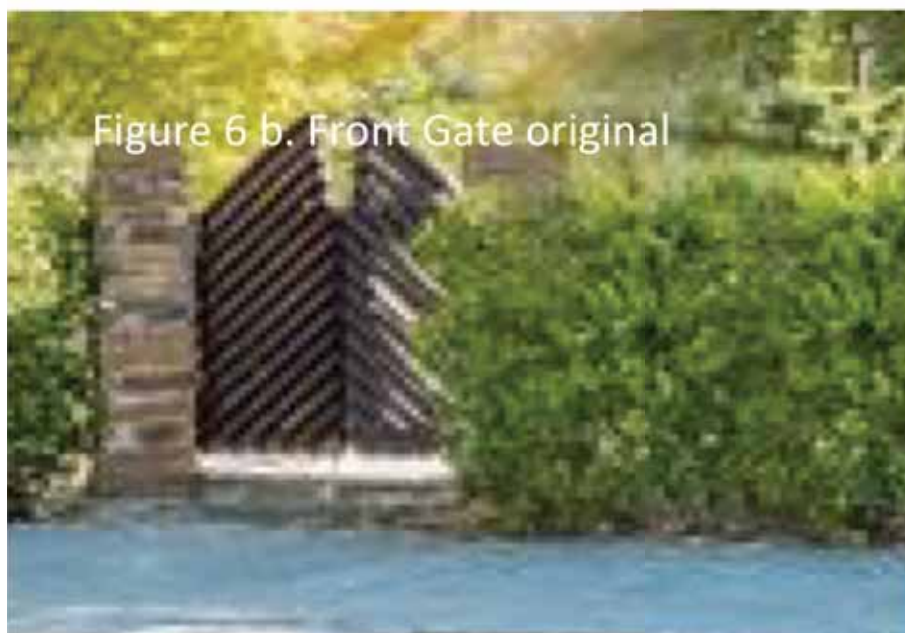
-Front Gate, current and original. Both with two posts, different gate face (**Figure 6**)

9. Legalization of unpermitted gate modification (Figure 6)
10. Legalization of unpermitted modification and Proposed Improvement – installation of new fence design and material at various locations. Includes modification to existing gate design and material (Figure's 7, 8, 9, 10, 11). This includes landscape improvements (Schematic Page 16, current; proposed Page 21 and additional copies).

4. The front brick gateposts were covered with concrete-like material. The original slotted wooden gate was replaced with solid wood front. This will be altered in accord with returning to original wood color.

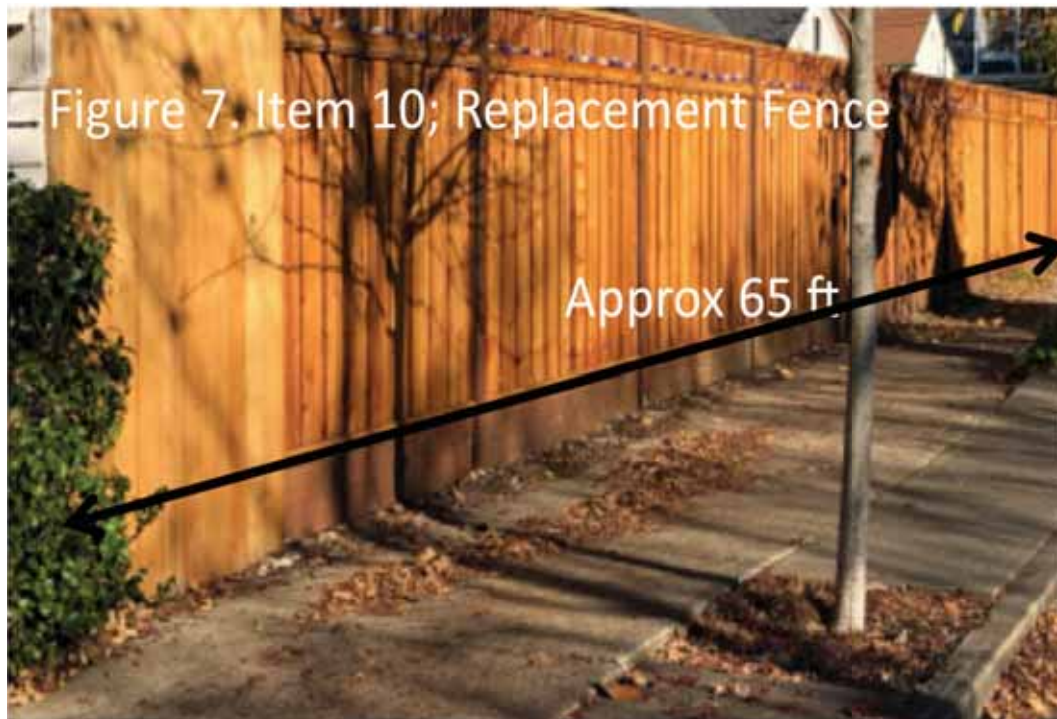
1. Fence, previously natural wood but painted white prior to our purchase (approx. 65 feet, south, side, 13th street) was vine covered. Removal of vines indicated they had been “structural support” and fence was collapsing. We replaced with a natural fence installed by Redwood Residential Fencing, Santa Rosa CA. Same configuration (13th street with wrap to garage at rear) as original and similar to other side fences on street. **(Figure 7)**

6. Original 35-year-old wood shingle fence was painted white by seller. Buyer replaced with board on board redwood fence returning the fence to original natural color.

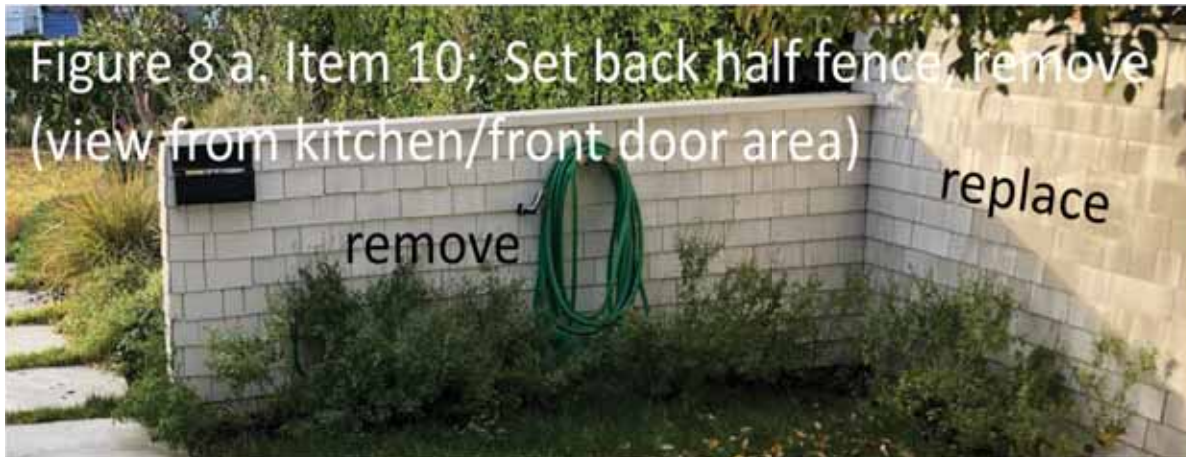
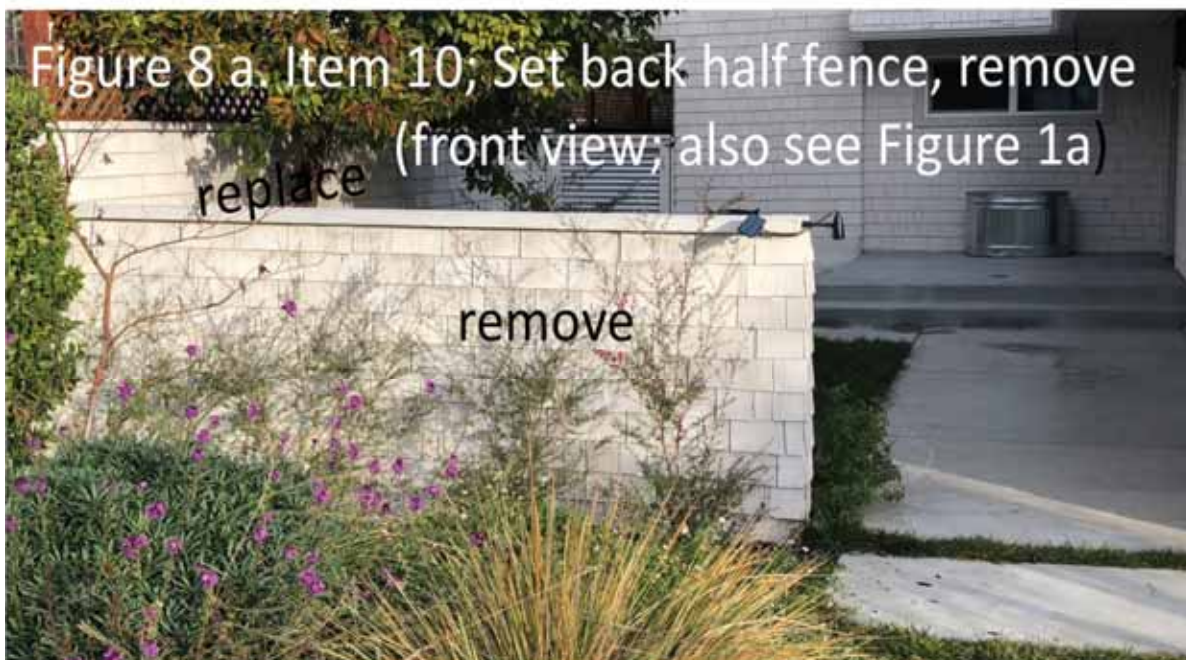
-Remove set back fence at left front of house (Figure 8 a, b)

1. The original set back half-fence, left-front will be removed. As part of landscaping a low bench and low water feature will be installed at approximately the same location. This fence is collapsing and removal is essential
2. The set back fence and shed facing, right front, will be replaced with redwood. The material had been obscured over the years by growing bushes. The change will return to approximately original appearance.
3. 20 feet of fence to north will be replaced with unpainted redwood, again approximating original appearance and adjoining neighbors equivalent fence from east to west.

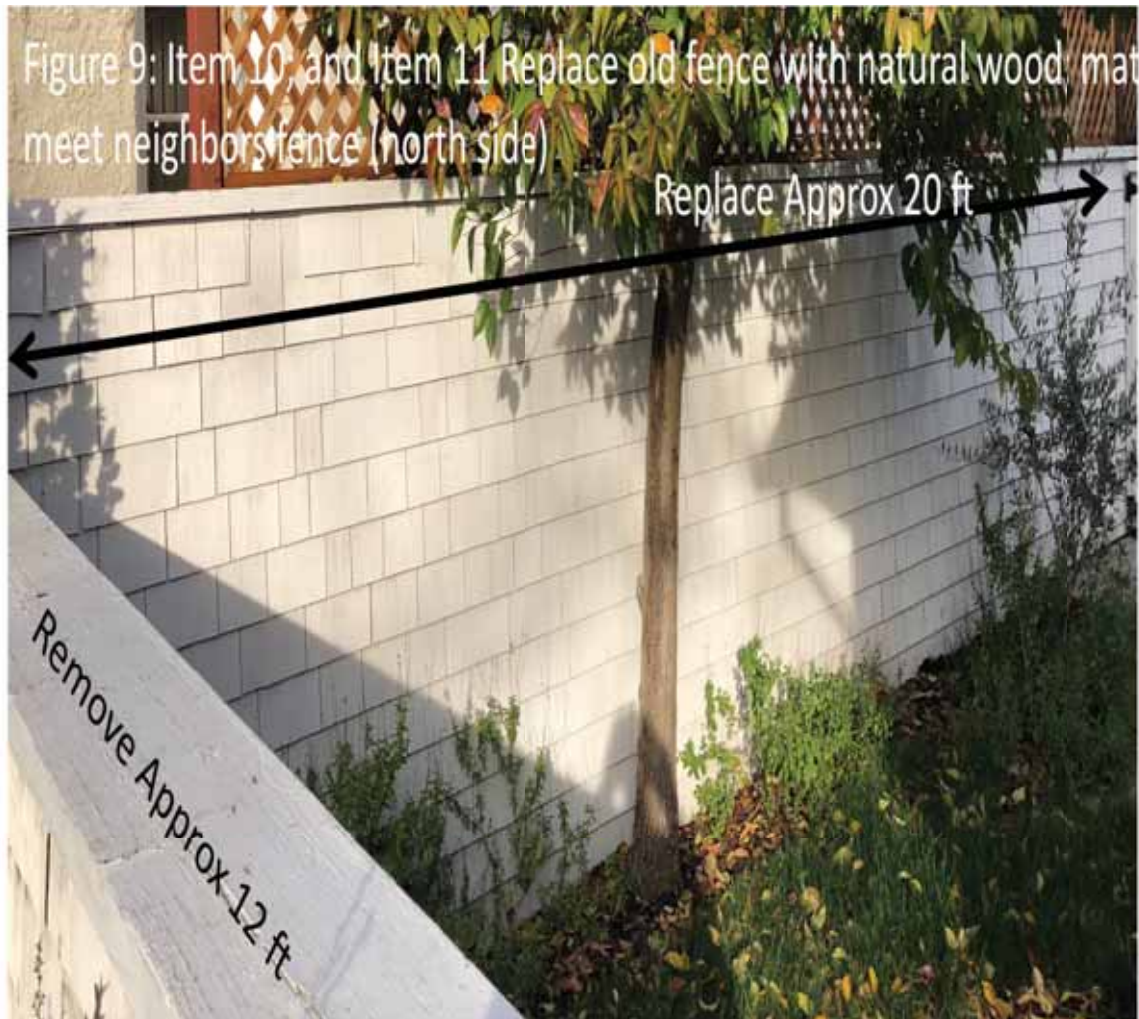
-Replace old original fence with natural unpainted wood 20 feet of that abuts neighbors new identical fence between houses (north side) **(Figure 9)**

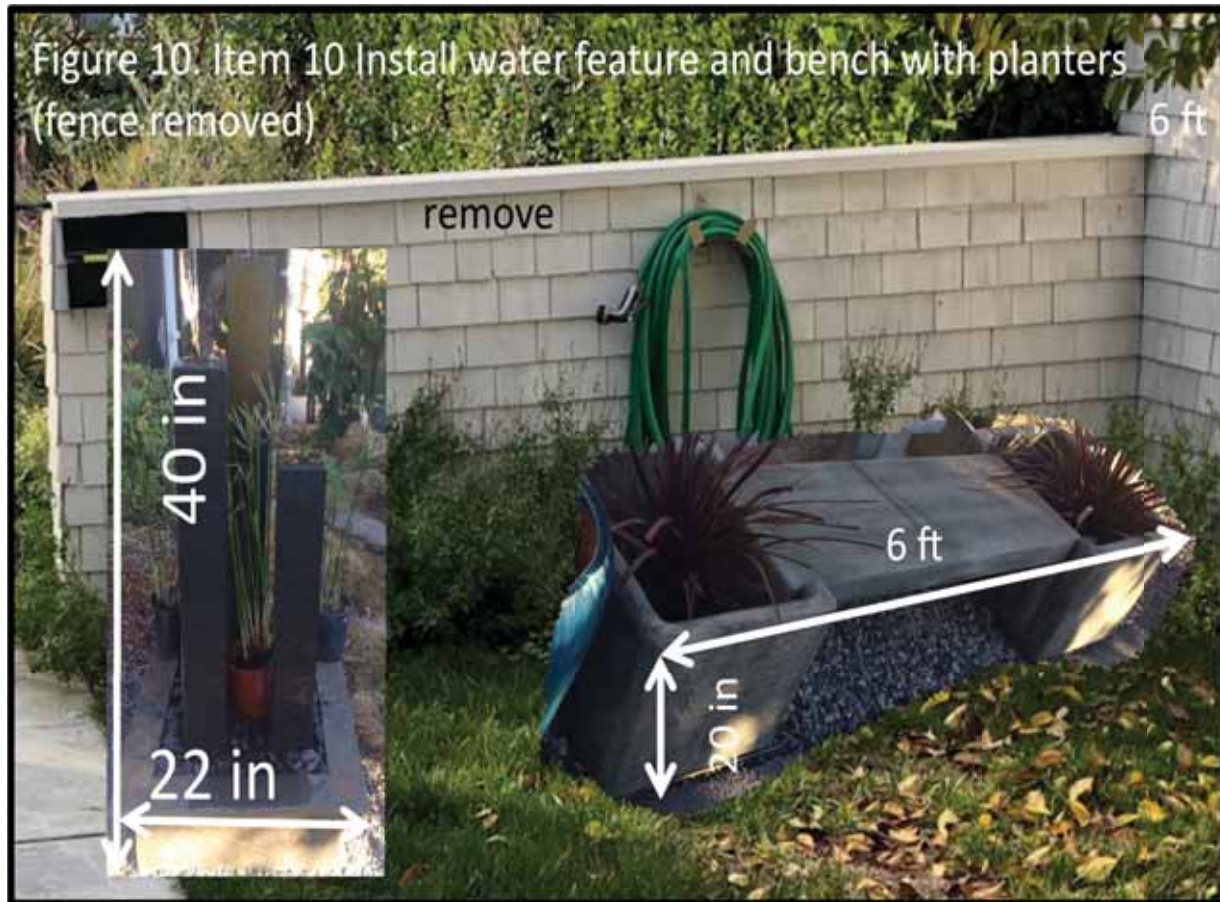
1. Install modest vertical water feature/fountain (H=40 in, W/D 22 in) and low concrete planter bench (H=20 in L=72 in) behind line (closer to house) of fence after its removal. **(Figure 10)**

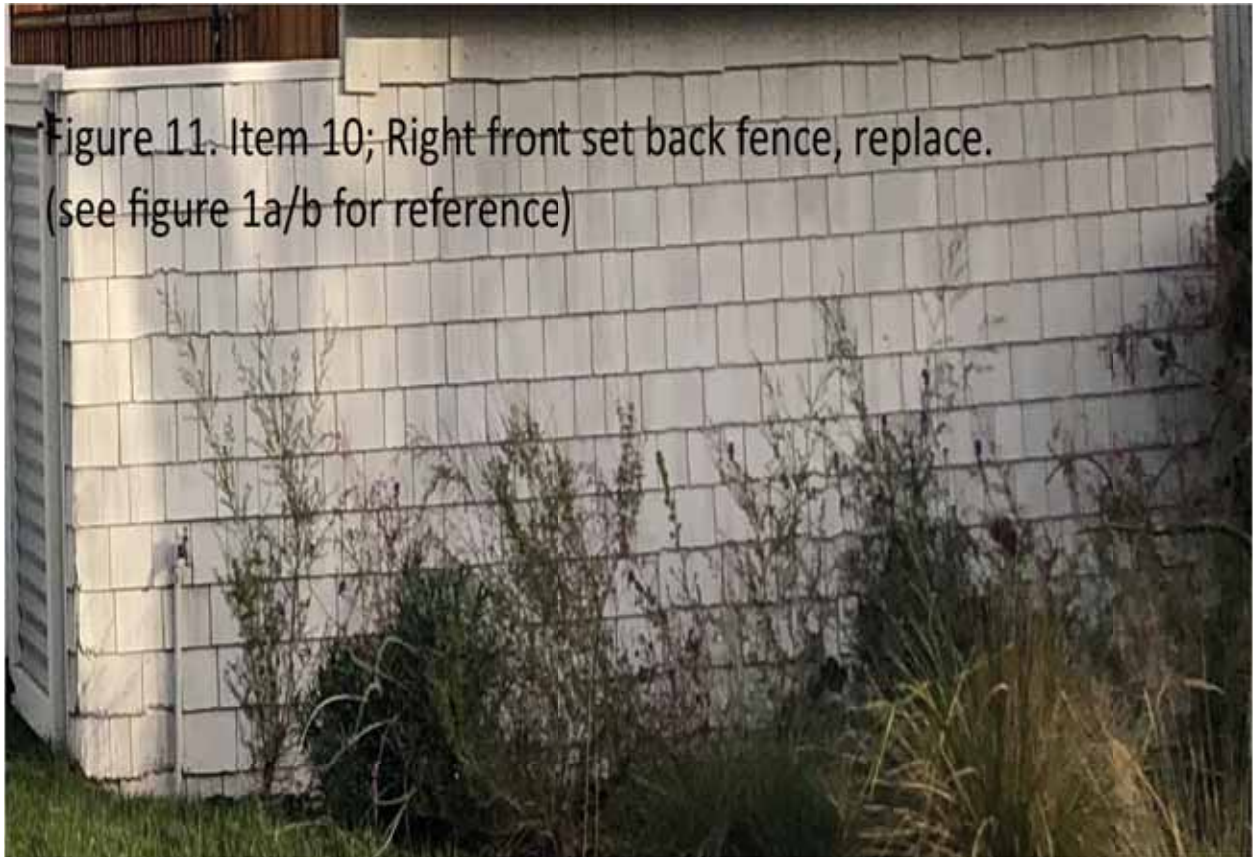
-Replace set back fence at right front of house with natural wood (**Figure 11**)

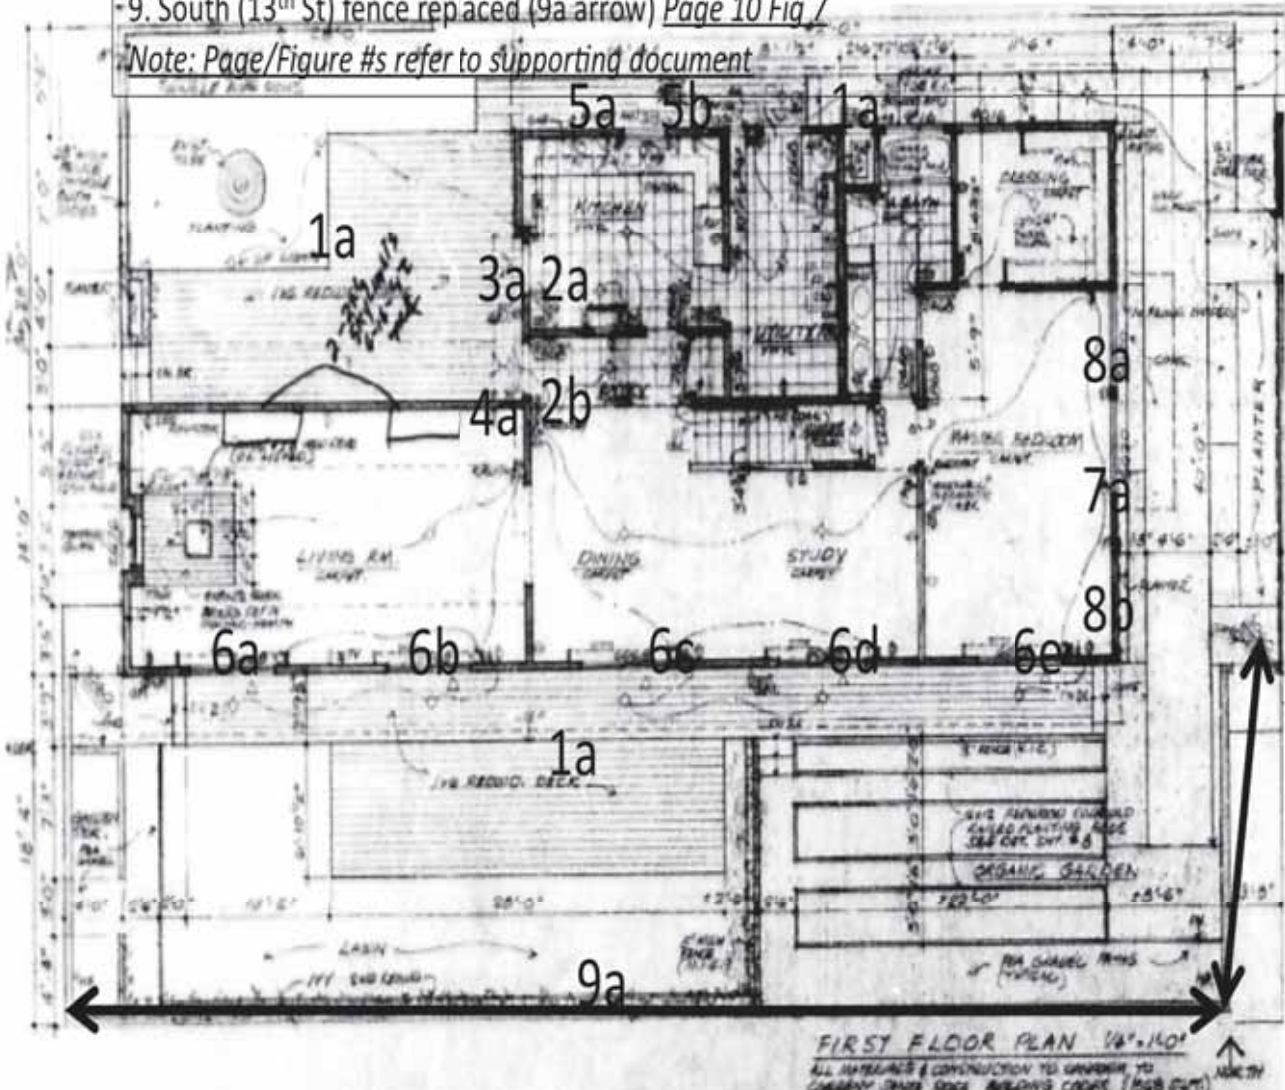
Schematic A
Changes
requiring
Legalization
notations jg

800 Mc Donald Original 1st Flr Plan

1. Redwood decking replaced with concrete (1a), Page 5, Fig 2, also Page 7, Fig 4
2. Two front doors removed (2a, 2b), Page 5, Fig 2
3. Window at kitchen replaced one door (W57in x H21 in) (3a) Page 5, Fig 2
4. Entry door installed at right front (W36 in x H 80 in) (4a) Page 5, Fig 2
5. North kitchen window removed (5a), laundry window replaced (5b) Page 6, Fig3
6. Sliding glass doors (south) replaced/double doors (W70 in x H78) (6 a-e) Page 7, Fig 4
7. Center (east) window removed (7a) Page 8, Fig 5 #1
8. Two windows (east) installed(W33 in x H57in) (8a, 8b), left and right Page 8, Fig 5 #2
9. South (13th St) fence replaced (9a arrow) Page 10 Fig 7

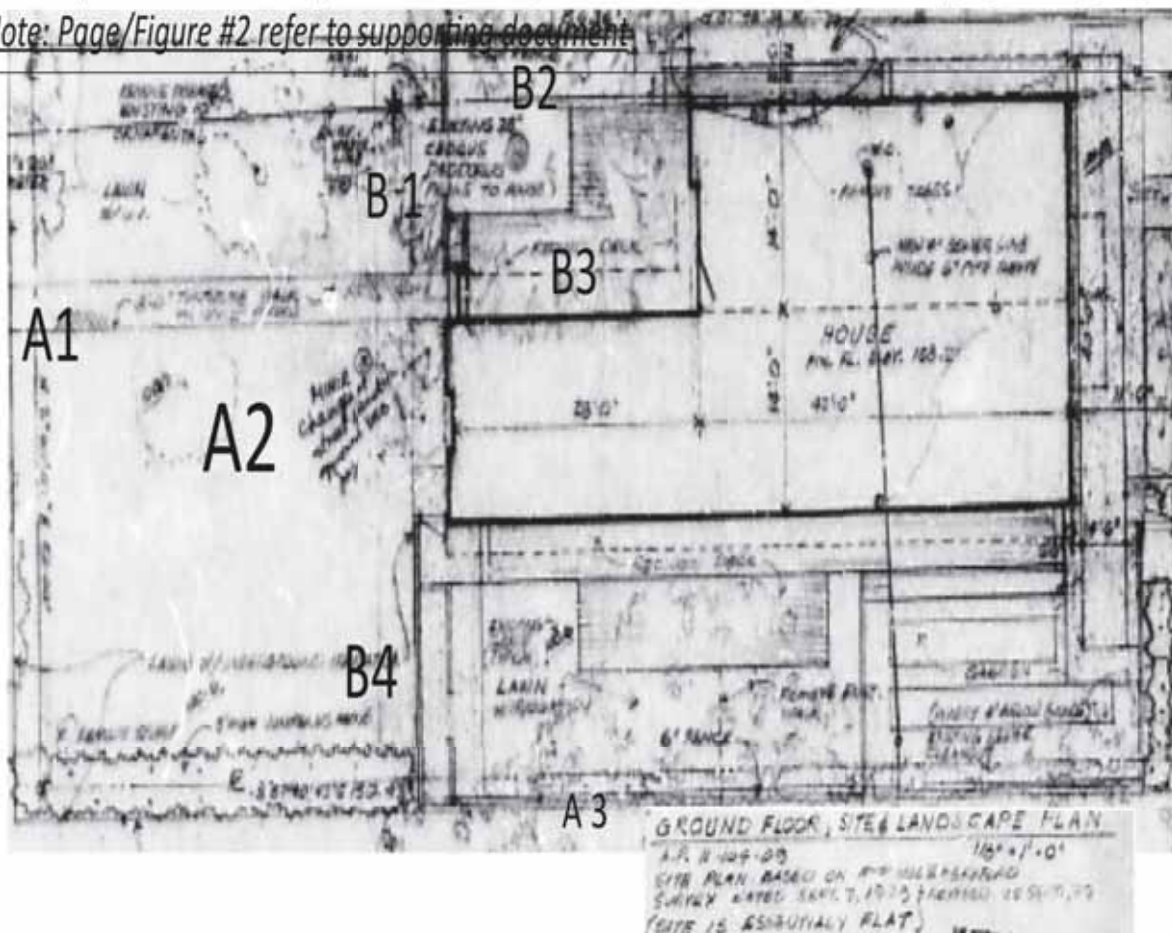
Schematic B (notations jg)

800 McDonald Original Landscape Plan

A. Changes requiring legalization

1. Gate appearance change Page 9 Fig 6
2. Indeterminate plant changes front yard; to be re landscaped (plan attached)
3. South facing fence replaced (13th St), Page 10 Fig 7

B. Approval requested (new)

1. Remove west facing set back half fence Page 11, Fig 8a/b
2. Replace 20 ft north facing fence to match neighbors Page 11, 12, Fig 8, 9
3. Install low water feature and bench Page 13, Fig 10
4. Replace fence and adjacent shed wall (to match north and south fence) Page 14 Fig 11

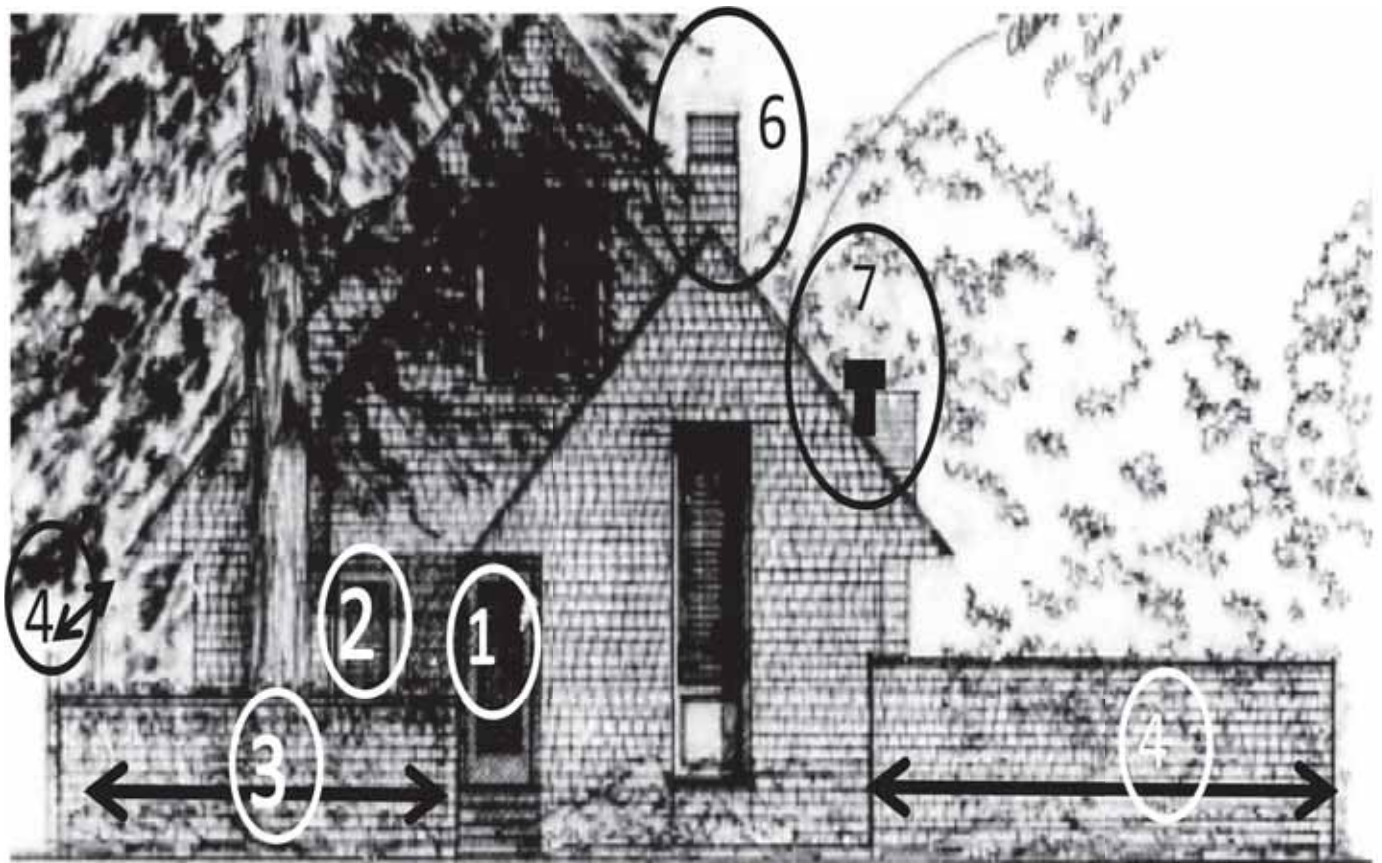
Front (West Facing) Elevation

Front McDonald Original and Current Elevation (except #7)

1. Front door removed, moved to right, facing north
2. Window installed, facing east
3. Left: Remove east facing set back half fence; *Figures 8 and 10, Pages 10 and 12*
4. Left (not visible): Replace north facing fence from half fence to junction with neighbors equivalent redwood fence; *Figure 9, Page 11*
5. Right: Replace half fence and shed facing with natural redwood (will adjoin redwood fence on south (13th Street); *Figure 11, Page 13*
6. Chimney removed in renovation; *Figure 1, Page 3*
7. Chimney current location (set back ~15 ft); *Figure 4, Page 6*

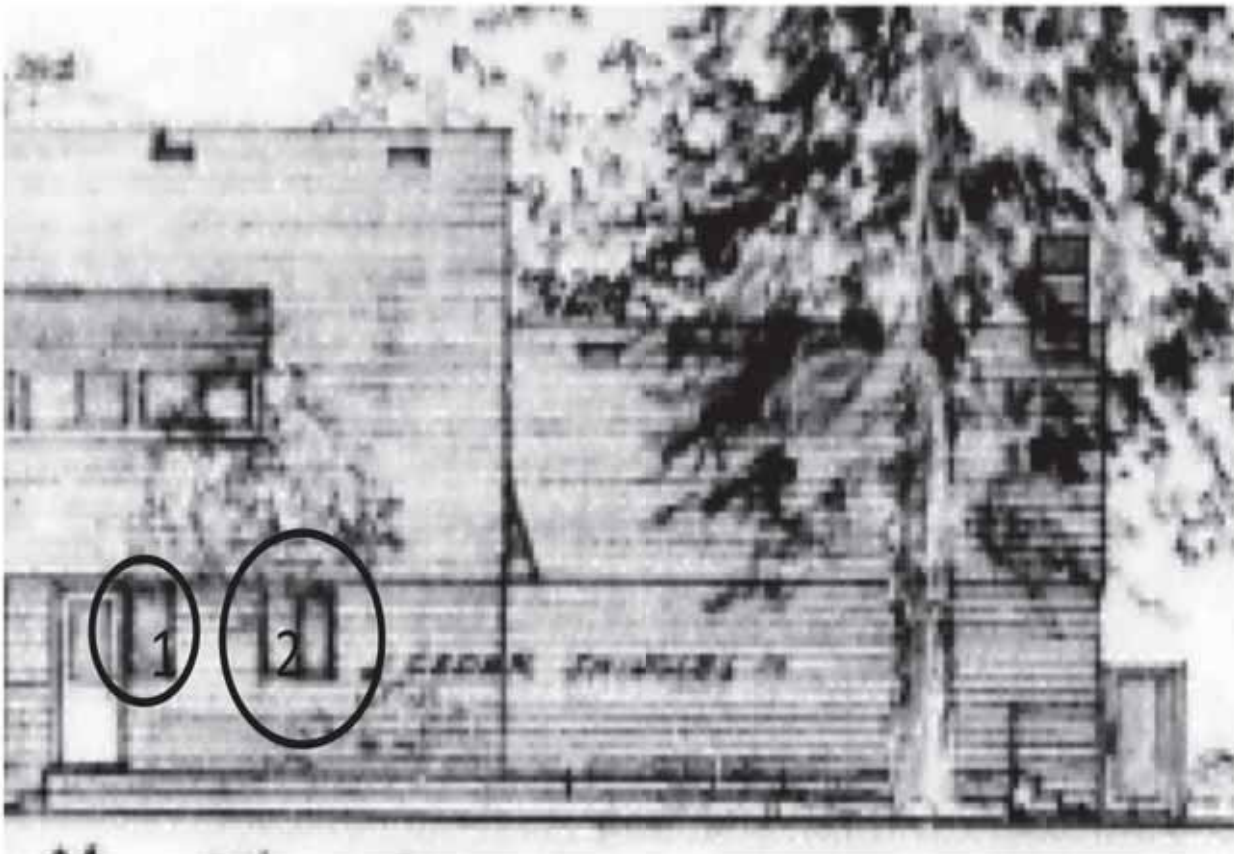
800 Mc Donald Original and Change North elevation

1. Laundry room window replaced
2. Kitchen window removed

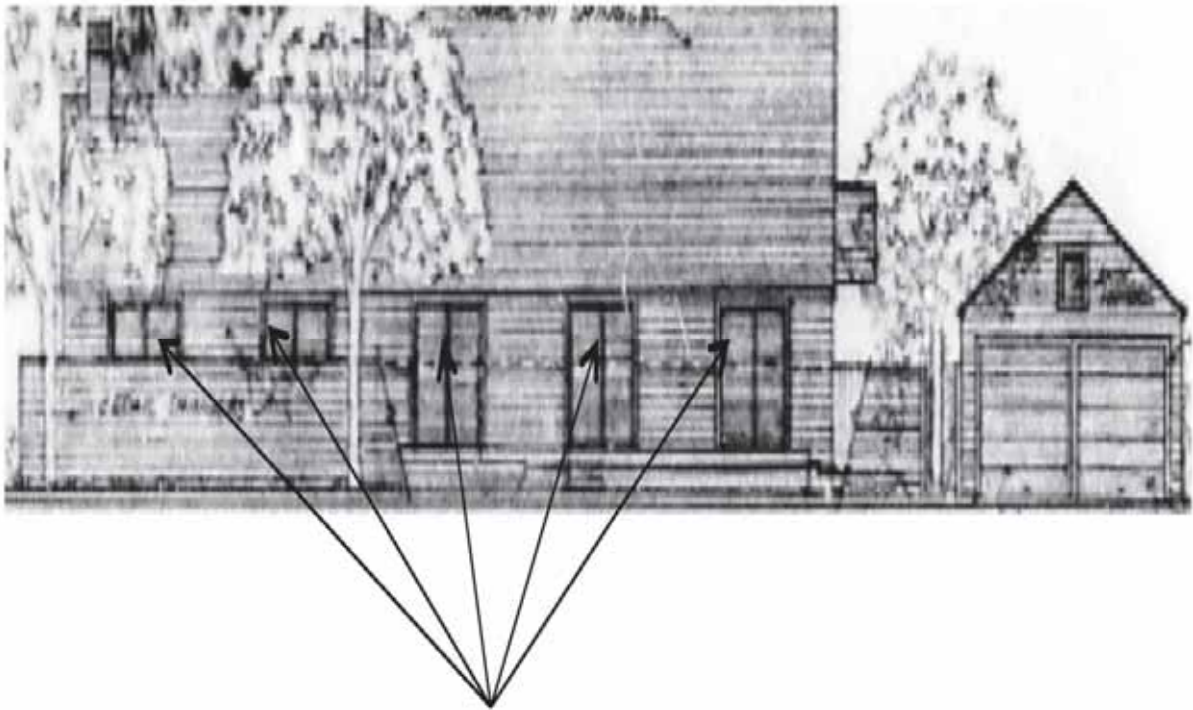
800 Mc Donald Original and Current South Facing Elevation

Sliding glass doors replaced with double open doors ("French Doors")
(at arrows)

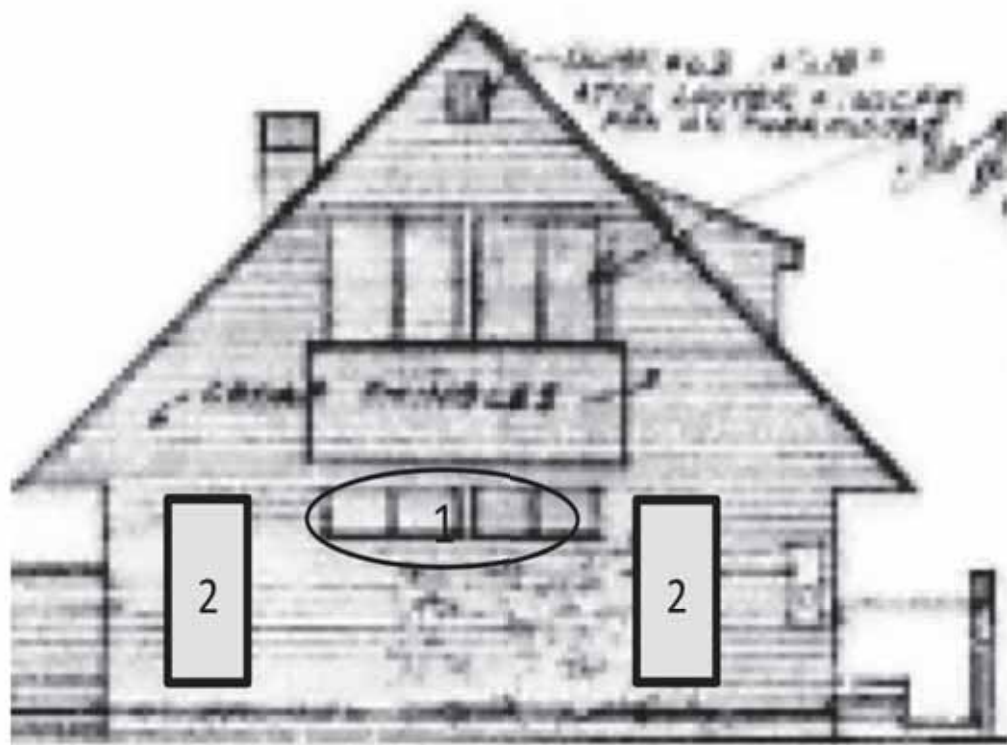
800 Mc Donald Original and Change East Facing Elevation

1. Windows removed--oval
2. Windows installed

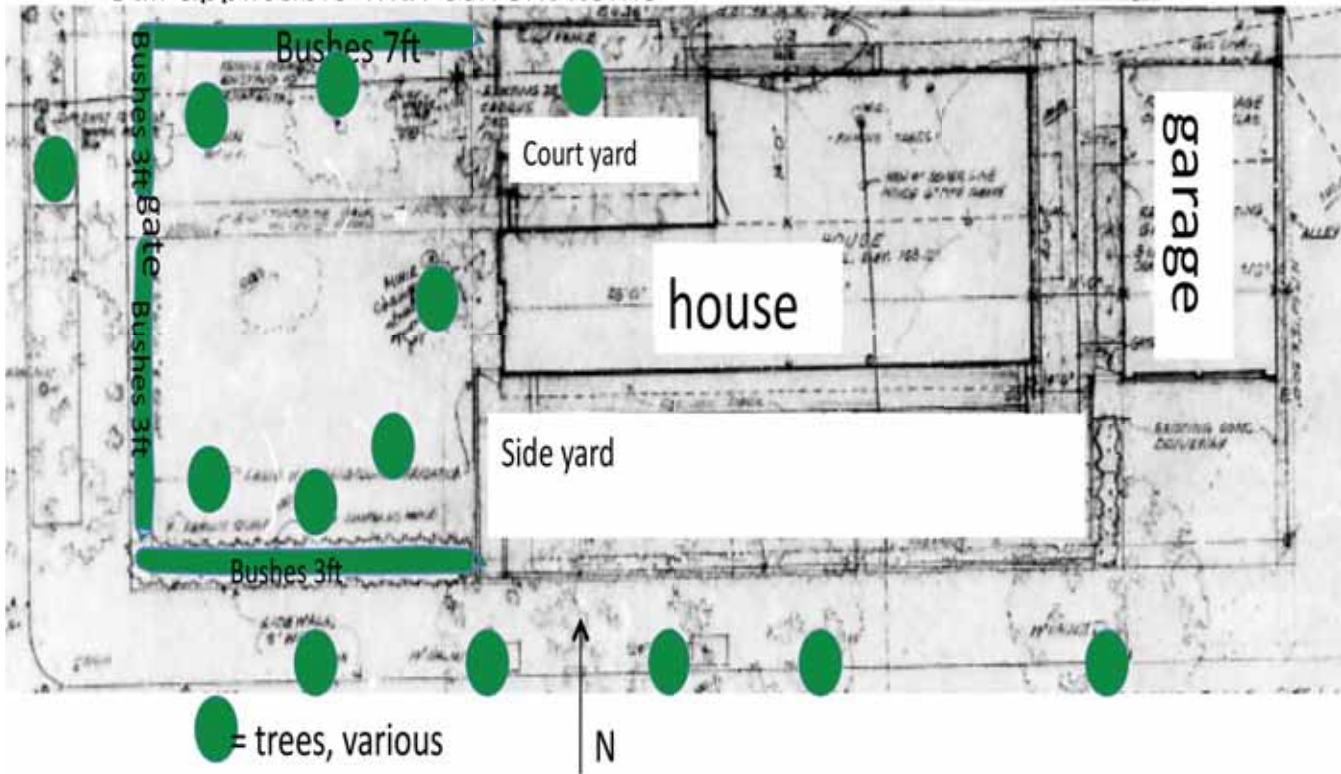
Site Plan; from microfiche

Still applicable with current items
