**RE: 2028 Piner Road, Santa Rosa, Sonoma County, CA; APN 036-011-053**

**SITE PHOTOGRAPHS August 20, 2018**

**Re: Potential for California tiger salamander (*Ambystoma californiense*) occurring at 2028 Piner Road, Santa Rosa**

**PRE-JURISDICTIONAL DETERMINATION,  
WATERS OF THE UNITED STATES,  
A.P. 036-790-052, BAY VILLAGES HOMES PROJECT SITE  
SANTA ROSA, CALIFORNIA**

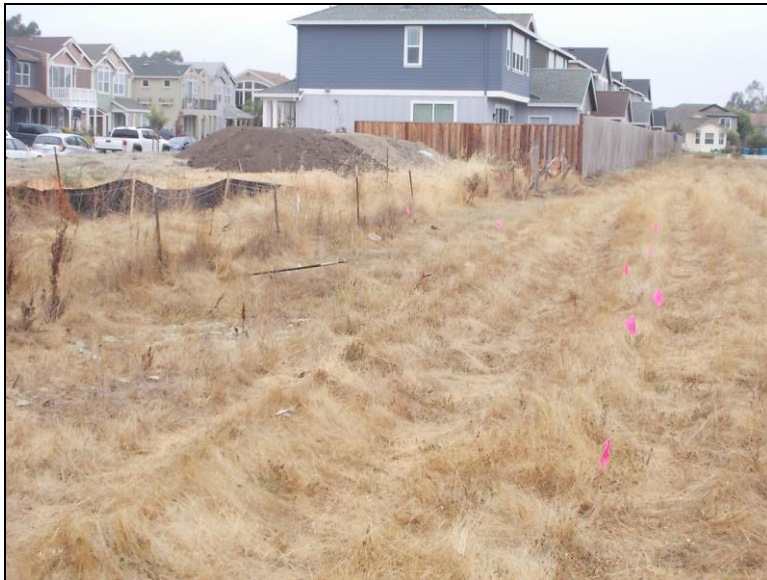
Photo showing area flagged as wetland.

Based on my review of the most recent site plan that you provided in your email of August 21, 2018, there is a more than sufficient buffer between the wetland and any proposed development to provide an adequate watershed and protection for the existing wetland. The closest point is where the driveway for the Fire Department has to access the rear of the building. At this point the driveway is about 15 feet from the wetland. Otherwise there is a 20 foot or greater buffer zone which is more than adequate to sustain this wetland feature. As discussed, I understand that a fence will be installed that further protects the wetland area from any human traffic and signs could be posted to educate the public that this is a wetland area and is protected so no disturbance is allowed. During construction I recommend that this area be fenced using an orange barrier or other fencing to avoid any disturbance to the area during construction.

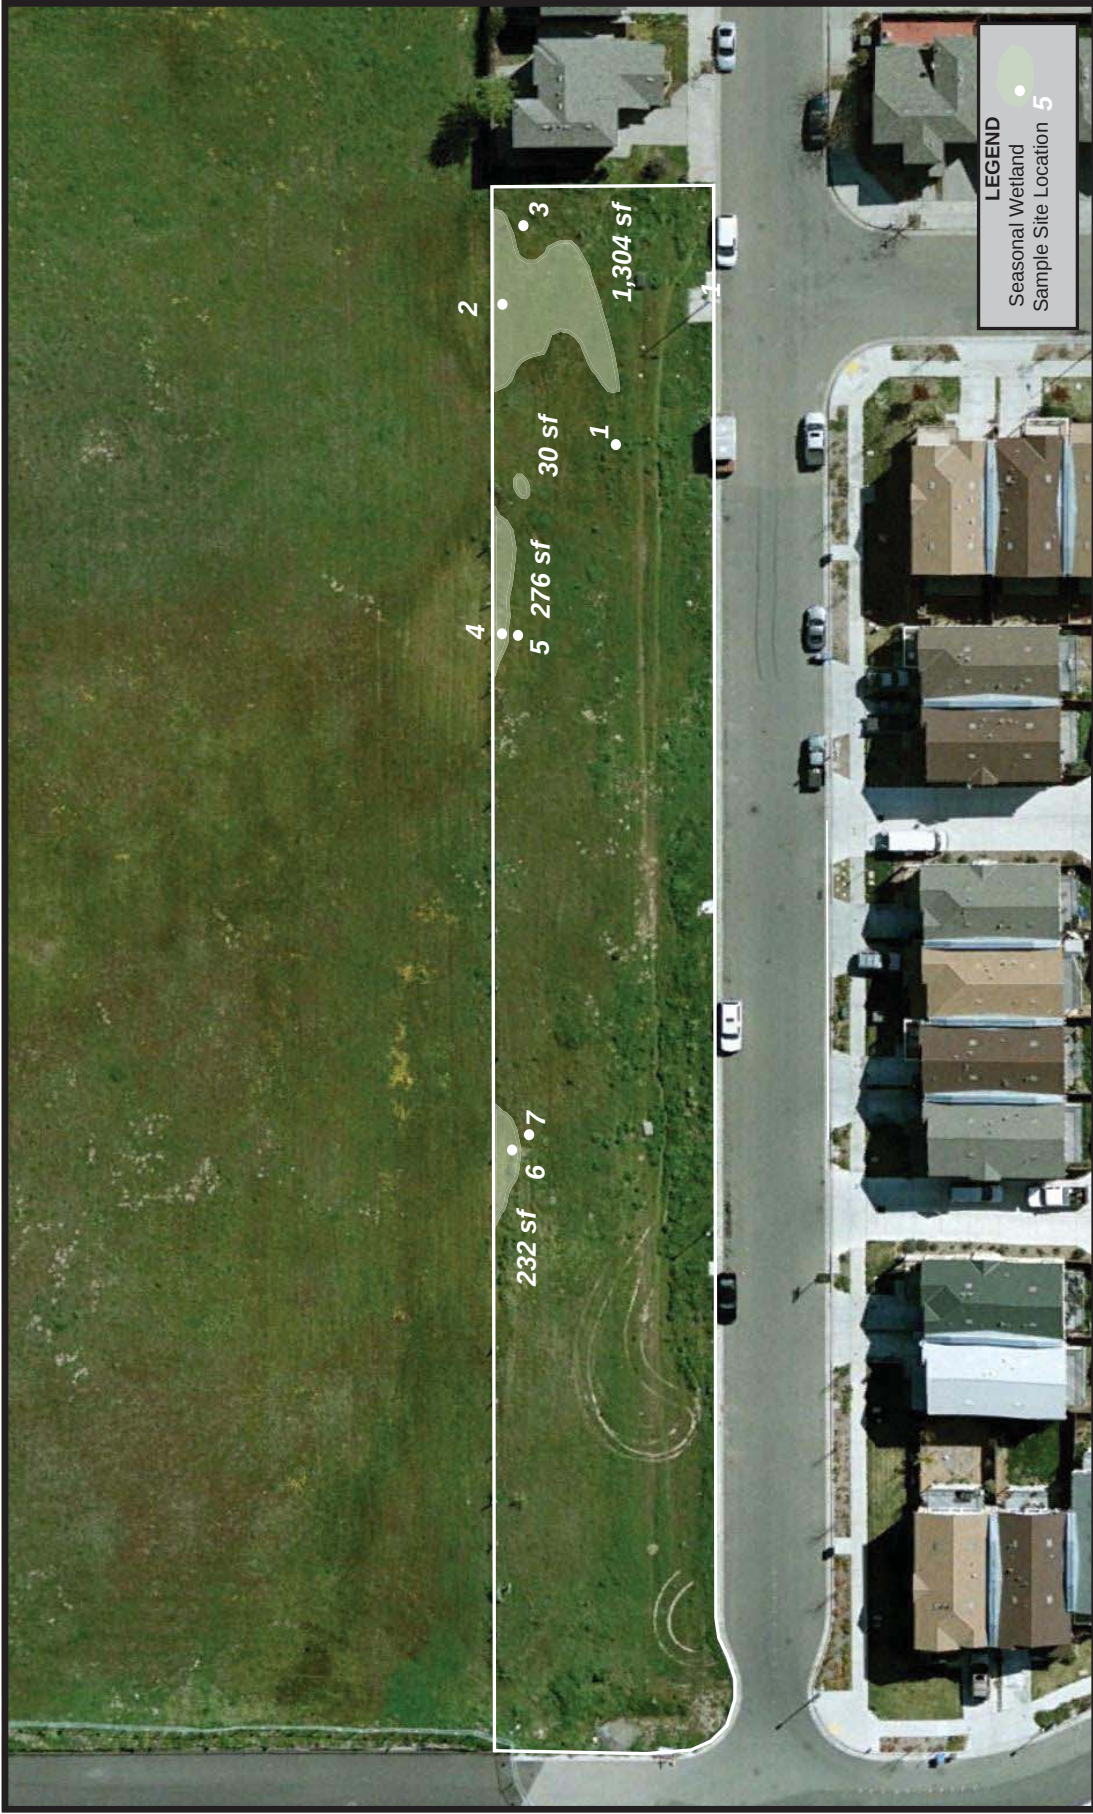
Figure 3.  
Pre-jurisdictional Determination of Waters  
of the State and United States

The result of the field delineation is a map showing four small seasonal wetlands. The locations of the seven sample sites and the seasonal wetlands are shown on the map in Figure 3 at the rear of the report. Appendix A to this report contains the data sheets (Data Form 1 for routine on-site determinations, modified for use in herbaceous vegetation) completed in the field at sample sites.

The area of the seasonal wetland on the site is estimated to be approximately 1,842 sf or 0.042 acres.
