INITIAL STUDY/MITIGATED NEGATIVE DECLARATION

Recess Storage Project 4224 Sonoma Highway Santa Rosa, California

June 2019

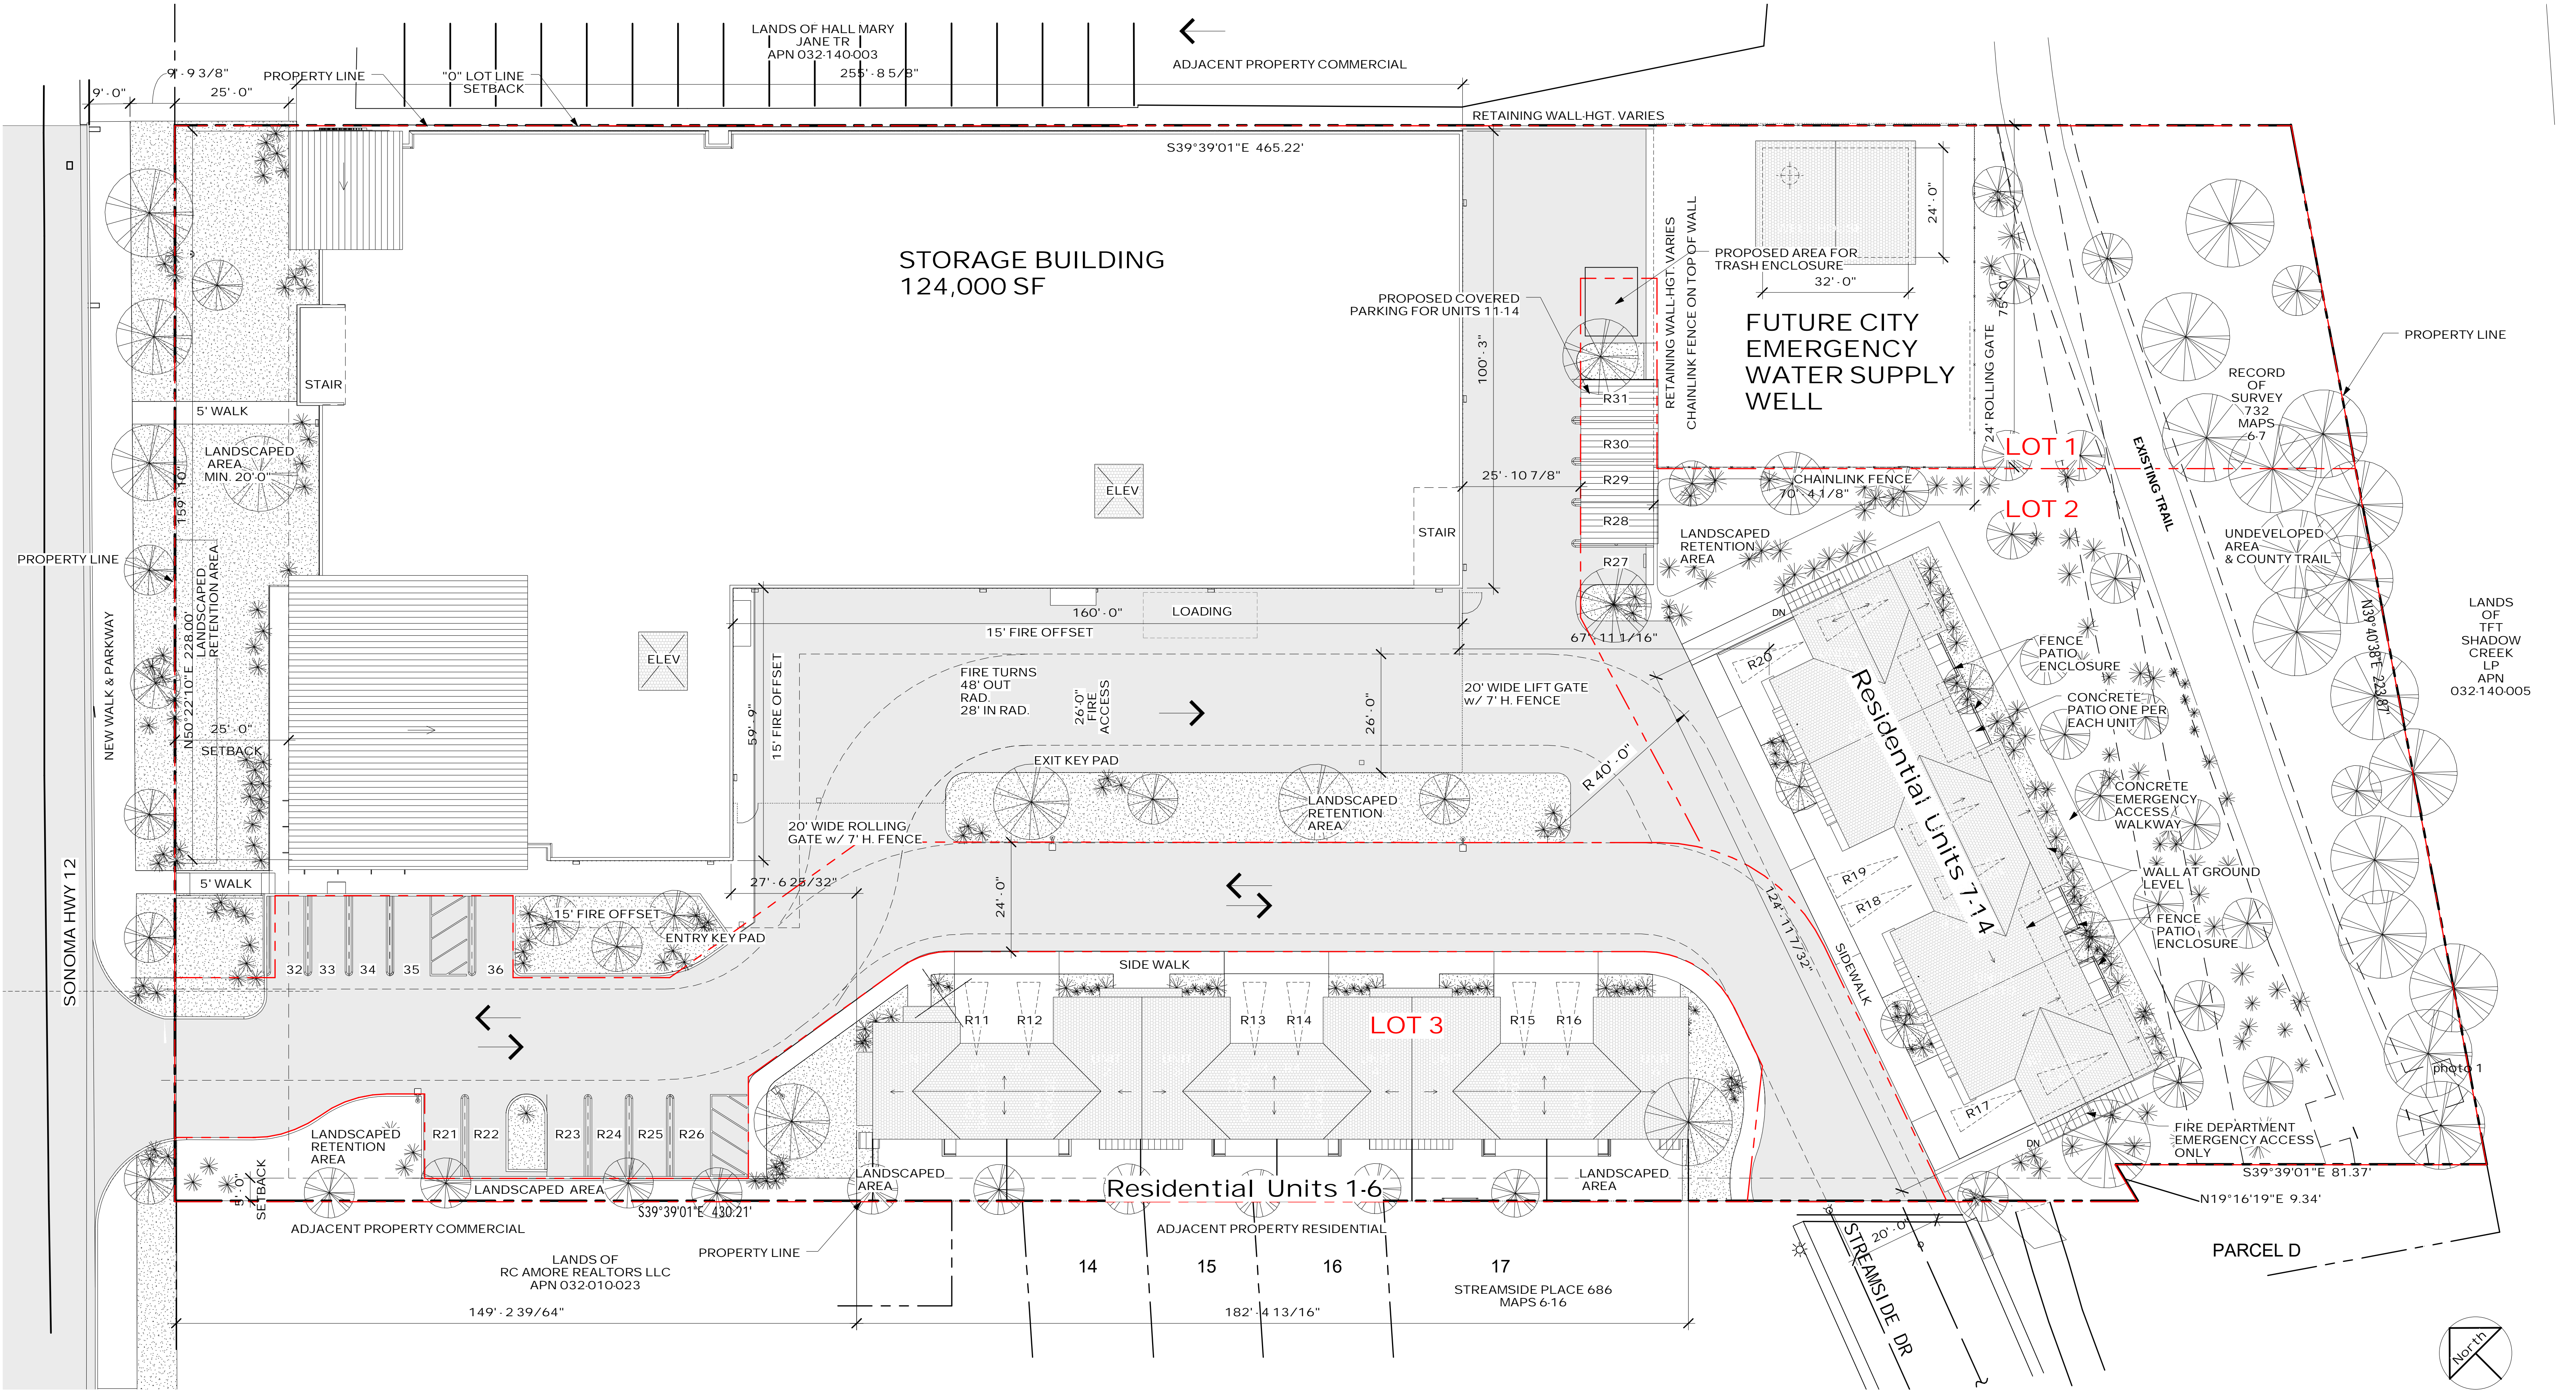
Site Plan/ Roof Plan

Scale 1/16" = 1'-0"

As shown in Figure 2 Site Plan, the storage structure will be setback 25 feet from the property line. The residential structure on the southwestern property line will be setback approximately 150 feet from the interior side of the sidewalk, which will not readily visible from Sonoma Highway. The Project will be setback approximately 150 feet from Santa Rosa Creek (Figure 4). All three structures will have a variety of exterior siding materials, varied roof lines, and landscaping.

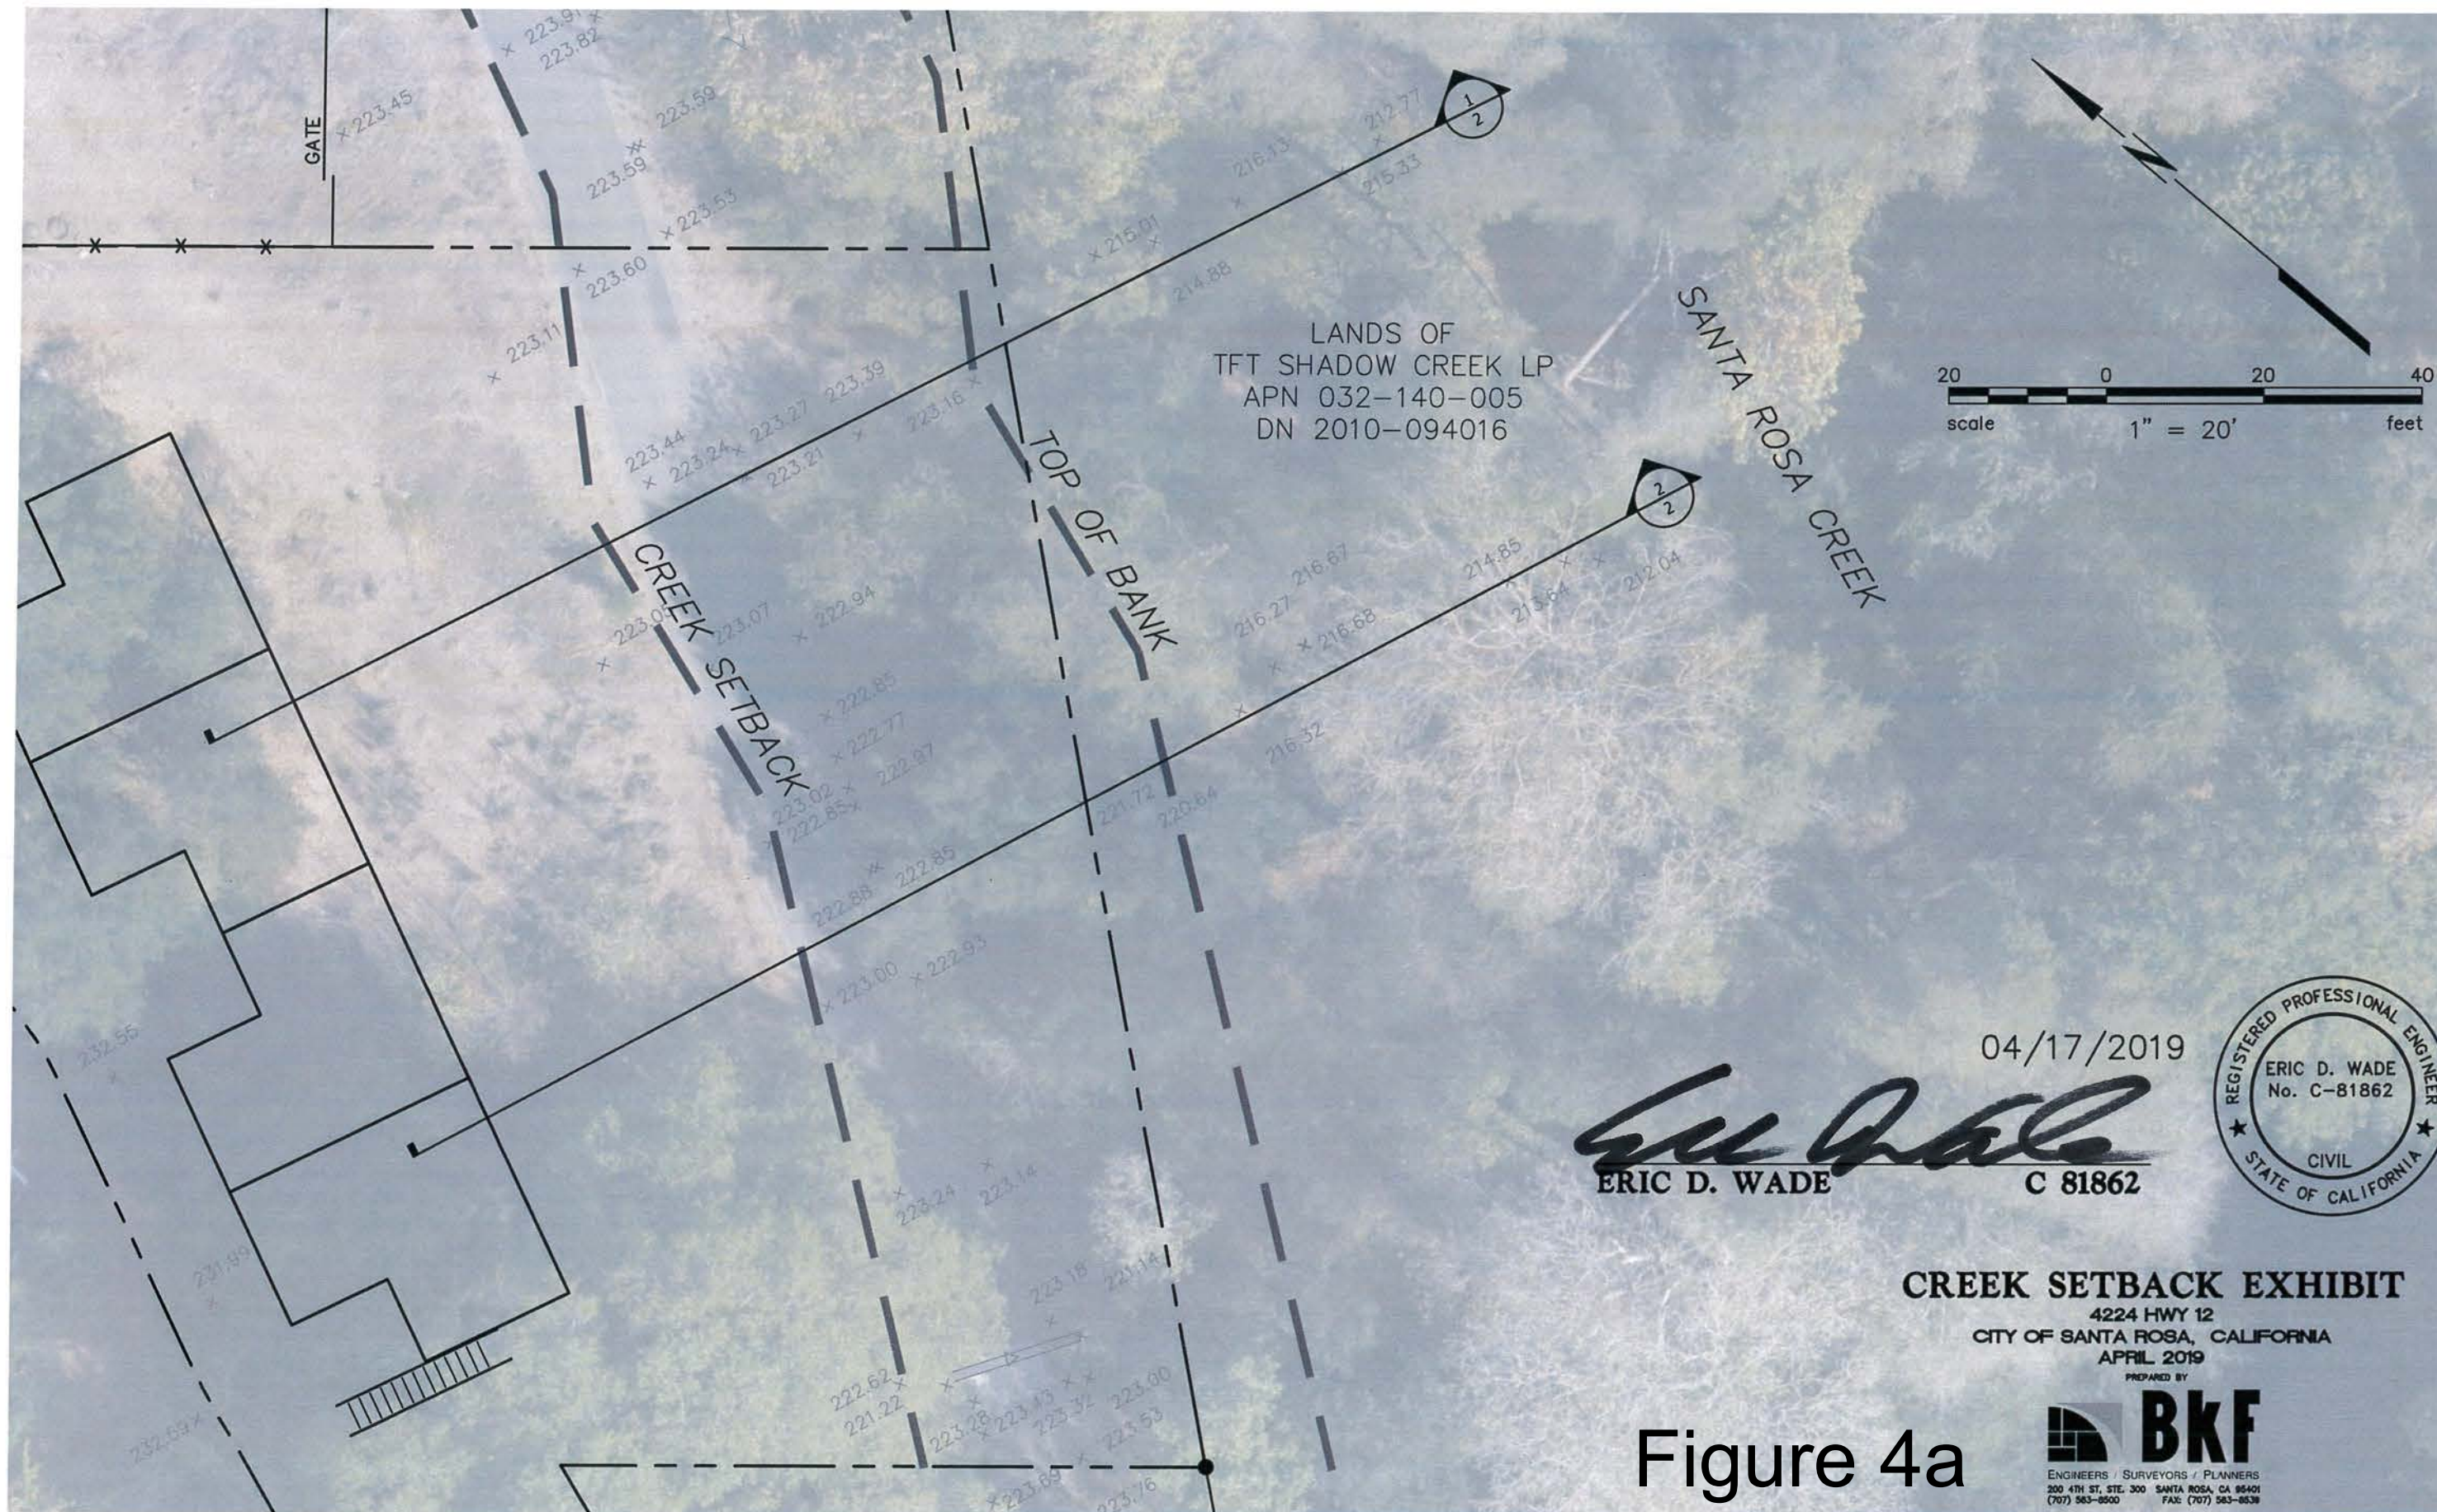
Figure 4a

CREEK SETBACK EXHIBIT

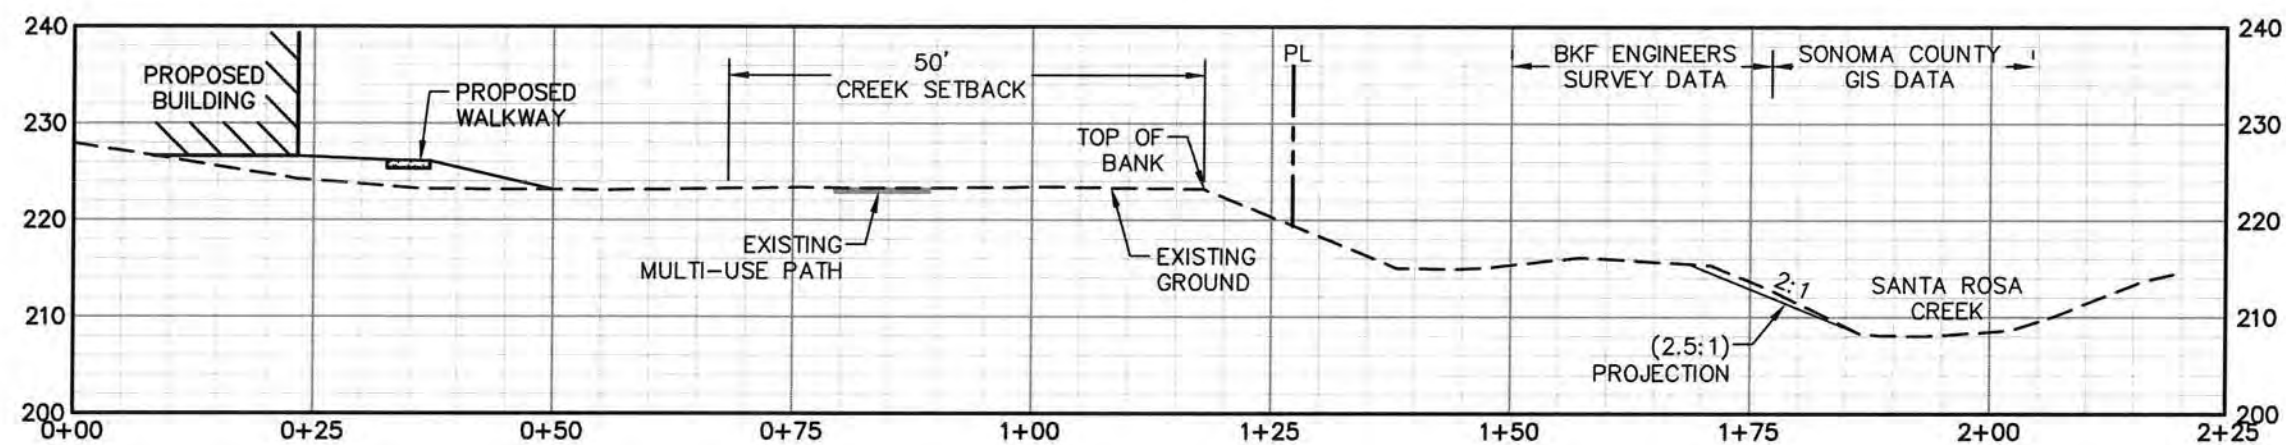
SECTION 1
 H: 1"=20'
 V: 1"=20'

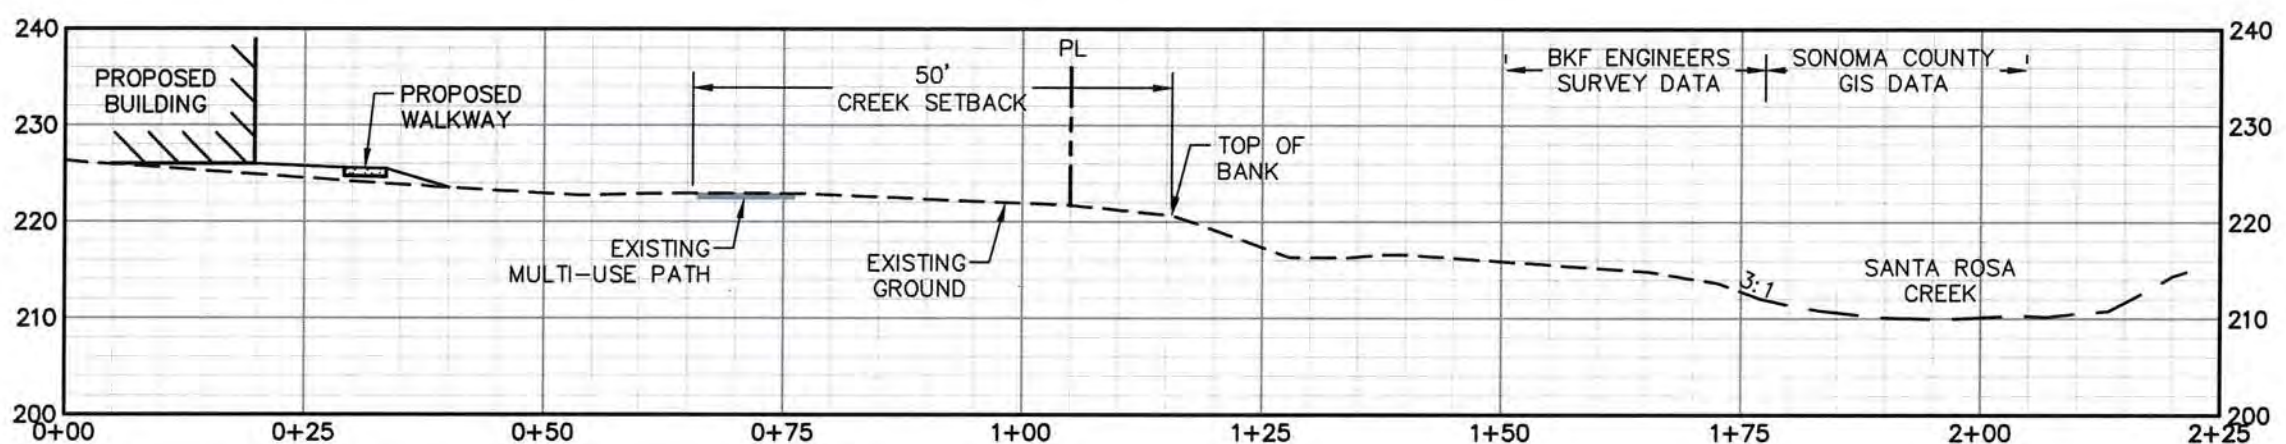
SECTION 2
 H: 1"=20'
 V: 1"=20'

CREEK SETBACK SECTIONS
 4224 HWY 12
 CITY OF SANTA ROSA, CALIFORNIA
 APRIL 2019
 PREPARED BY

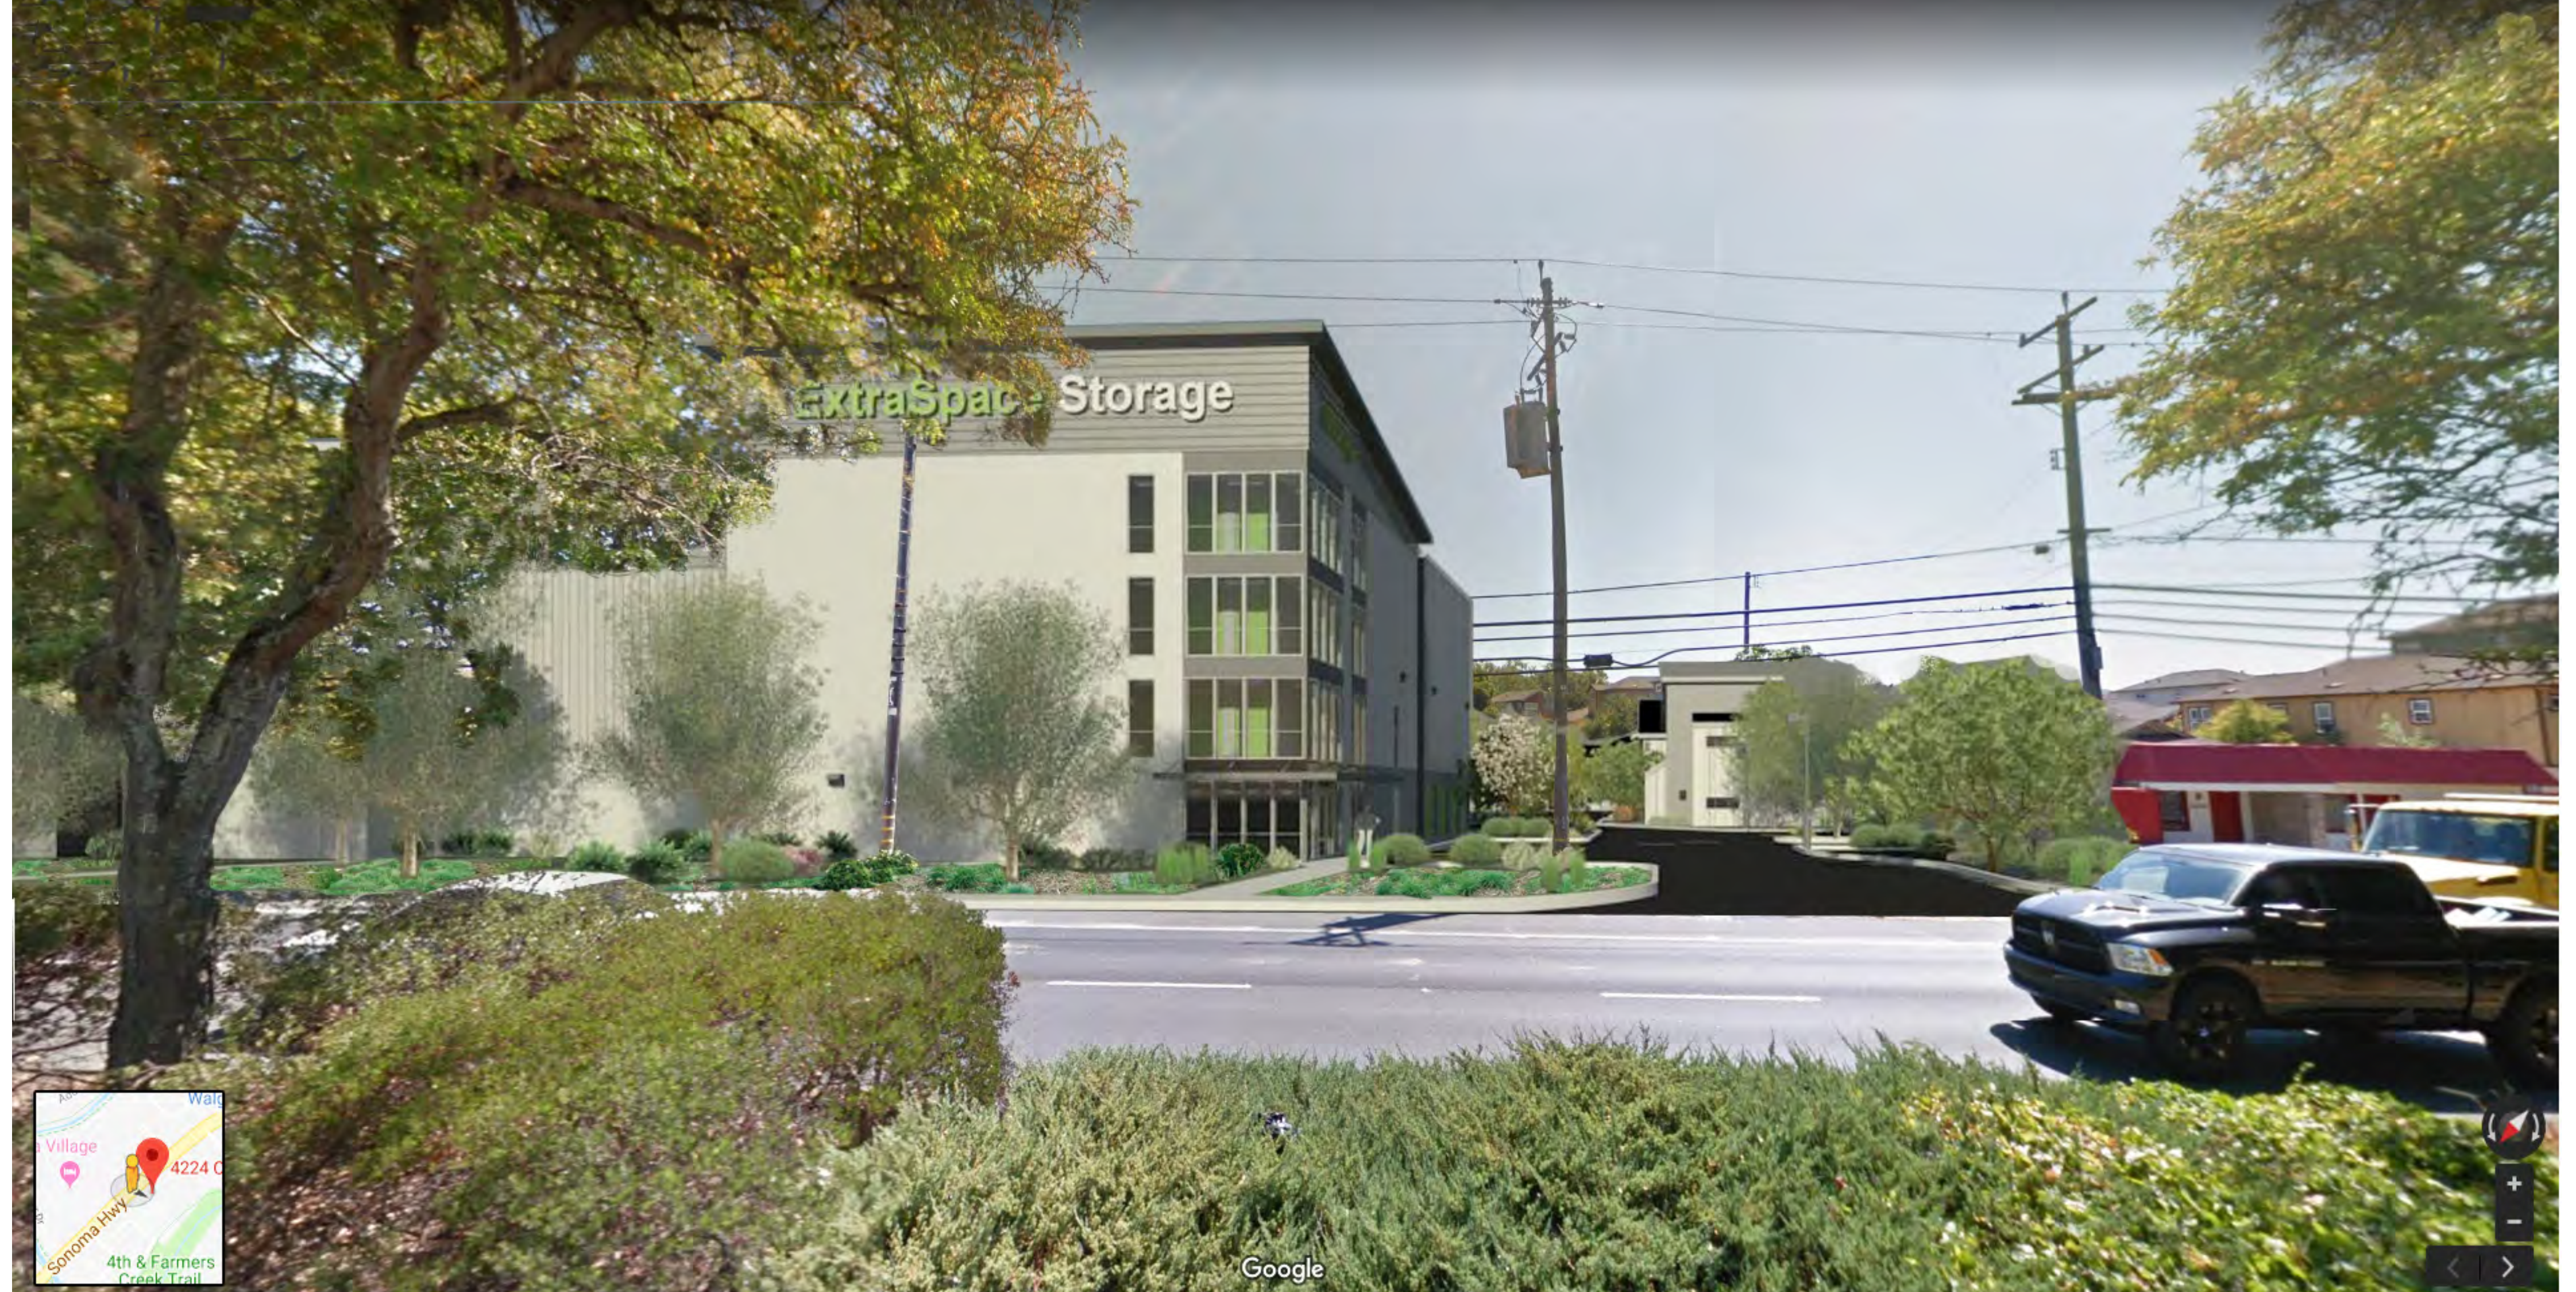
Recess Storage Project
Santa Rosa, California

Figure 5
View from Sonoma Highway

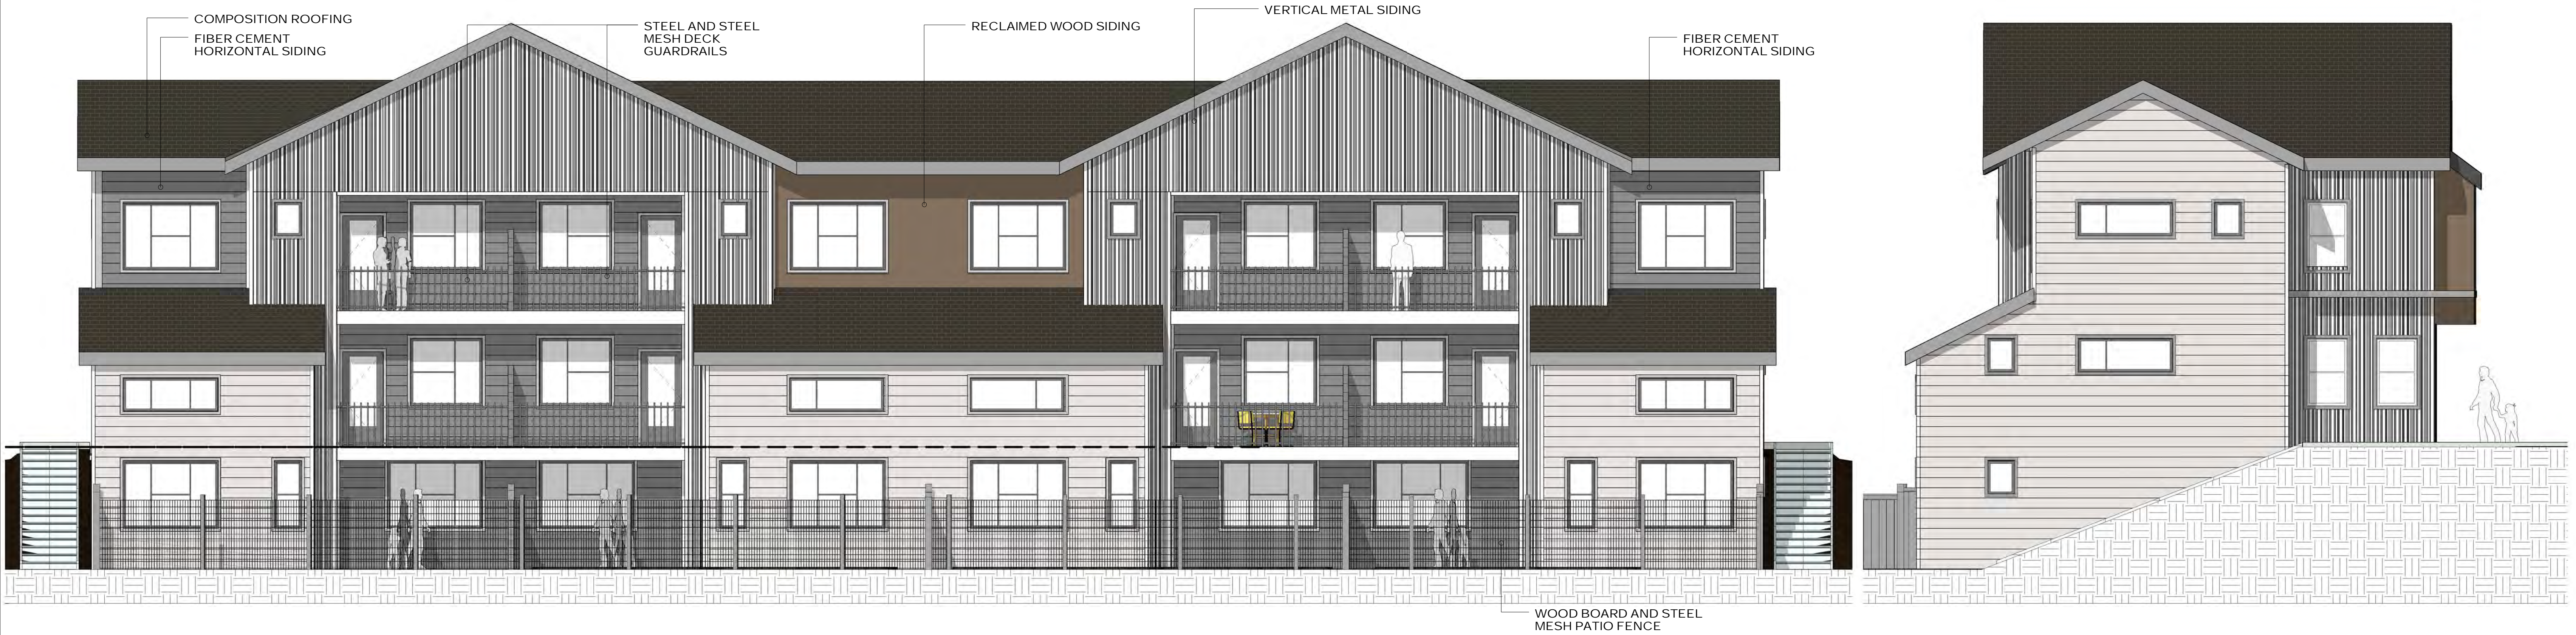
Residential Units 7-14 East El evation
Scale 3/16" = 1'-0"

Residential Units 7-14 North El evation
Scale 3/16" = 1'-0"

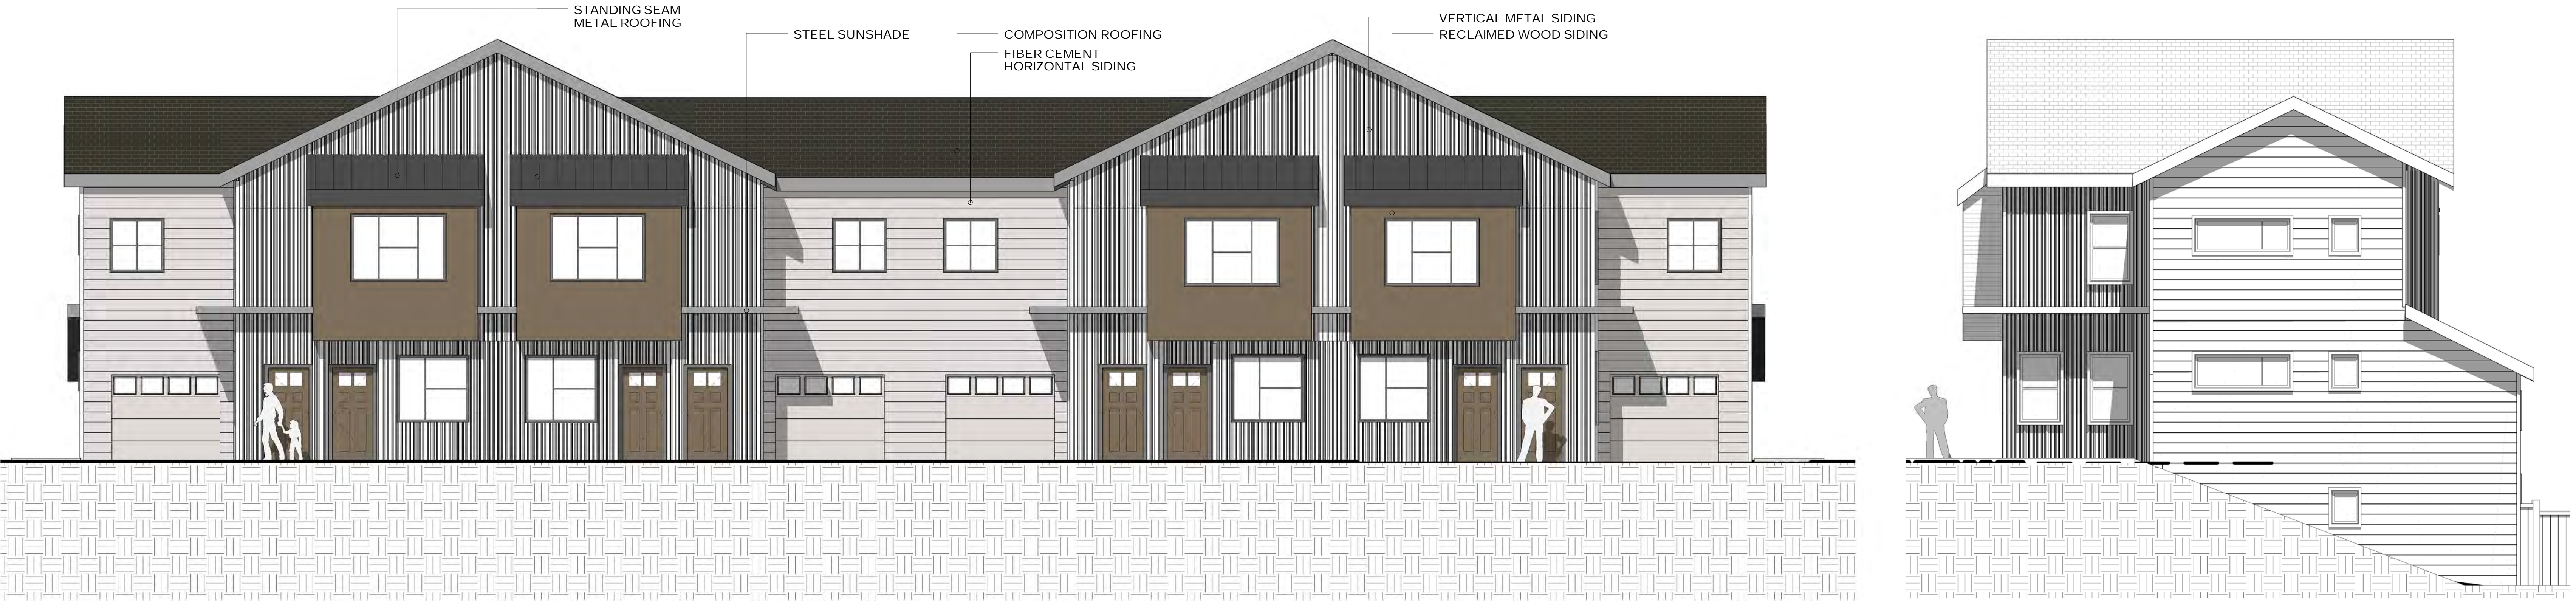
Residential Units 7-14 West El evation
Scale 3/16" = 1'-0"

Residential Units 7-14 South El evation
Scale 3/16" = 1'-0"

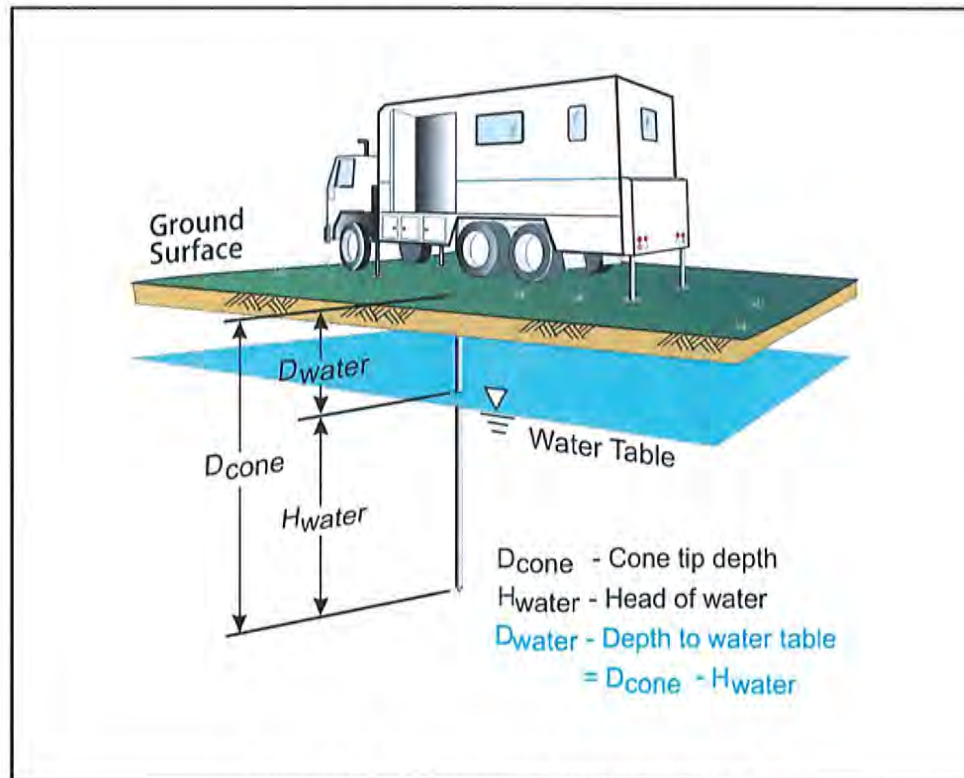
The cone penetration test is halted at specific depths to carry out pore pressure dissipation (PPD) tests, shown in Figure PPD-1. For each dissipation test the cone and rods are decoupled from the rig and the data acquisition system measures and records the variation of the pore pressure (u) with time (t).

Figure PPD-1. Pore pressure dissipation test setup

Pore pressure dissipation data can be interpreted to provide estimates of ground water conditions, permeability, consolidation characteristics and soil behavior.

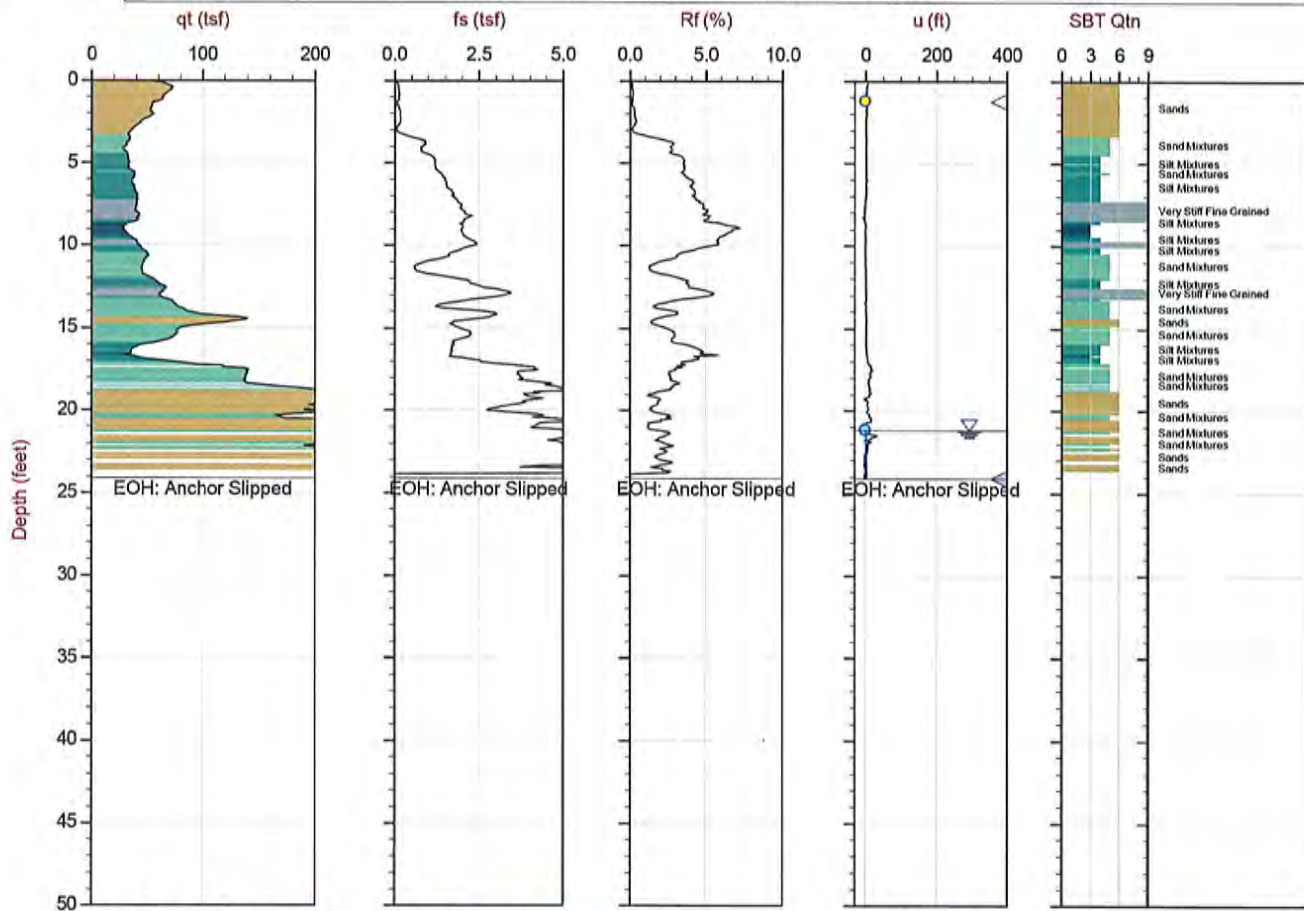
Sounding: CPT-01
Cone: 443:T1500F15U500

Max Depth: 7.350 m / 24.11 ft
Depth Inc: 0.025 m / 0.082 ft
Avg Int: Every Point

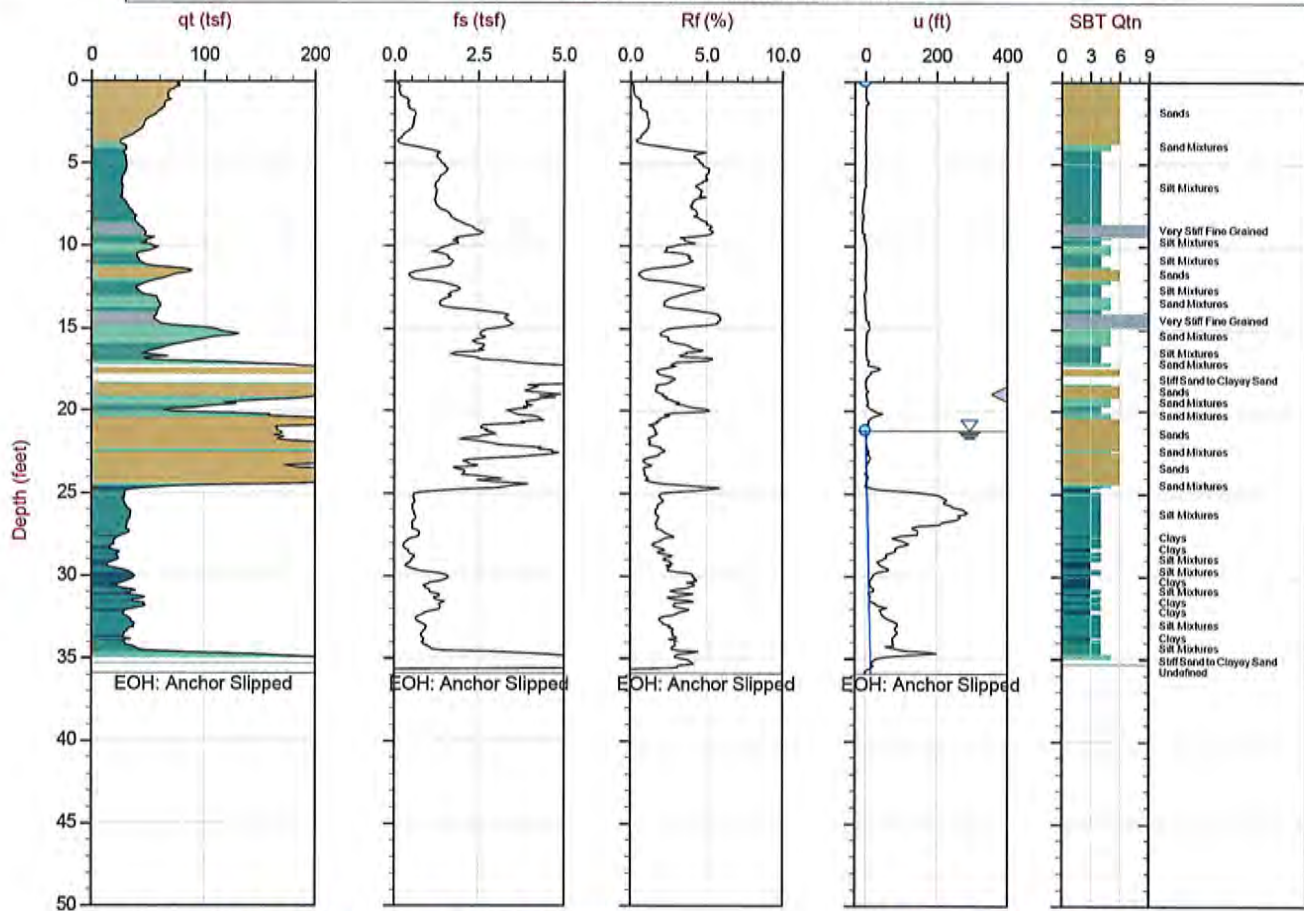
Sounding: CPT-02
Cone: 443:T1500F15U500

Max Depth: 10.950 m / 35.92 ft
Depth Inc: 0.025 m / 0.082 ft
Avg Int: Every Point

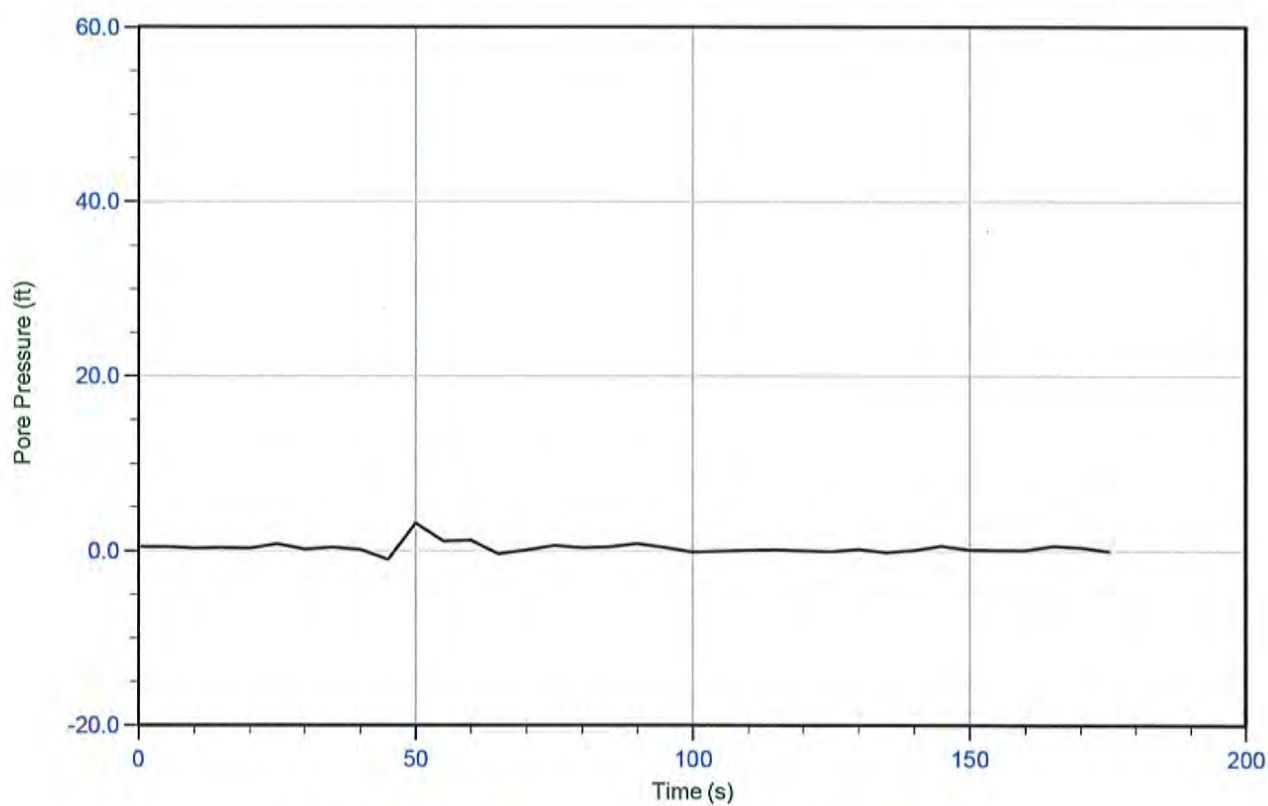
| Trace Summary: | Filename: 18-56099_CP01.PPF | U Min: -1.0 ft | WT: 0.375 m / 1.230 ft |
| | Depth: 0.375 m / 1.230 ft | U Max: 3.2 ft | Ueq: 0.0 ft |

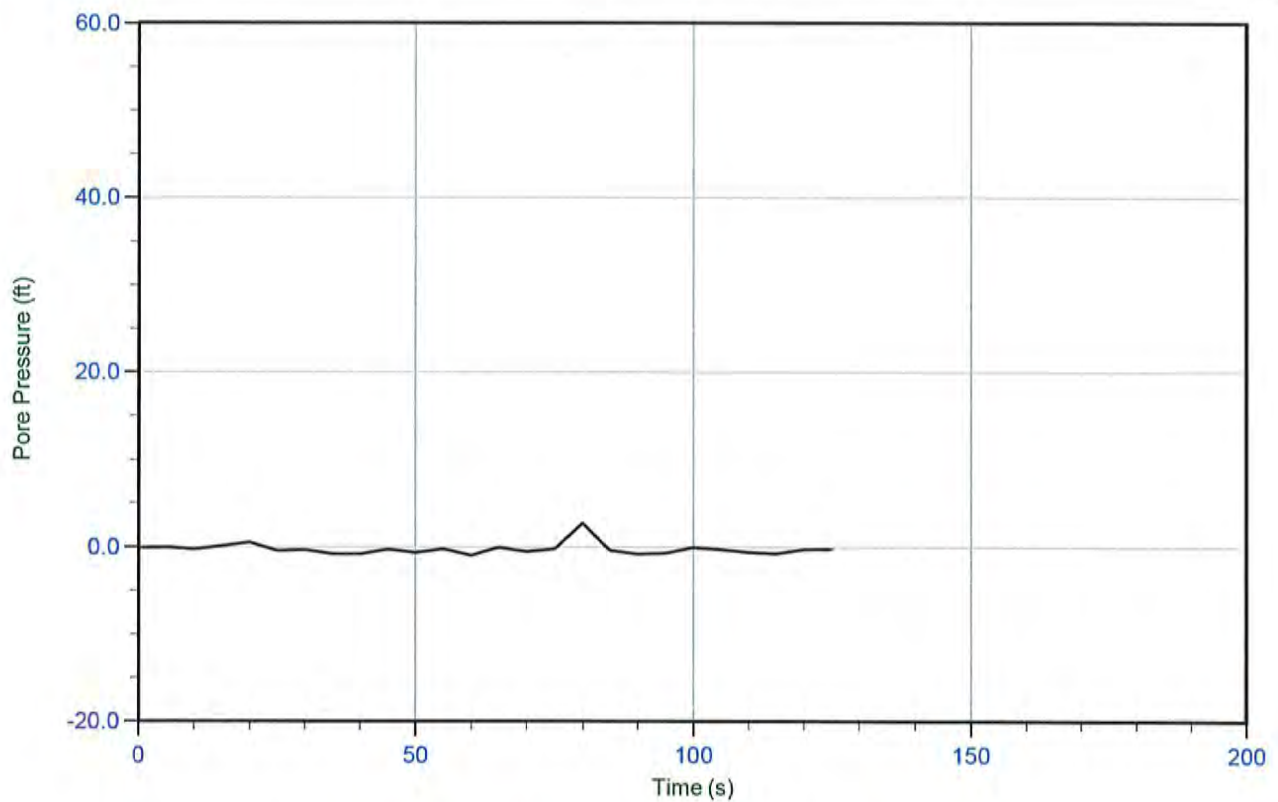
Sounding: CPT-04
Cone: 443:T1500F15U500 Area=15 cm²

| Trace Summary: | Filename: 18-56099_CP04.PPF | U Min: -1.0 ft | WT: 0.275 m / 0.902 ft |
| | Depth: 0.275 m / 0.902 ft | U Max: 2.7 ft | Ueq: 0.0 ft |

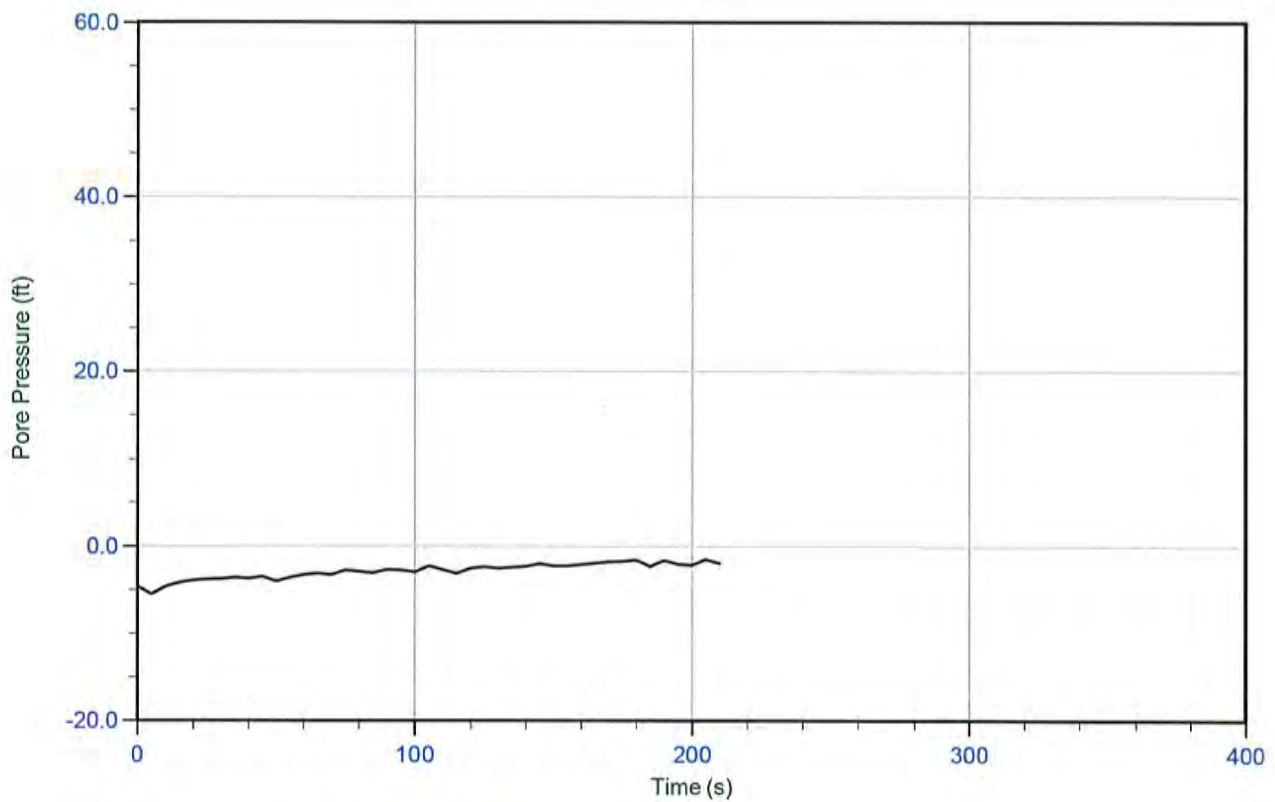
Sounding: CPT-06
Cone: 443:T1500F15U500 Area=15 cm²

Trace Summary: Filename: 18-56099_CP06.PPF U Min: -5.5 ft
 Depth: 3.475 m / 11.401 ft U Max: -1.5 ft
 Duration: 210.0 s
