INITIAL STUDY/MITIGATED NEGATIVE DECLARATION

Recess Storage Project 4224 Sonoma Highway Santa Rosa, California

June 2019

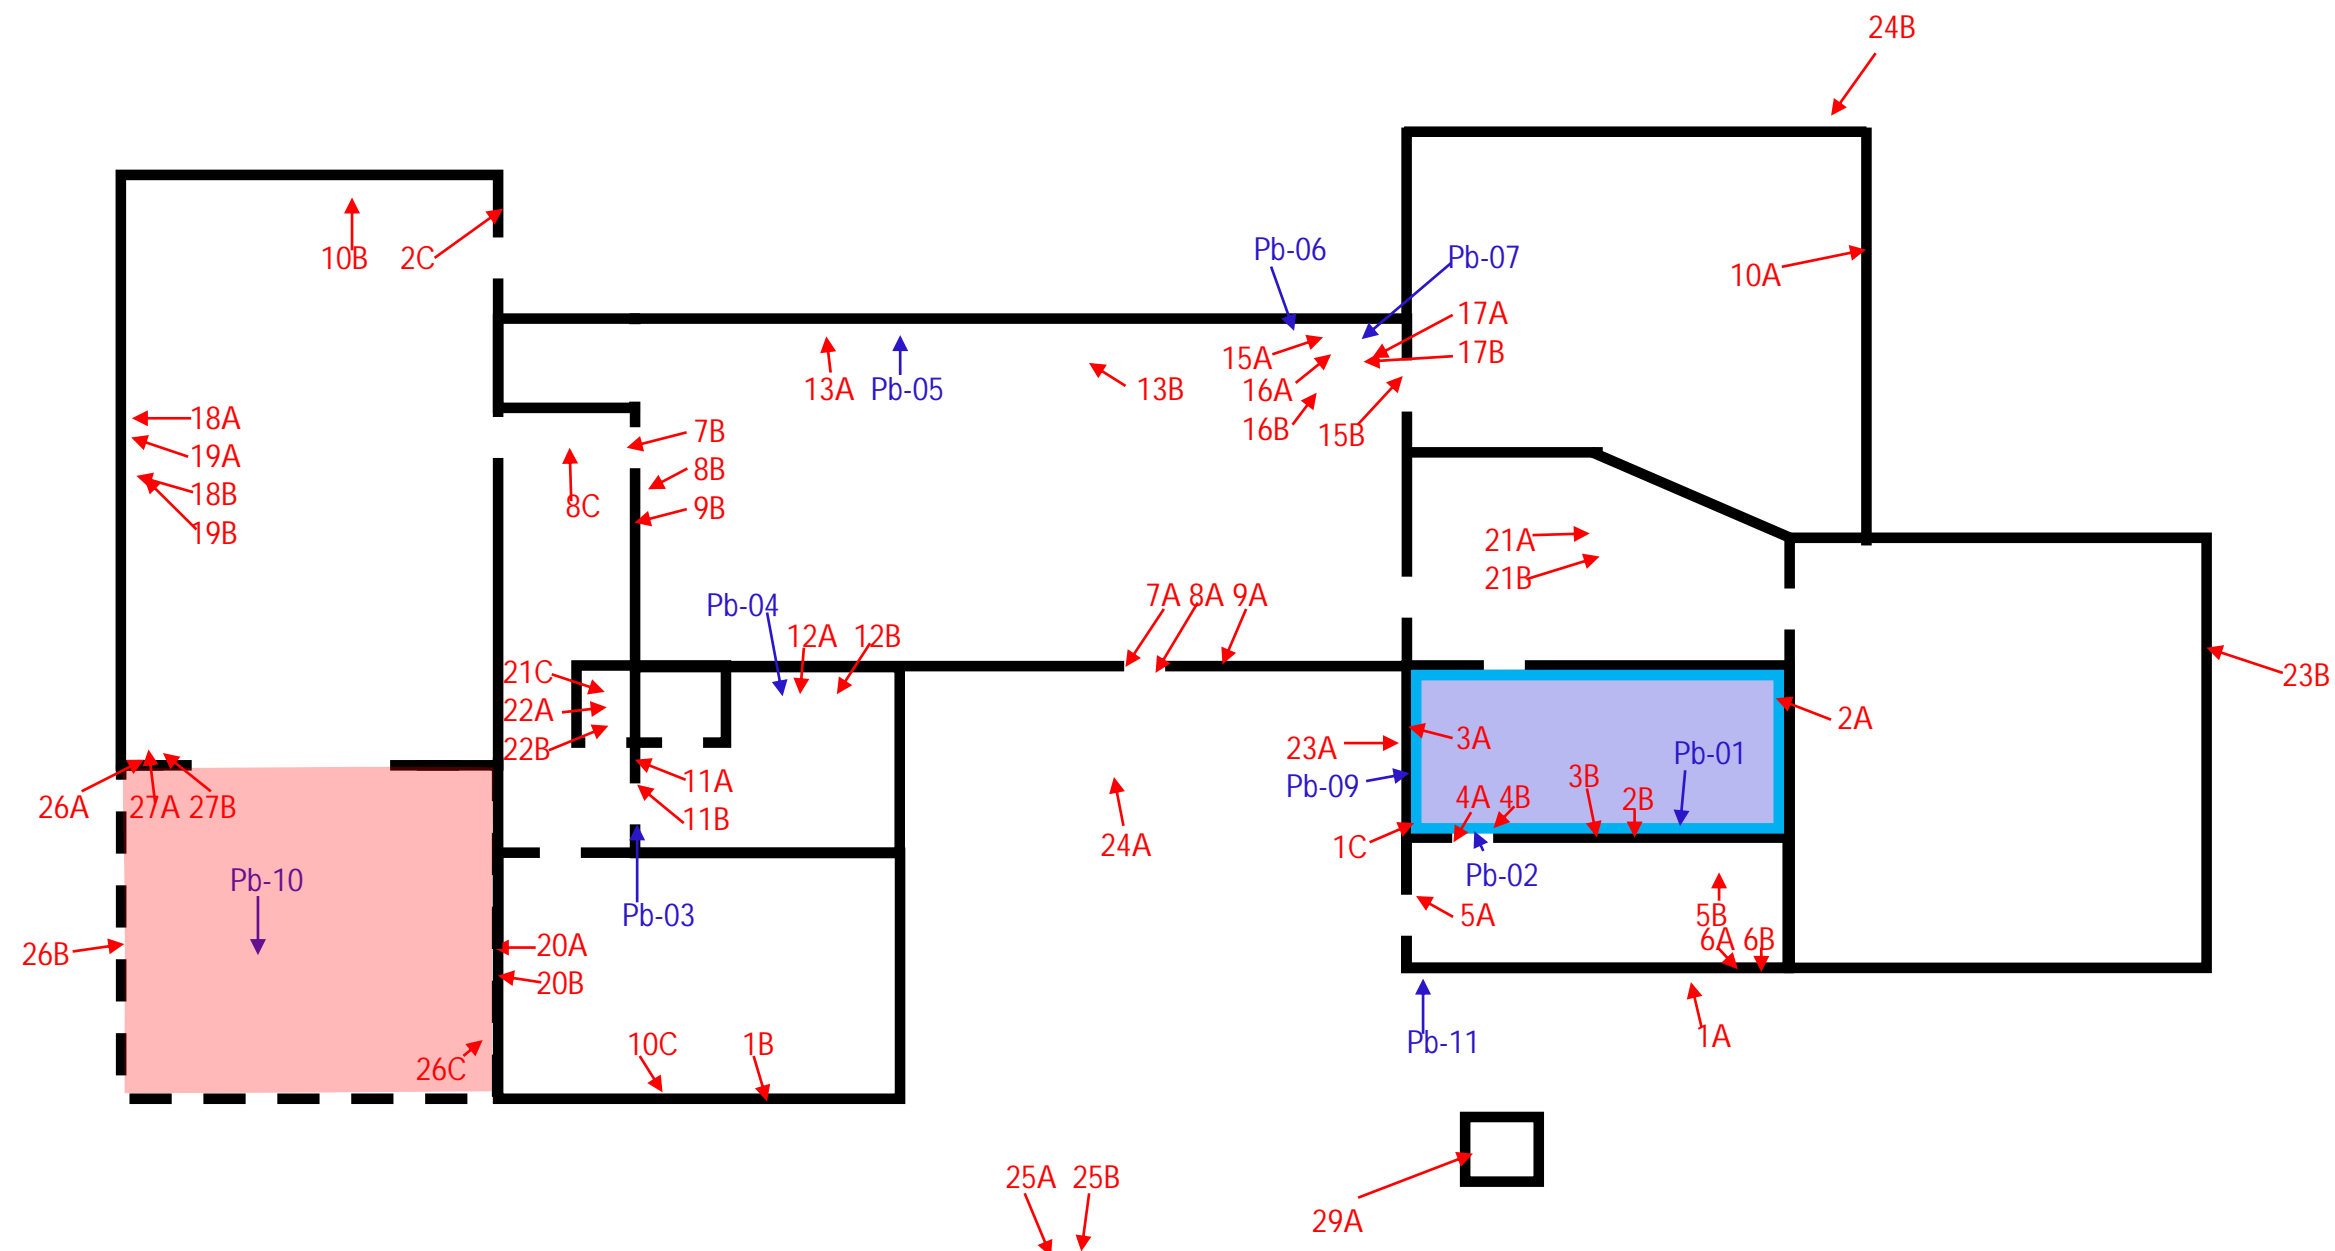
- Asbestos containing Gray Cementitious Material (<0.25% CH) associated ceramic wall tile system and drywall system (2% CH)
- Asbestos containing Gray Mortar and Gray Cementitious Material (<1%CH) associated with the ceramic floor tile system
- Lead containing 4" pink ceramic wall tile (4,790 ppm)
- Lead containing red paint (117 ppm) on concrete porch.

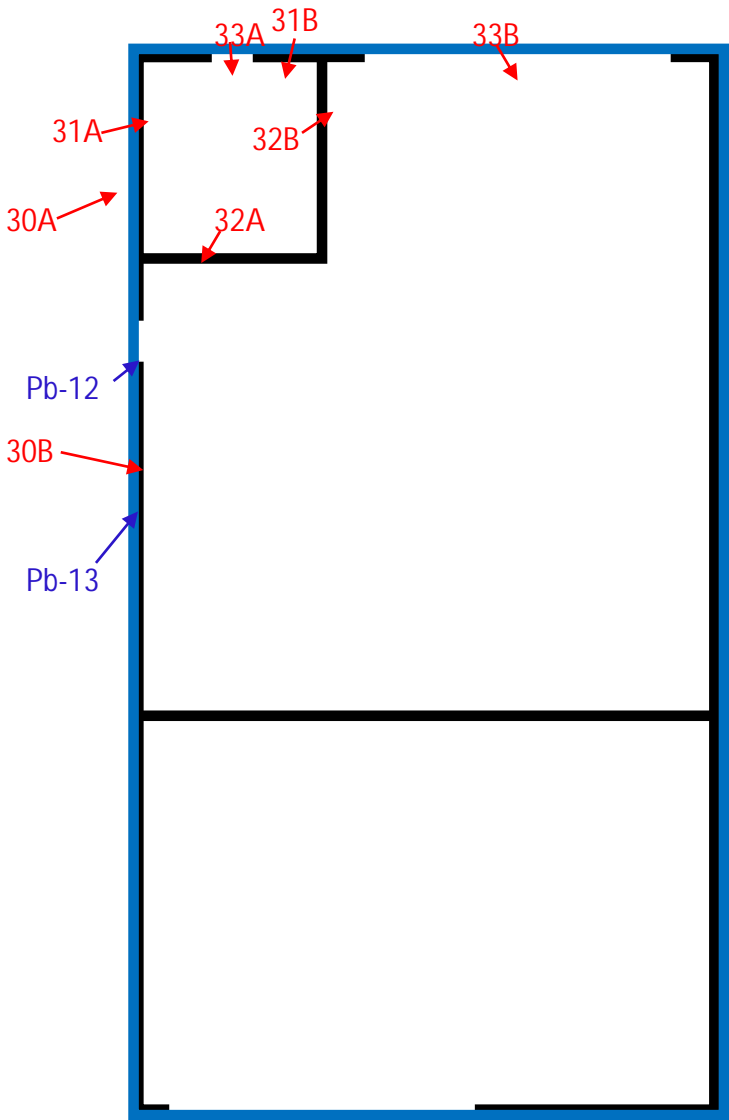
Legend:
Asbestos was not detected in the sampled materials.
■ Lead containing white exterior paint (16,900 ppm).

The following materials are not depicted:
• Lead containing white exterior window glazing putty (168 ppm).

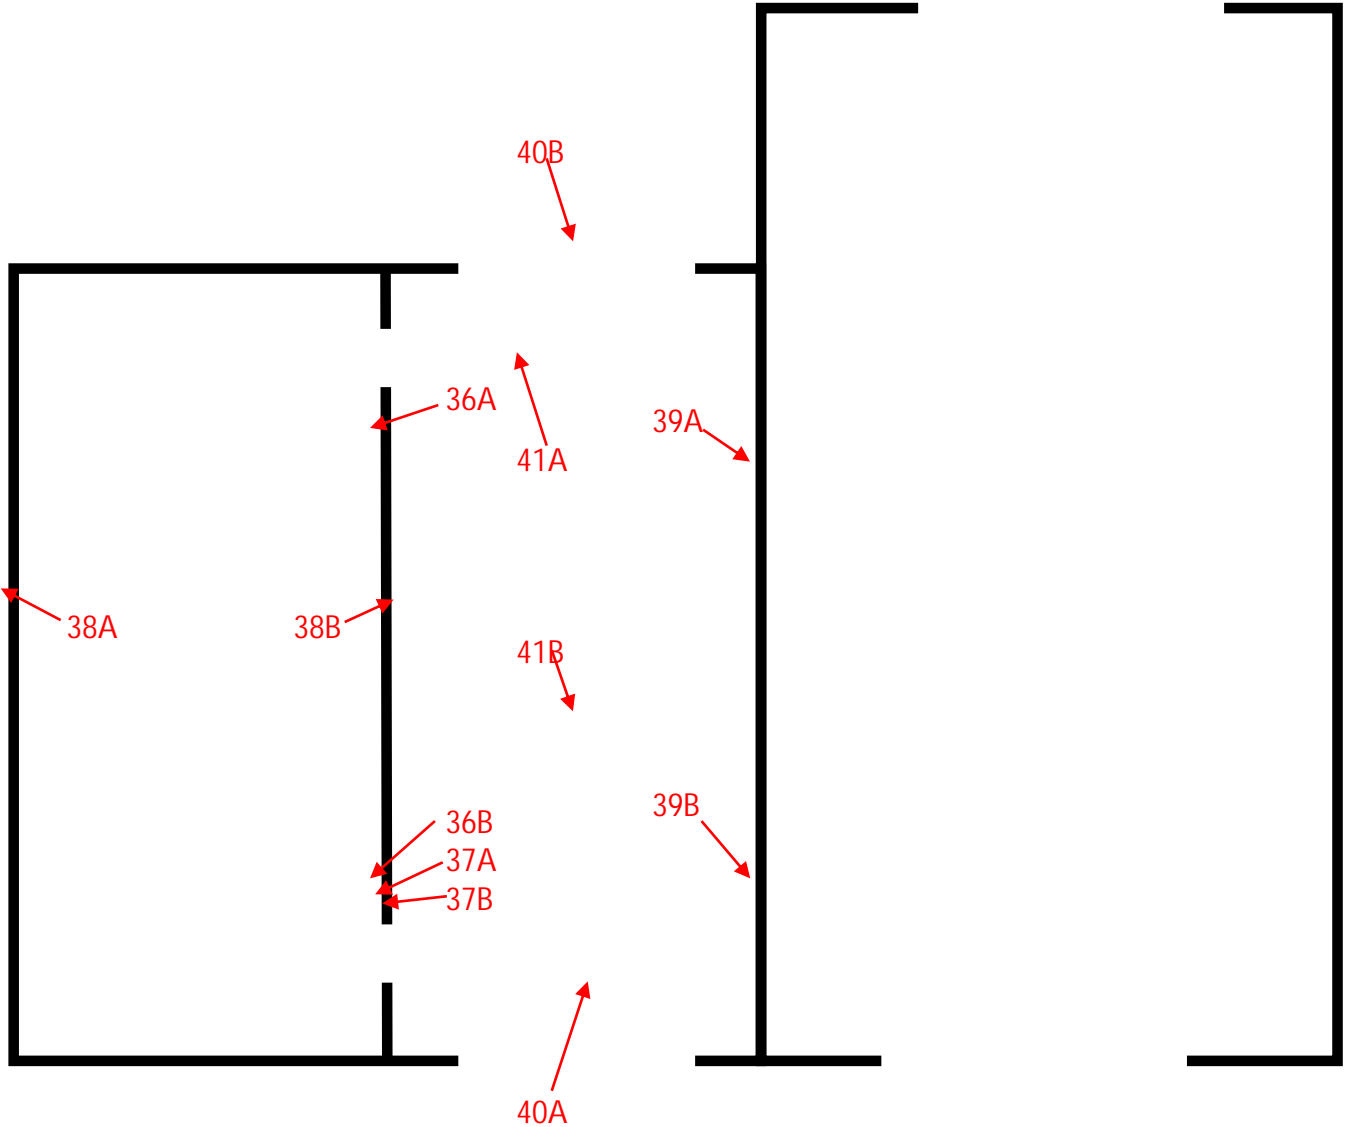
Asbestos was not detected in the sampled materials.
Lead was not detected in the sampled materials above the laboratory detection limit.

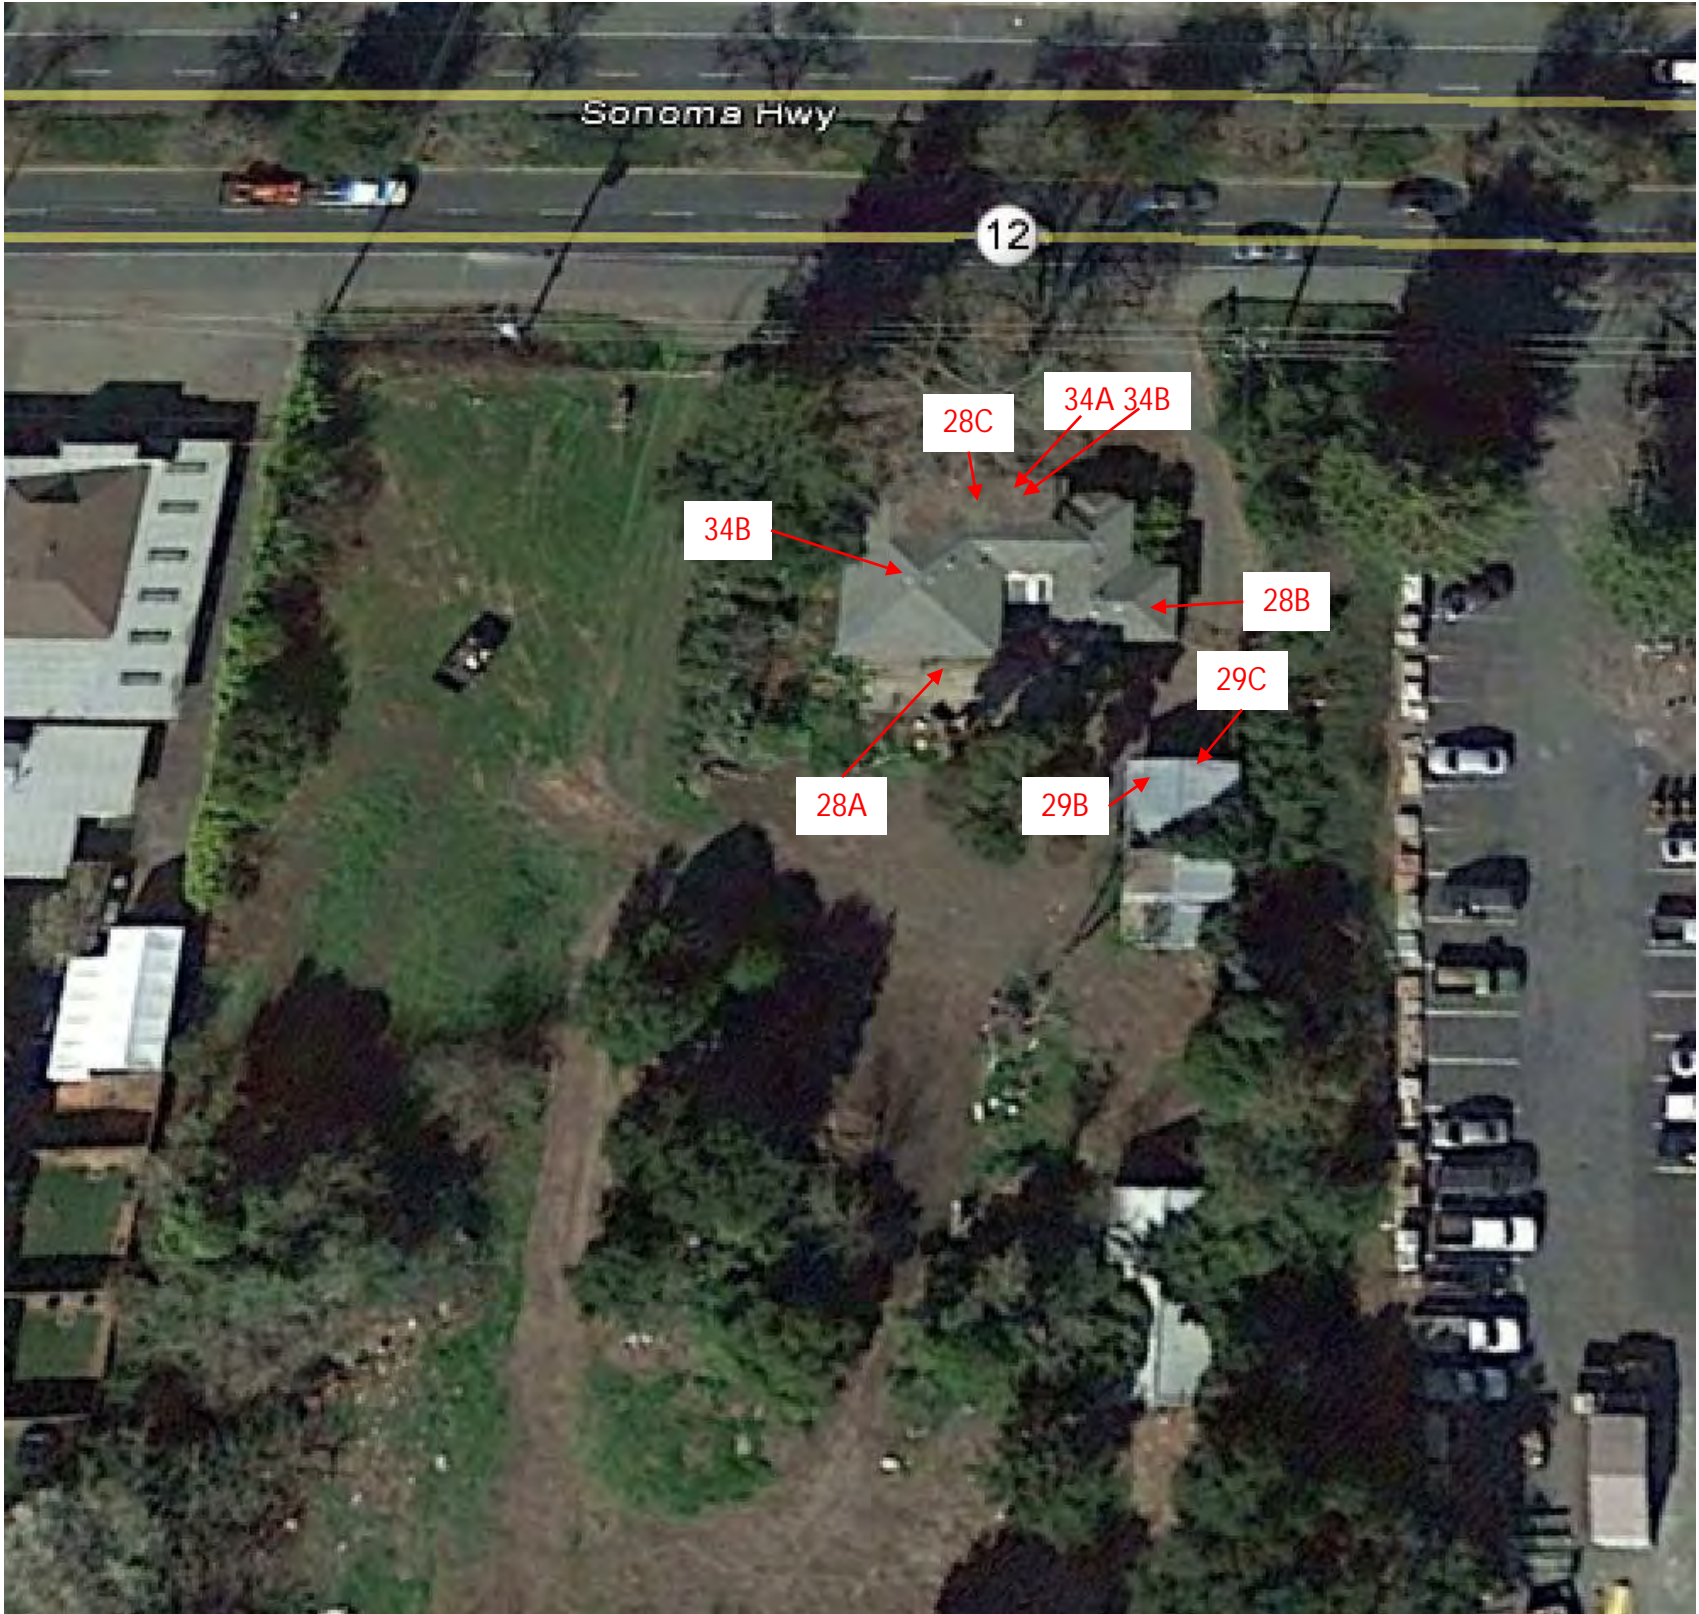
| <u>Sheet Number</u> Figure 3 | |

Asbestos was not detected in the sampled materials.
Lead was not detected in the sampled materials above the laboratory detection limit.
