HISTORIC RESOURCE EVALUATION + CONSISTENCY ANALYSIS

403 BROWN STREET, SANTA ROSA, CA

May 6, 2019

This Historic Resource Evaluation (HRE) and Consistency Analysis has been prepared for the "Kranz & Meuser Residence Rehabilitation" located at 403 Brown Street (APN.009-262-001) in Santa Rosa, California. The subject residence is a California Bungalow built between 1924 and 1928. The property is located within the boundaries of the Burbank Gardens Historic District and the H-Combining District Overlay. Per City of Santa Rosa Resolution No.25606, Exhibit A, and as confirmed by the City Planning Department, 403 Brown Street is identified as a contributor to the District. As a contributor to a designated historic district, any modifications proposed for the resource are subject to the standards outlined in Santa Rosa Code Section 20-28.040 "Historic (-H) combining district" and Code Section 20-58.060 "Landmark Alteration Permits," as well as, The Secretary of the Interior's Standards for Rehabilitation.

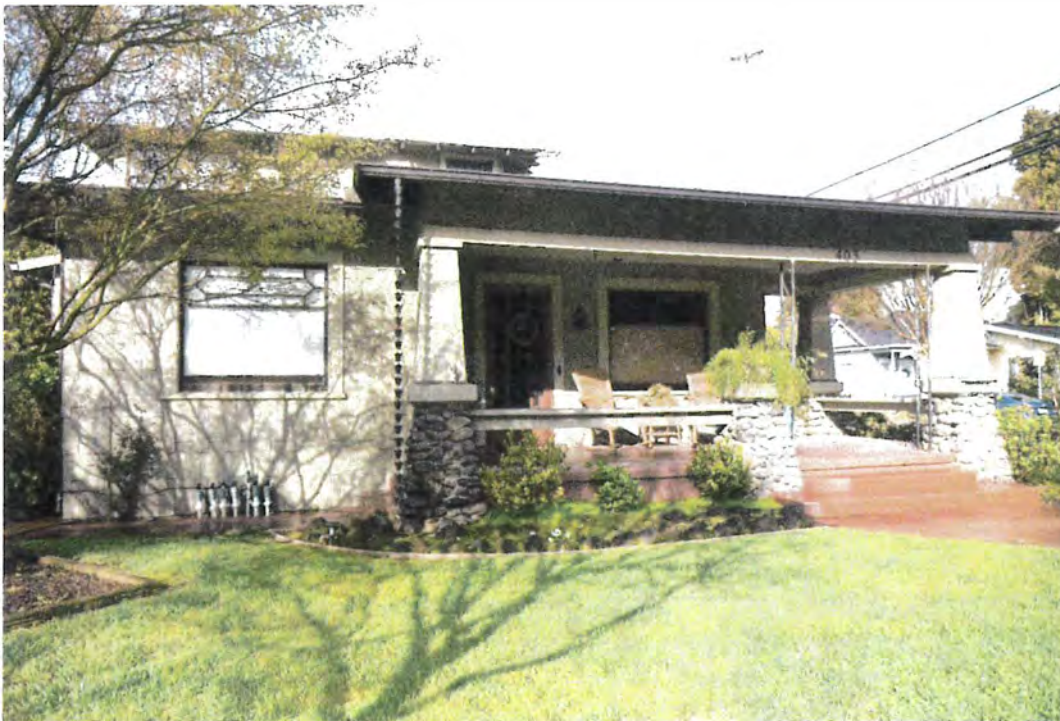
Figure 2 Brown Street Facade.

The Brown Street façade features a partial width porch that projects slightly outward to the north. The gabled porch roof is supported by battered piers set atop massive river rock piers; piers are connected via an open wood railing. The porch features a beadboard ceiling. The front door is a glazed door and is flanked on either side by cottage picture windows featuring a plain lower pane with patterned pain above (a typical design element of this style). The porch is accessed via a series of three concrete stairs. As mentioned above, there is a two-thirds second-story addition above the southern-most portions of the residence, it does not match the original residence in detailing and features a hipped roof, clapboard siding, and simple double hung windows.

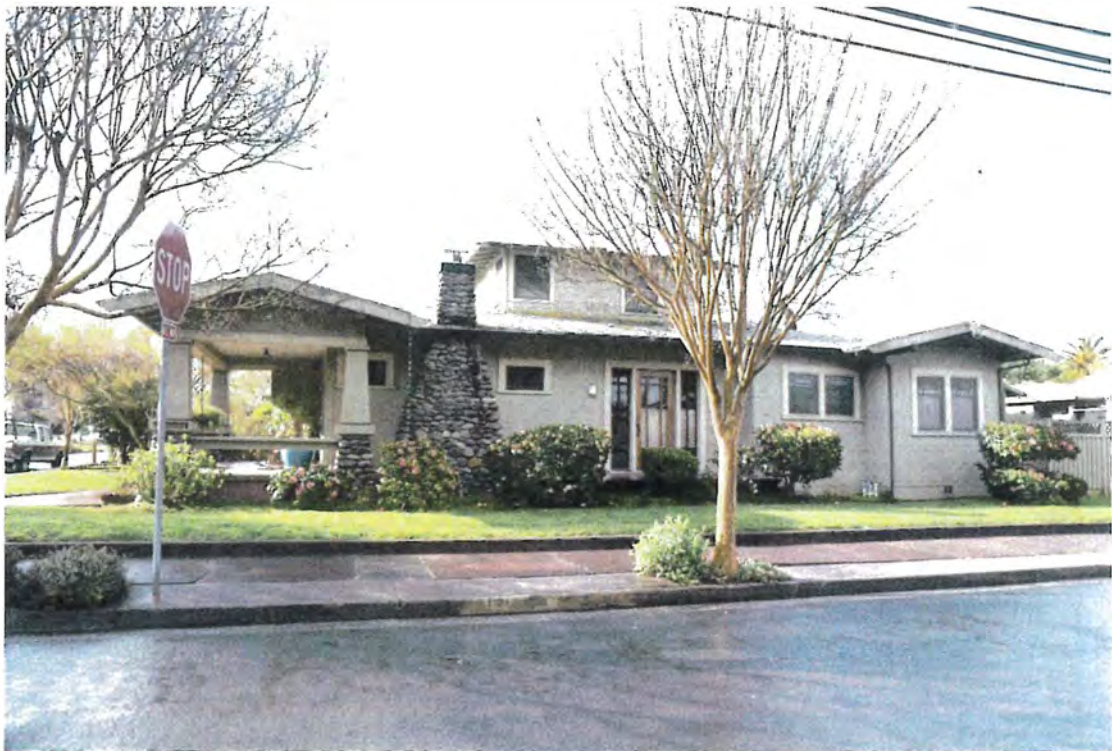
Figure 6 Wheeler Street Elevation

The Wheeler Street elevation features a similar level of detail and articulation as the primary façade but is somewhat subordinate to that of Brown Street. This elevation features a dominant wall plane that extends to the hipped roof main mass of the house, the wall plan is broken up with the presence of the porch projection at the eastern end and a small gabled projection at the western end. The elevation is punctuated with a series of fixed cottage windows and paired, double hung cottage windows, all featuring the same patterned detailing in the top light. The main focal point of this elevation is a large river rock chimney. At the center of this elevation is a nine-lite prairie style door flanked by two sidelights and accessed by a series of steps leading to a small concrete porch.

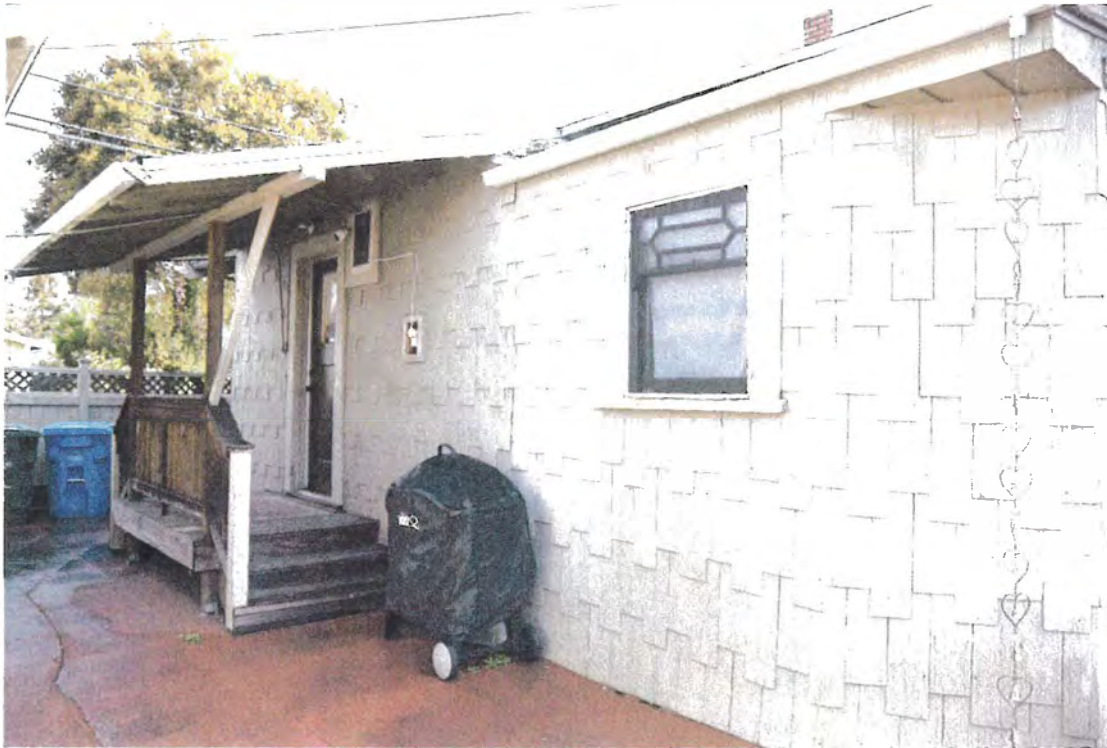
Figure 8 Rear (West) Elevation

The rear elevation features varied wall planes clad in staggered shingle siding and which is punctuated by cottage windows. The rear features a partially glazed door accessed by a small integrated wooden porch with simple wooden balustrade. Per the Assessor's building records, it appears that a small rear addition was constructed in 1970 at the southwest corner.

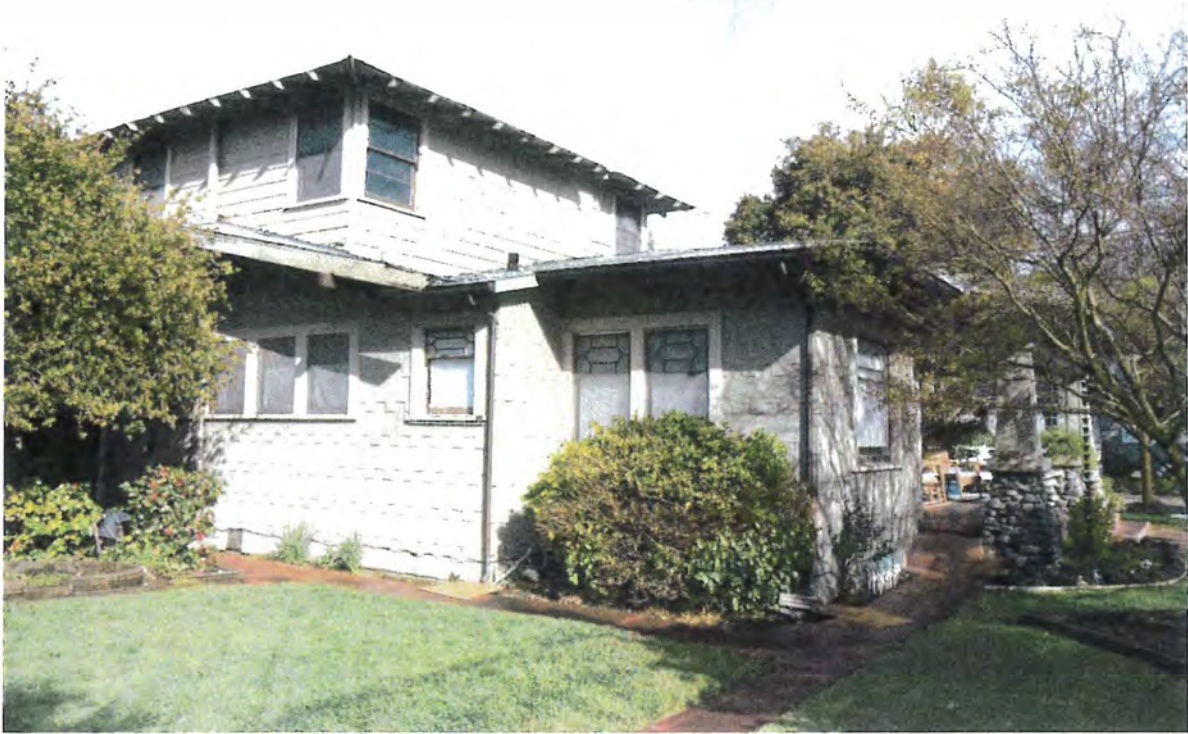
Figure 10 South Elevation

The south elevation faces the interior setback; this elevation features a varied wall plane, sided in staggered wood shingle siding and punctuated with a series of single, paired, and ribbon cottage windows that carry through the same detailing seen on other windows. The main projecting wall plane is capped with a gabled roof featuring exposed rafter tails.

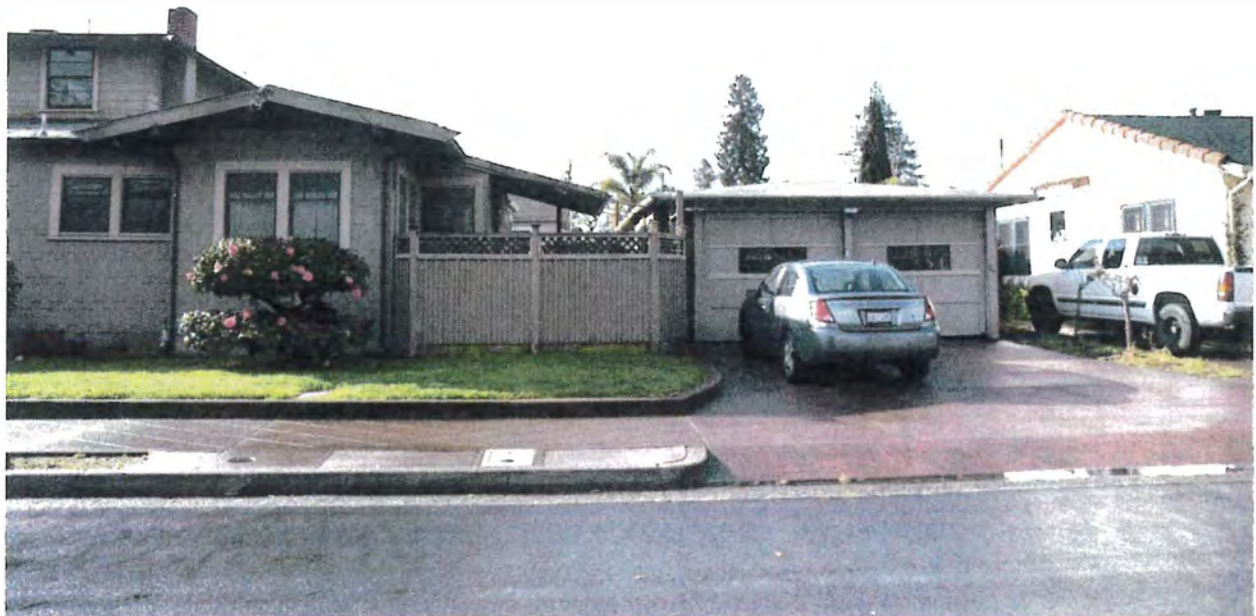
The detached 480 sf two-car garage is rectangular in plan. The garage is clad in a combination of board and batten siding and the staggered shingle siding seen on the house. It is capped with a hipped asphalt shingle roof. The front (facing Wheeler Street) features two paneled wooden garage doors, each with a central divided light.

Figure 9 Detached garage as viewed from opposite side of Wheeler Street.

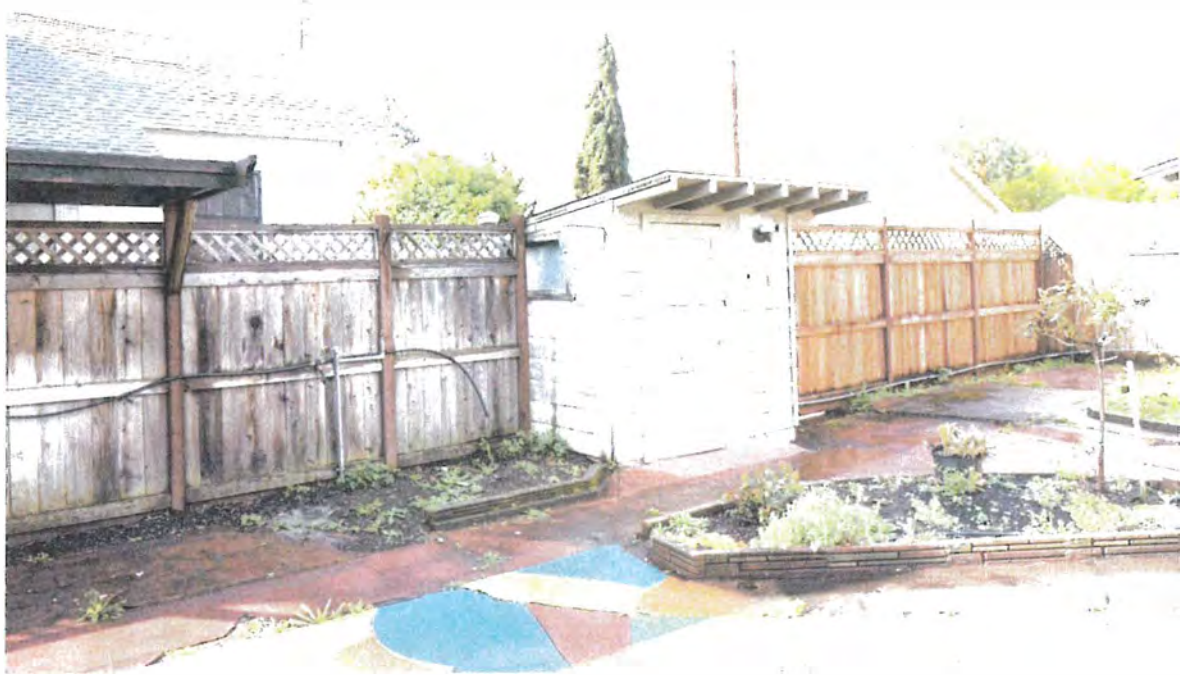
Figure 13 Accessory Structure (1) Pumphouse

A small pumphouse is located along the southern property line and serves a small well. The structure features a shed roof structure clad in clapboard siding, accessed via a centered wood panel door. The shed roof features a wide unenclosed overhang at front with exposed rafters. The structure is partially integrated with the fence, which was likely added at a later date.

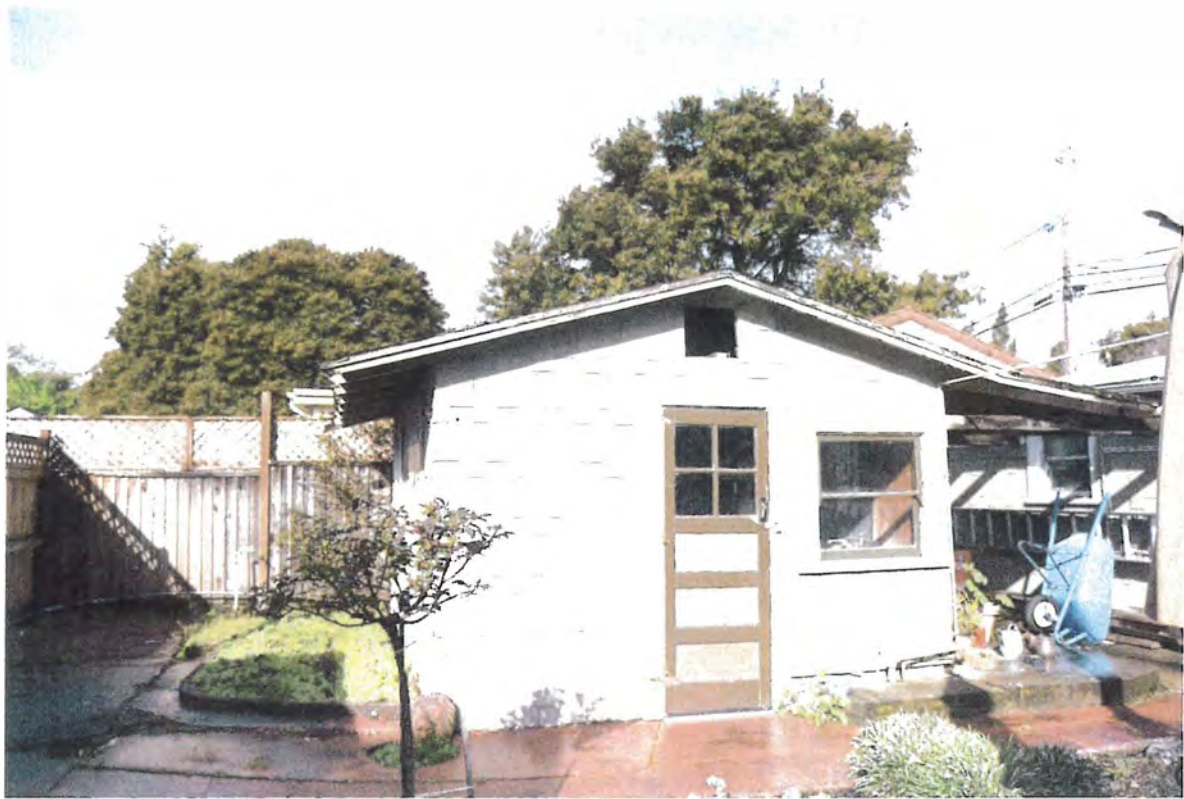
Figure 16 Accessory Structure (2) Storagehouse

This accessory structure is 192 sf and is situated in the western extents of the property. It exhibits a rectangular footprint and is clad in the same staggered shingle siding as the primary residence. It is capped by a gabled roof with asphalt shingles. It features a partially glazed, paneled front door centered on the façade. It is punctuated with a series of simple double hung windows. The roof has been extended along the eastern side to overlay with a makeshift trellis which provided connectivity to the adjacent garage structure.

*The project involves the removal of non-contributing elements, namely, the c.1940s second-story addition, accessory structure 2 (storage house) and accessory structure 3 (existing garage). None of these components are important in conveying the property's historic significance and their removal would not negatively affect the historic character of the property. In respect to the removal of the non-contributing second-story — this is expected to be beneficial in that it would remove an inappropriate addition and would restore the original form/massing of the residence. **Consistent.***

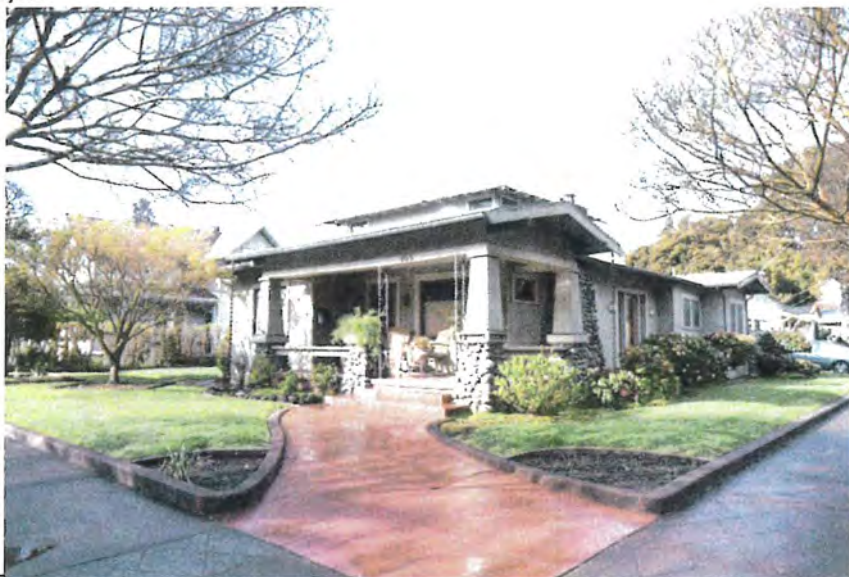
*P3b. Resource Attributes: (List attributes and codes) HP2*P4. Resources Present: ☒ Building ☒ Structure ☐ Object ☐ Site ☐ District ☒ Element of District ☐ Other (Isolates, etc.)P5b. Description of Photo: (view, date, accession #) Façade, 03/28/2019*P6. Date Constructed/Age and Source: ☒ Historic ☐ Prehistoric ☐ Both
1924-1928
