HISTORIC RESOURCE EVALUATION + CONSISTENCY ANALYSIS

403 BROWN STREET, SANTA ROSA, CA

May 6, 2019

This Historic Resource Evaluation (HRE) and Consistency Analysis has been prepared for the "Kranz & Meuser Residence Rehabilitation" located at 403 Brown Street (APN.009-262-001) in Santa Rosa, California. The subject residence is a California Bungalow built between 1924 and 1928. The property is located within the boundaries of the Burbank Gardens Historic District and the H-Combining District Overlay. Per City of Santa Rosa Resolution No.25606, Exhibit A, and as confirmed by the City Planning Department, 403 Brown Street is identified as a contributor to the District. As a contributor to a designated historic district, any modifications proposed for the resource are subject to the standards outlined in Santa Rosa Code Section 20-28.040 "Historic (-H) combining district" and Code Section 20-58.060 "Landmark Alteration Permits," as well as, The Secretary of the Interior's Standards for Rehabilitation.

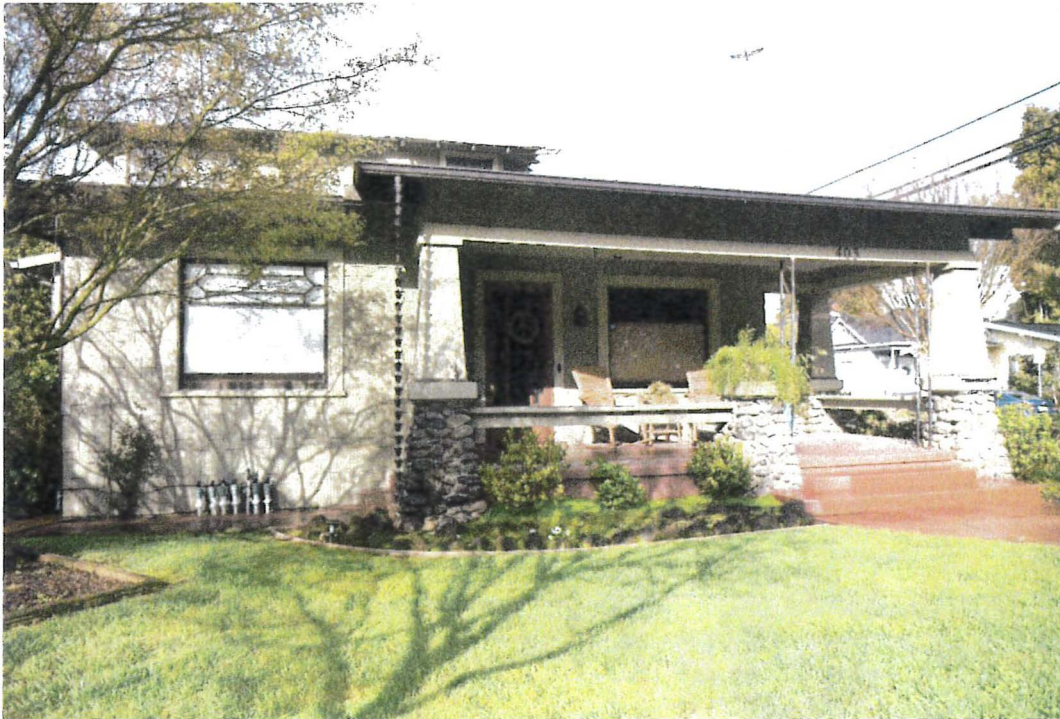
Figure 2 Brown Street Facade.

The Brown Street façade features a partial width porch that projects slightly outward to the north. The gabled porch roof is supported by battered piers set atop massive river rock piers; piers are connected via an open wood railing. The porch features a beadboard ceiling. The front door is a glazed door and is flanked on either side by cottage picture windows featuring a plain lower pane with patterned pain above (a typical design element of this style). The porch is accessed via a series of three concrete stairs. As mentioned above, there is a two-thirds second-story addition above the southern-most portions of the residence, it does not match the original residence in detailing and features a hipped roof, clapboard siding, and simple double hung windows.

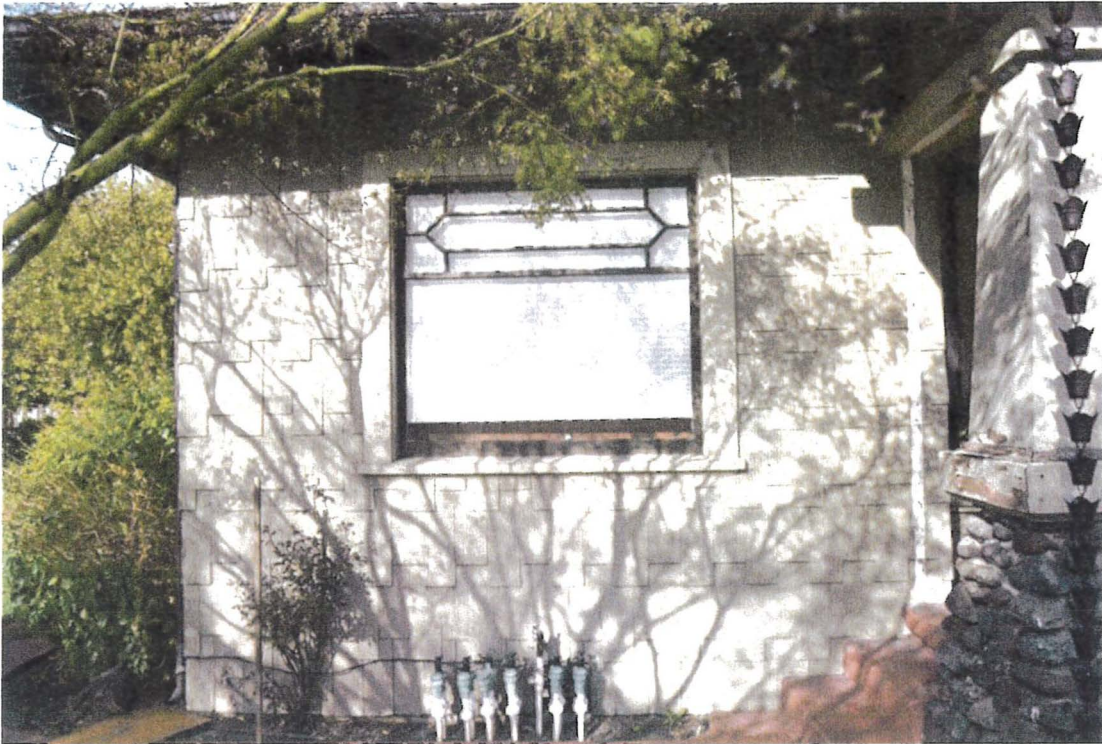
Figure 3 Brown Street Facade Window Detail

The residence at 403 Brown Street is located on a rectangular lot of 0.20 acres at the corner of Brown and Wheeler Streets. Constructed between 1924 and 1928, 403 Brown Street is designed as a California Bungalow (also known as a vernacular Craftsman). The residence is rectangular in plan, two stories (originally one) and supported by concrete stem wall foundation with girder beams. It is clad in staggered wood shingle siding and is capped with a low-pitched hipped roof. The façade (facing Brown Street) features a partial front porch with a side gabled roof supported by battered piers set atop massive river rock pedestals. Walls are punctuated with cottage windows

featuring patterned top lights and unadorned lower lights. A two-thirds second-story addition (252 sf) estimated to have been constructed at some point in the 1940s, sits above the southern-most portions of the residence and features a hipped roof, clapboard siding, and simple double hung windows.

As mentioned above under Standard 5, features in repairable condition, such as the original wood windows, are to be repaired. Components that require replacement will be done in-kind, including roofing, staggered wood shingles. It is of note that due to the unavailability of shingles that exactly match those used historically, the property owners will utilize ones that are alike in material, shape, and width, but will feature a shorter length thereby resulting in a shorter reveal than was featured historically (9 inches versus 18 inches

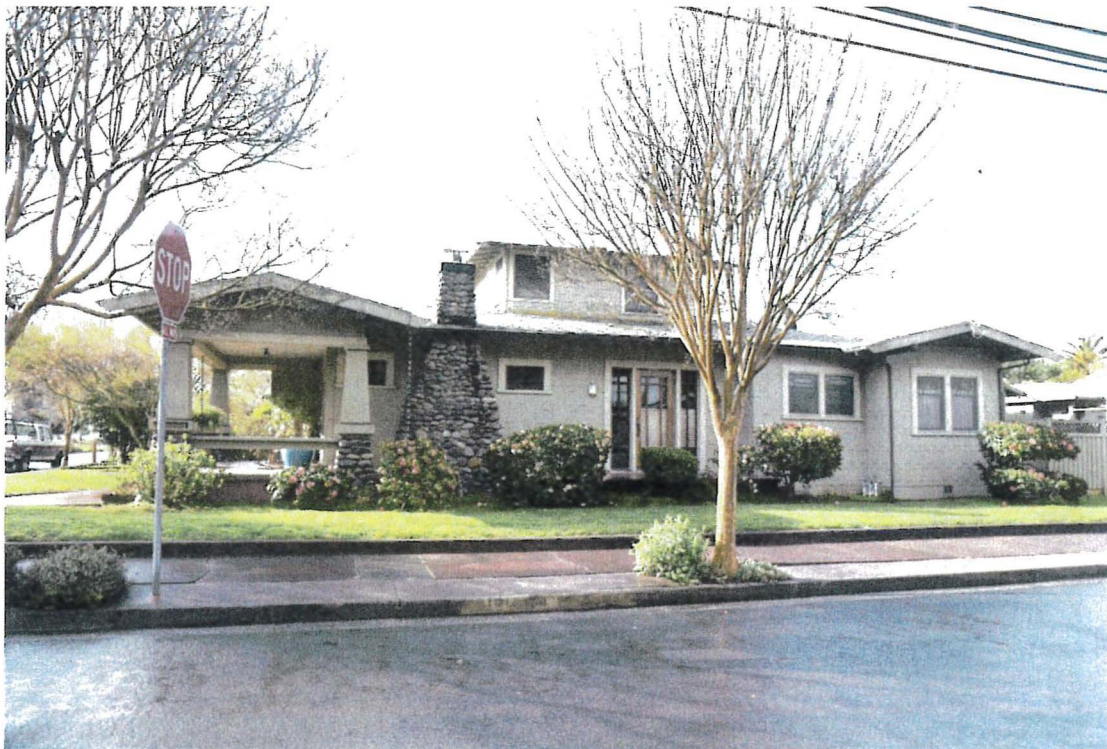
Figure 6 Wheeler Street Elevation

The Wheeler Street elevation features a similar level of detail and articulation as the primary façade but is somewhat subordinate to that of Brown Street. This elevation features a dominant wall plane that extends to the hipped roof main mass of the house, the wall plan is broken up with the presence of the porch projection at the eastern end and a small gabled projection at the western end. The elevation is punctuated with a series of fixed cottage windows and paired, double hung cottage windows, all featuring the same patterned detailing in the top light. The main focal point of this elevation is a large river rock chimney. At the center of this elevation is a nine-lite prairie style door flanked by two sidelights and accessed by a series of steps leading to a small concrete porch.

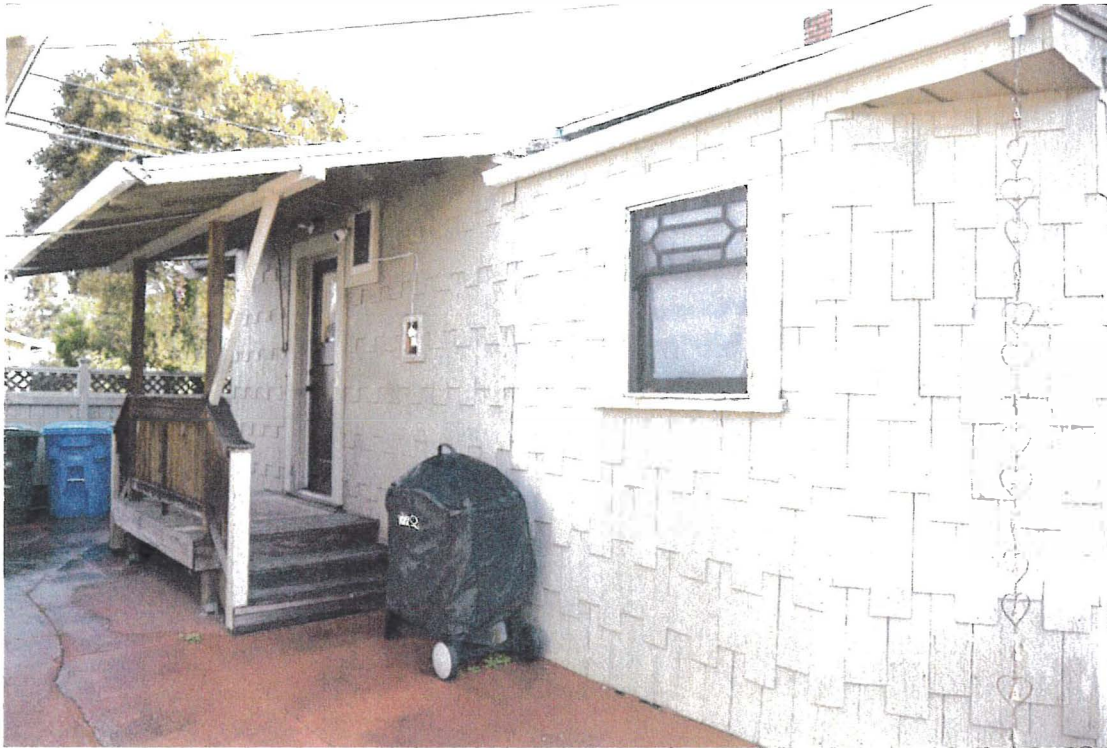
Figure 8 Rear (West) Elevation

The rear elevation features varied wall planes clad in staggered shingle siding and which is punctuated by cottage windows. The rear features a partially glazed door accessed by a small integrated wooden porch with simple wooden balustrade. Per the Assessor's building records, it appears that a small rear addition was constructed in 1970 at the southwest corner.

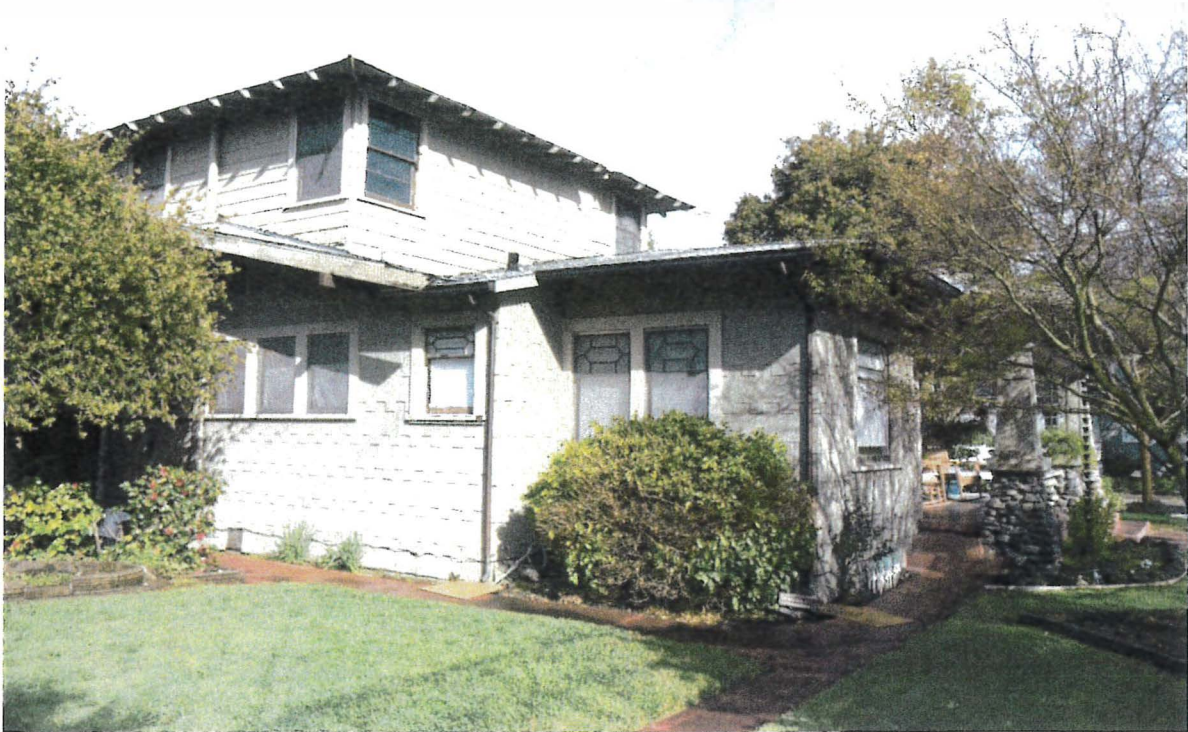
Figure 10 South Elevation

The south elevation faces the interior setback; this elevation features a varied wall plane, sided in staggered wood shingle siding and punctuated with a series of single, paired, and ribbon cottage windows that carry through the same detailing seen on other windows. The main projecting wall plane is capped with a gabled roof featuring exposed rafter tails.

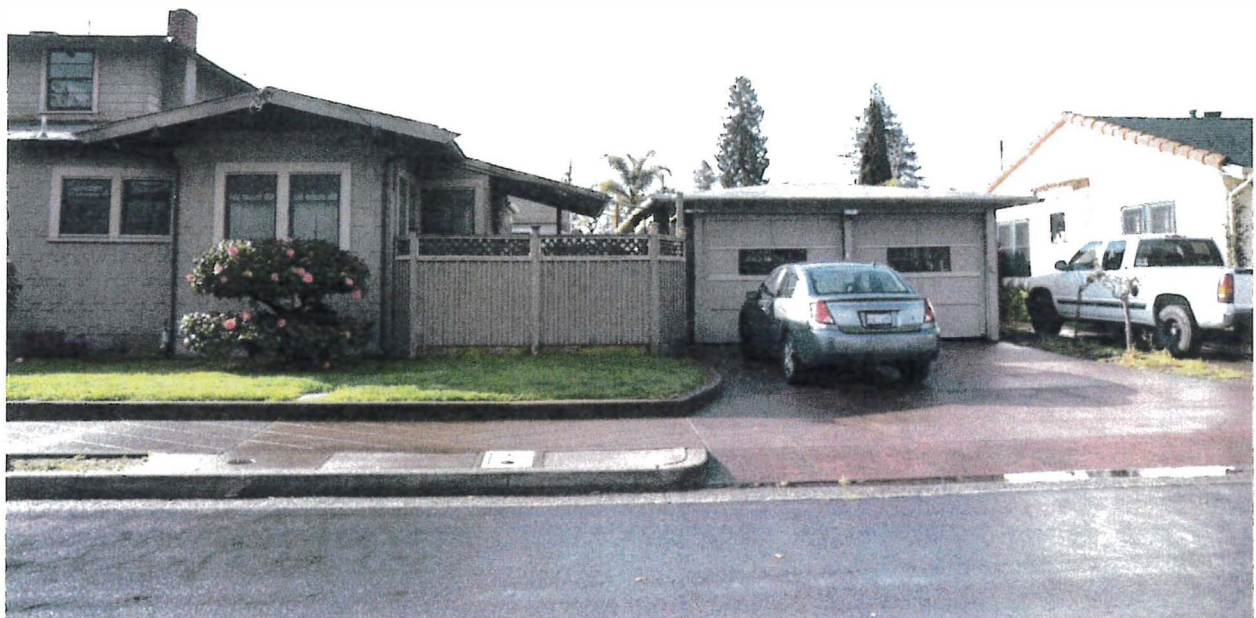
Figure 9 Detached garage as viewed from opposite side of Wheeler Street.

The detached 480 sf two-car garage is rectangular in plan. The garage is clad in a combination of board and batten siding and the staggered shingle siding seen on the house. It is capped with a hipped asphalt shingle roof. The front (facing Wheeler Street) features two paneled wooden garage doors, each with a central divided light.

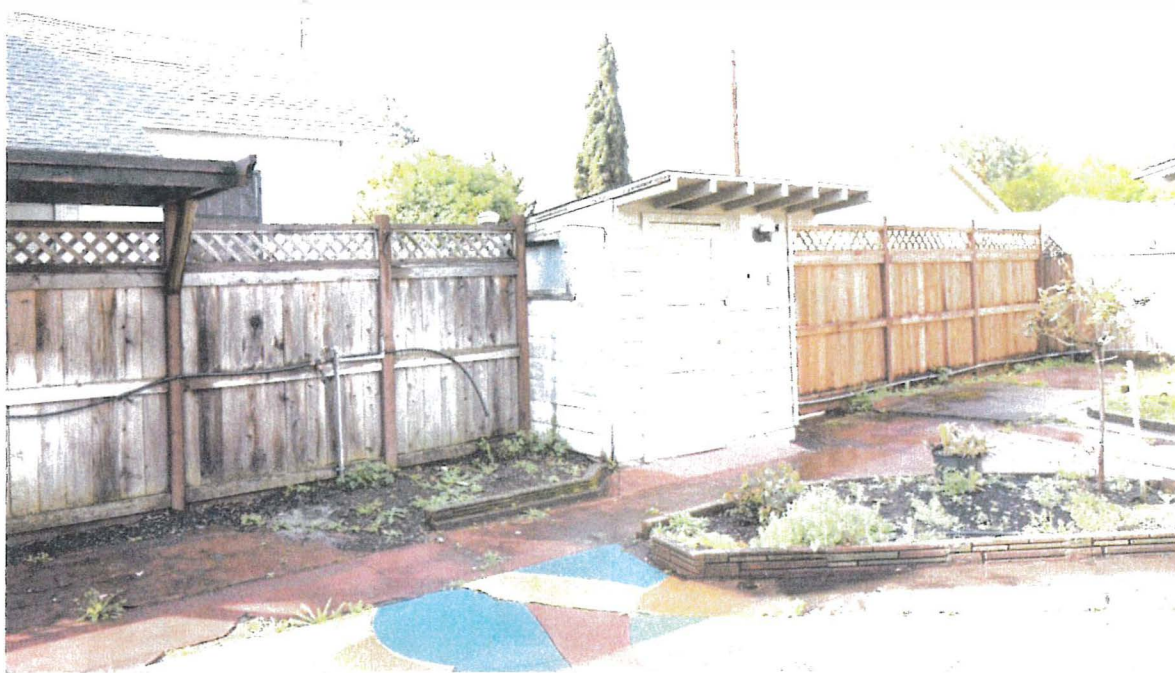
Figure 13 Accessory Structure (1) Pumphouse

A small pumphouse is located along the southern property line and serves a small well. The structure features a shed roof structure clad in clapboard siding, accessed via a centered wood panel door. The shed roof features a wide unenclosed overhang at front with exposed rafters. The structure is partially integrated with the fence, which was likely added at a later date.

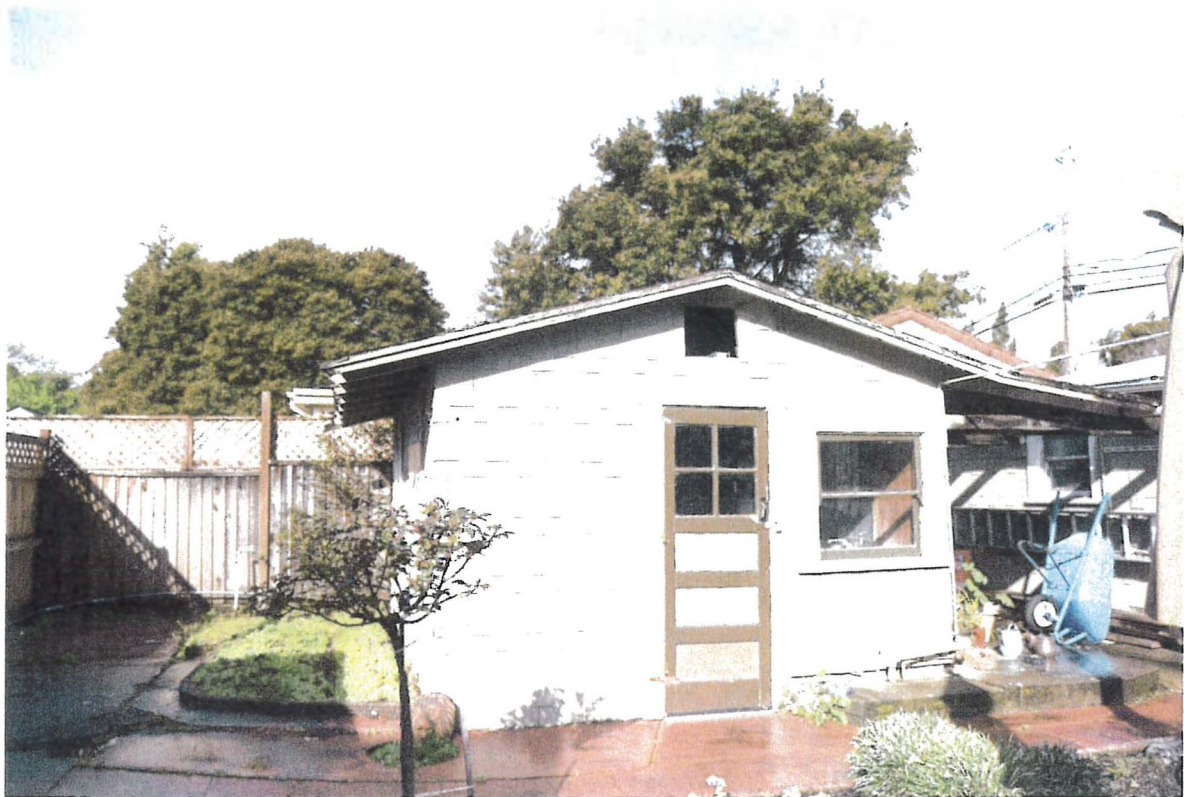
Figure 16 Accessory Structure (2) Storagehouse

This accessory structure is 192 sf and is situated in the western extents of the property. It exhibits a rectangular footprint and is clad in the same staggered shingle siding as the primary residence. It is capped by a gabled roof with asphalt shingles. It features a partially glazed, paneled front door centered on the façade. It is punctuated with a series of simple double hung windows. The roof has been extended along the eastern side to overlay with a makeshift trellis which provided connectivity to the adjacent garage structure.
