RESOLUTION NO. 11972

RESOLUTION OF THE PLANNING COMMISSION OF THE CITY OF SANTA ROSA ADOPTING A MITIGATED NEGATIVE DECLARATION, INCLUDING A MITIGATION MONITORING PROGRAM, FOR RECESS SELF-STORAGE (A MIXED-USE DEVELOPMENT), LOCATED AT 4200 AND 4224 SONOMA HIGHWAY; ASSESSOR'S PARCEL NUMBERS 032-010-005 AND 032-010-023; FILE NO. PRJ18-050

The Recess Storage Project (Project) will construct a four-story, 124,000-square foot, self-storage facility and two multi-family residential structures; one structure will have six dwelling units and one structure will have eight dwelling units. The Project entitlements include a Rezoning to the CG (General Commercial) zoning district for Annexation to the City of Santa Rosa; a Tentative Parcel Map to subdivide an approximately 2.68-acre parcel into three separate lots; a minor Conditional Use Permit for a self-storage facility and multi-family housing; a Design Review for the construction of a commercial building greater than 10,000 square feet and attached housing; and a Hillside Development Permit for development on slopes greater than 10 percent.

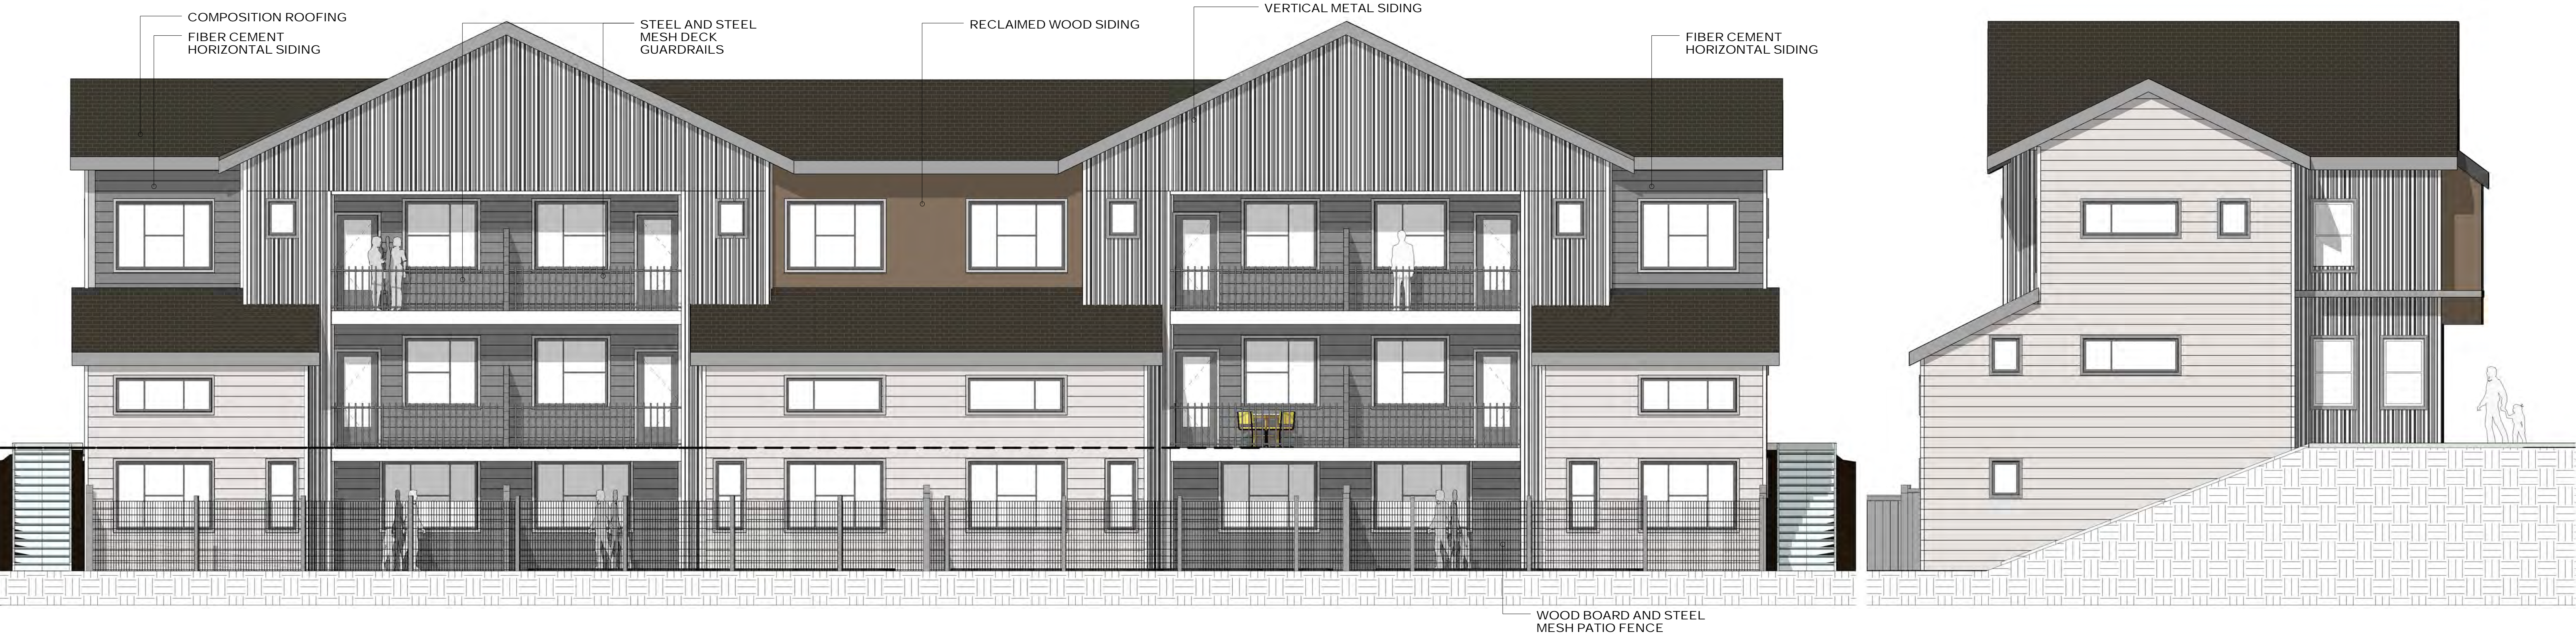
Residential Units 7-14 East El evation  
Scale 3/16" = 1'-0"

Residential Units 7-14 North El evation  
Scale 3/16" = 1'-0"

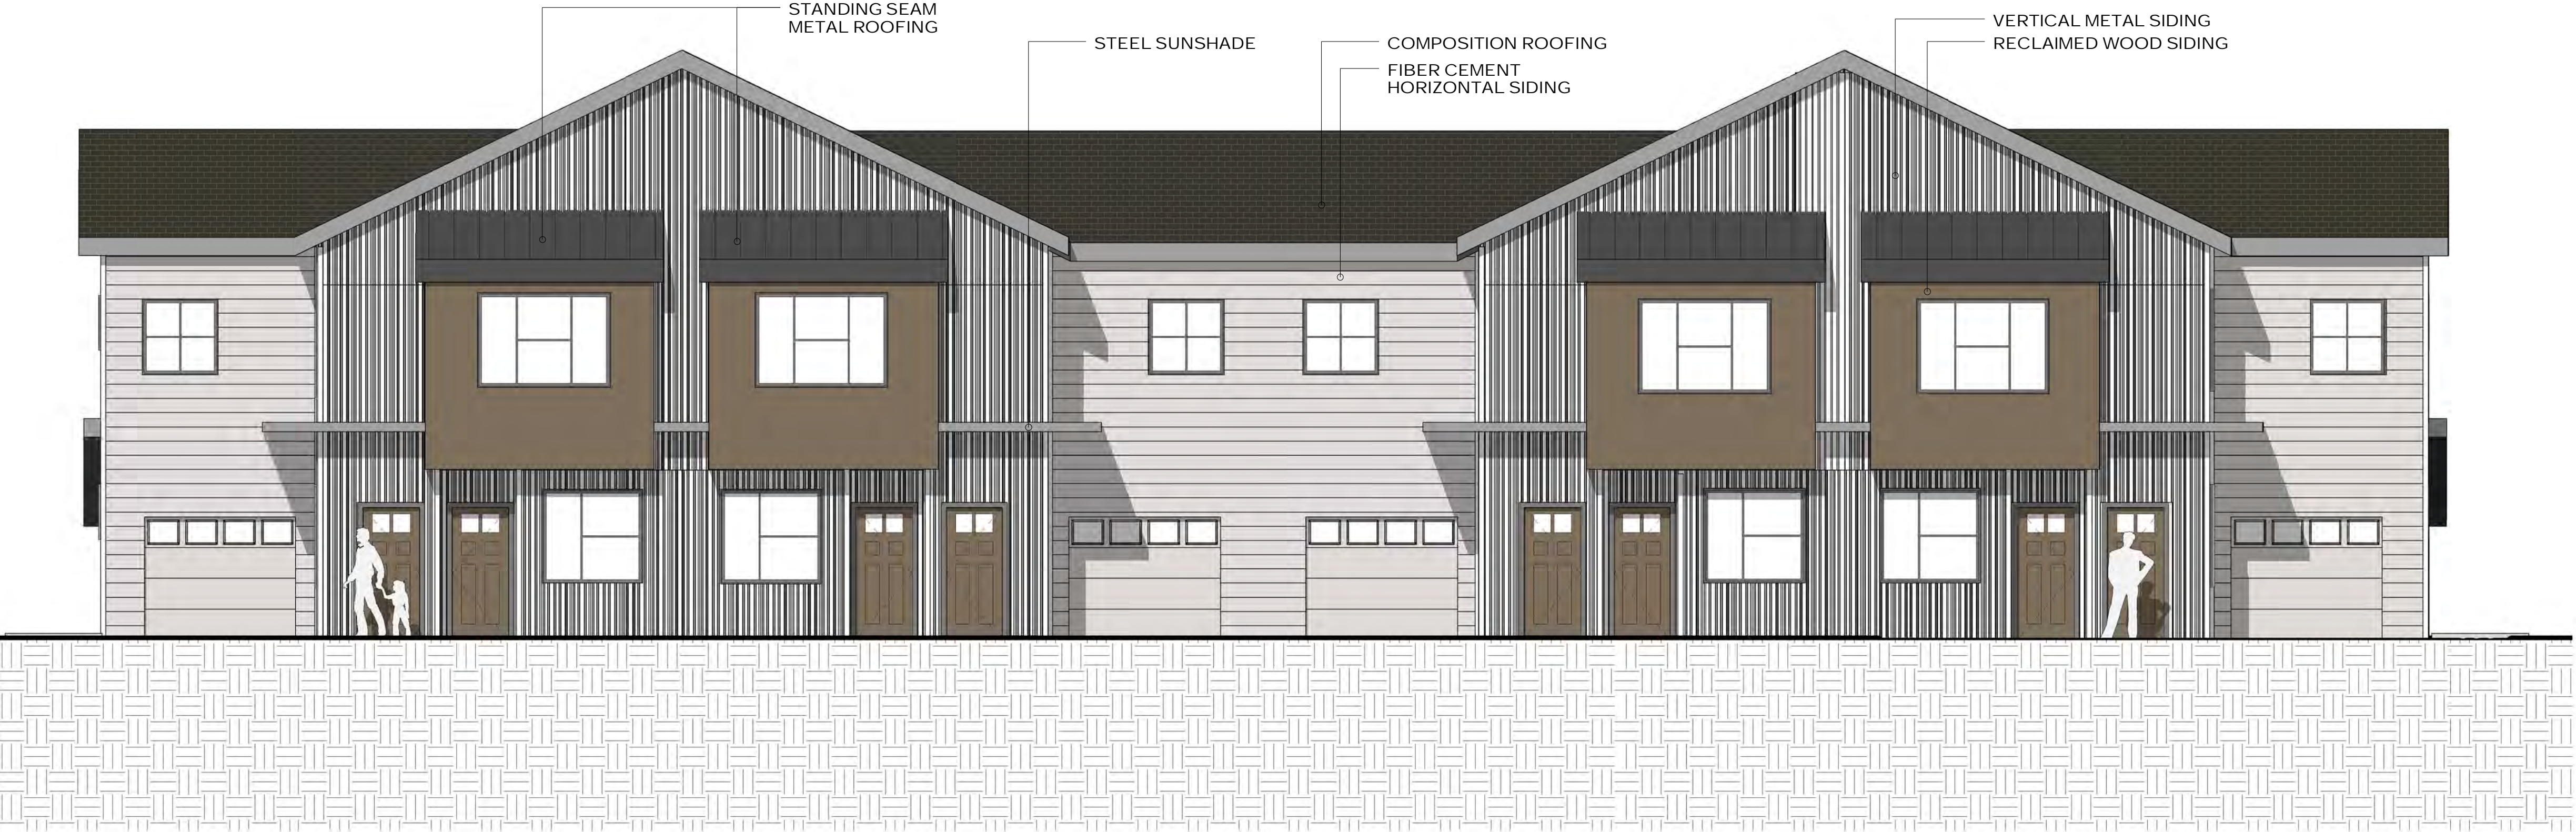
Residential Units 7-14 West El evation  
Scale 3/16" = 1'-0"

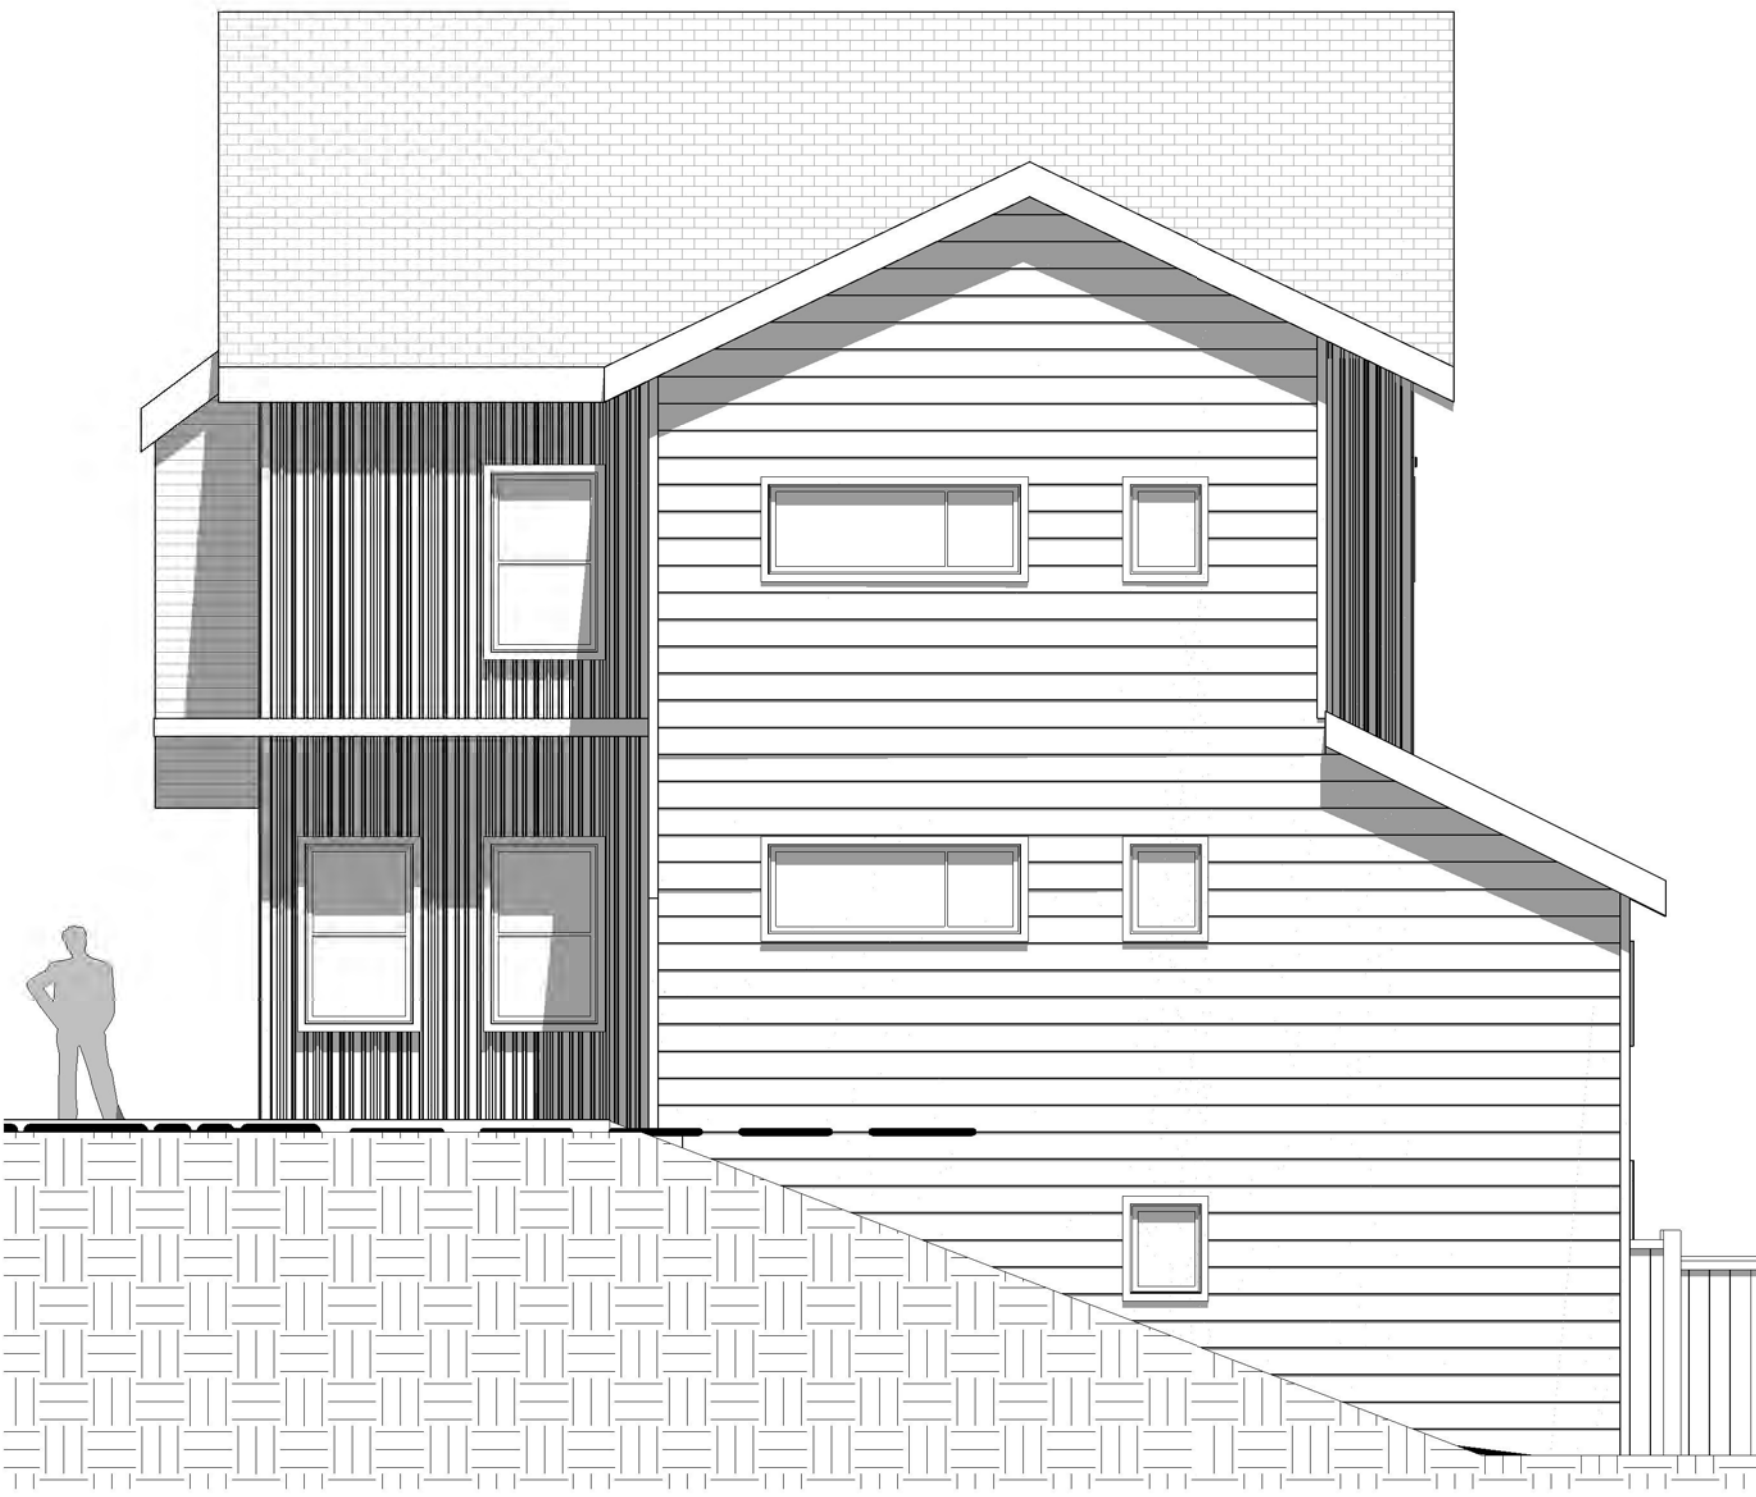
Residential Units 7-14 South El evation  
Scale 3/16" = 1'-0"

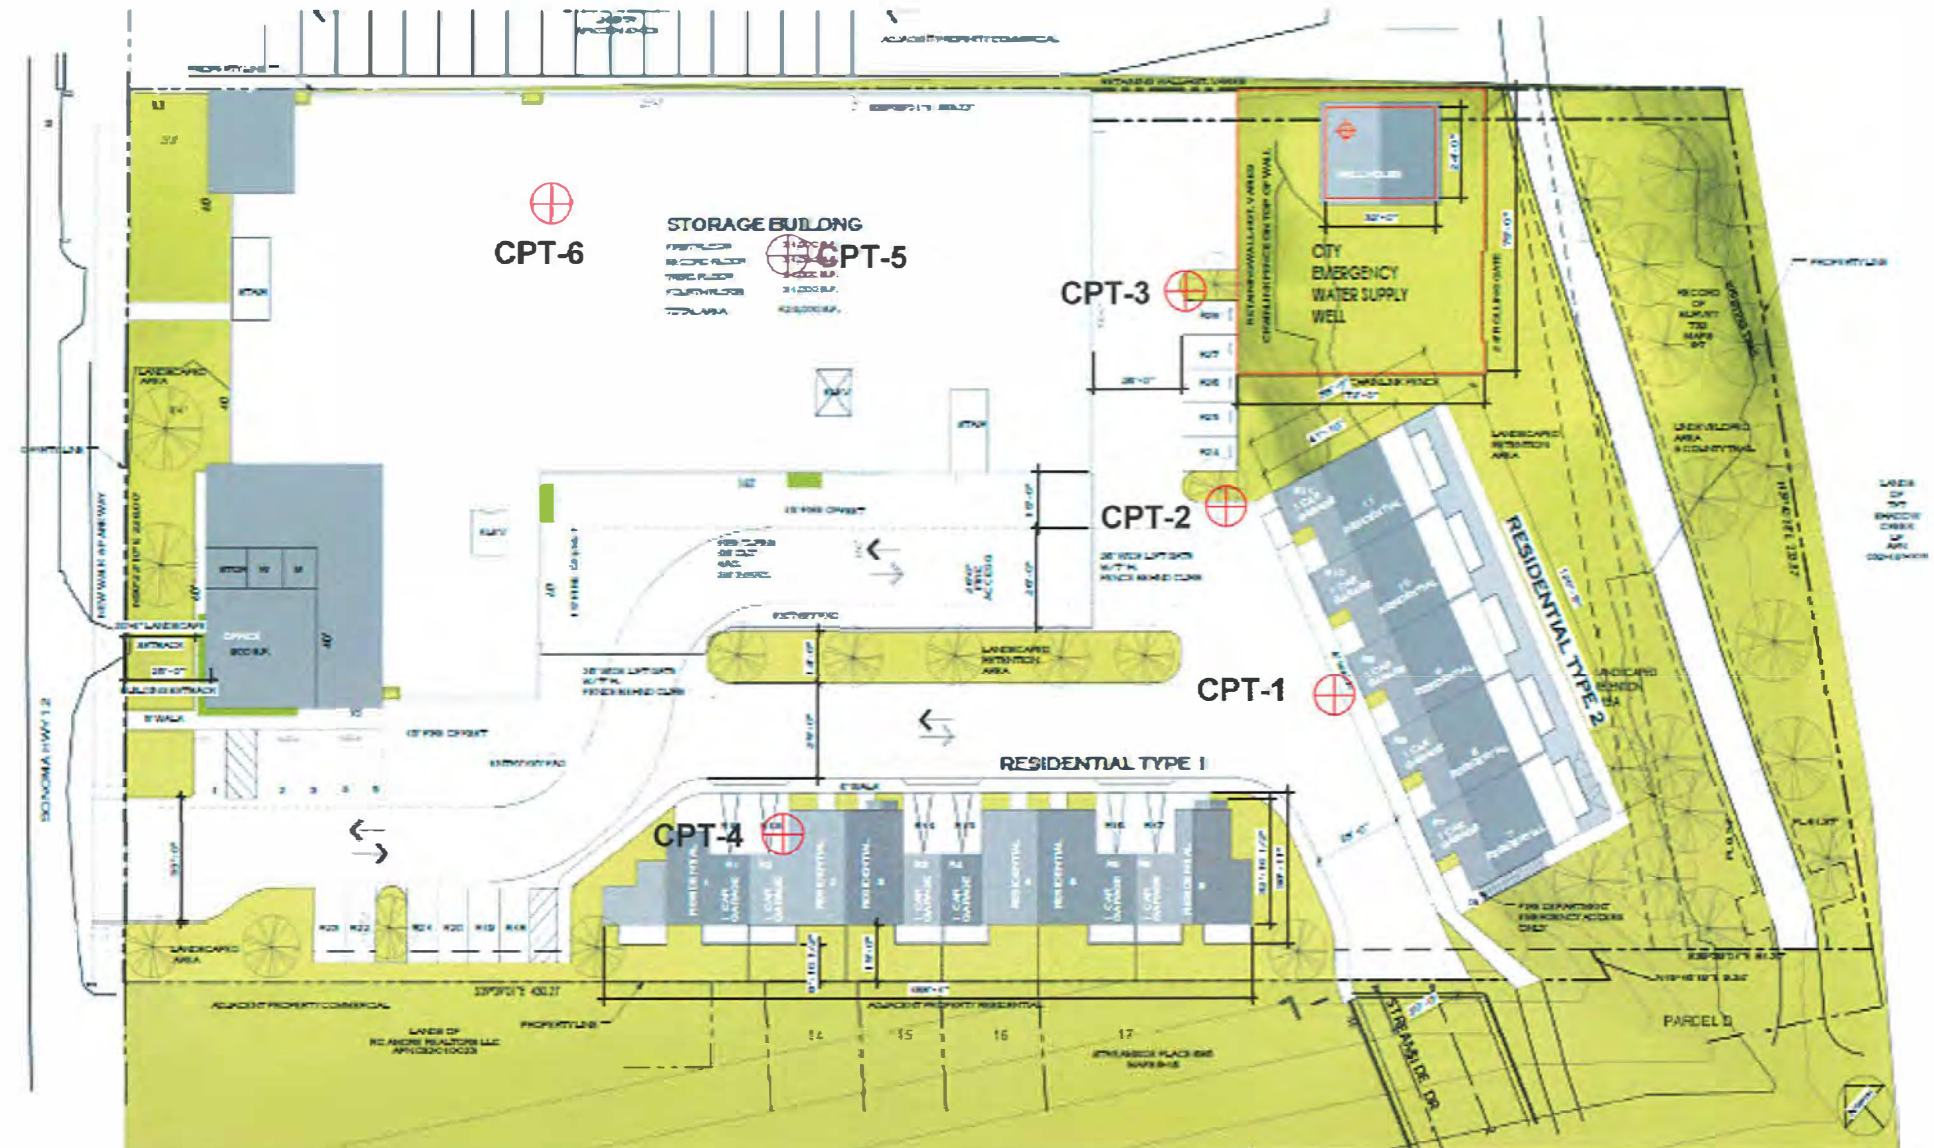
⊕ Indicates approximate location of CPT probe.  
CPT-6

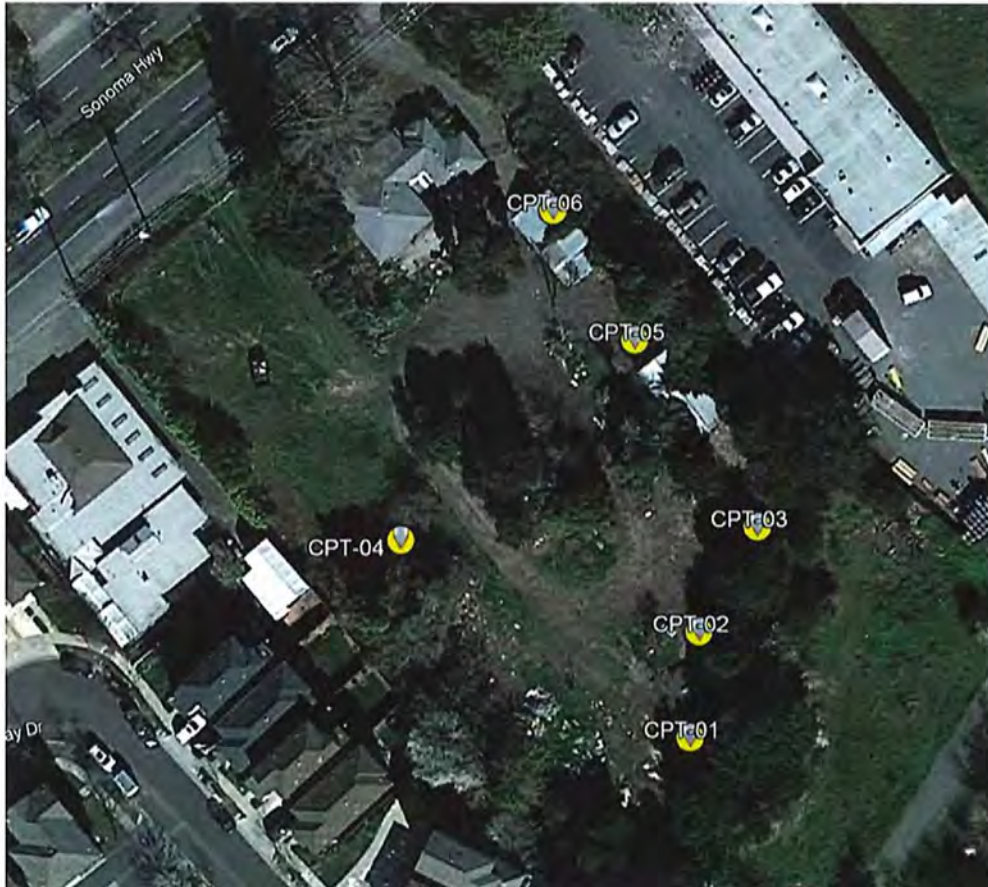
An aerial overview from Google Earth including the CPT locations is presented below.

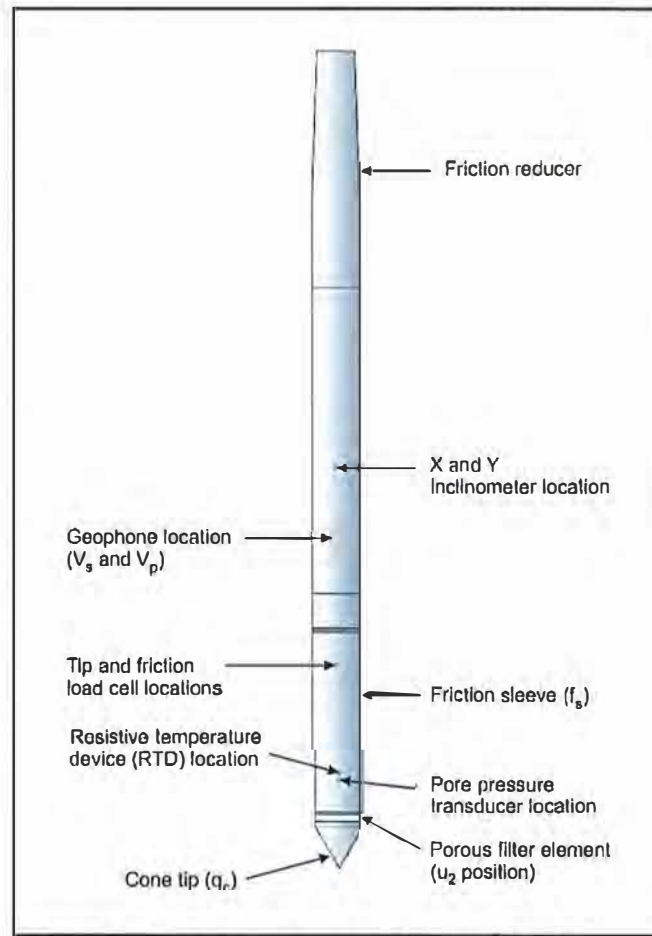
Figure CPTu. Piezocone Penetrometer (15 cm<sup>2</sup>)

The piezocone penetrometers are manufactured with dimensions, tolerances and sensor characteristics that are in general accordance with the current ASTM D5778 standard. Our calibration criteria also meet or exceed those of the current ASTM D5778 standard. An illustration of the piezocone penetrometer is presented in Figure CPTu.

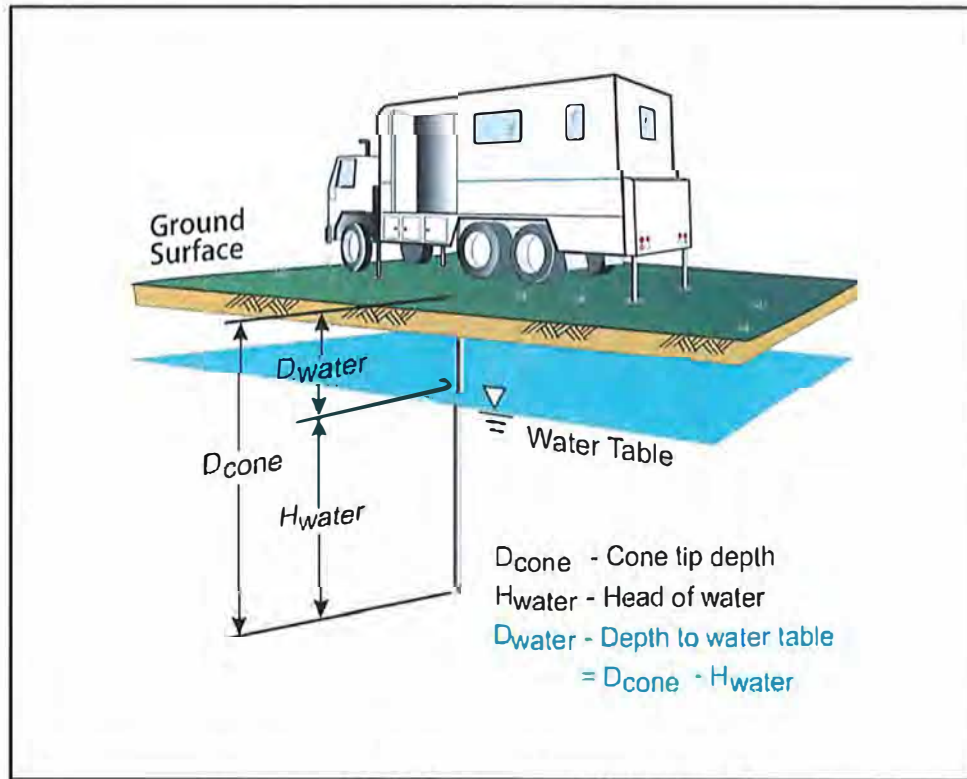
Figure PPD-1. Pore pressure dissipation test setup

The cone penetration test is halted at specific depths to carry out pore pressure dissipation (PPD) tests, shown in Figure PPD-1. For each dissipation test the cone and rods are decoupled from the rig and the data acquisition system measures and records the variation of the pore pressure ( $u$ ) with time ( $t$ ).

Pore pressure dissipation data can be interpreted to provide estimates of ground water conditions, permeability, consolidation characteristics and soil behavior.

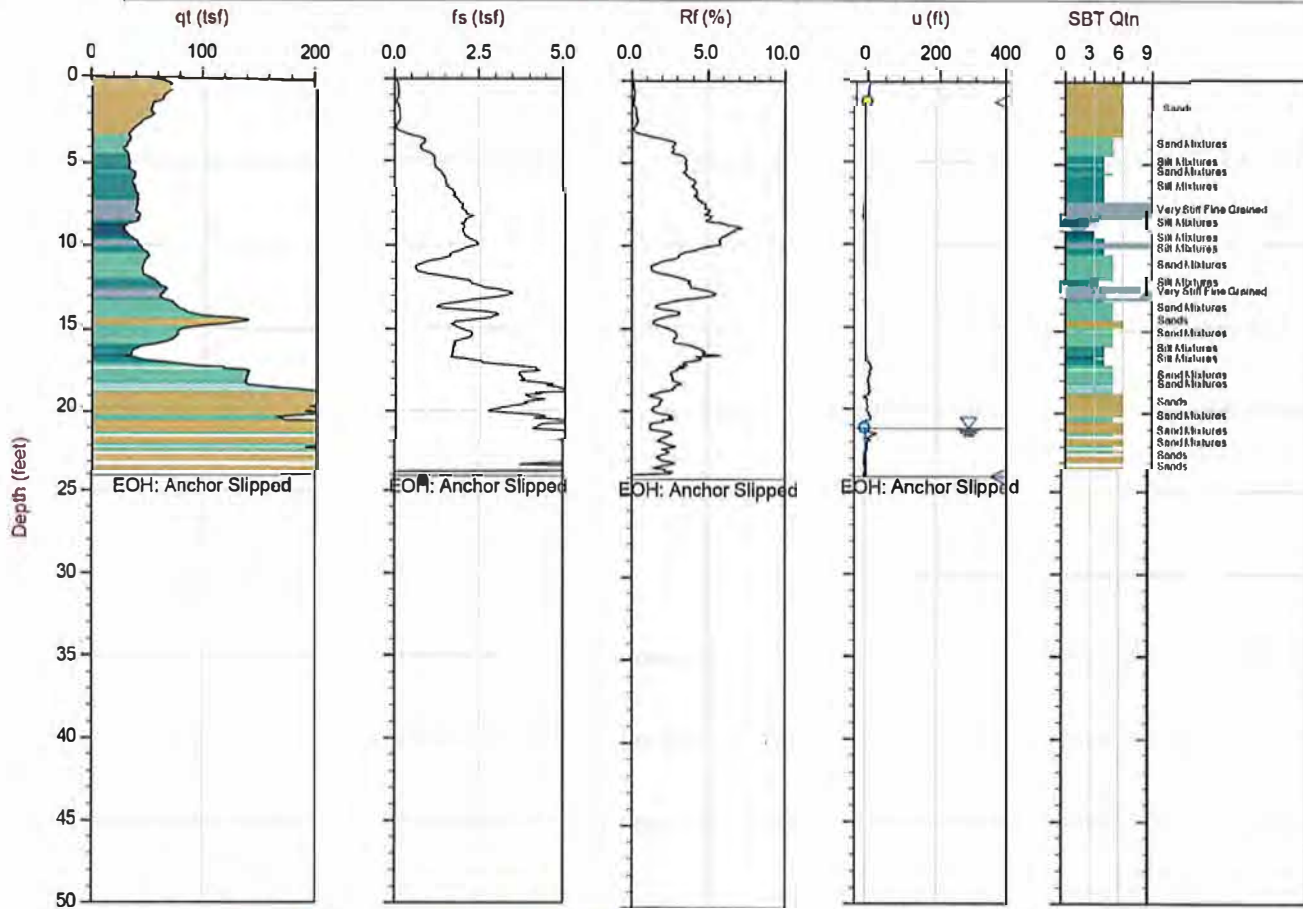
Max Depth: 7.350 m / 24.11 ft  
Depth Inc: 0.025 m / 0.082 ft  
Avg Int: Every Point

File: 18-56099\_CP01.COR  
Unit Wt: SBTQin(PKR2009)

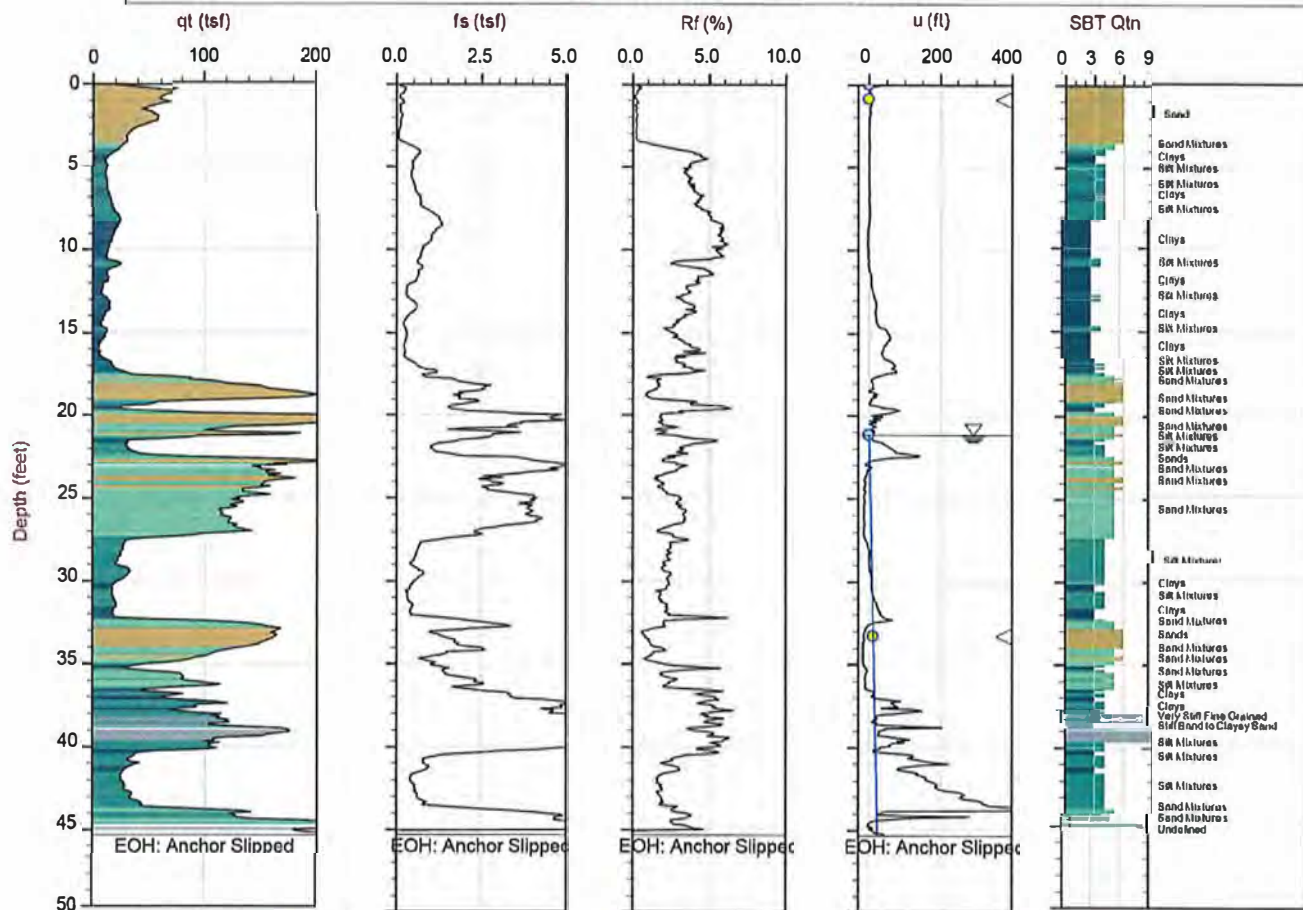
Sounding: CPT-04  
Cone: 443:T1500F15U500

Max Depth: 13.825 m / 45.36 ft  
Depth Inc: 0.025 m / 0.082 ft  
Avg Int: Every Point

File: 18-56099\_CP04.COR  
Unit Wt: SBTQIn (PKR2009)

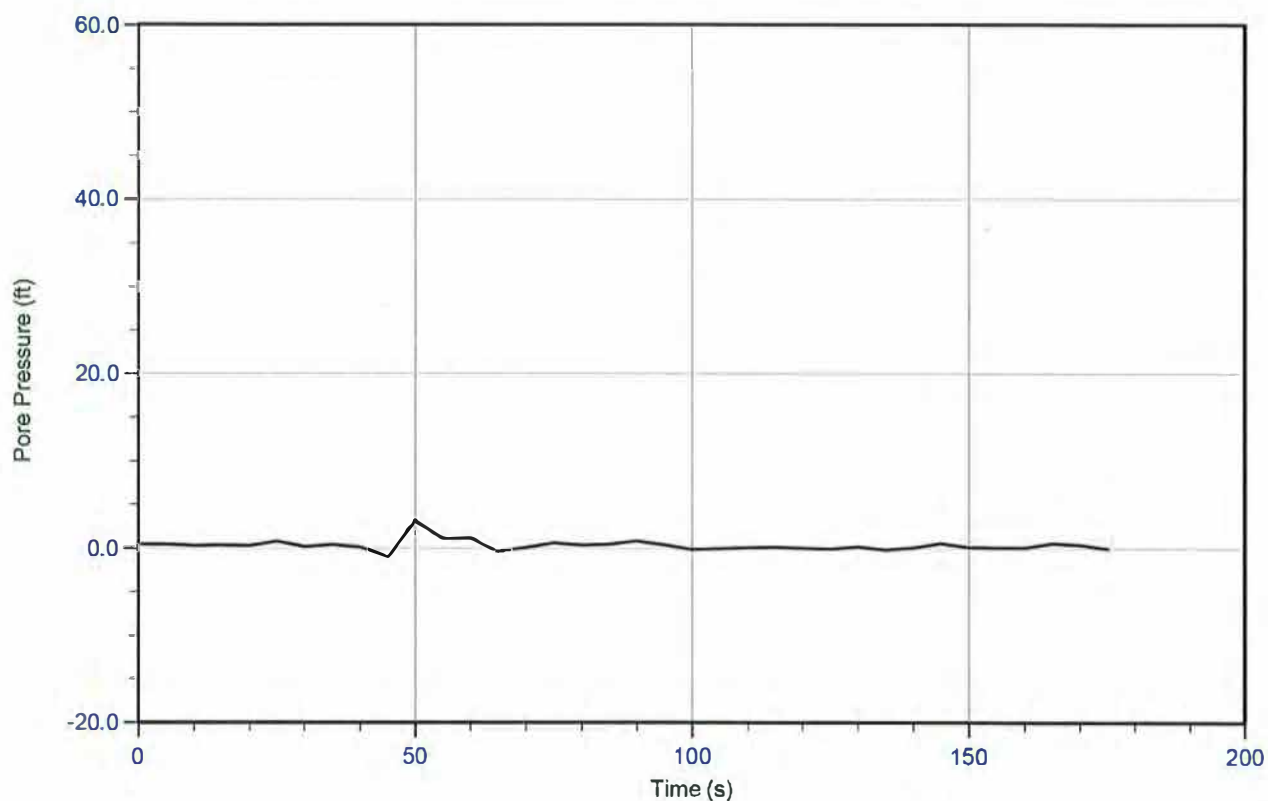
Sounding: CPT-01  
Cone: 443:T1500F15U500 Area=15 cm<sup>2</sup>

Trace Summary:	Filename: 18-56099_CP01.PPF	U Min: -1.0 ft	WT: 0.375 m / 1.230 ft
	Depth: 0.375 m / 1.230 ft	U Max: 3.2 ft	Ueq: 0.0 ft
	Duration: 175.0 s

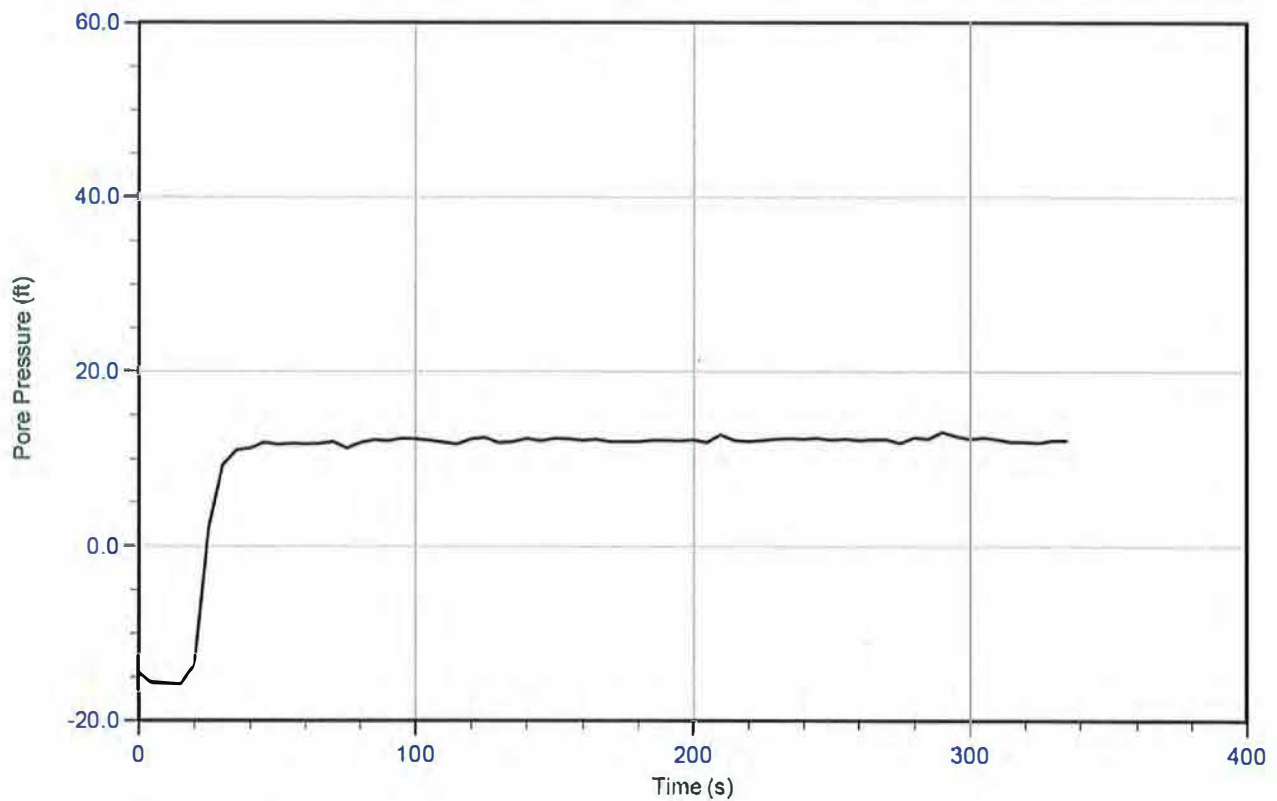
Sounding: CPT-04  
Cono: 443:T1500F15U500 Area=15 cm<sup>2</sup>

Trace Summary:	Filename: 18-56099_CP04.PPF	U Min: -15.8 ft	WT: 6.456 m / 21.181 ft
	Depth: 10.150 m / 33.300 ft	U Max: 13.1 ft	Ueq: 12.1 ft
	Duration: 335.0 s

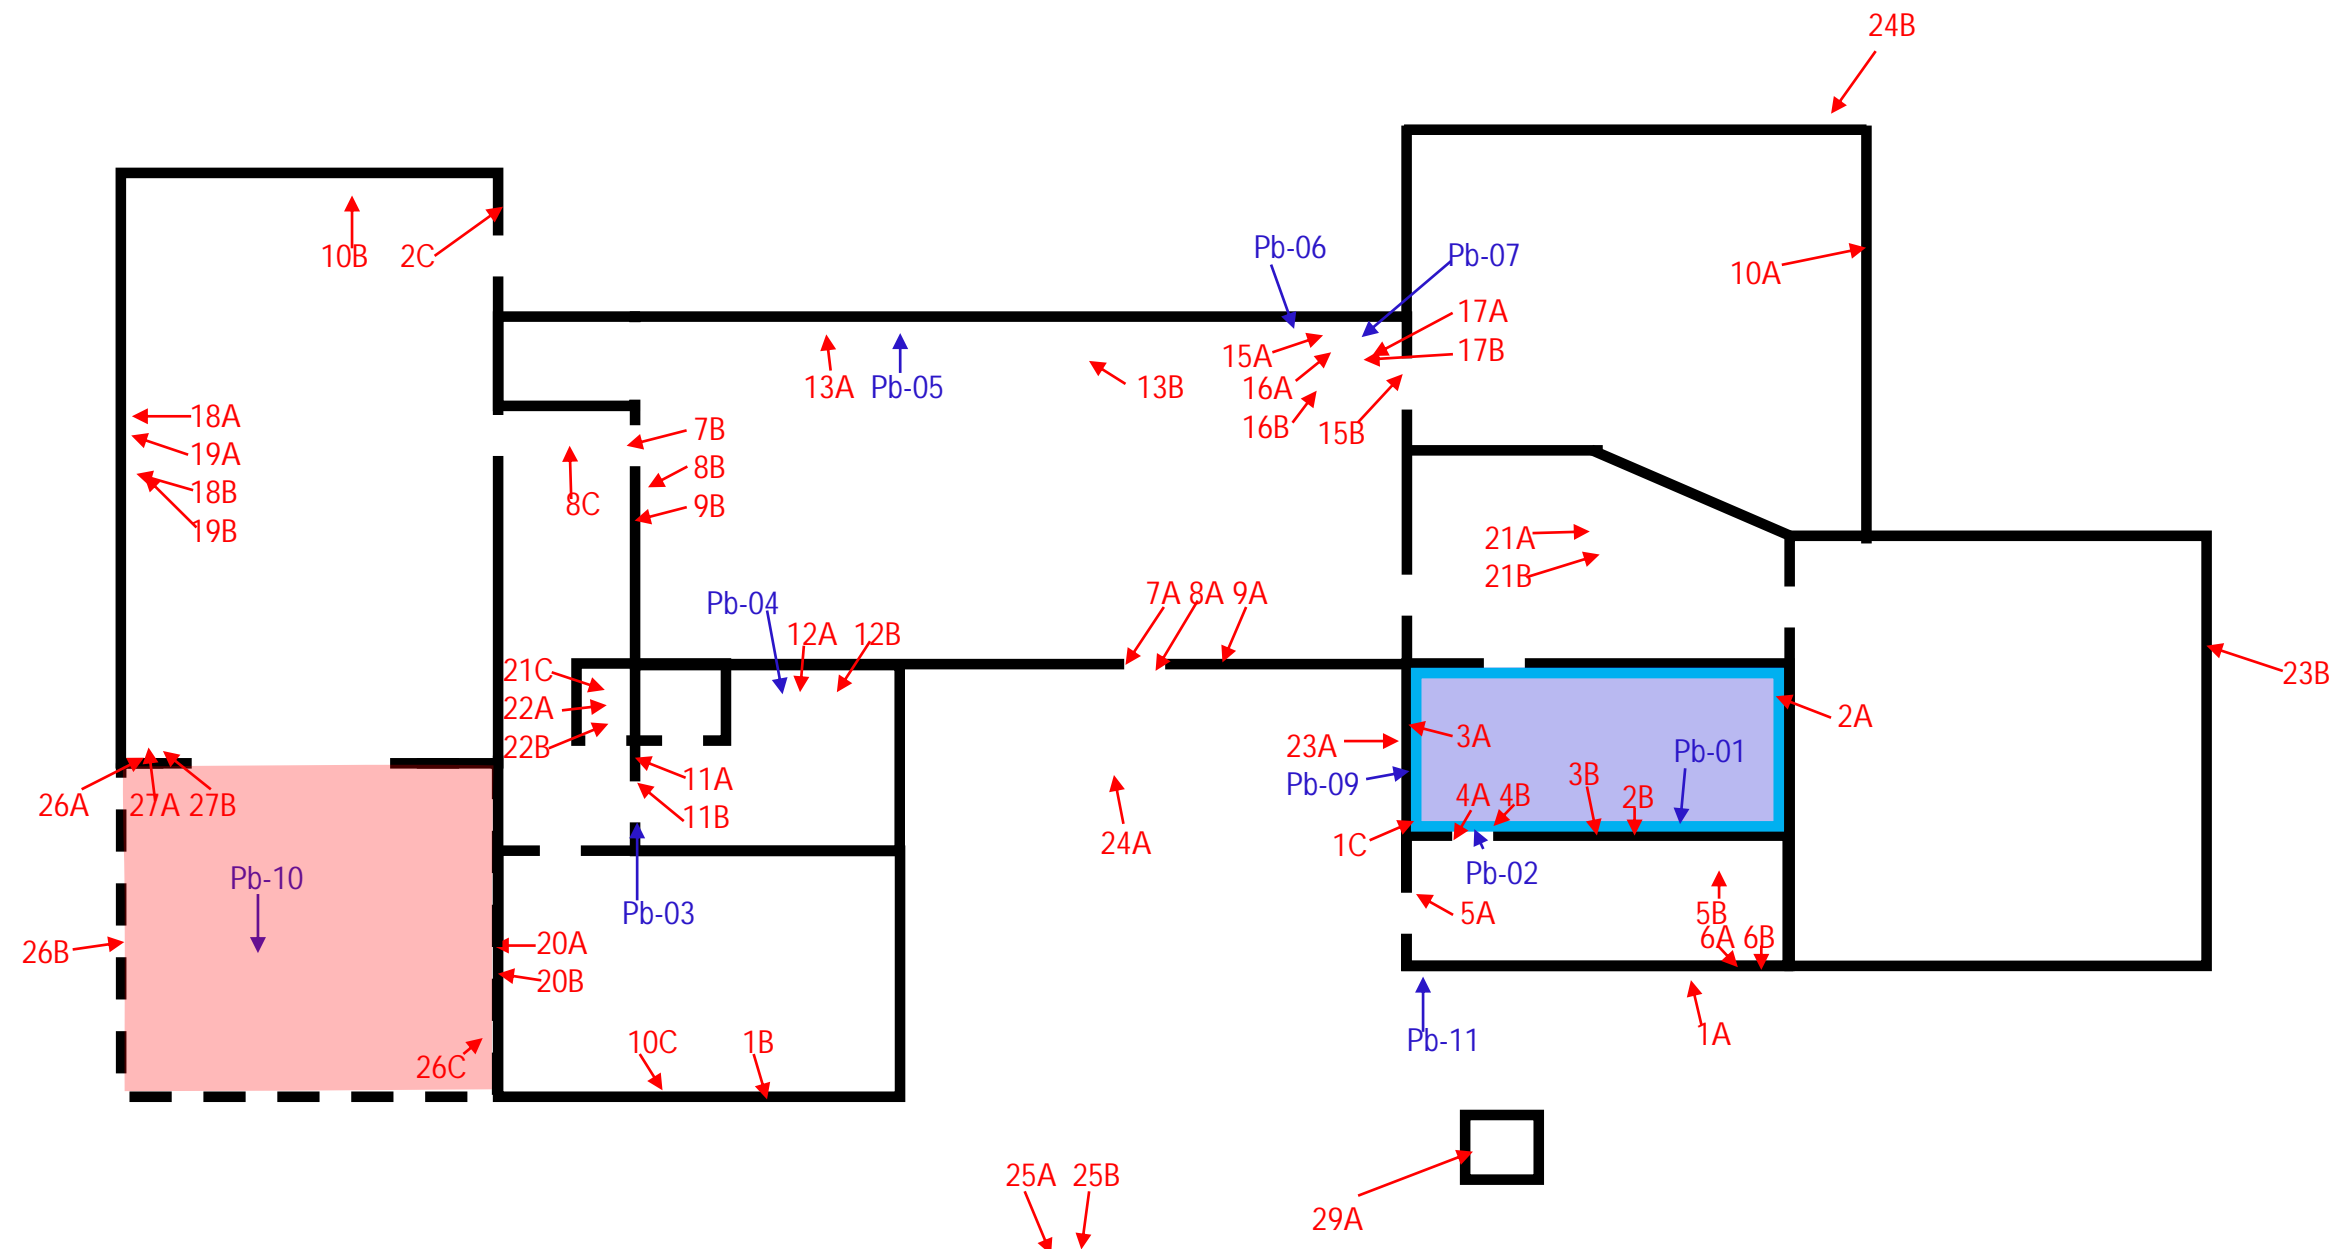
- Asbestos containing Gray Cementitious Material (<0.25% CH) associated ceramic wall tile system and drywall system (2% CH)
- Asbestos containing Gray Mortar and Gray Cementitious Material (<1%CH) associated with the ceramic floor tile system
- Lead containing 4" pink ceramic wall tile (4,790 ppm)
- Lead containing red paint (117 ppm) on concrete porch.

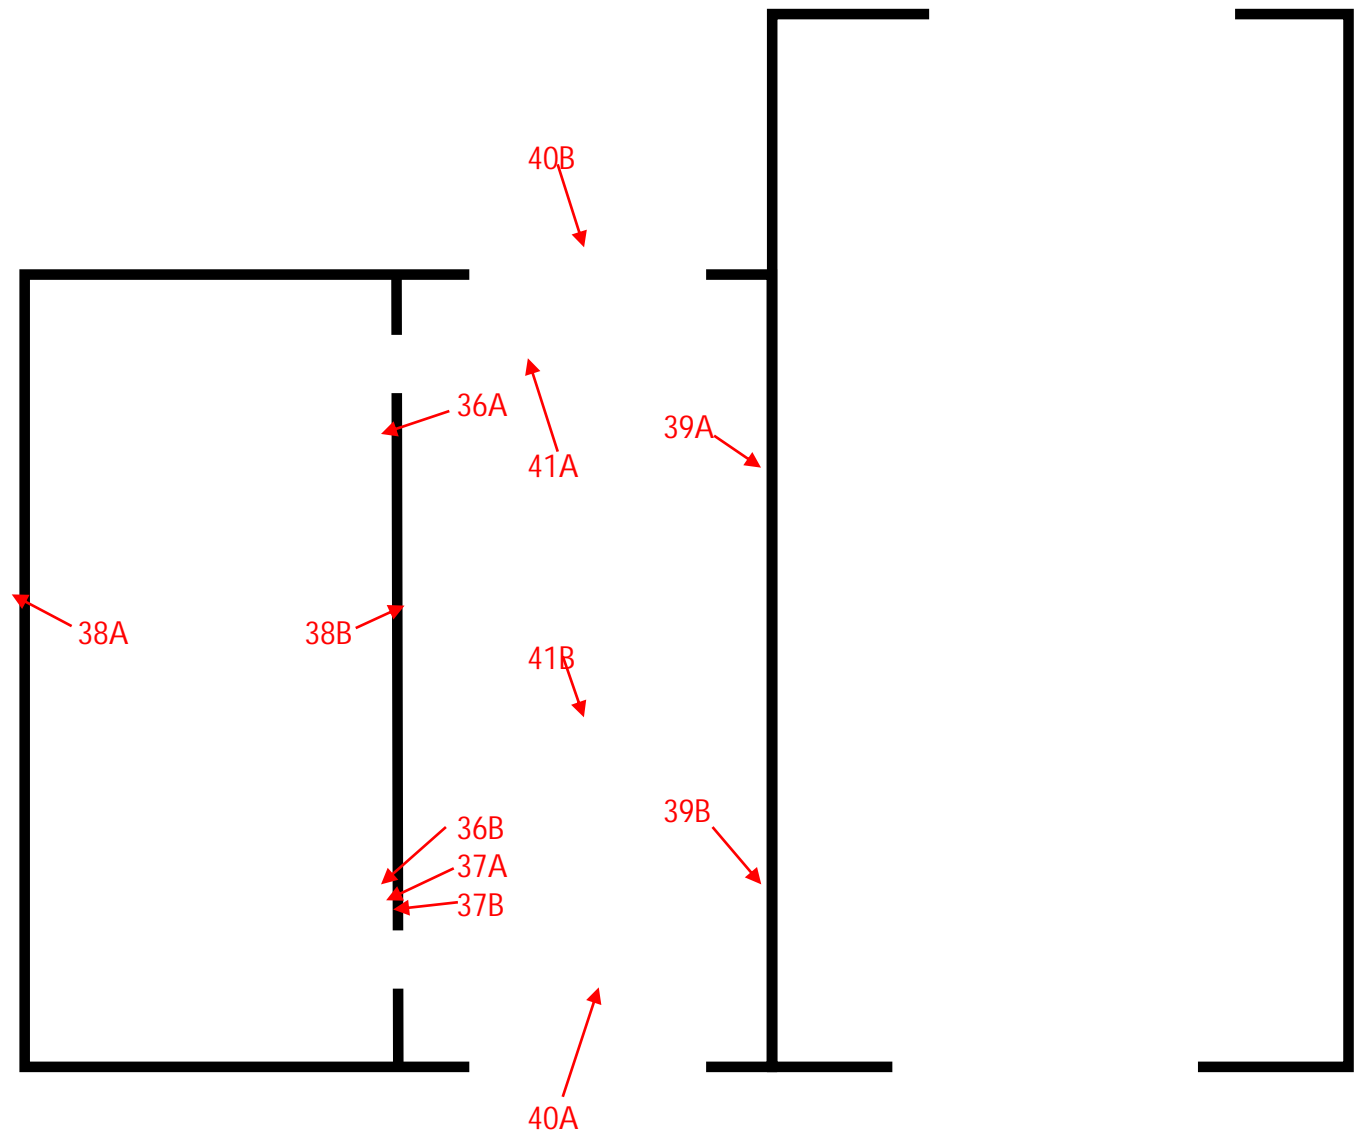
Asbestos was not detected in the sampled materials.  
Lead was not detected in the sampled materials above the laboratory detection limit.

<u>Date</u> November 2018	<u>Drafted By</u> WMF
<u>Project Number</u> R1187D02	<u>Checked By</u> KMS
<u>Sheet Name</u> Kiln/Barn Building - Sample Location Diagram	
<u>Sheet Number</u> Figure 3
