Tank and Pump Station Evaluations

Prepared for
City of Santa Rosa

June 2018

WEST YOST

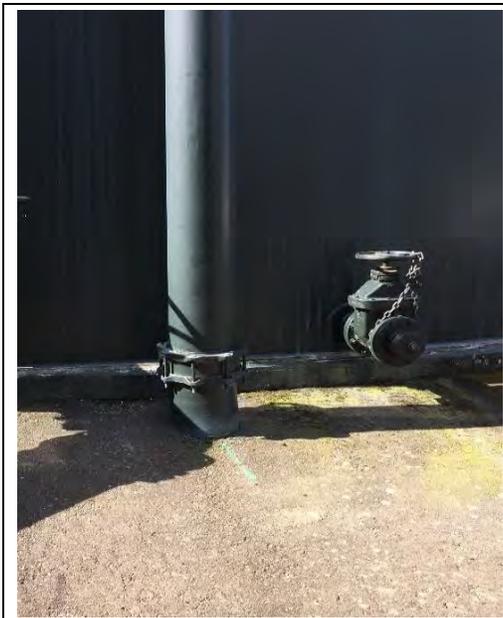
- **Direct connection of drainage facilities to a sanitary sewer or storm drain (California Title 22, Chapter 16, Article 6, 64585(b)(5)):** The tank overflow and drain pipes are directly connected to the storm drain system as shown in Photo 2-3. Current code requires an air gap between the storm drain system and the tank overflow and drain pipe. The following options are available to resolve this issue:
 - The overflow modification could be accomplished by cutting off the overflow pipe above the drain inlet and welding a flange to install an insert screen.
 - The tank drain modification requires rerouting the outlet to above grade, which would require pumping of the last three feet of water in order to drain the tank. A possible alternative that DDW has approved in the past includes installing a blind flange on the end of the drain in the storm drain inlet to prevent cross-connection.

Photo 2-3. Tank Overflow

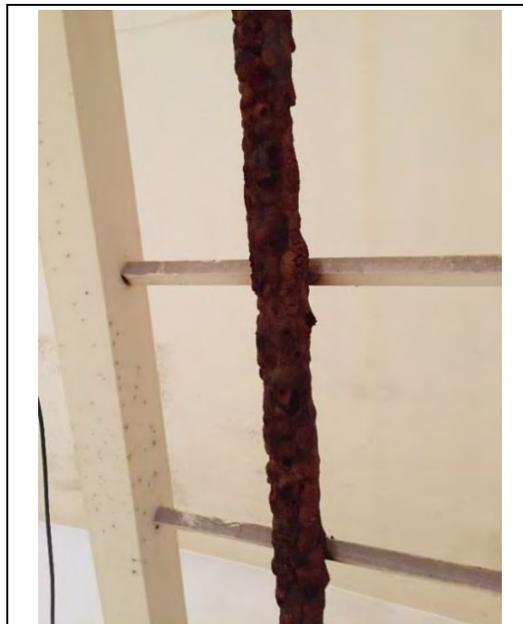
- **Interior ladder Saf-T-Climb:** The existing interior ladder Saf-T-Climb has a large amount of corrosion product on the surface (see Photo 2-4). During field inspection, a small amount of the corrosion material was removed and it appeared the corrosion is on the surface and the material structure is still intact. Therefore, the recommended first step is to remove the surface corrosion and determine the condition of the steel material. Should the material structure be compromised, then the Saf-T-Climb should be replaced.

Photo 2-4. Interior Ladder Saf-T-Climb with Corrosion Product on the Surface

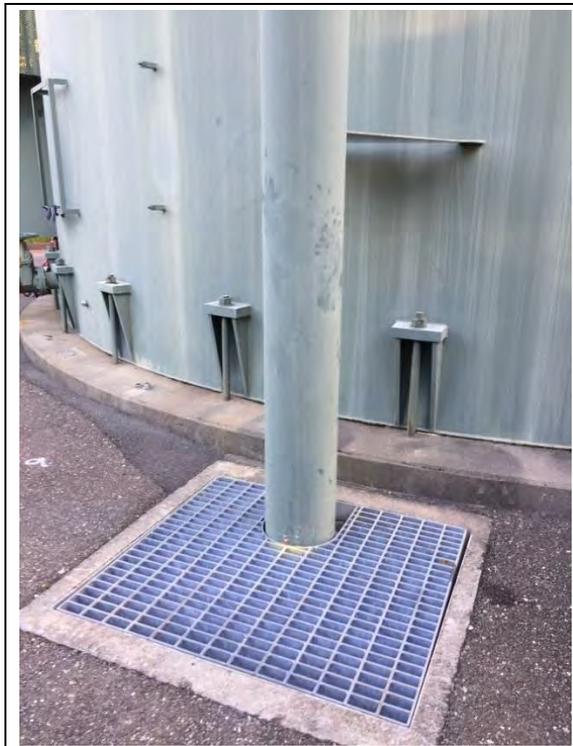
- **Direct connection of drainage facilities to a sanitary sewer or storm drain (California Title 22, Chapter 16, Article 6, 64585(b)(5)):** The tank overflow and drain pipes are directly connected to the storm drain system as shown in Photo 3-2. Current code requires an air gap between the storm drain system and the tank overflow and drain pipe. The following options are available to resolve this issue:
 - The overflow modification could be accomplished by cutting off the overflow pipe above the drain inlet and welding a flange to install an insert screen.
 - The tank drain modification requires rerouting the outlet to above grade, which would require pumping of the last three feet of water in order to drain the tank. A possible alternative that DDW has approved in the past includes installing a blind flange on the end of the drain in the storm drain inlet to prevent cross-connection.

Photo 3-2. Reservoir R-16 Overflow Direct Connection to the Storm Drain System

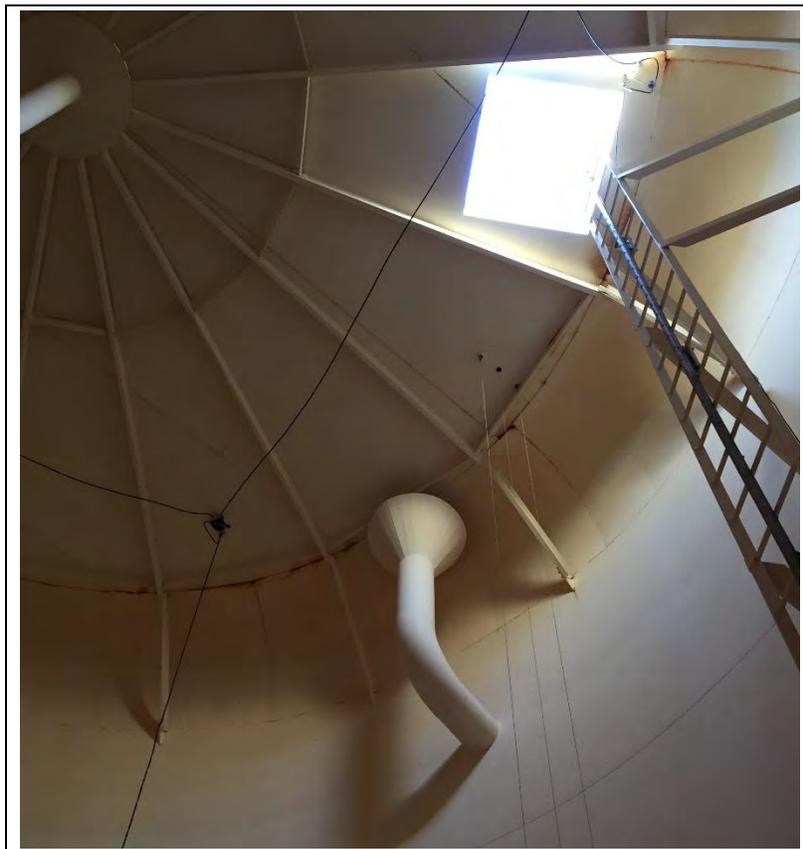
1. Operate the tank at the existing storage capacity by replacing/strengthening the column and roof and strengthening the shell and anchorage.
2. Avoid structural improvements to the tank by decreasing the maximum fill height of the tank. Based on the results of the structural and seismic evaluation, the fill height should be reduced to 27 feet. This would decrease the capacity from 0.25 million gallons to approximately 0.2 million gallons. The overflow would also need to be lowered to be in compliance with AWWA D100-11, 13.5.4.4 and 1.2. See Photo 3-3, which shows the overflow cone near the tank roof.

Photo 3-3. Reservoir R-16 Overflow Cone.

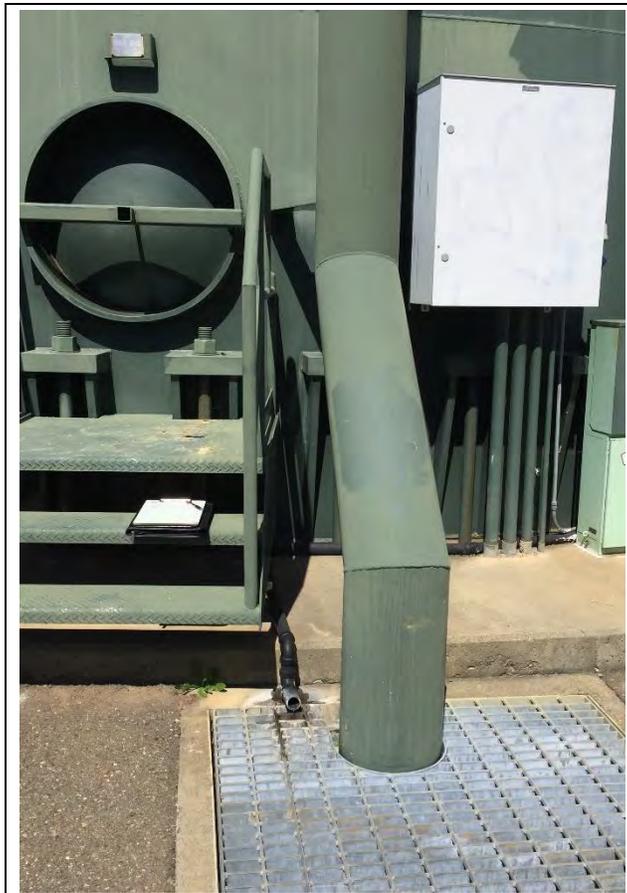
- **Direct connection of drainage facilities to a sanitary sewer or storm drain (California Title 22, Chapter 16, Article 6, 64585(b)(5)):** The tank overflow and drain pipes are directly connected to the storm drain system as shown in Photo 4-2. Current code requires an air gap between the storm drain system and the tank overflow and drain pipe. The following options are available to resolve:
 - The overflow modification could be accomplished by cutting off the overflow pipe above the drain inlet and welding a flange to install an insert screen.
 - The tank drain modification requires rerouting the outlet to above grade, which would require pumping of the last three feet of water in order to drain the tank. A possible alternative that DDW has approved in the past includes installing a blind flange on the end of the drain in the storm drain inlet to prevent cross-connection.

Photo 4-2. Reservoir R-17 Overflow Direct Connection to the Storm Drain System

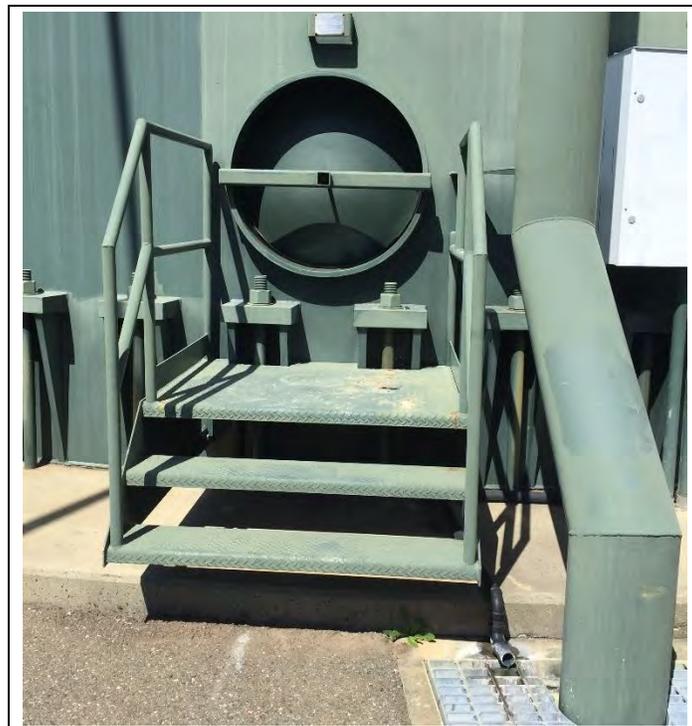
- **Manway access staircase:** The existing manway access staircase used to access the tank interior through one of the shell manways extends into the driveway and is a safety hazard. See Photo 4-3. City staff suggested, and West Yost agrees it would be reasonable to modify or replace the existing staircase so that it does not extend into the driveway.

Photo 4-3. Manway Access Staircase

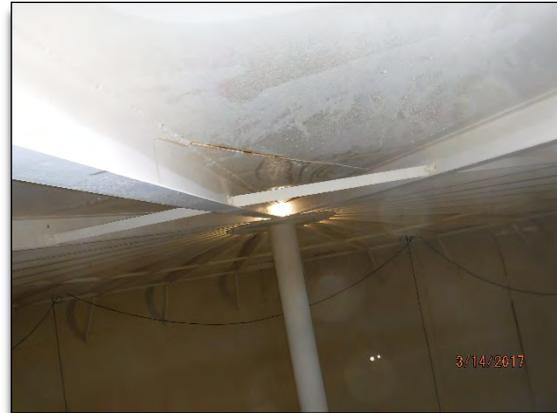
Photo No. 8 – Interior roof view of R-17 with minor corrosion on roof seams.

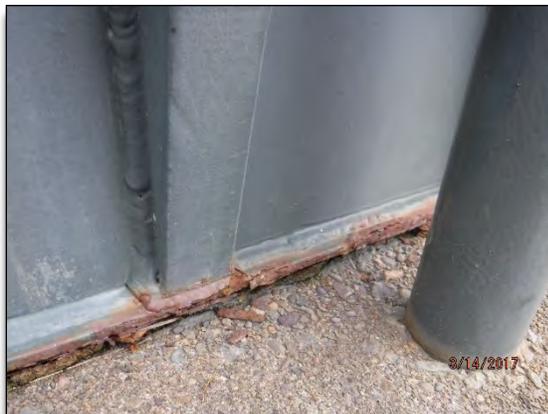
Photo No. 9 – Annular ring of R-17 with corrosion product on ring.

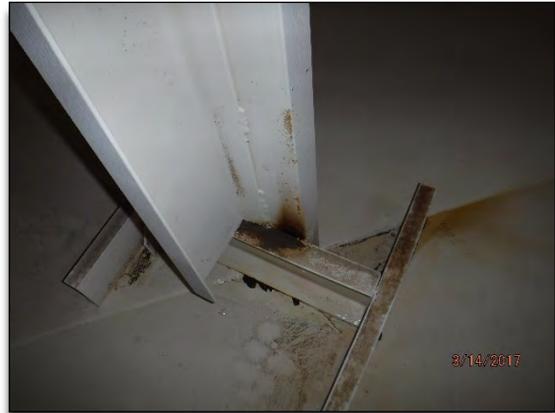
Photo No. 14 – Interior of R-9A with minor corrosion at seams.

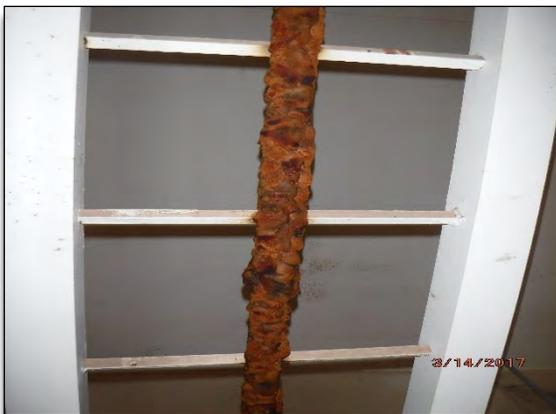
Photo No. 15 – R-9A with corrosion product on ladder climbing safety system.

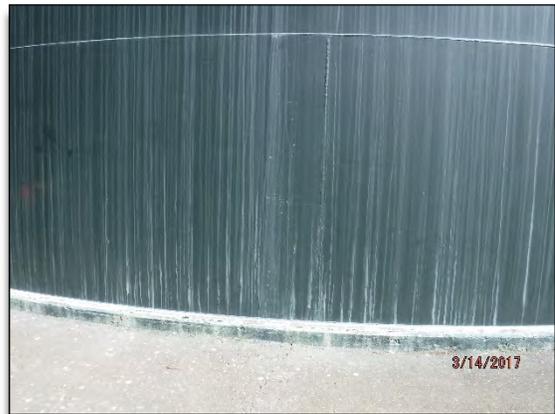
Photo No. 16 – Exterior of R-9A with chalking present on exterior coating.

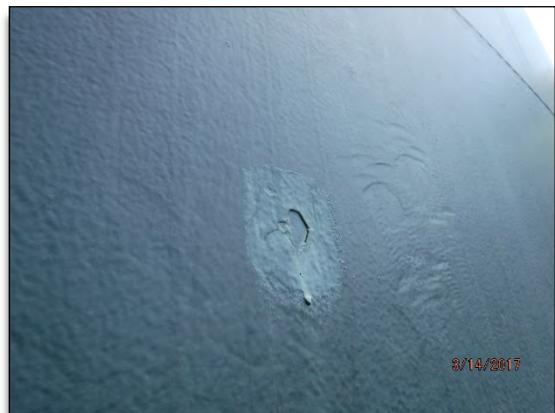
Photo No. 18 – Exterior coating repair of R-9A likely from rock damage.

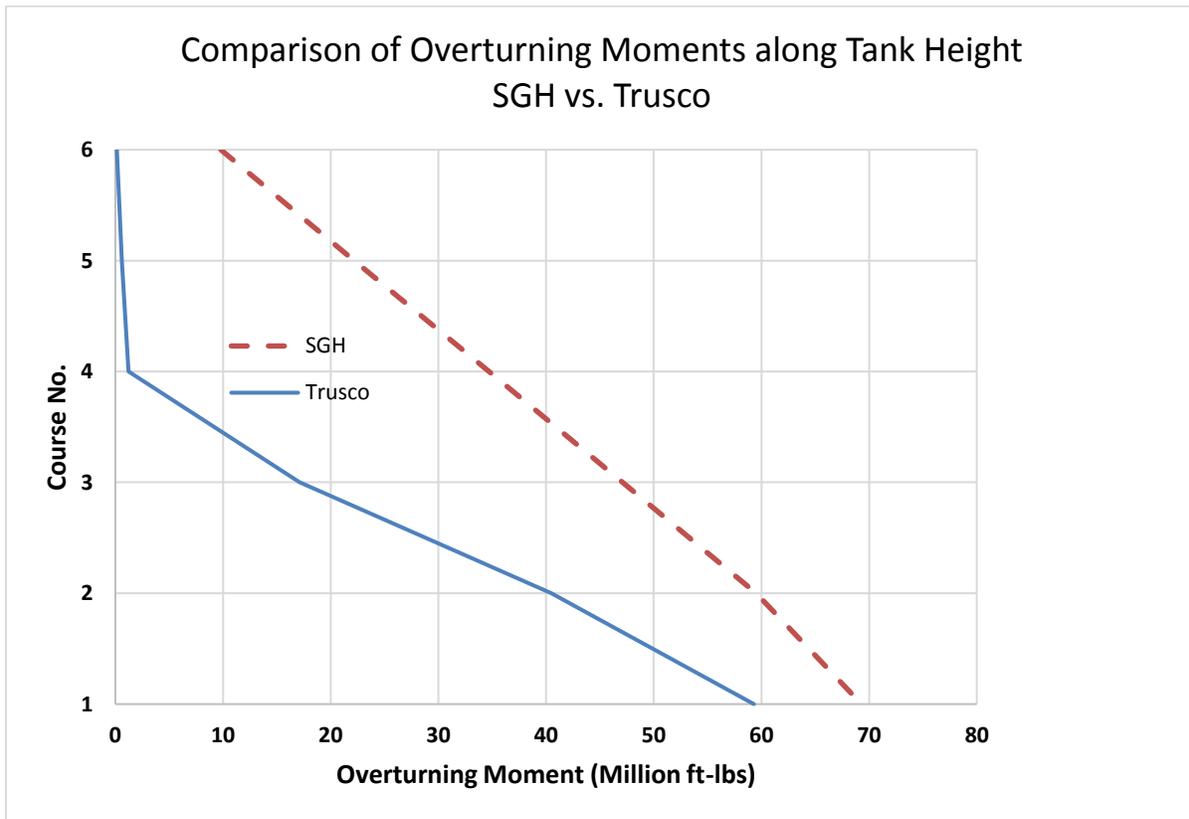
- It appears that Trusco made major calculation errors in determining the overturning moment in the upper courses of the tank wall. Figure 4-1 shows the overturning moment along the height of the tank, at the base of each course, from the Trusco design calculations and the SGH calculations. While the difference in values at the base can be attributed to changes in the code requirements, Trusco’s calculations along the height simplified the impulsive load as a point load at the center of gravity of the tank rather than as a distributed load. As a result, they did not include any seismic impulsive load in the shell design for the upper courses above the center of gravity. AWWA D100-11, Section A.13.5.4.2.2 suggests a linear reduction in the overturning moment from the base to the roof, which is what we assumed in our calculations. The net result is that Courses 2 through 5 were undersized in the original design, and Courses 3 to 5 in particular are highly overstressed for shell compressive stresses when using the current code, by a factor ranging from 1.9 to 3.2.

Figure 4-1: Comparison of loads along tank height as calculated by Trusco in original design vs. calculations by SGH using current code. Trusco calculation errors resulted in underdesign of upper courses.

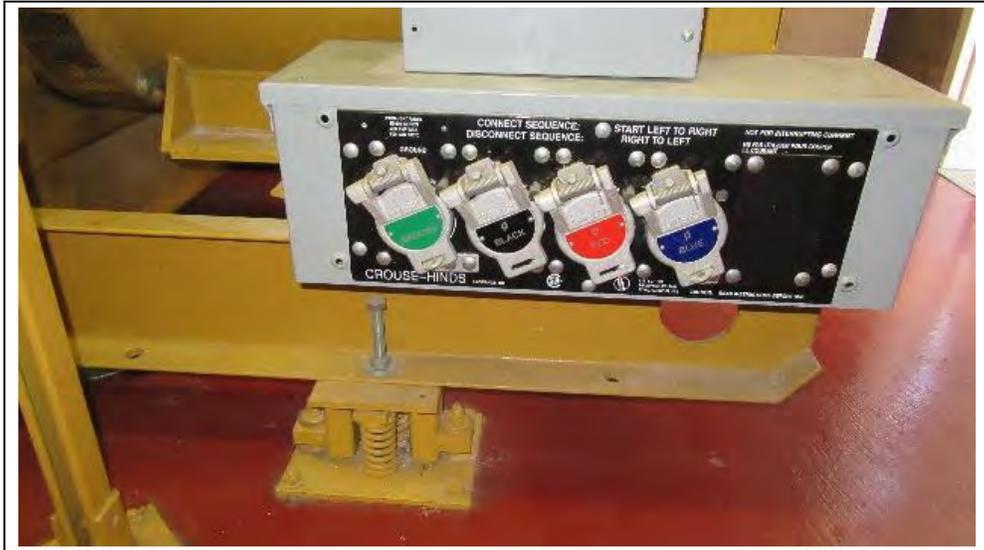
The generator's main circuit breaker is mounted to the skid. There is a 225A load bank breaker mounted to the side of the generator along with a Crouse-Hines Posi-Lock panel "E0400" series generator receptacle. The Posi-lock panel is used for exercising the generator (see Photo 6).

Photo 6. Posi-lock panel

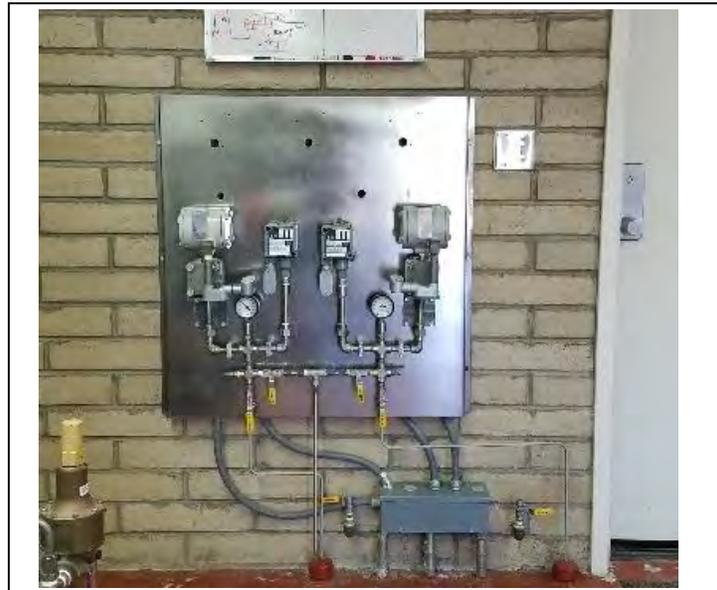
Pressure transmitters are located on the suction and discharge sides of the pumps, along with lo-lo suction pressure switch and hi-hi discharge pressure switch. The pressure transmitters are Bristol Babcock Signature model (suction 2408-10B-511-110-110-A230; 0-100 URL 150PSI; discharge 2408-10B-511-110-100; 0-117, URL 150PSI) and the pressure switches are Allen-Bradley 836T pressure switches (suction-836T-T253J; Discharge 836T- T253J). These instruments are located inside the pump/electrical room, on the north wall, next to the Hydropneumatic tank door (see Photo 11).

Photo 11. Pump Instrument Panel

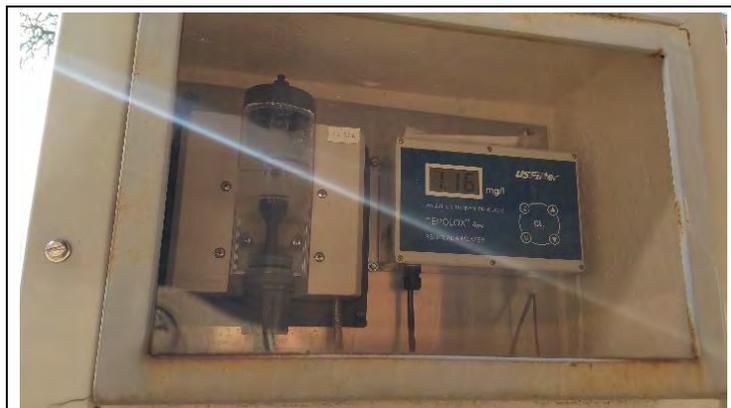
Next to the Hydropneumatic tank is a US Filter (Wallace & Tiernan) Depolox Basic Free Chlorine analyzer in a galvanized steel enclosure with viewing window. There are signs of corrosion on the panel (see Photo 12).

Photo 12. Chlorine Analyzer

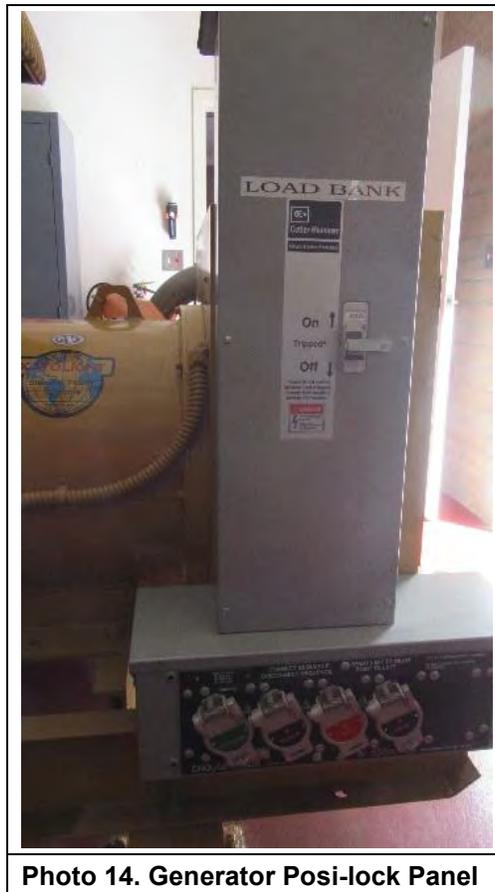
The generator's main circuit breaker is mounted to the skid. There is a 225A load bank breaker mounted to the side of the generator along with a Crouse-Hines Posi-Lock panel "E0400" series generator receptacle. The Posi-lock panel is used for exercising the generator (see Photo 14).

Photo 14. Generator Posi-lock Panel

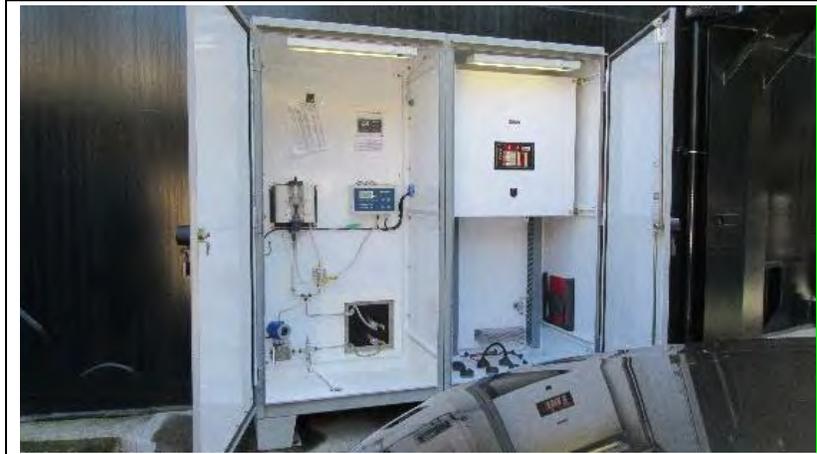
The Reservoir 4B Storage Tank Telemetry Panel (Tesco T-29635) houses the tank instrumentation and RTU. It has a “wet” left instrument side and a “dry” PLC & telemetry side. There is no corrosion at the bottom of the wet side of the panel (see Photo 15).

Photo 15. Reservoir 4B Telemetry Panel

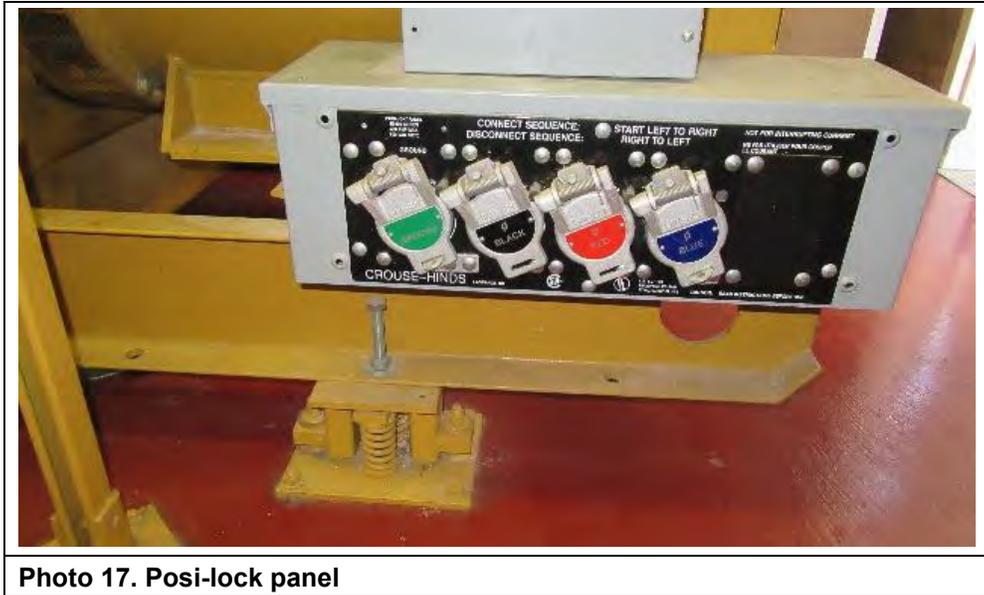
The generator's main circuit breaker is mounted to the skid. There is a 225A load bank breaker mounted to the side of the generator along with a Crouse-Hines Posi-Lock panel "E0400" series generator receptacle. The Posi-lock panel is used for exercising the generator (see Photo 17).

Photo 17. Posi-lock panel
