## MEMORANDUM

**PROJECT:** Luther Burbank Home and Gardens Re-Roofing Project  
TreanorHL Project #: HP0883.2001.00

The purpose of this Memorandum is to outline the research undertaken to date on the roofs of the Main House and Carriage House and to provide recommendations for the re-roofing project.

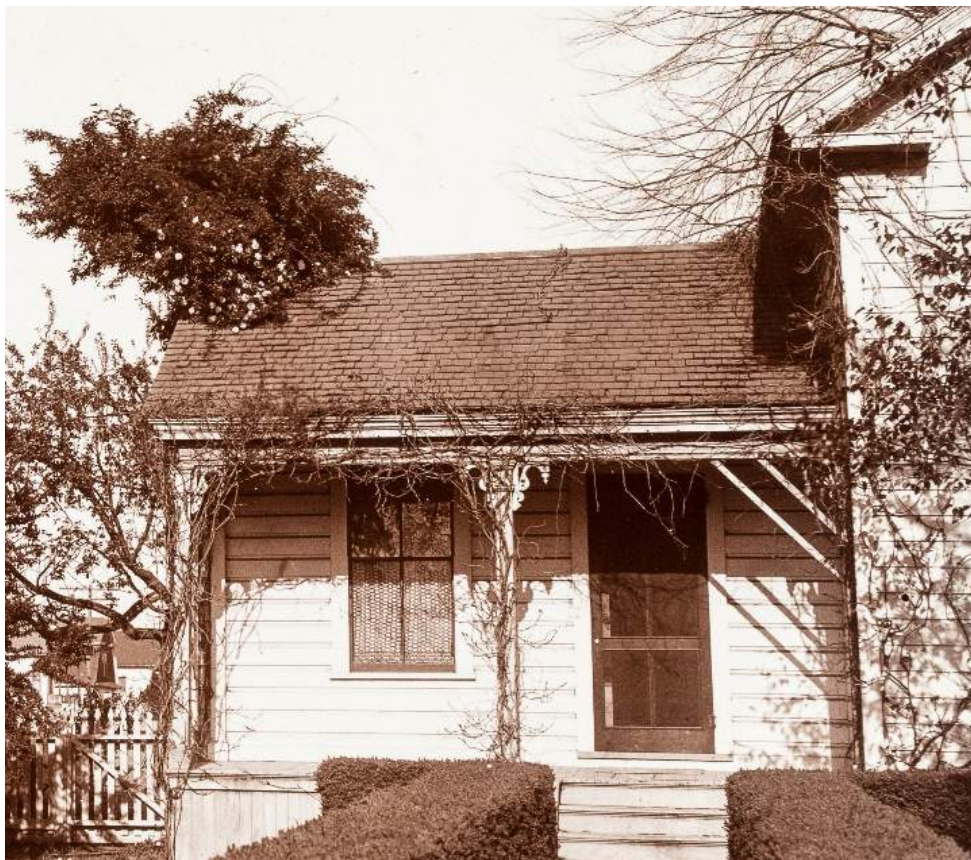
Image courtesy of the Luther Burbank Home & Gardens Association. c.1890. Only part of the original photograph is shown.  
Note wood shingle roof and lack of gutters or downspouts.

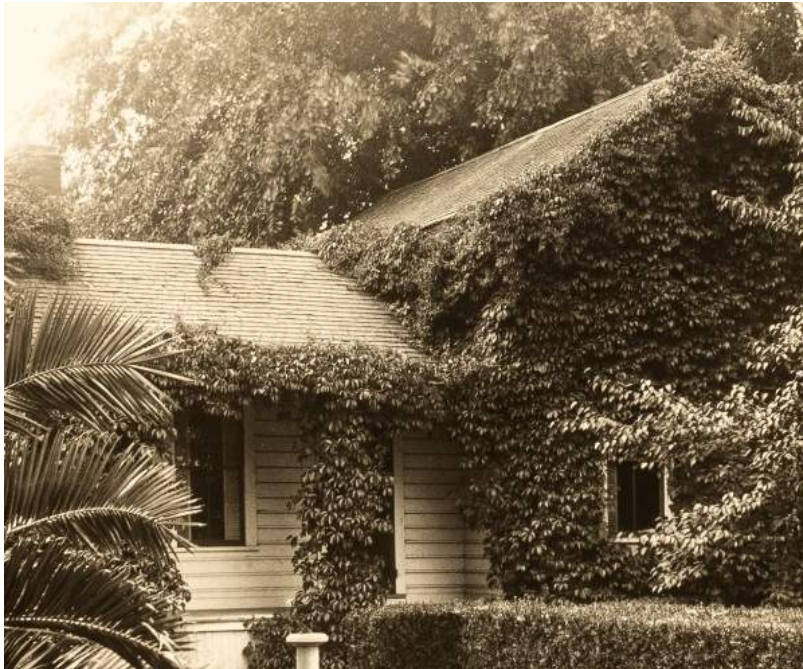
Image courtesy of the City of Santa Rosa and the Luther Burbank Home & Gardens Association c.1916 Only part of the original photograph is shown. Note unchanged wood shingle<sup>1</sup> roof.

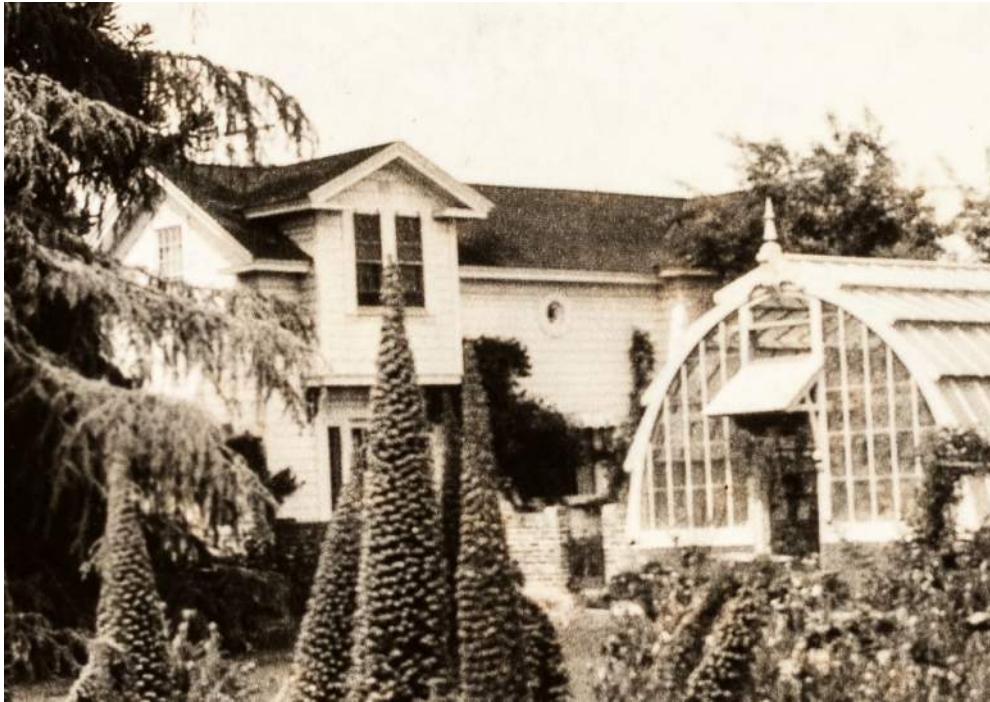
Image courtesy of the City of Santa Rosa and the Luther Burbank Home & Gardens Association c.1935. Only part of the original photograph is shown. Note roofing material is indistinguishable in the image.

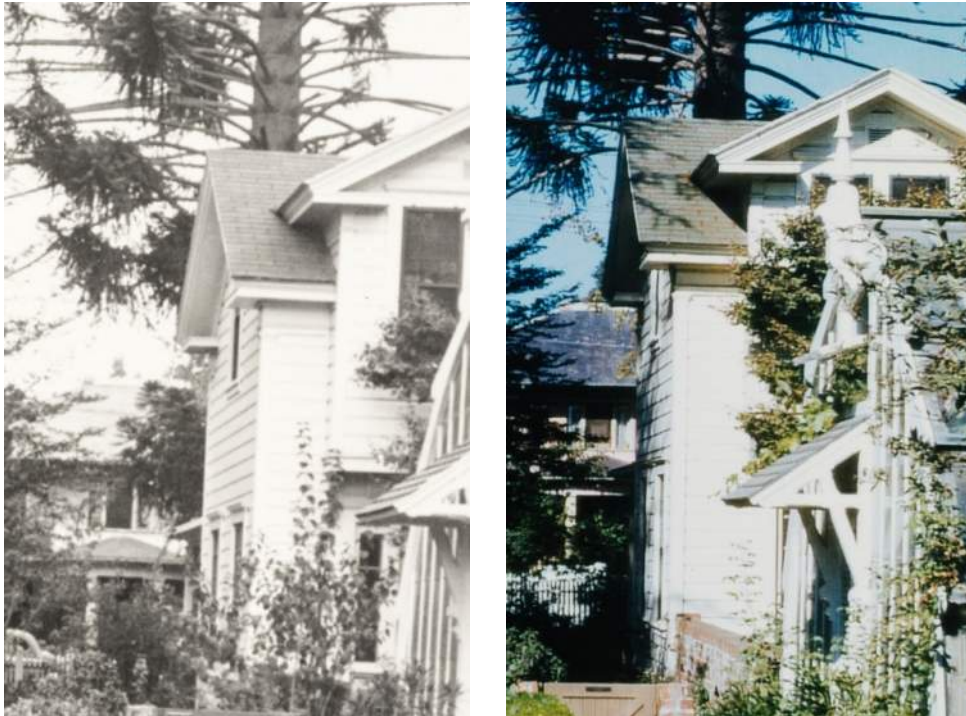
Images courtesy of the City of Santa Rosa and the Luther Burbank Home & Gardens Association. c.1940 (left) and c.1950 (right). Only part of the original photograph is shown. Note asphalt shingle roofing.

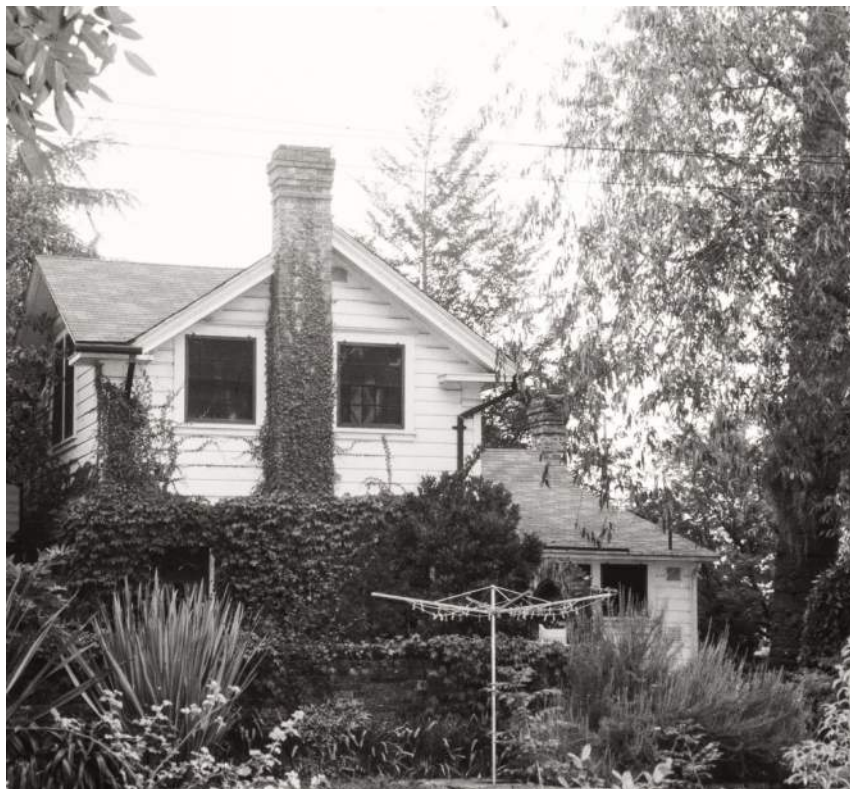
Image courtesy of the City of Santa Rosa and the Luther Burbank Home & Gardens Association. c.1950. Only part of the original photograph is shown. Note asphalt roof and gutters.

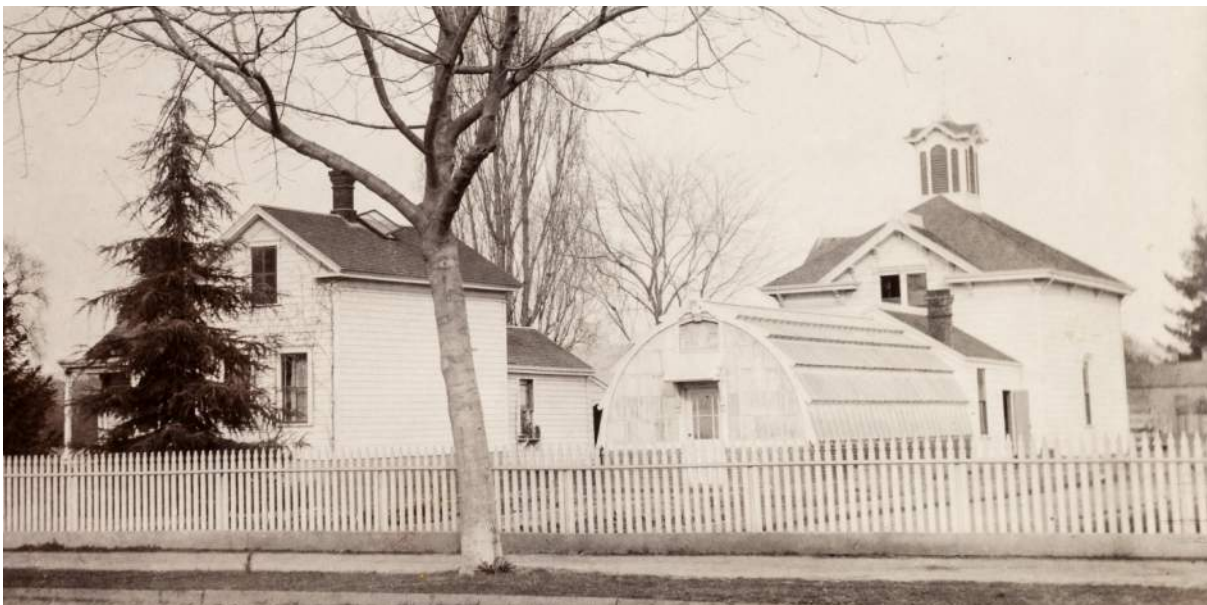
Image courtesy of the Luther Burbank Home & Gardens Association. c.1890. Only part of the original photograph is shown. Note wood shingle roof on Carriage House.

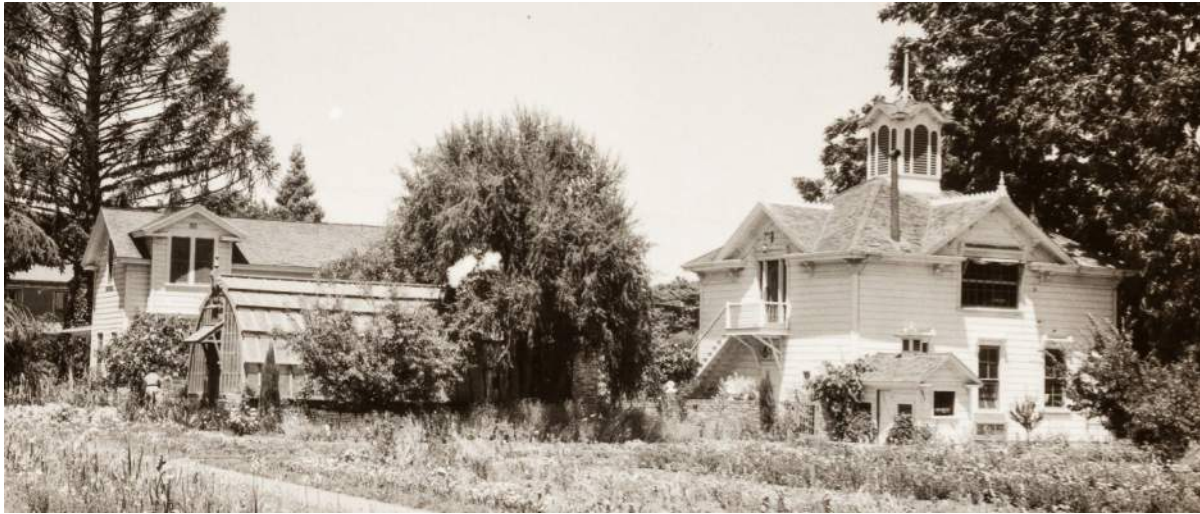
Image courtesy of the Luther Burbank Home & Gardens Association. c.1930. Only part of the original photograph is shown.  
Note cupola and cresting on roof of Carriage House.

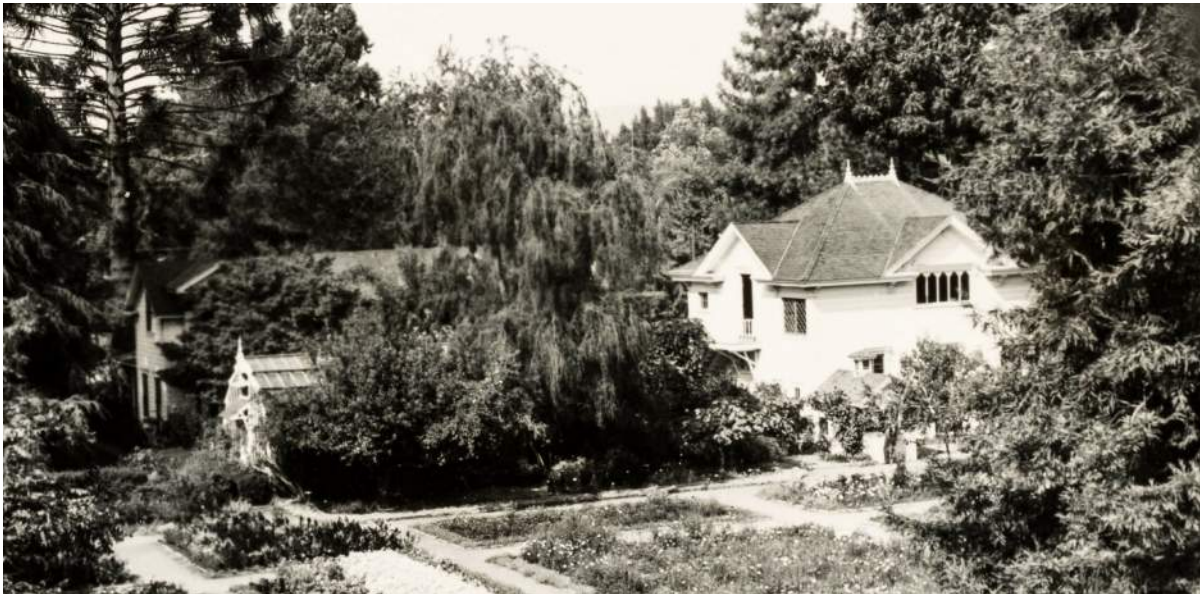
Image courtesy of the Luther Burbank Home & Gardens Association. c.1953. Only part of the original photograph is shown.  
Note missing cupola and cresting on roof of Carriage House.

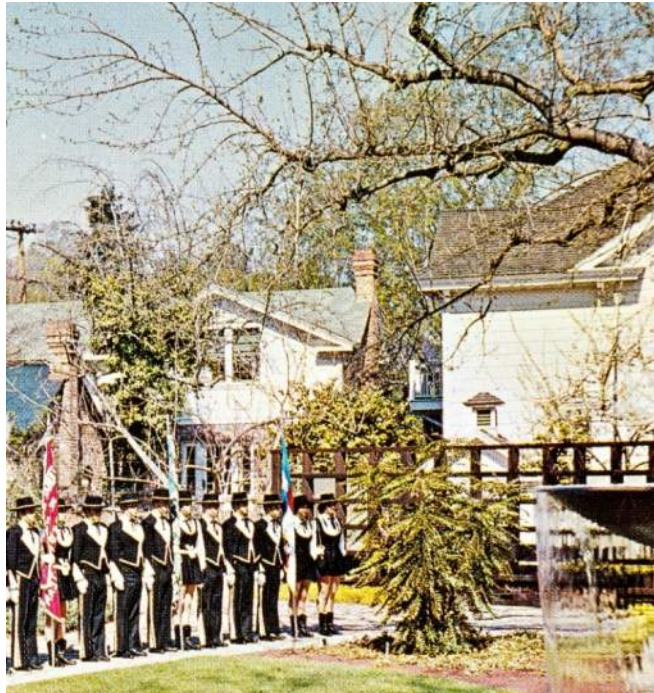
Image courtesy of the Luther Burbank Home & Gardens Association. c.1960. Only part of the original photograph is shown. Note what appear to be wood shingle roof on Carriage house.

The Carriage House retains a strong association with Luther Burbank due to his involvement in the construction and relatively few alterations over time. A new wood shingle roof would be the most compatible choice for the building, but fire codes prohibit the use of wood roofing. Therefore, it is recommended that new asphalt roofing material simulate the original roofing to the greatest extent possible in size, shape, and color. The color of the Carriage House roof should match that of the Main House. The gutters and downspouts date to 2014 and are recommended to remain in place with any deficiencies repaired as part of the project.
