MEMORANDUM

PROJECT: Luther Burbank Home and Gardens Re-Roofing Project
TreanorHL Project #: HP0883.2001.00

The purpose of this Memorandum is to outline the research undertaken to date on the roofs of the Main House and Carriage House and to provide recommendations for the re-roofing project.

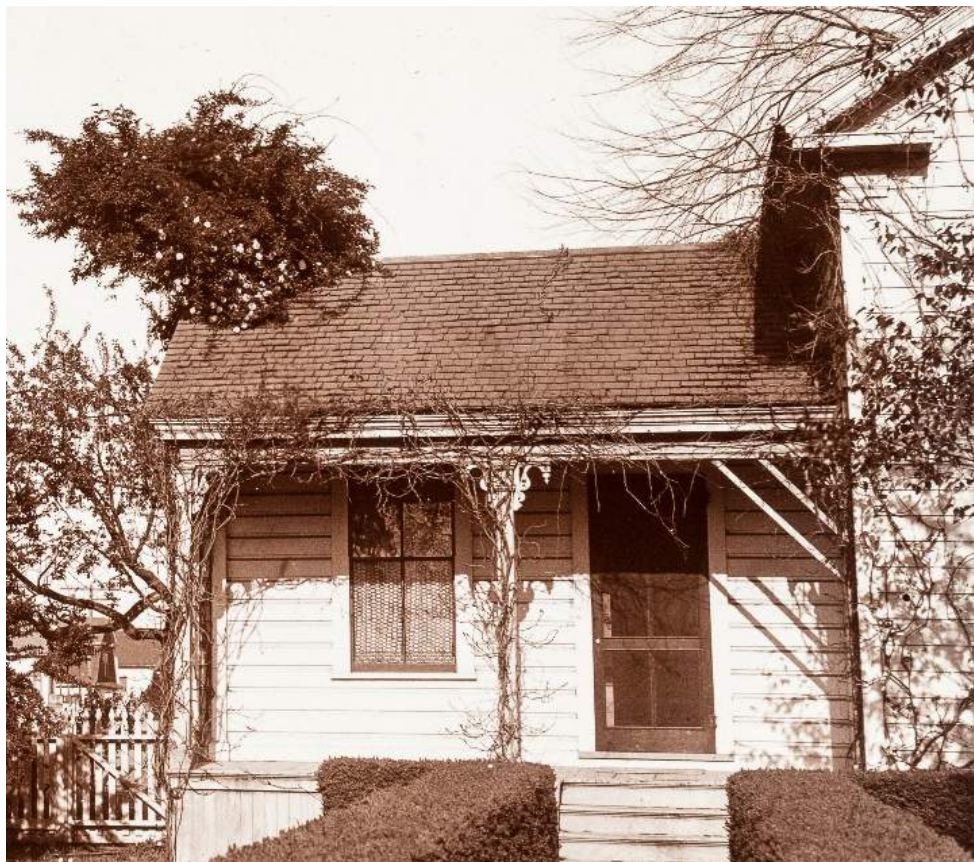
Image courtesy of the Luther Burbank Home & Gardens Association. c.1890. Only part of the original photograph is shown.
Note wood shingle roof and lack of gutters or downspouts.

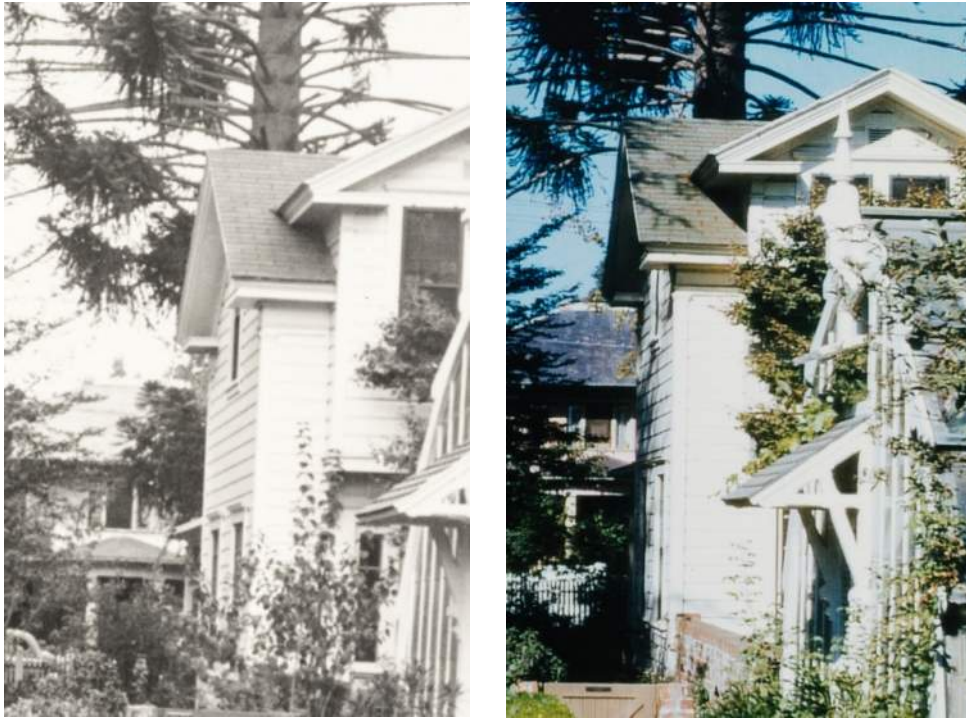
Images courtesy of the City of Santa Rosa and the Luther Burbank Home & Gardens Association. c.1940 (left) and c.1950 (right). Only part of the original photograph is shown. Note asphalt shingle roofing.

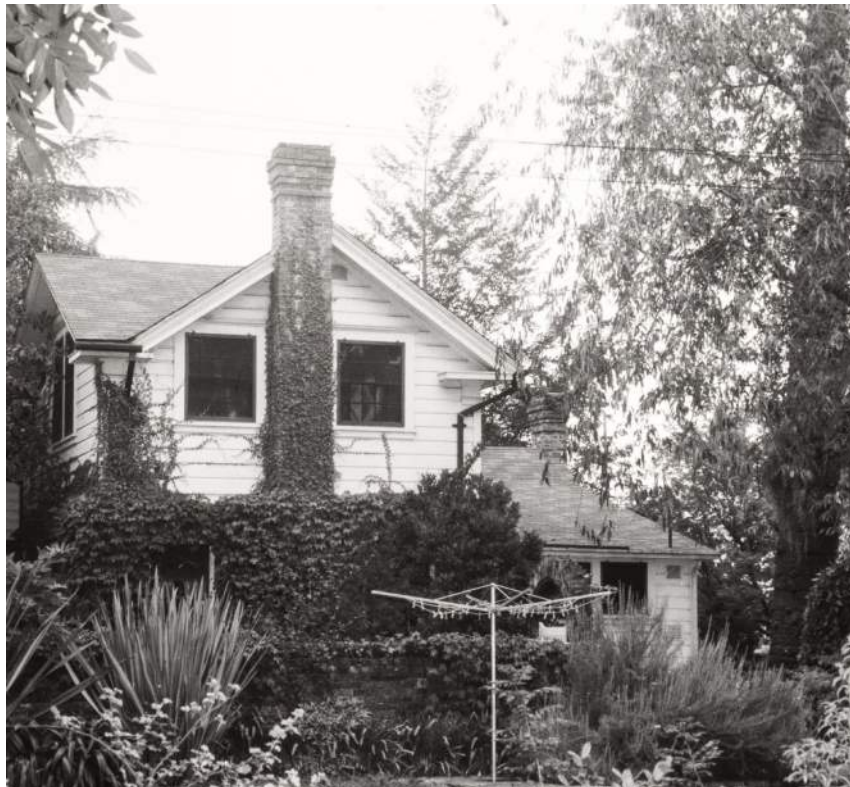
Image courtesy of the City of Santa Rosa and the Luther Burbank Home & Gardens Association. c.1950. Only part of the original photograph is shown. Note asphalt roof and gutters.

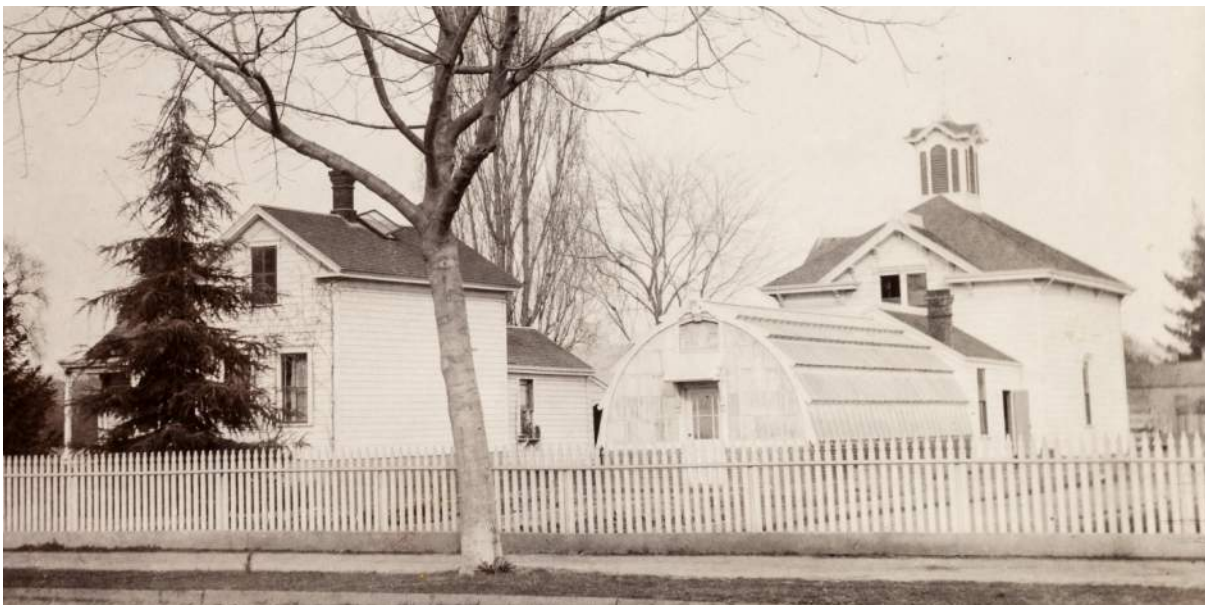
Image courtesy of the Luther Burbank Home & Gardens Association. c.1890. Only part of the original photograph is shown.
Note wood shingle roof on Carriage House.

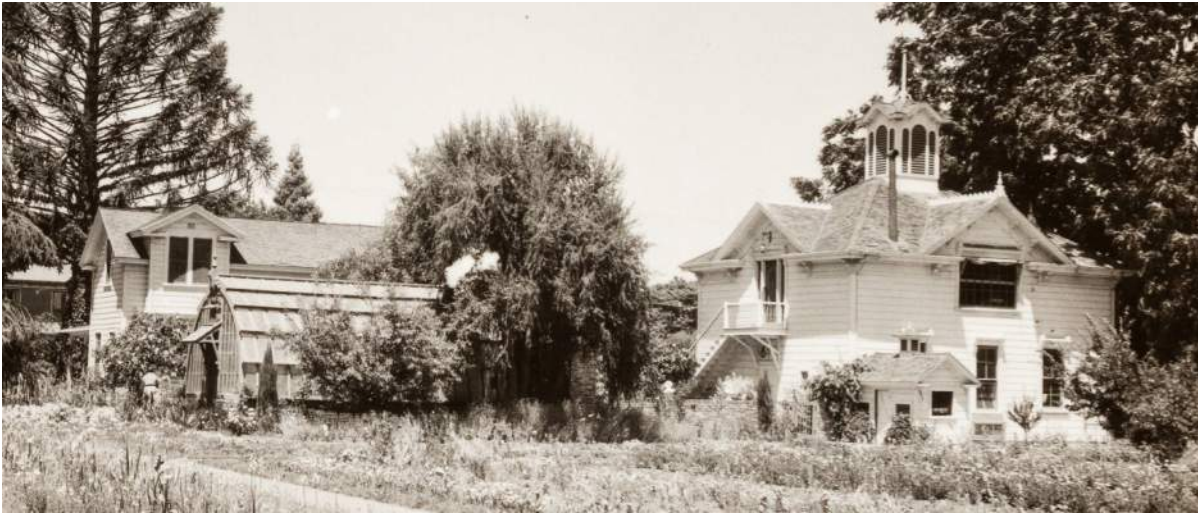
Image courtesy of the Luther Burbank Home & Gardens Association. c.1930. Only part of the original photograph is shown.
Note cupola and cresting on roof of Carriage House.
