Painter Preservation
HISTORIC PRESERVATION & URBAN DESIGN

May 16, 2022

Re Historic Resource Evaluation (HRE) for Minor Landmark Alteration, 349 College Avenue

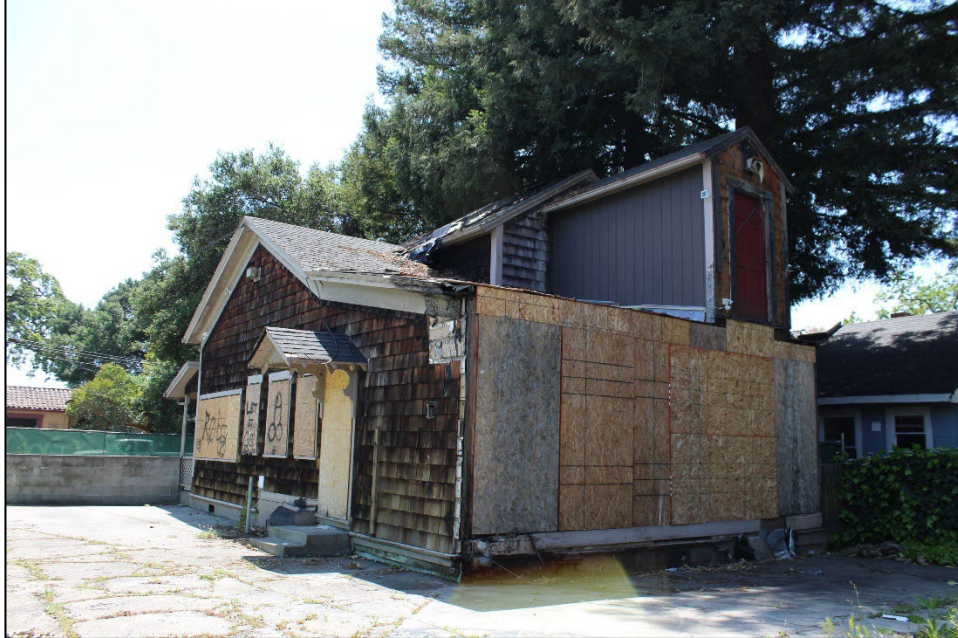
The fire that damaged the building burned the exterior stairs on the north side (not original to the building) and the materials on the north façade of the building.

Photo 8: East side and north (rear) façade, looking SW

Deteriorated historic features, including the burned areas on the back of the building, will be repaired as part of the proposed changes for the building. No missing features will be added.
