Post-fire Water Quality Investigation

March 27, 2018

Joint City Council and Board of Public Utilities Meeting

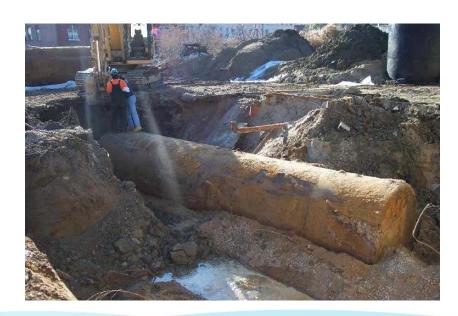
What Sources can we Rule Out?

- Fuel Spill
- Leaking Underground Storage Tank

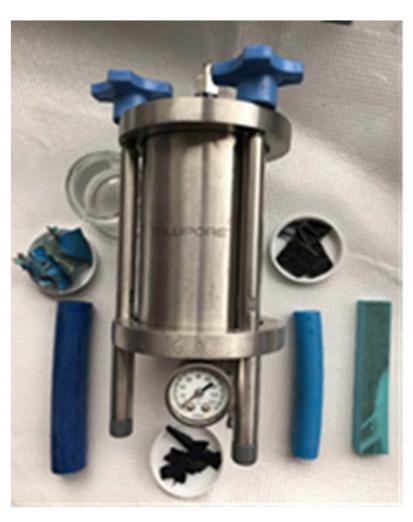
Chemical Testing - Leachability

- Determination of leach potential of piping and ancillary equipment
- Identification of contaminants and byproducts leached from materials impacted by fire damage
- Samples are placed in ultrapure water for a minimum of 69 hours using a zero headspace extraction (ZHE) vessel to prevent loss of volatile compounds during leaching
- The leachate is then analyzed for organic compounds including benzene

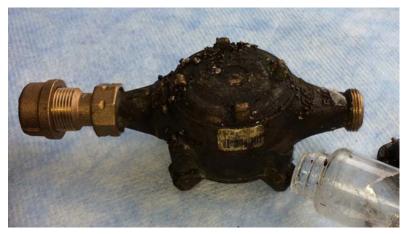
PRELIMINARY FINDINGS

1. The contamination present is related to fire damage through:

- Thermal degradation of system components such as plastics
- Entry of ash, soot and other debris into the piping and ancillary equipment when compromised during the fire event

2. The contamination present is not due to gasoline

Although benzene is a constituent of gasoline, the chemical fingerprint of the contamination found in samples submitted to Apex Forensics is not consistent with a subsurface petroleum release.

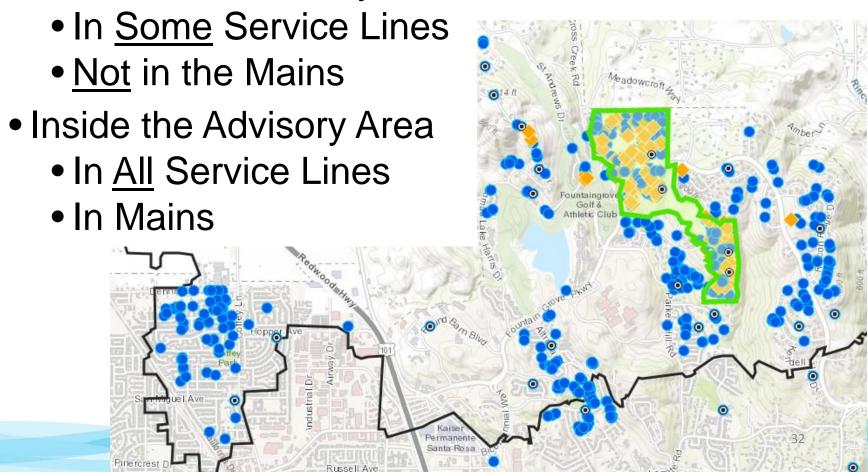
Outside the Advisory Area

What is the Extent?

- Partial Replacement
 - Replacing contaminated service lines
