BOARD OF COMMUNITY SERVICES REGULAR MEETING AGENDA AND SUMMARY REPORT - CANCELLED SEPTEMBER 28, 2022

8.2 PARKS CONDITION ASSESSMENT AND PRIORITIZATION REPORT UPDATE

- CITY OF SANTA ROSA -PARKS CONDITION ASSESSMENT & PRIORITIZATION REPORT

- FUNDED BY MEASURE M - PARKS FOR ALL -

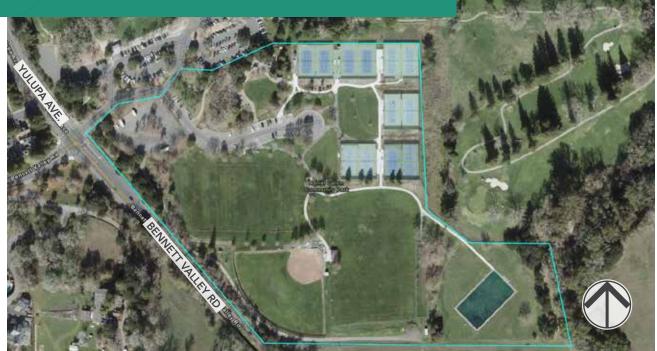
GALVIN COMMUNITY PARK

The overall condition of the park is good, with a majority of the amenities in good condition. Galvin Park has a very high level of recreation programming, very high play value, and has a few significantly non-compliant ADA features.

The critical condition amenities within the park are the tennis courts and structures. Tennis courts #9 and #10 have cracking throughout the court surfacing. The storage shed near tennis court #1 has been vandalized.

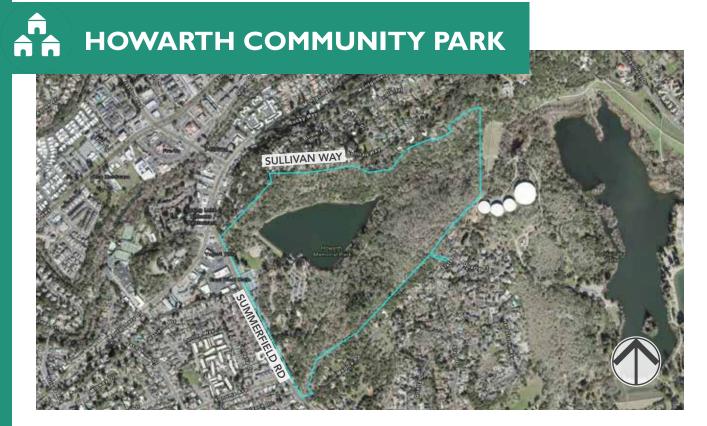
The overall condition of the park is adequate, and a majority of the amenities are fully functional. Howarth Park has a very high level of recreation programming, very high play value, and has a number of significantly non-compliant ADA elements.

The critical condition amenities within the park are the playgrounds and tennis courts. The sand play areas have low levels of sand and portions of the tennis court surfacing have substantial cracking, making those areas unplayable.

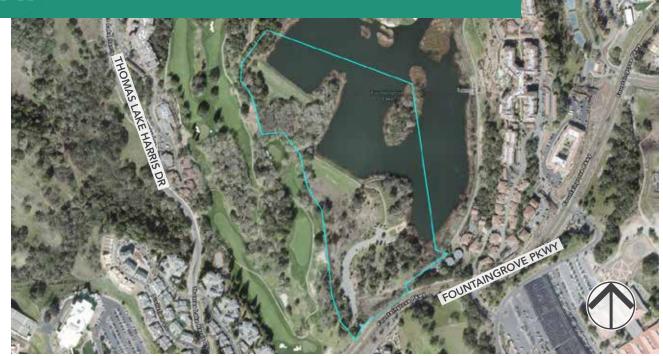
The overall condition of the park is adequate, and a majority of the amenities are fully functional. Nagasawa Community Park does not have recreation programming, has moderate play value, and has a few significantly non-compliant ADA features.

The critical condition amenity within the park is the irrigation system, which was damaged by the 2017 wildfire.

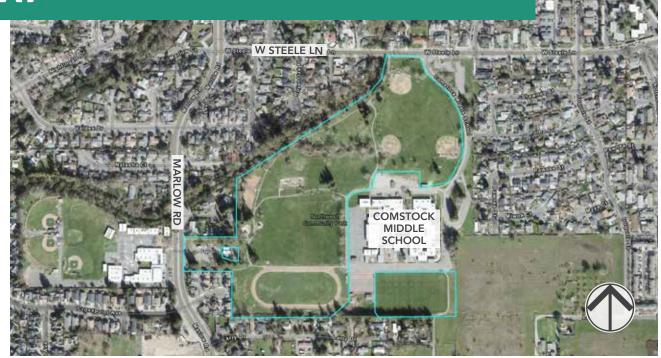
NORTHWEST COMMUNITY PARK

The overall condition of the park is adequate, and a majority of the amenities are fully functional. Northwest Community Park has a very high level of recreation programming, very high play value, and a number of significantly non-compliant ADA features.

The critical condition amenities within the park are the landscape, hardscape, and rugby field. The landscape has a substantial amount of weeds, the hardscape has deterioration in the asphalt pavement, and the rugby field has issues with irrigation coverage and furnishings that are worn.

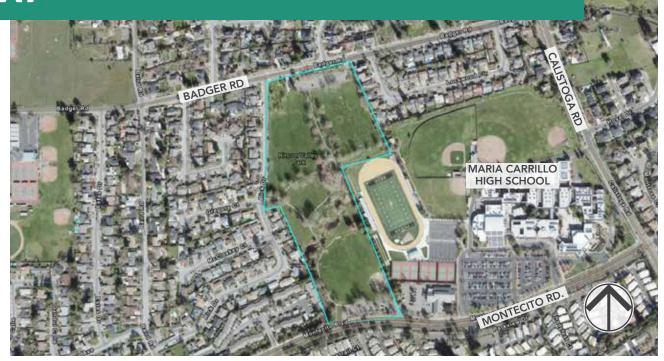
RINCON VALLEY COMMUNITY PARK

The overall condition of the park is adequate, with a majority of the amenities fully functional, while a few are in poor condition. Rincon Valley Community Park has a high level of recreation programming, very high play value, and has a number of significantly non-compliant ADA elements.

The critical condition amenities within the park are the playground and the dog park. The playground equipment has splintering wood, corrosion on metal surfaces, paint deterioration and substantial damage to the rubber tile surfacing. The dog park fence and gate have minor damage, the site furnishings are aged and deficient in quantity, and the drinking fountain is leaking.

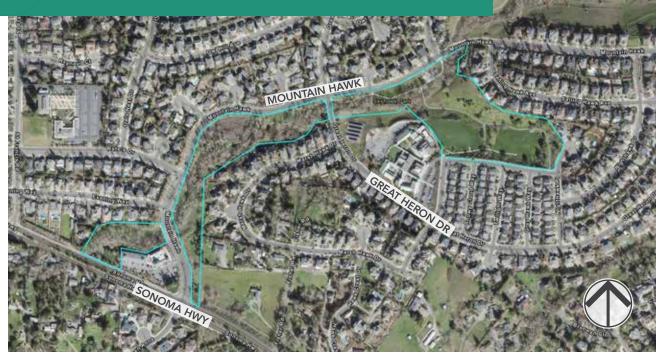
The overall condition of the park is good and a majority of the amenities are in good condition. Skyhawk Community Park does not have recreation programming, has very high play value, and has a few significantly non-compliant ADA features.

The critical condition amenity is the park's trail, which has significant cracking in the asphalt, moderate weed growth, and damaged fencing.

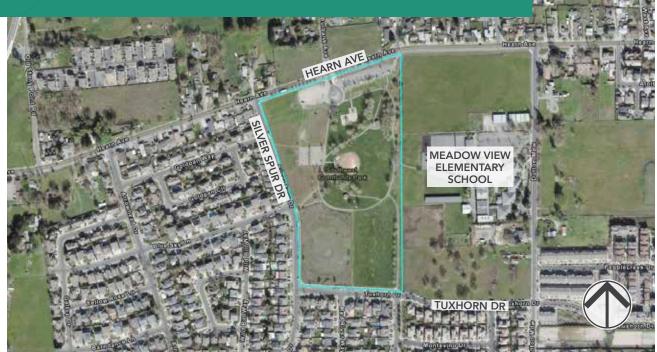
SOUTHWEST COMMUNITY PARK

The overall condition of the park is below adequate, with a majority of the amenities fully functional, while a few others are in critical condition. Southwest Park has a moderate level of recreation programming, very high play value, and has several significantly non-compliant ADA elements.

The critical condition amenities within the park are the general hardscape and the gravel parking lot. The asphalt has major cracking, while the parking lot has uneven surfacing and substantial pot holes.

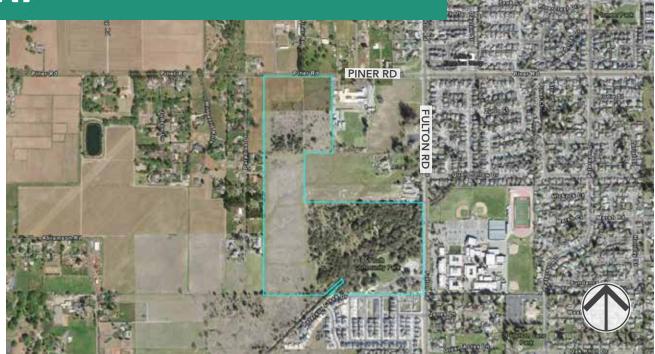
YOUTH COMMUNITY PARK

The overall condition of the park is adequate, with a majority of the amenities fully functional, while a few others are in critical condition. Youth Community Park has a very high level of recreation programming, very high play value, and has a number of significantly non-compliant ADA elements.

The critical condition amenity within the park is the trail, which has uneven surfacing throughout.

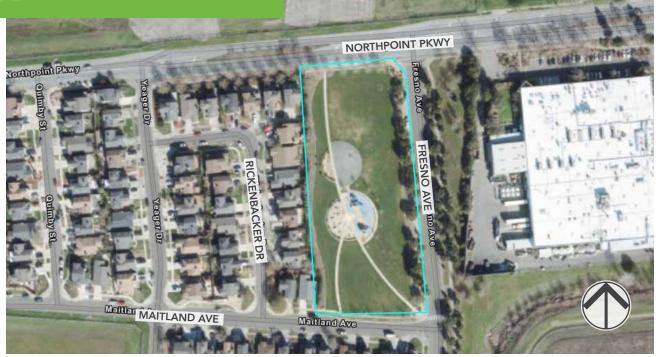
The overall condition of the park is good and a majority of the amenities are in good condition. Airfield Park does not have recreation programming, has very high play value, and has a few significantly non-compliant ADA features.

There are no critical condition amenities within the park. However, the playground has missing signage and the trees around the picnic areas have died or been removed.

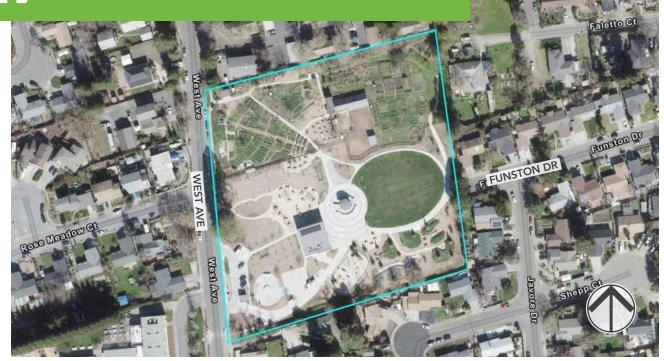
BAYER PARK AND GARDENS

The overall condition of the park is very good, a majority of the amenities are functional, and the park is not anticipated to need major improvements in the near-term. Bayer Park and Gardens has a high level of recreation programming, very high play value, and does not have non-compliant features identified by the 2013 and 2016 ADA assessments.

There are no critical condition amenities within the park. However, the playground mulch will soon need replenishing and the volleyball court does not have a net.

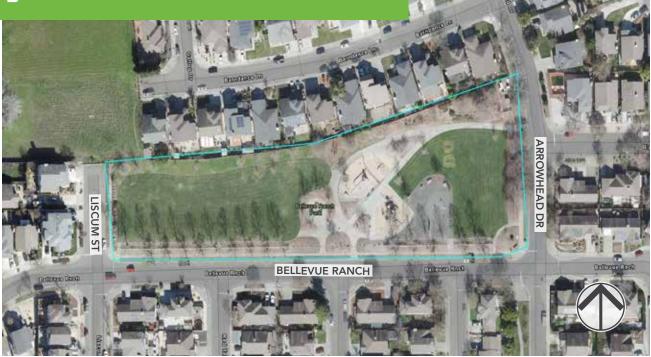
BELLEVUE RANCH PARK

The overall condition of the park is good and a majority of the amenities are fully functional. Bellevue Rank Park does not have recreation programming, has very high play value, and has a few significantly non-compliant ADA features.

The critical condition amenities within the park are the ornamental landscape areas, which have large gaps in vegetation, significant weeds and no mulch, and furnishings where there is a deficient quantity of trash receptacles.

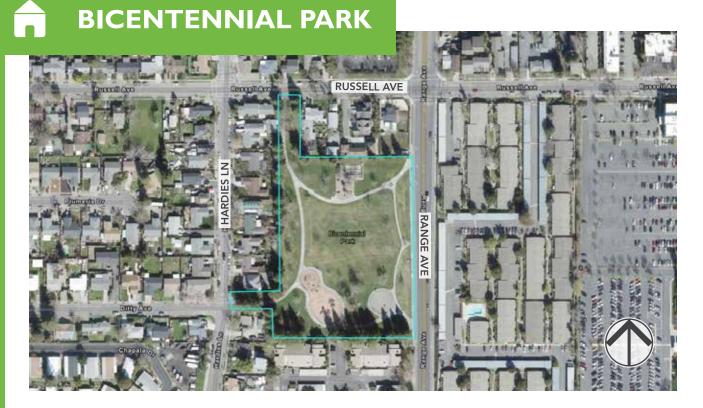
The overall condition of the park is adequate, aside from a number of deficient amenities. Bicentennial Park has minimal recreation programming, very high play value, and a few significantly non-compliant ADA features.

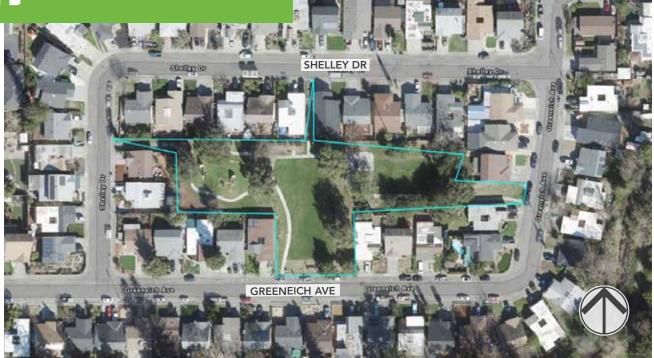
BRENDON PARK

The overall condition of the park is adequate, with a few amenities broken and not functioning. Brendon Park does not have recreation programming, has very high play value, and has a few significantly non-compliant ADA features.

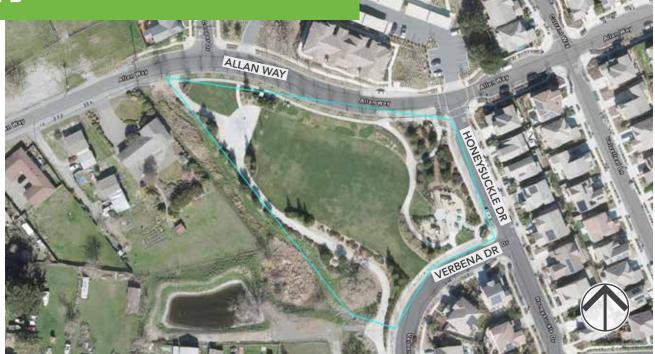
DAUENHAUER PARK

The overall condition of the park is very good, a majority of the amenities are functional, and the park is not anticipated to need major improvements in the near-term. Dauenhauer Park does not have recreation programming, has very high play value, and has a few significantly non-compliant ADA features.

There are no critical condition amenities at the park, though the basketball court lacks court striping.
